FINAL REPORT

SURVEY	MOORING ROPES INSPECTION
TO	TERMINAL TOTOTALILLO.
FROM	ALS INSPECTION CHILE SPA.
CLIENT REF	N/A.
ALS REF	ANF-2502-0365.
SCOPE OF SURVEY	INSPECTION OF 16 MOORING LINES.
VESSEL NAME	HEDWIG OLDENDORFF.
OWNER	OLDENDORFF CARRIERS GMBH Y CO. KS.
DISPONENT OWNER	OLDENDORFF CARRIERS GMBH Y CO. KS.
CHARTERERS	COMPAÑÍA MINERA DEL PACIFICO S.A SHIPPERS.
PLACE OF SURVEY	CALDERA, BAY.
DATE OF SURVEY	FEBRUARY 20, 2025.
TIME OF SURVEY	10:10 HRS. TO 12:32 HRS.

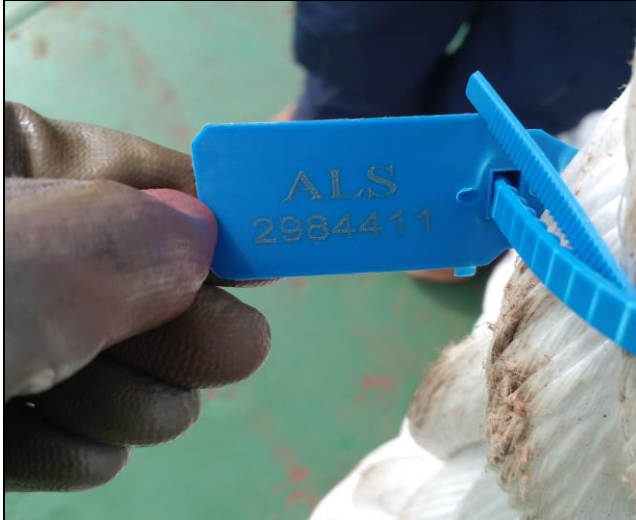
1. View of seal N° 2984411.

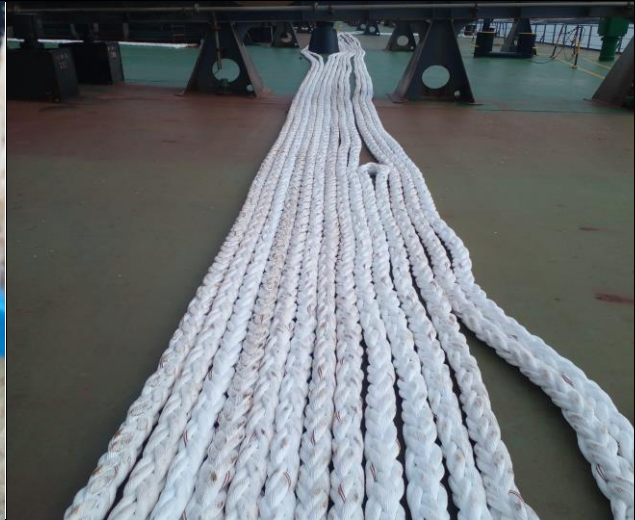
2. General view of the rope.

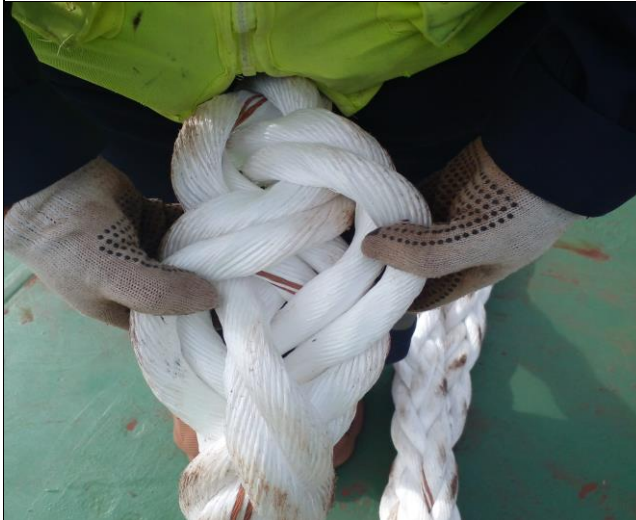
3. Internal condition of the ropes.

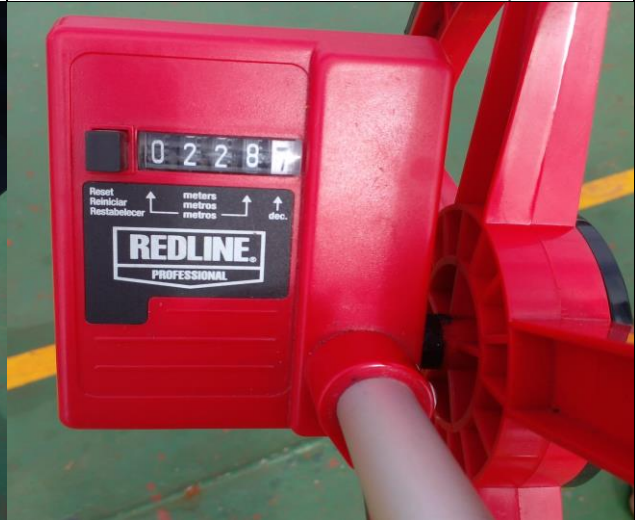
Length measured by surveyor: **228,7** meters.

4. Length measured by surveyor.

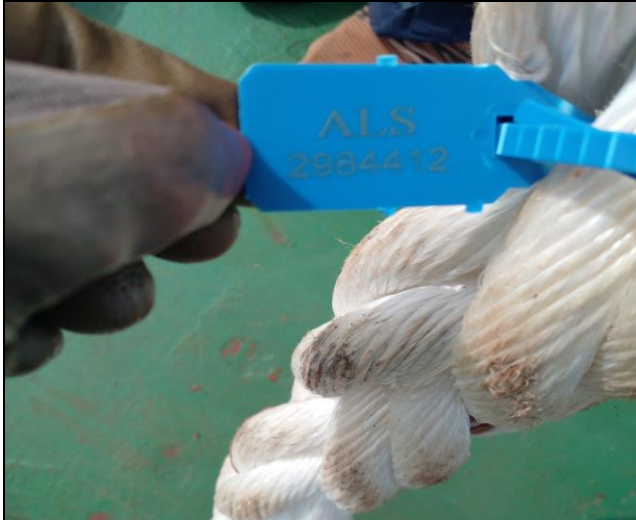
5. View of seal N° 2984412.

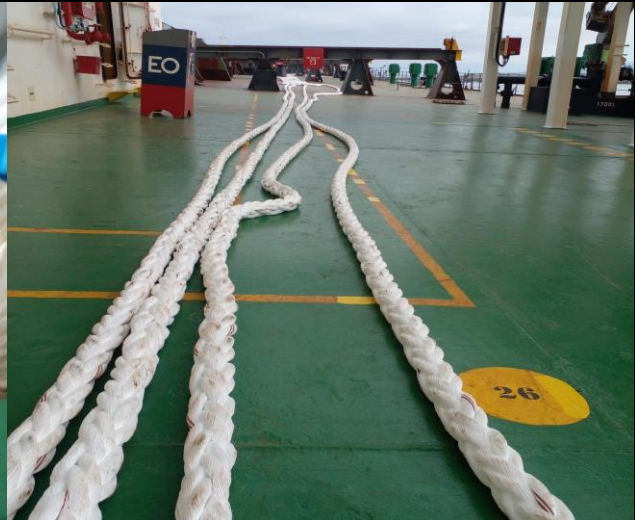
6. General view of the rope.

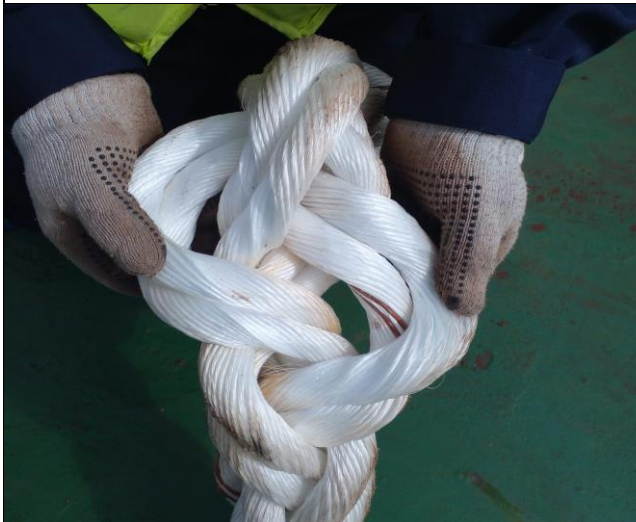
7. Internal condition of the ropes.

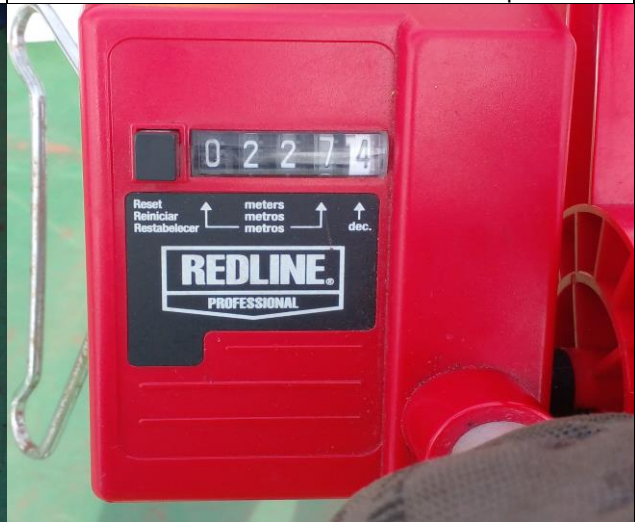
Length measured by surveyor: **227,4** meters.

8. Length measured by surveyor.

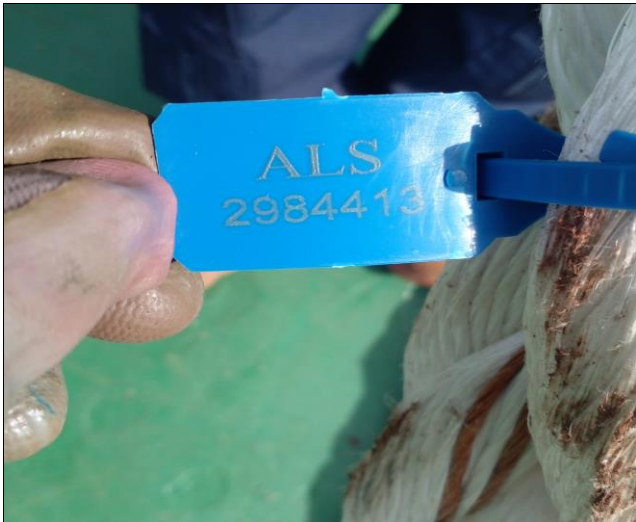
9. View of seal N° 2984413.

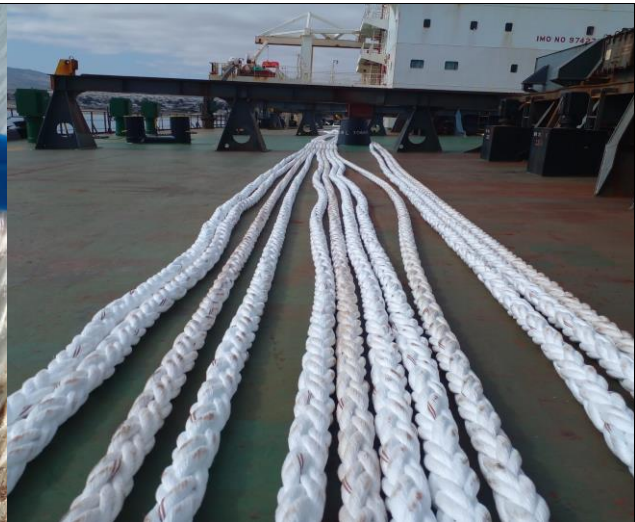
DAMAGE ITEM	GOOD	FAIR	POOR
Ext. Abrasion (max 25%)	<input type="checkbox"/>	<input checked="" type="checkbox"/>	Over 25% <input type="checkbox"/>
Int. Abrasion	<input checked="" type="checkbox"/>	<input type="checkbox"/>	<input type="checkbox"/>
Cut strands	<input checked="" type="checkbox"/>	<input type="checkbox"/>	<input type="checkbox"/>
Burn/ heated parts / fusion	<input checked="" type="checkbox"/>	<input type="checkbox"/>	<input type="checkbox"/>
Sun degradation /discoloration	<input checked="" type="checkbox"/>	<input type="checkbox"/>	<input type="checkbox"/>
Fiber broken	<input checked="" type="checkbox"/>	<input type="checkbox"/>	<input type="checkbox"/>
Black stains / dirty	<input checked="" type="checkbox"/>	<input type="checkbox"/>	<input type="checkbox"/>
Inconsistent diameter	<input checked="" type="checkbox"/>	<input type="checkbox"/>	<input type="checkbox"/>
Inconsistent flexibility	<input checked="" type="checkbox"/>	<input type="checkbox"/>	<input type="checkbox"/>

10. General view of the rope.

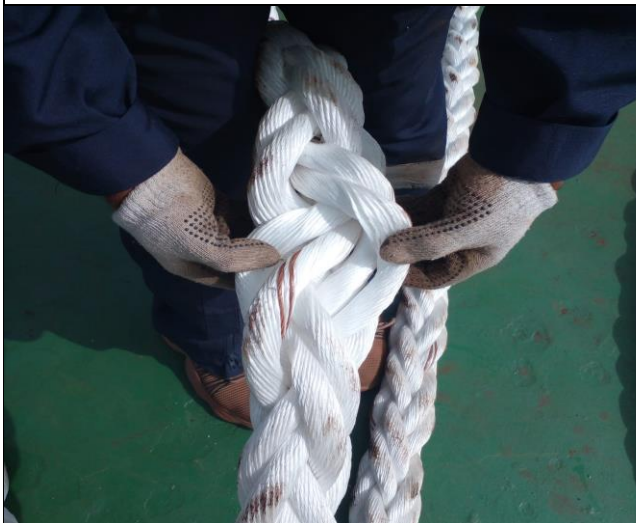
11. Internal condition of the ropes.

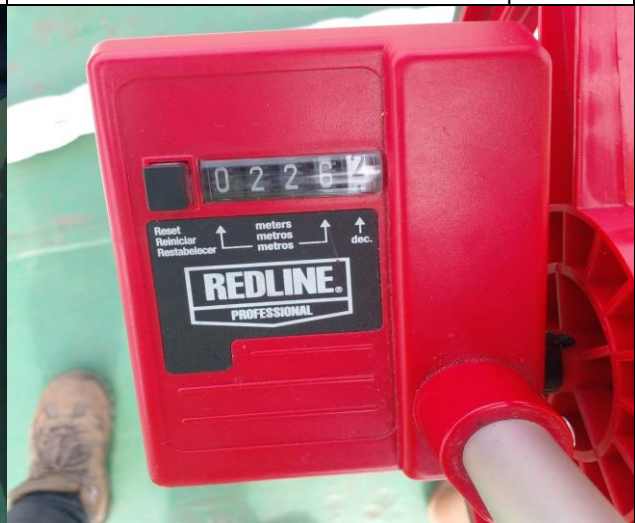
Length measured by surveyor: **226,2** meters.

12. Length measured by surveyor.

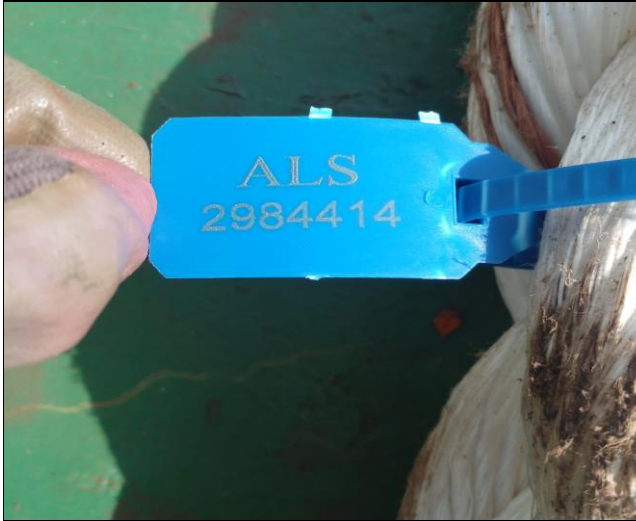
13. View of seal N° 2984414.

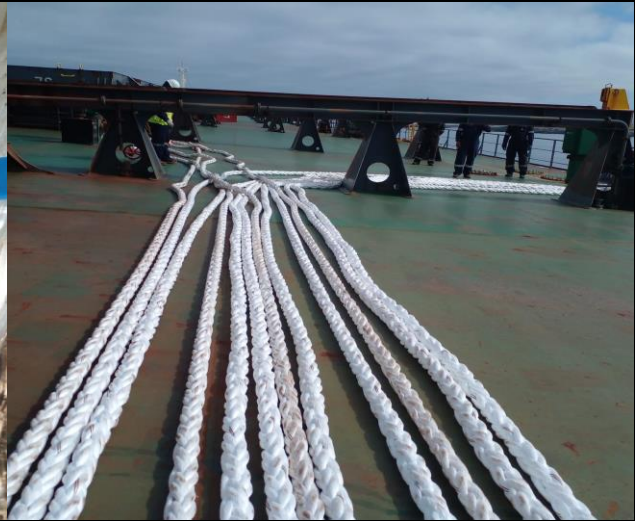
14. General view of the rope.

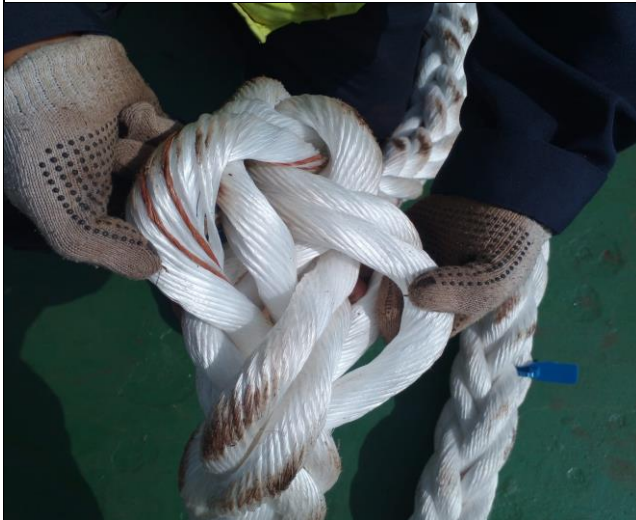
15. Internal condition of the ropes.

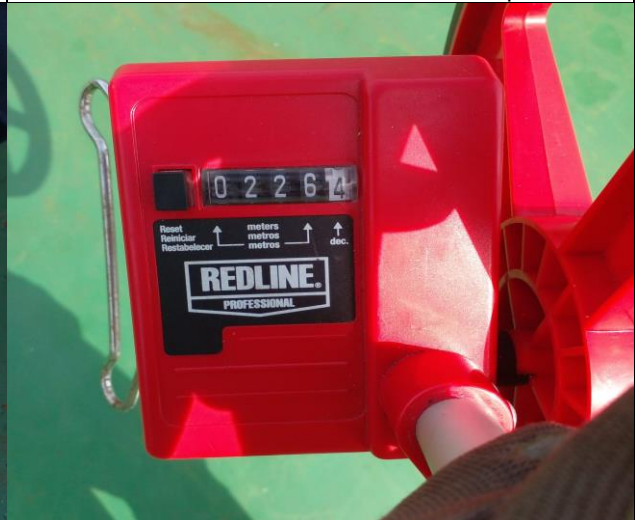
Length measured by surveyor: **226,4** meters.

16. Length measured by surveyor.

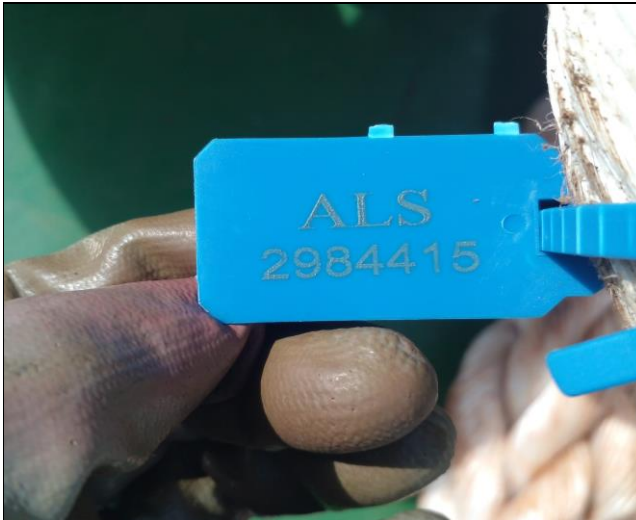
17. View of seal N° 2984415.

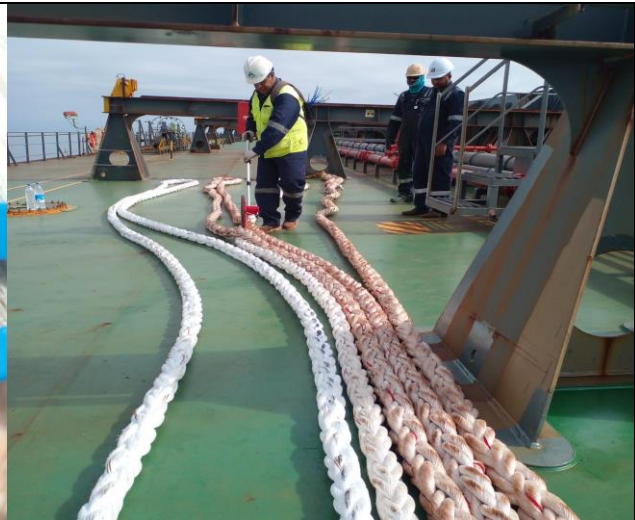
18. General view of the rope.

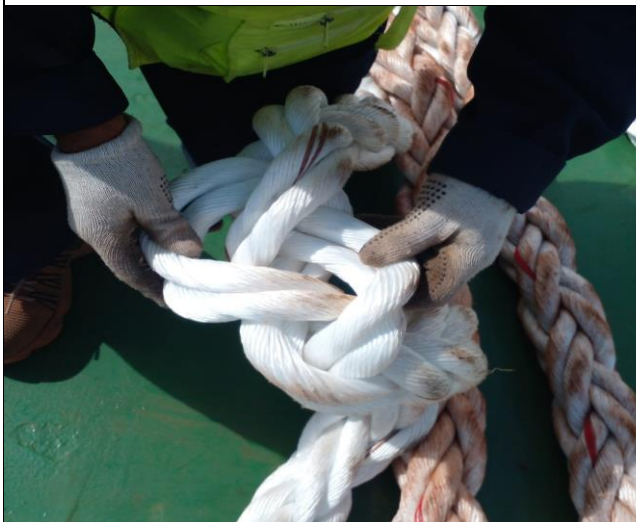
19. Internal condition of the ropes.

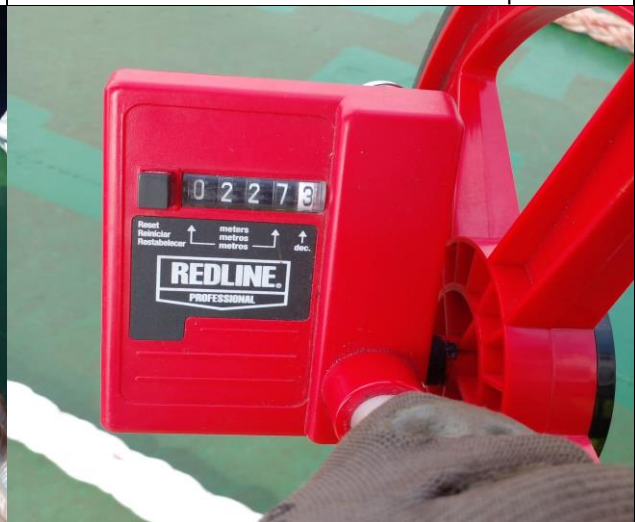
Length measured by surveyor: **227,3** meters.

20. Length measured by surveyor

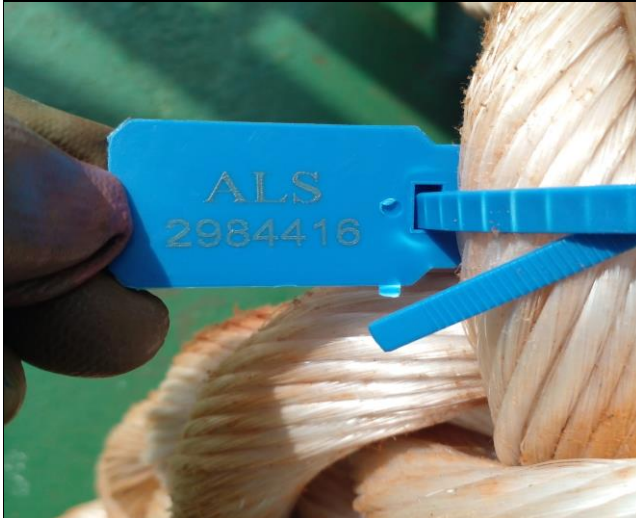
21. View of seal N^a 2984416.

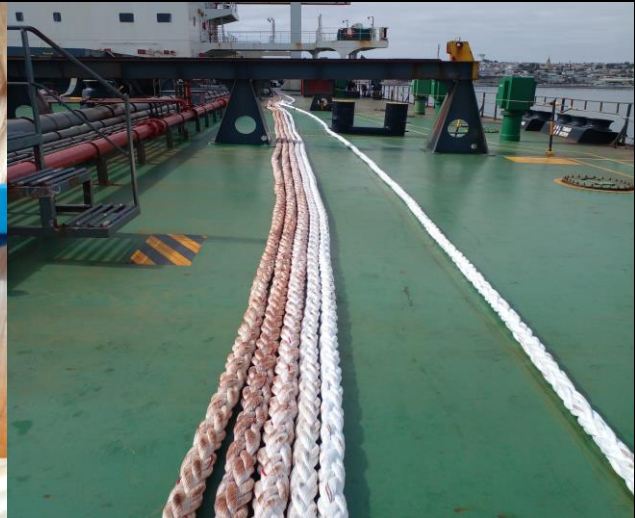
22. General view of the rope.

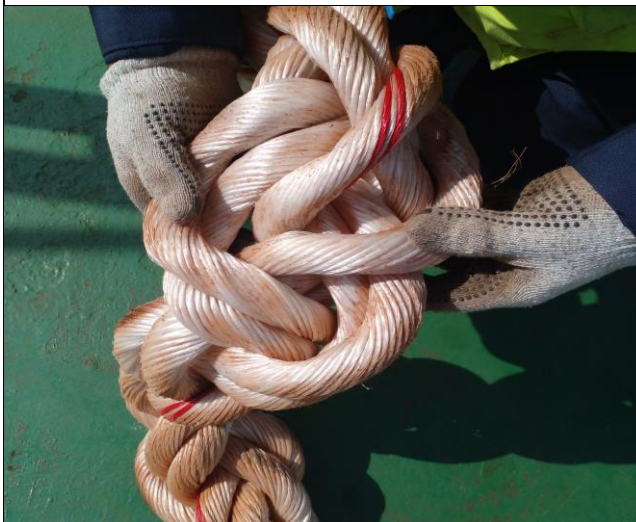
23. Internal condition of the ropes

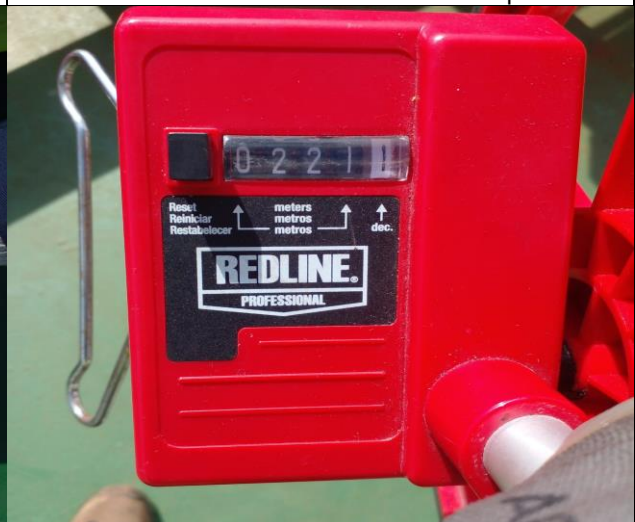
Length measured by surveyor: **221,1** meters.

24. Length measure by surveyor.

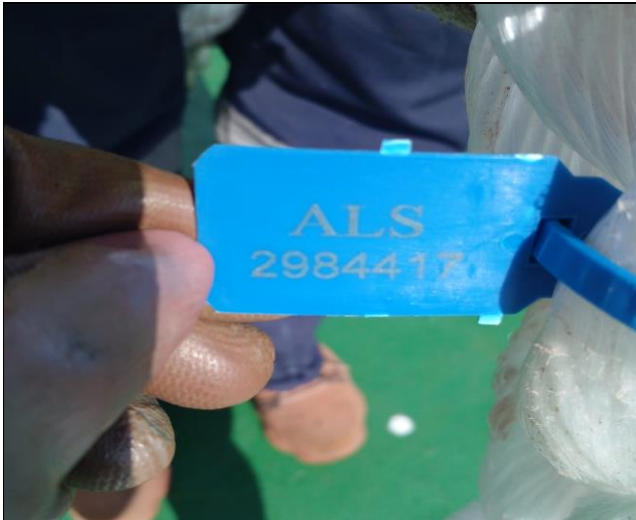
25. View of seal N° 2984417.

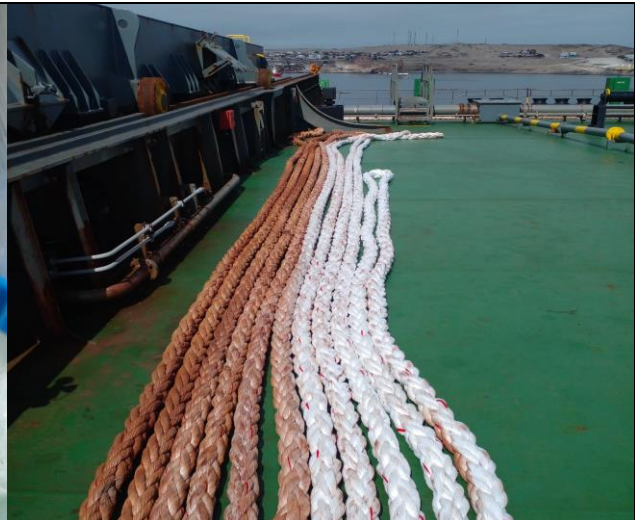
26. General view of the rope.

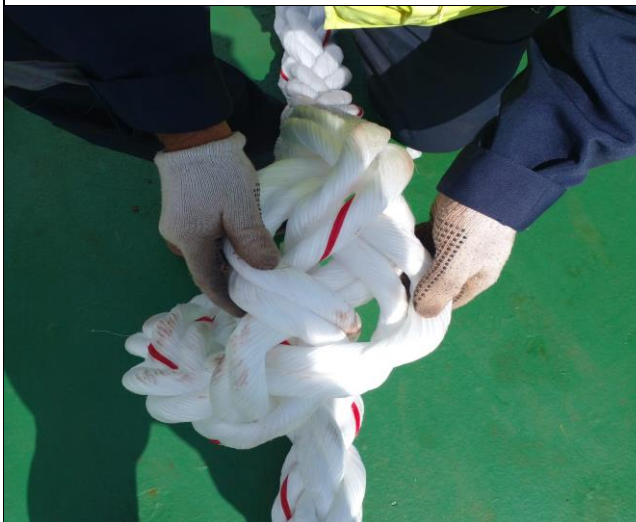
27. Internal condition of the ropes.

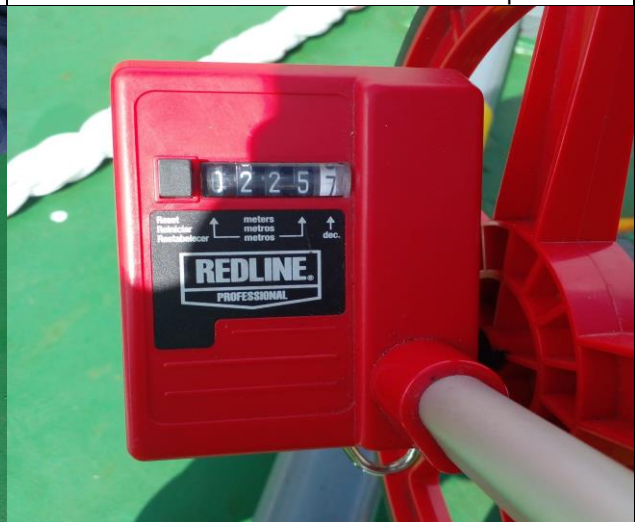
Length measured by surveyor: **225,7** meters.

28. Length measure by surveyor.

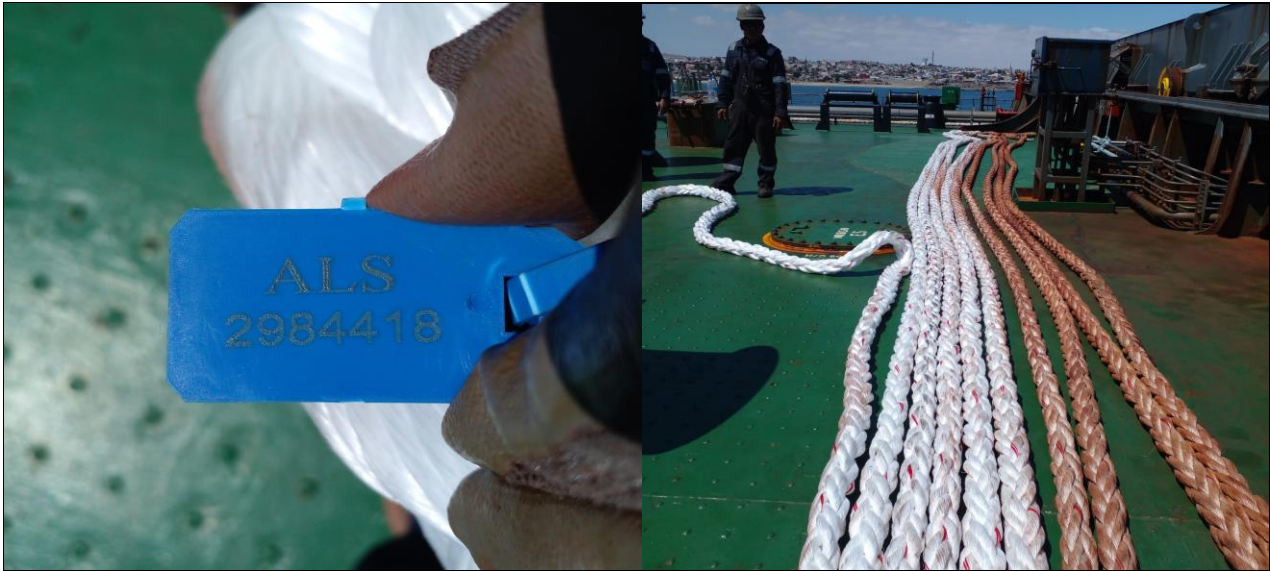
29. View of seal N° 2984418.

30. General view of the rope.

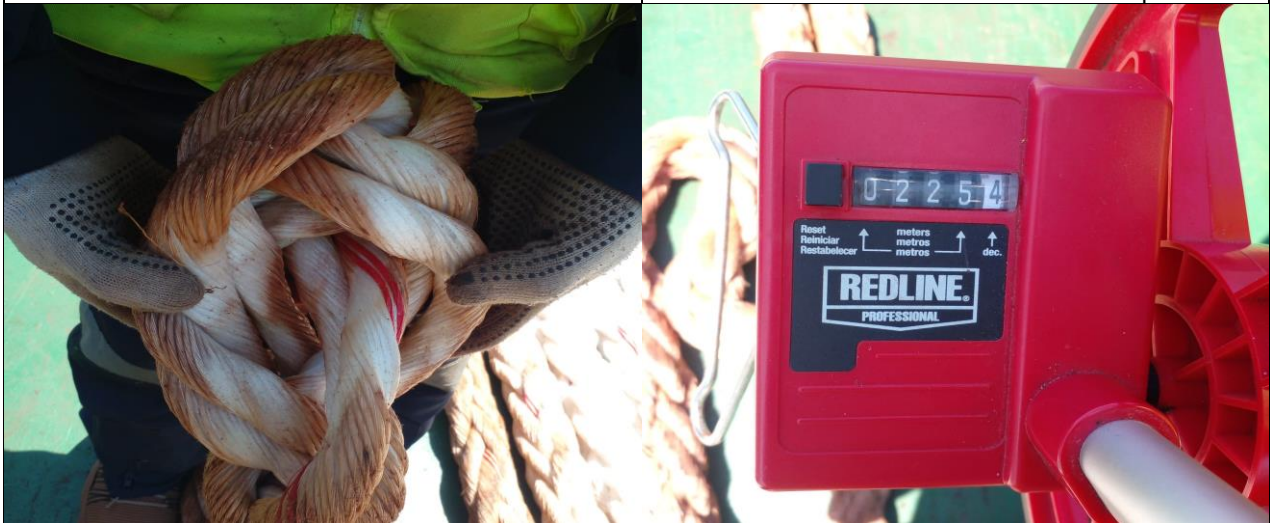
Length measured by surveyor: **225,4** meters.

31. Internal condition of the ropes.

32. Length measured by surveyor.

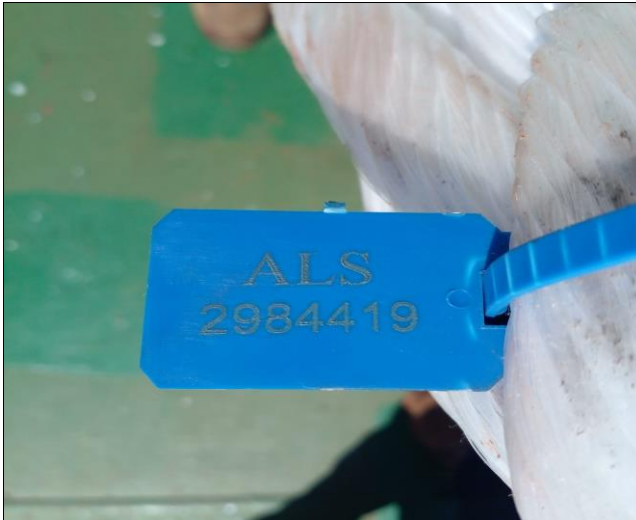
33. View of seal N° 2984419.

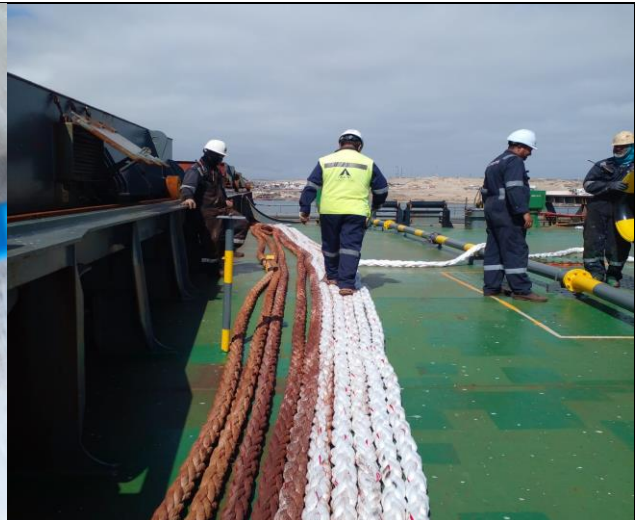
34. General view of the rope.

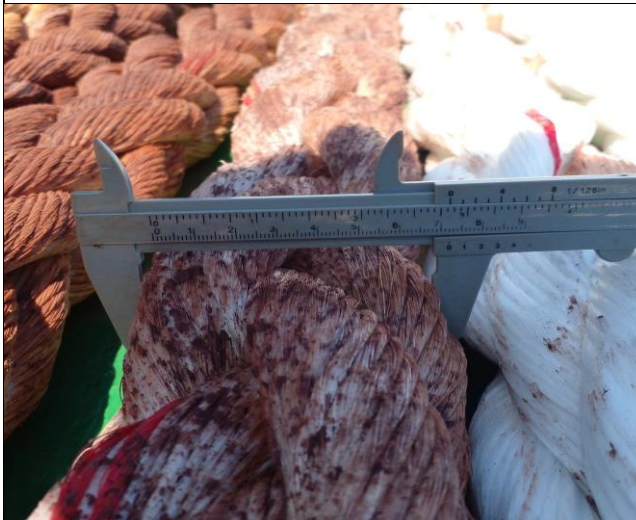
35. Diameter of the mooring line.

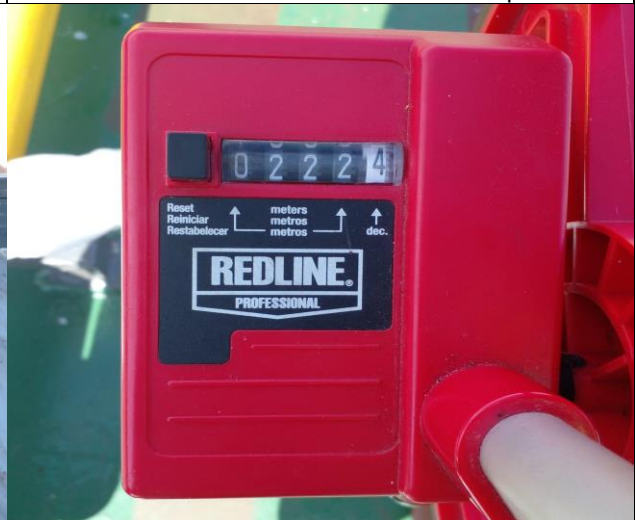
Length measured by surveyor: **222,4** meters.

36. Length measured by surveyor.

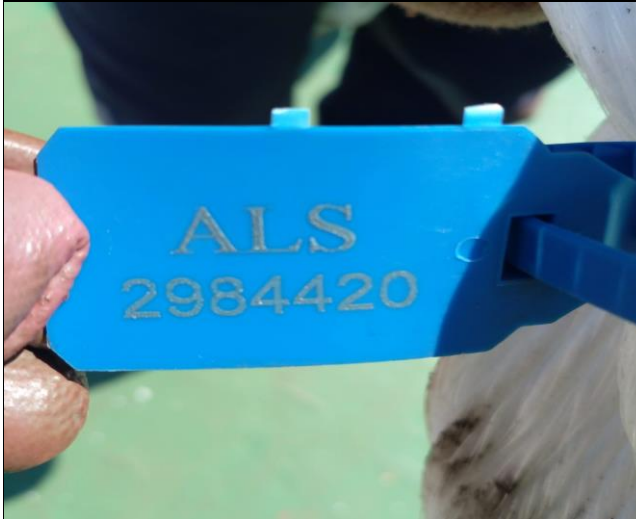
37. View of seal N° 2984420.

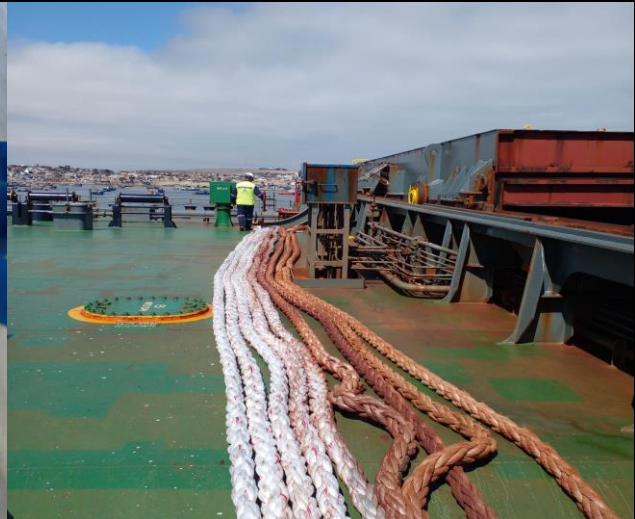
38. General view of the rope.

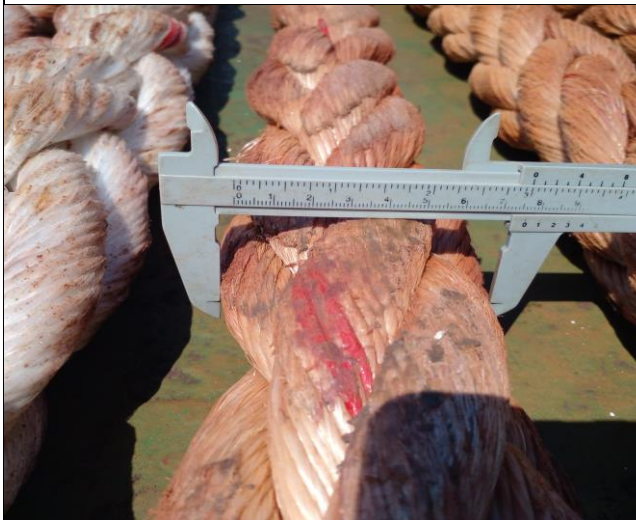
39. Diameter of the mooring line.

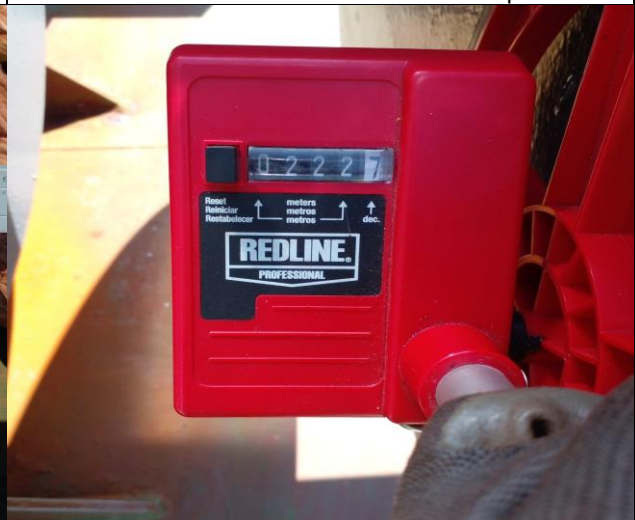
Length measured by surveyor: **222,7** meters.

40. Length measured by surveyor.

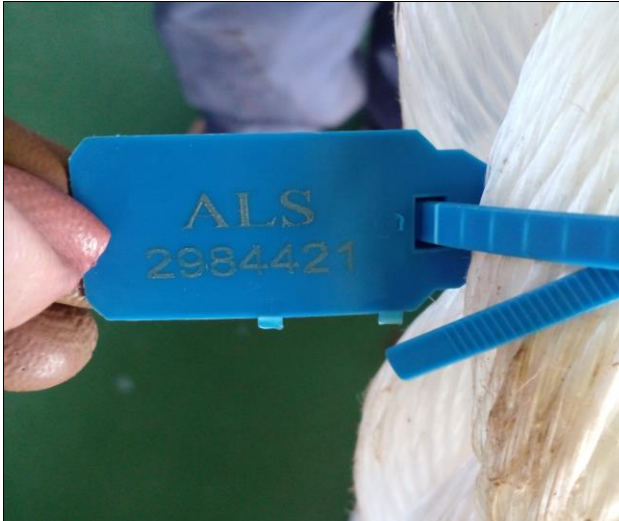
41. View of seal N° 2984421.

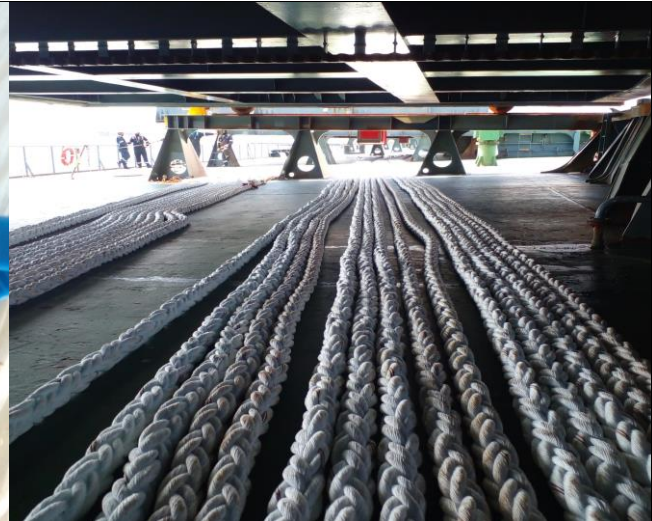
42. General view of the rope.

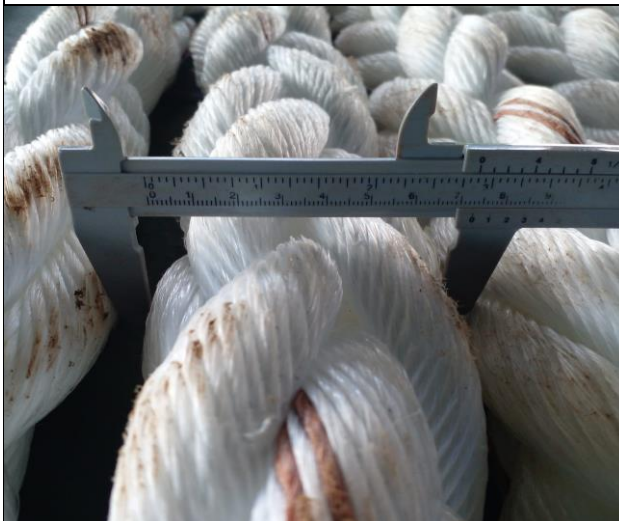
43 Diameter of the mooring line.

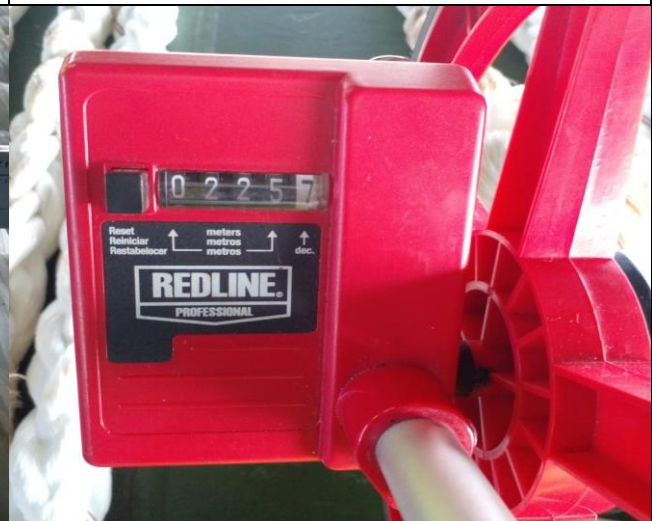
Length measured by surveyor: **225,7** meters.

44. Length measured by surveyor.

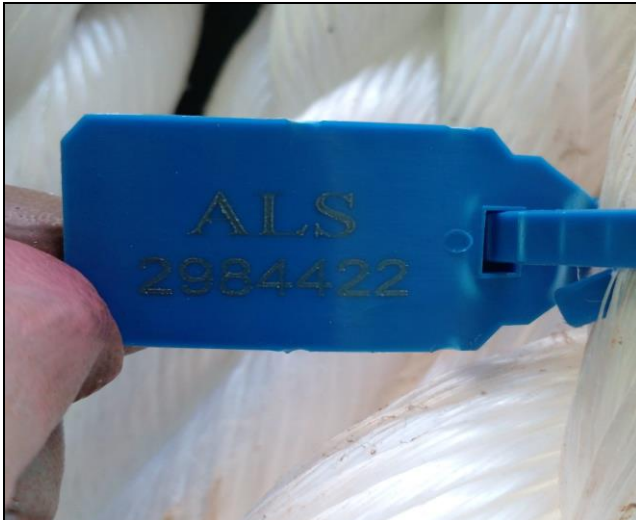
45. View of seal N° 2984422.

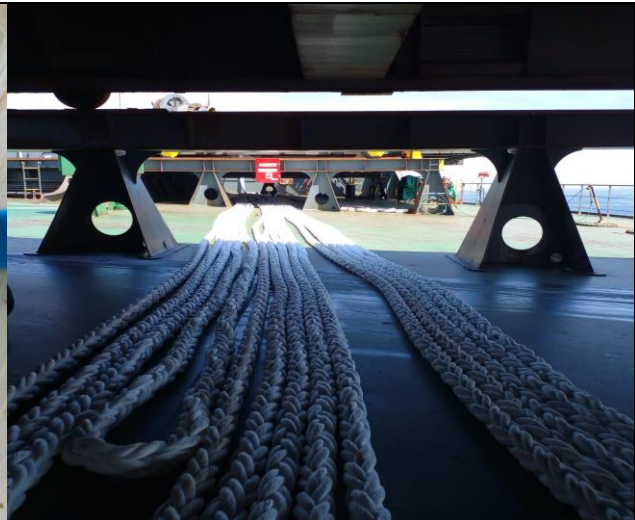
46. General view of the rope.

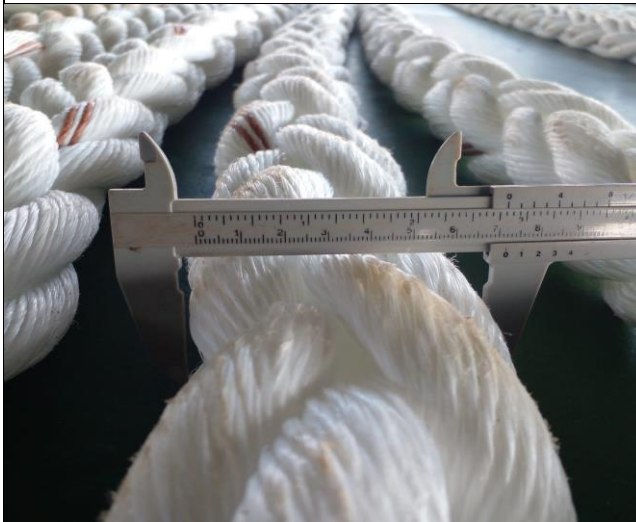
47. Diameter of the mooring line.

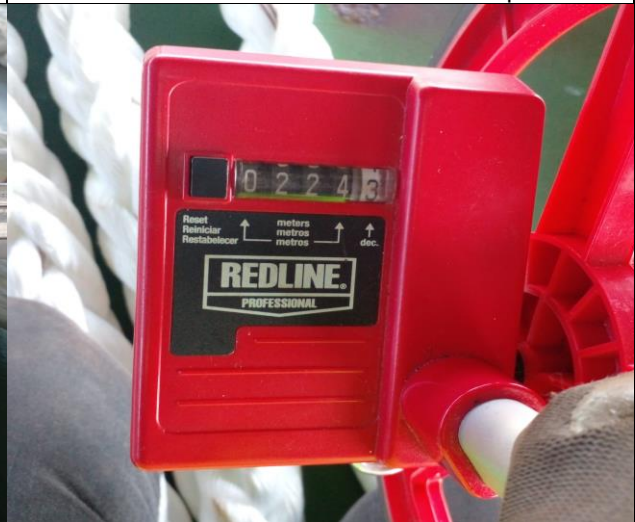
Length measured by surveyor: **224,3** meters.

48. Length measured by surveyor.

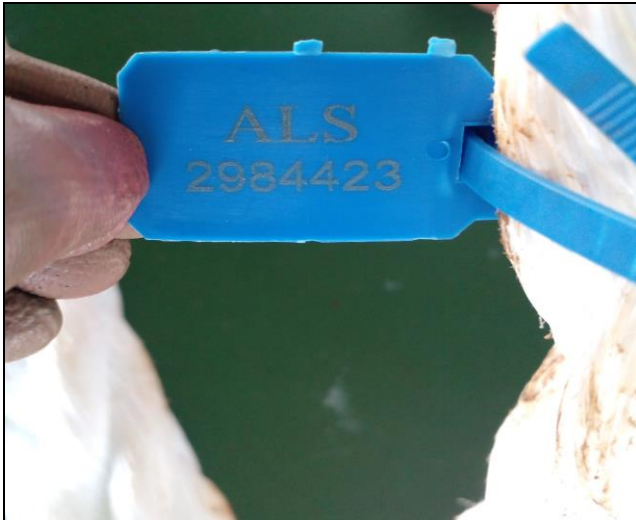
49. View of seal N° 2984423.

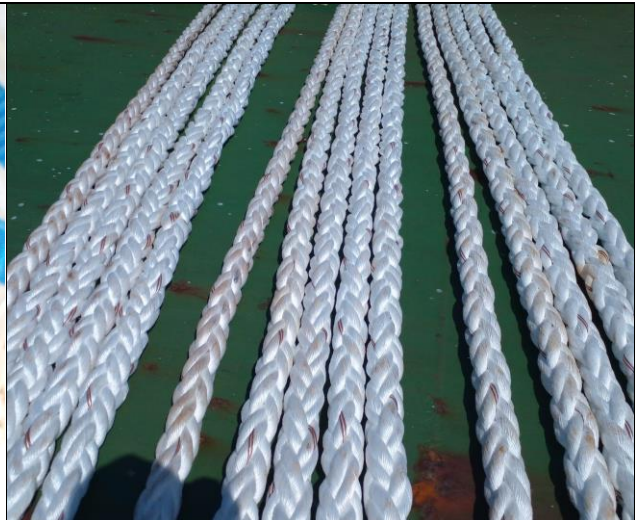
50. General view of the rope.

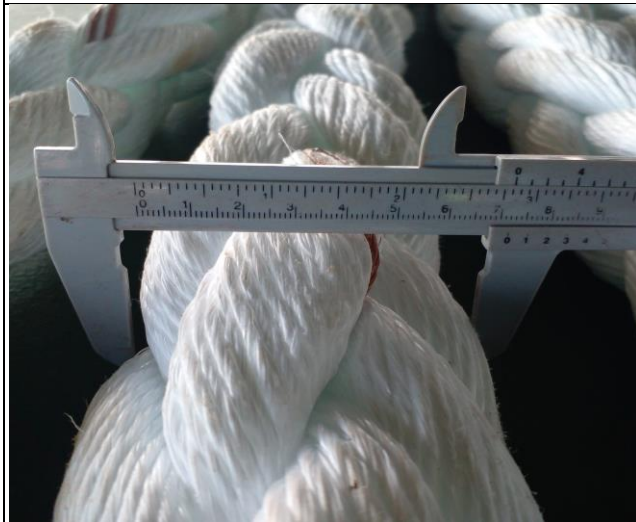
51. Diameter of the mooring line.

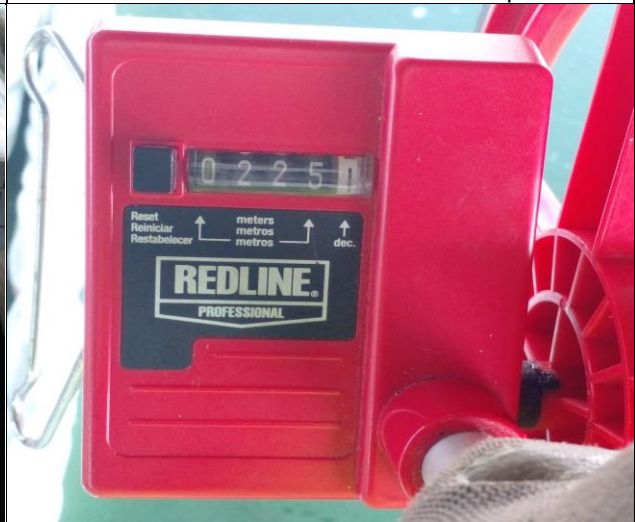
Length measured by surveyor: **225,1** meters.

52. Length measured by surveyor.

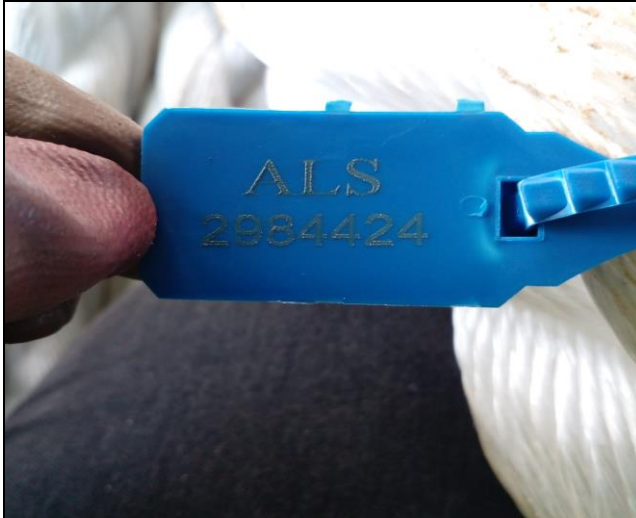
53. View of seal N° 2984424.

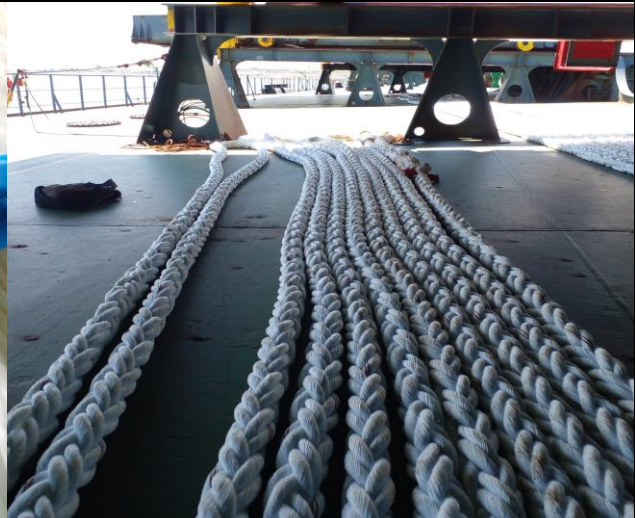
54. General view of the rope.

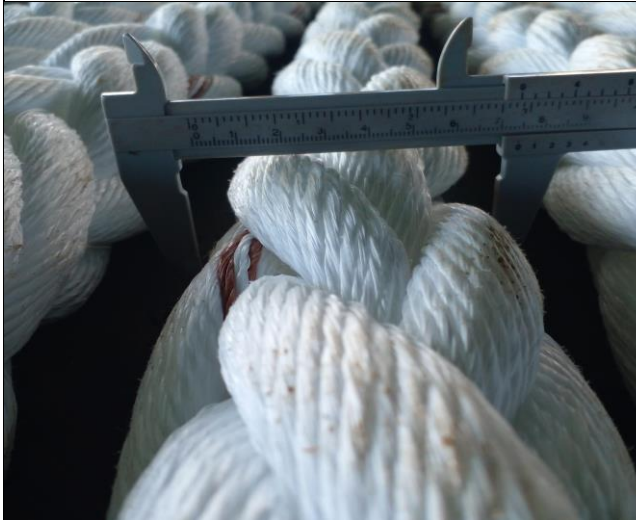
55. Diameter of the mooring line.

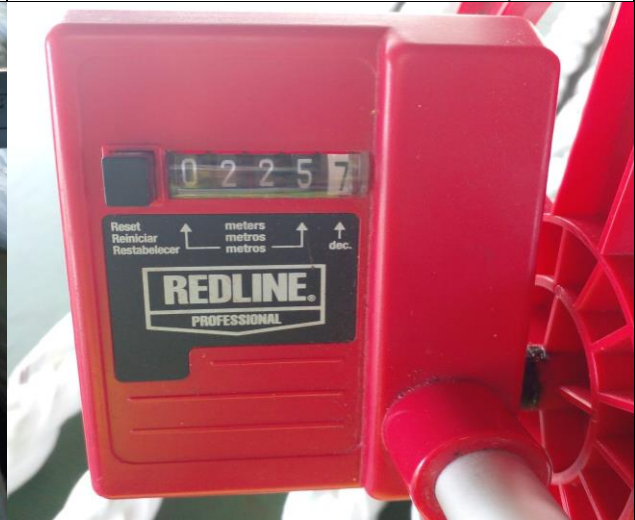
Length measured by surveyor: **225,7** meters.

56. Length measured by surveyor.

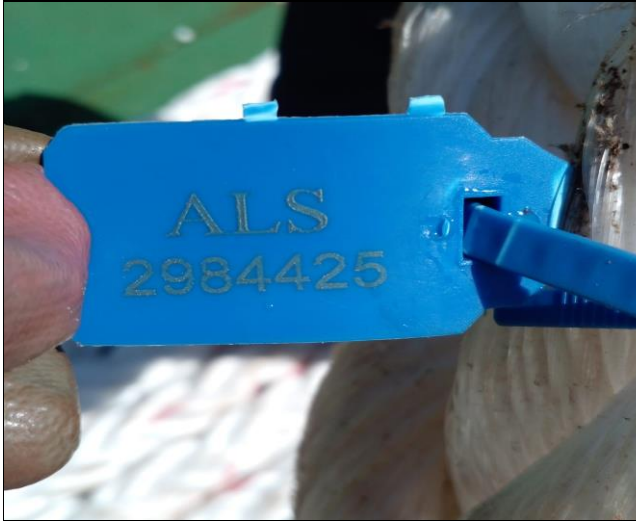
57. View of seal N° 2984425.

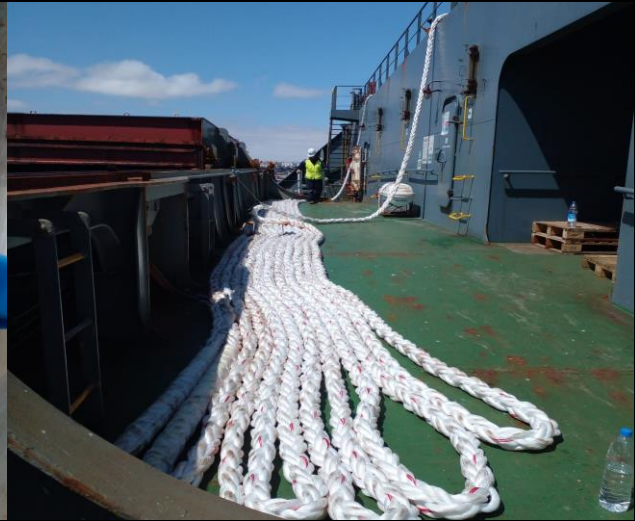
58. General view of the rope.

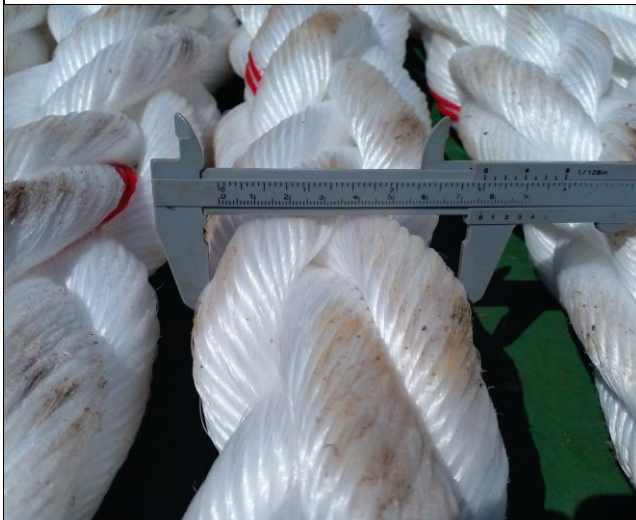
59. Diameter of the mooring line.

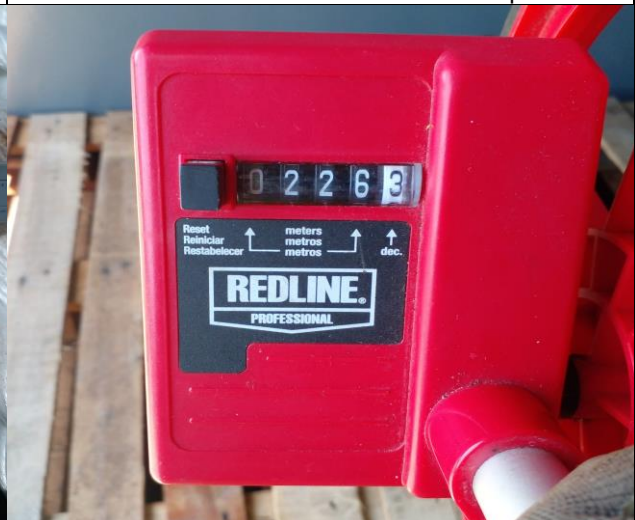
Length measured by surveyor: **226,3** meters.

60. Length measured by surveyor.

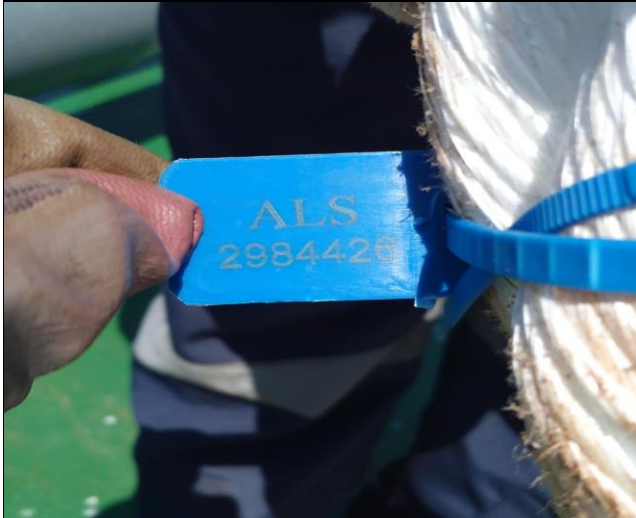
57. View of seal N° 2984426.

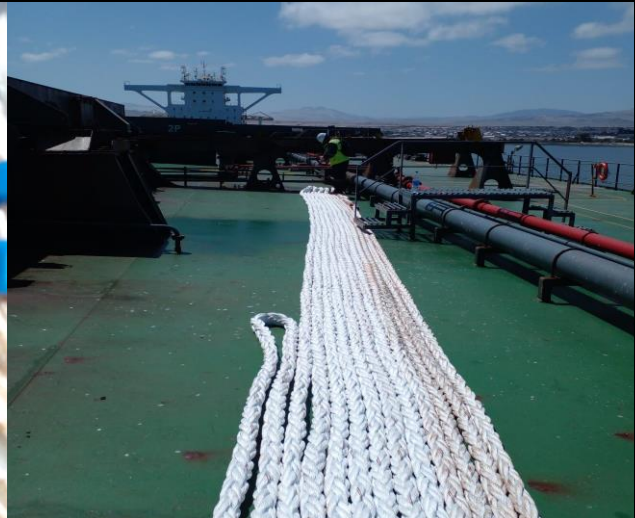
58. General view of the rope.

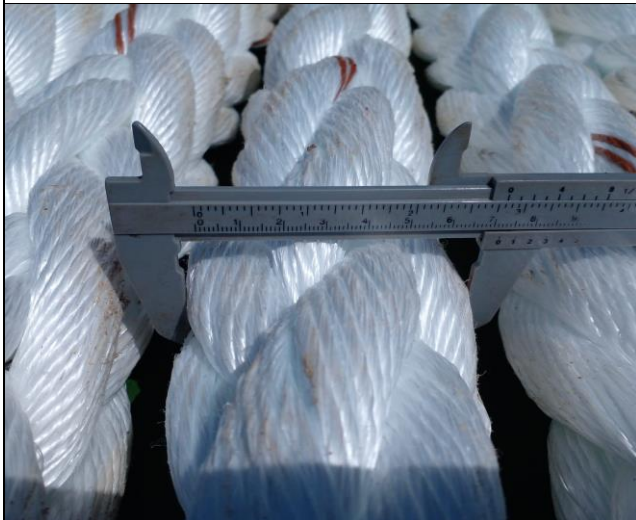
59. Diameter of the mooring line.

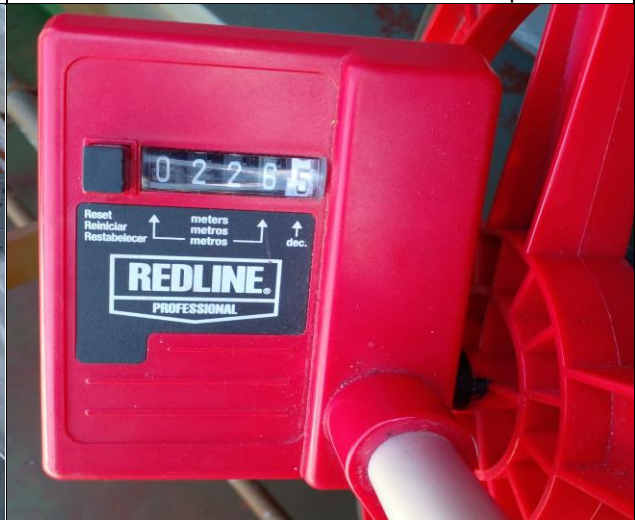
Length measured by surveyor: **226,5** meters.

60. Length measured by surveyor.
