## FINAL REPORT

<b>SURVEY</b>	<b>MOORING ROPES INSPECTION</b>
<b>TO</b>	TERMINAL TOTORALILLO.
<b>FROM</b>	ALS INSPECTION CHILE SPA.
<b>CLIENT REF</b>	N/A.
<b>ALS REF</b>	ANF-2509-1949.
<b>SCOPE OF SURVEY</b>	INSPECTION OF 17 MOORING LINES.
<b>VESSEL NAME</b>	SG. UNITED.
<b>OWNER</b>	NS UNITED KAIUN KAISHA LTD.
<b>DISPONENT OWNER</b>	NS UNITED KAIUN KAISHA LTD.
<b>CHARTERERS</b>	WODEN MARITIME S.A.
<b>PLACE OF SURVEY</b>	CALDERA, BAY.
<b>DATE OF SURVEY</b>	SEPTEMBER 13, 2025.
<b>TIME OF SURVEY</b>	12:40 HRS. TO 16:20 HRS.

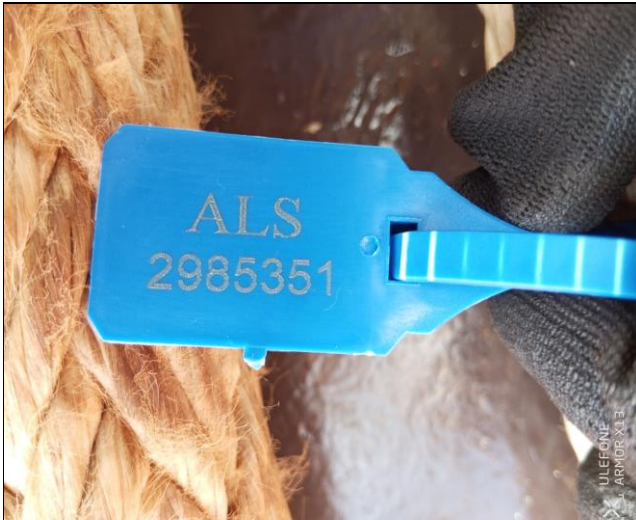
1. View of seal N° 2985351.

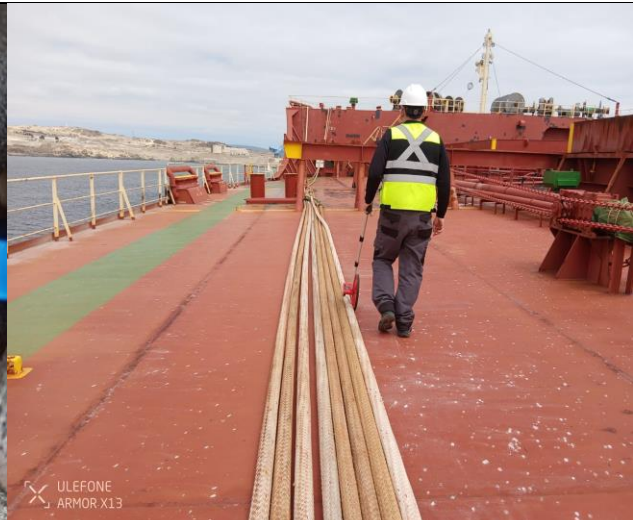
2. General view of the rope.

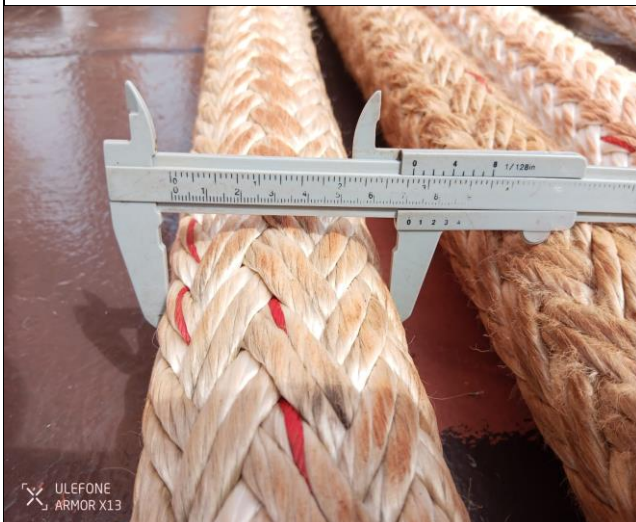
3. Diameter of the mooring line.

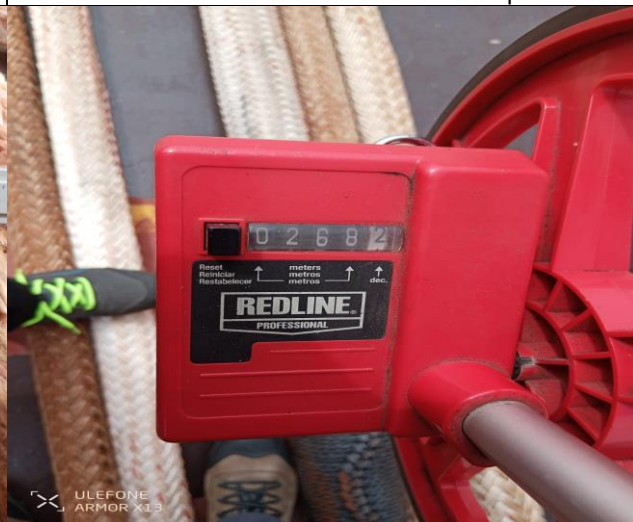
Length measured by surveyor: **268,2** meters.

4. Length measured by surveyor.

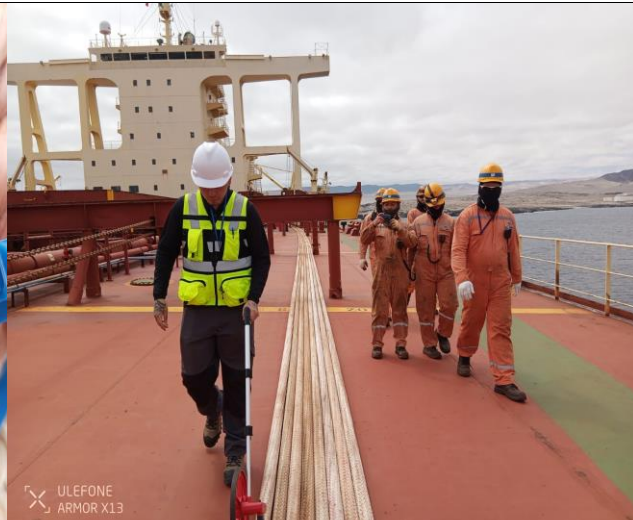
6. General view of the rope.

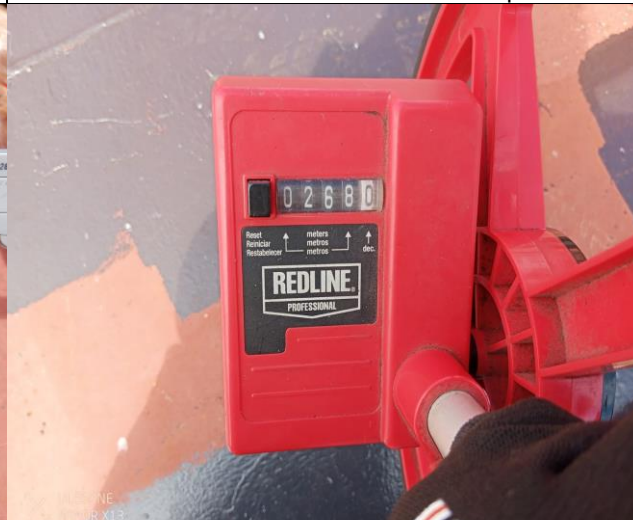
Length measured by surveyor: **268,0** meters.

8. Length measured by surveyor.

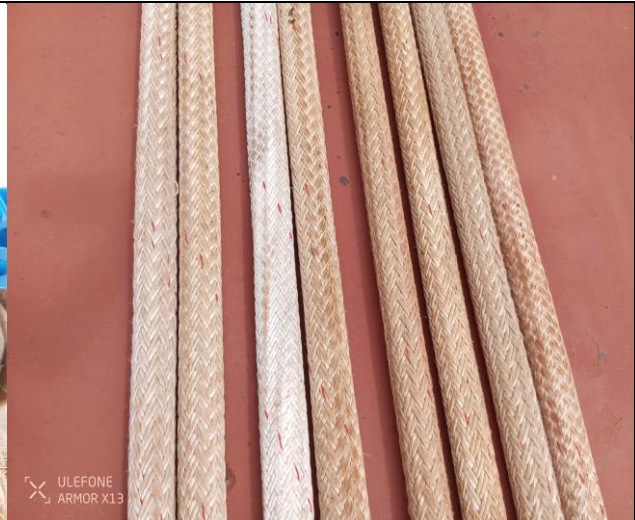
<b>DAMAGE ITEM</b>	<b>GOOD</b>	<b>FAIR</b>	<b>POOR</b>
Ext. Abrasion (max 25%)	<input type="checkbox"/>	<input checked="" type="checkbox"/>	Over 25% <input type="checkbox"/>
Int. Abrasion	<input checked="" type="checkbox"/>	<input type="checkbox"/>	<input type="checkbox"/>
Cut strands	<input checked="" type="checkbox"/>	<input type="checkbox"/>	<input type="checkbox"/>
Burn/ heated parts / fusion	<input checked="" type="checkbox"/>	<input type="checkbox"/>	<input type="checkbox"/>
Sun degradation /discoloration	<input checked="" type="checkbox"/>	<input type="checkbox"/>	<input type="checkbox"/>
Fiber broken	<input checked="" type="checkbox"/>	<input type="checkbox"/>	<input type="checkbox"/>
Black stains / dirty	<input type="checkbox"/>	<input checked="" type="checkbox"/>	<input type="checkbox"/>
Inconsistent diameter	<input checked="" type="checkbox"/>	<input type="checkbox"/>	<input type="checkbox"/>

10. General view of the rope.

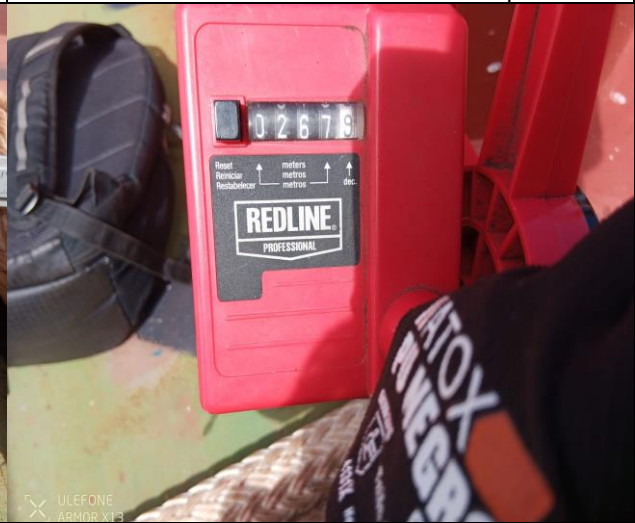
Length measured by surveyor: **267,9** meters.

12. Length measured by surveyor.

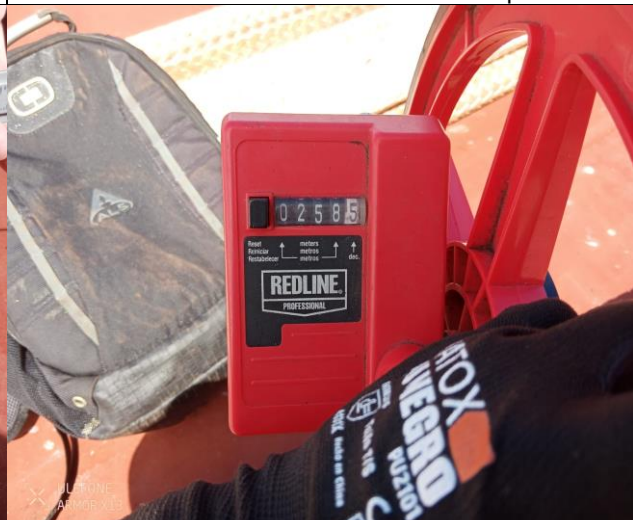
Length measured by surveyor: **258,8** meters.

16. Length measured by surveyor.

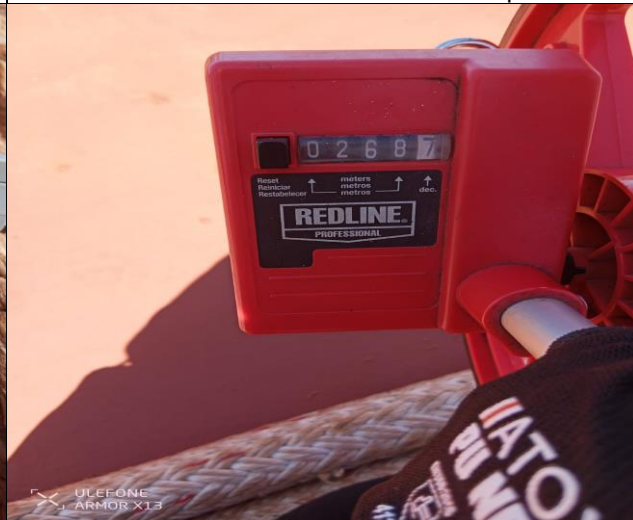
Length measured by surveyor: **268,7** meters.

20. Length measured by surveyor

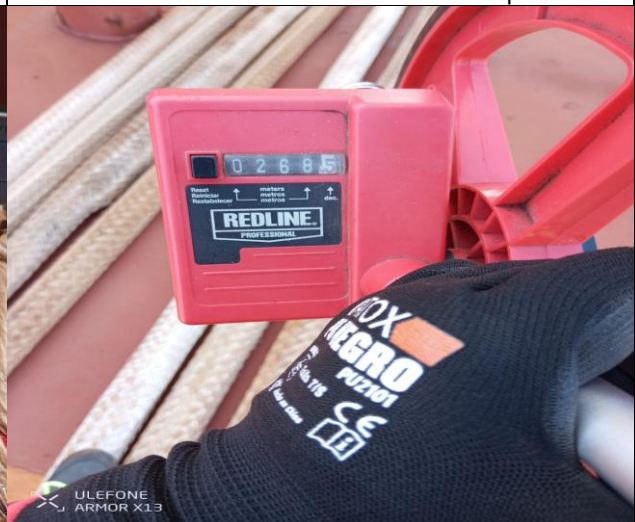
Length measured by surveyor: **268,5** meters.

24. Length measure by surveyor.

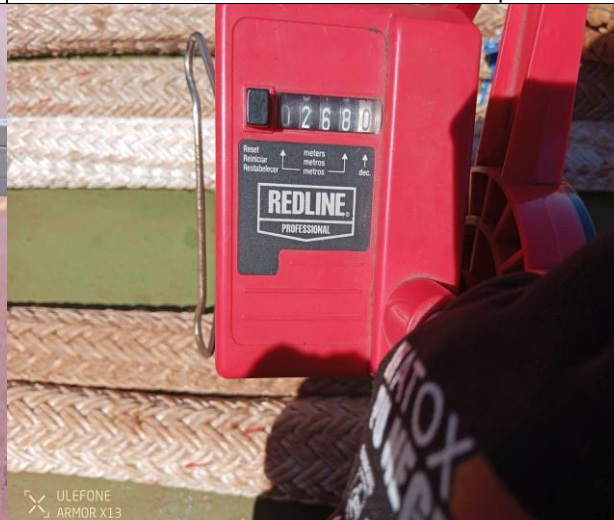
Length measured by surveyor: **268,0** meters.

28. Length measure by surveyor.

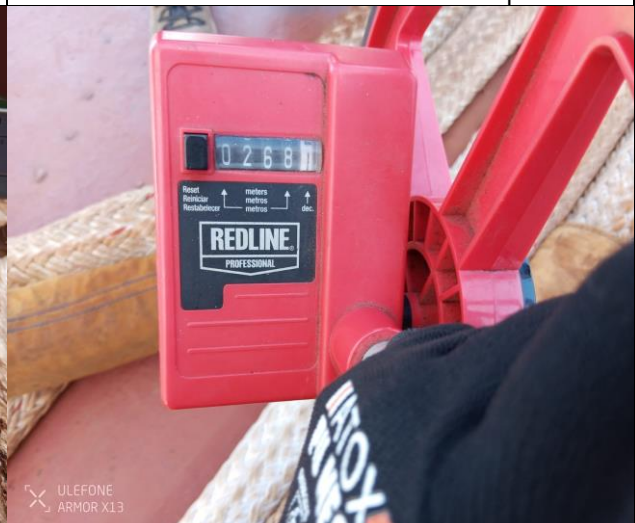
Length measured by surveyor: **268,1** meters.

32. Length measured by surveyor.

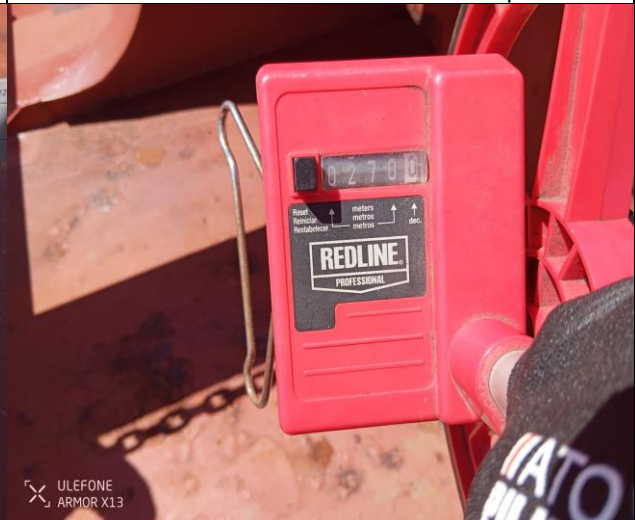
Length measured by surveyor: **270,0** meters.

36. Length measured by surveyor.

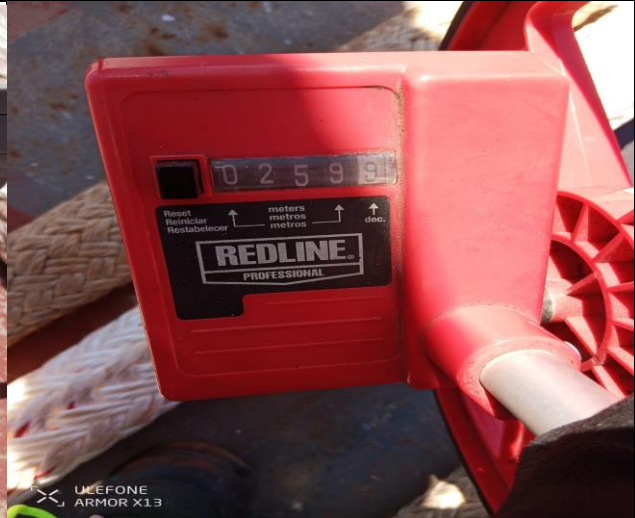
Length measured by surveyor: **259,9** meters.

40. Length measured by surveyor.

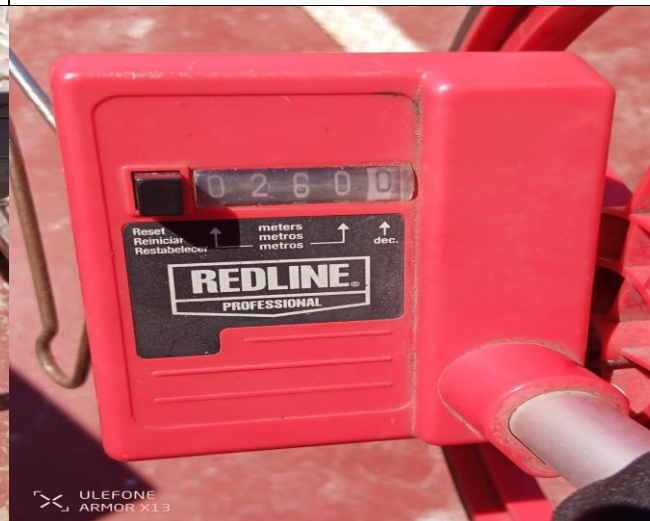
Length measured by surveyor: **260,0** meters.

44. Length measured by surveyor.

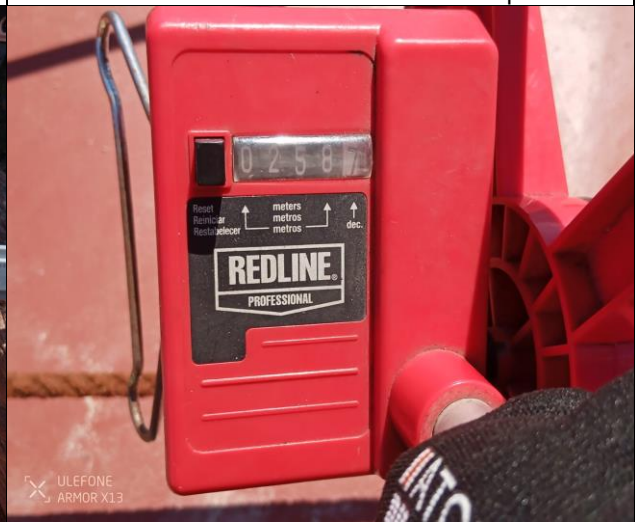
Length measured by surveyor: **258,7** meters.

48. Length measured by surveyor.

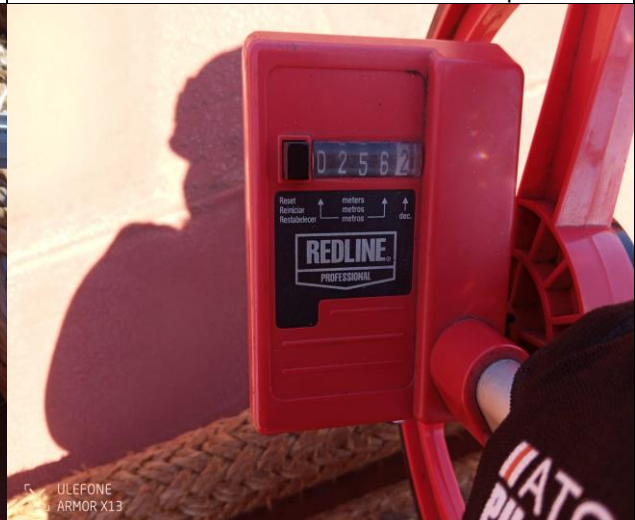
Length measured by surveyor: **256,2** meters.

52. Length measured by surveyor.

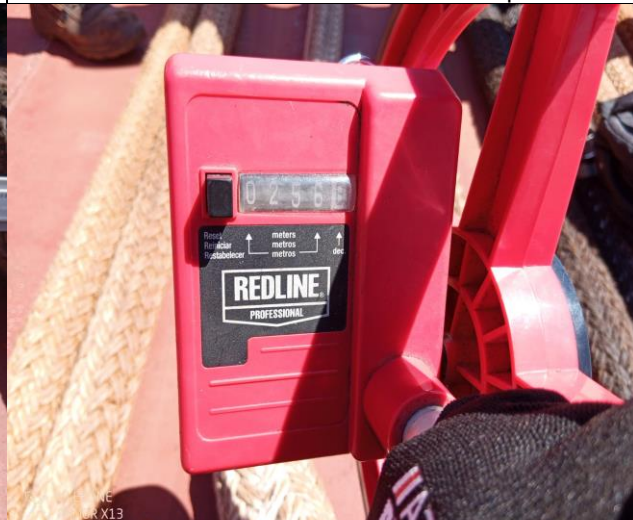
Length measured by surveyor: **256,8** meters.

56. Length measured by surveyor.

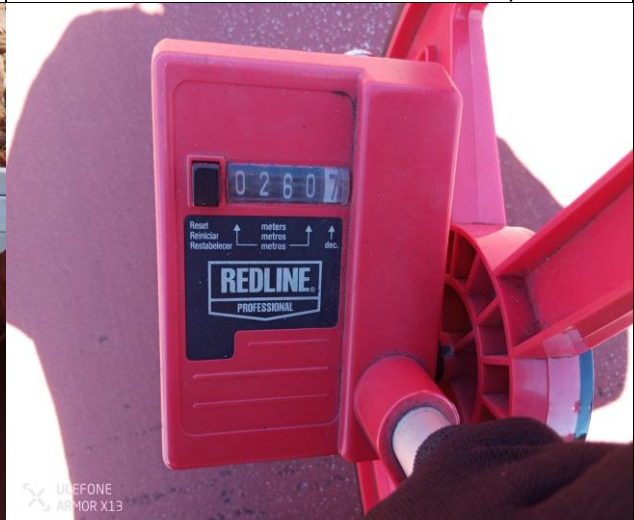
Length measured by surveyor: **260,7** meters.

60. Length measured by surveyor.

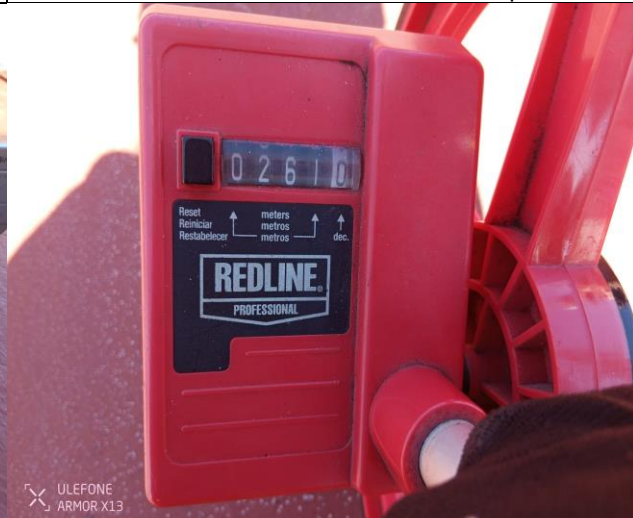
Length measured by surveyor: **261,0** meters.

60. Length measured by surveyor.

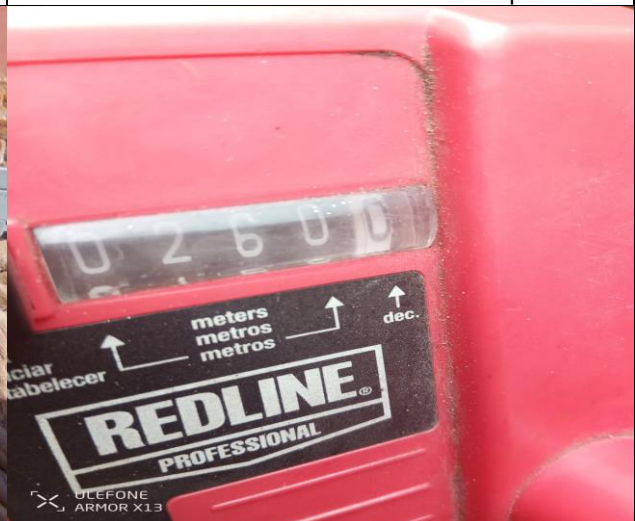
Length measured by surveyor: **260,0** meters.

60. Length measured by surveyor.
