MOTOR VESSEL "APEX" V. 54

SHIP'S GRABS AND CRANES, HATCH COVER, HATCH COAMING & HOLD INSPECTION

This is to certify that the undersigned representative of **ALS INSPECTION CHILE SpA** did, at the request of **Mr. Osvaldo Morales Cáceres**, from **EMPREMAR S.A.** attending on board motor vessel **"APEX"** with the Master consent, on November 03, 2025, as she was anchored at Caleta Patillos Terminal, Chile, to report upon Grabs & Hatch covers condition.

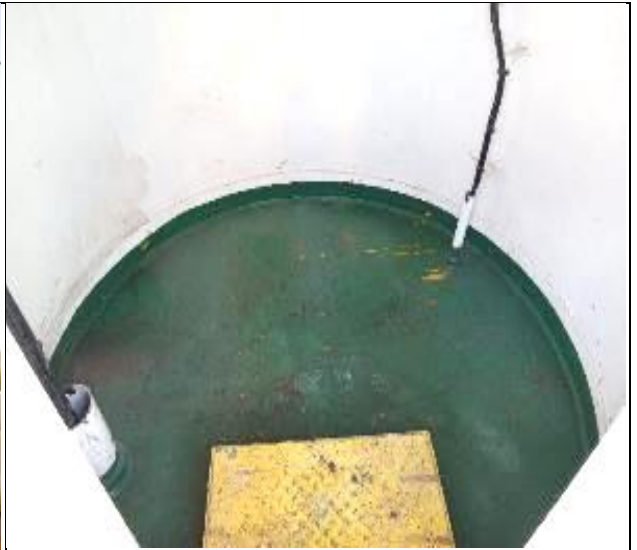
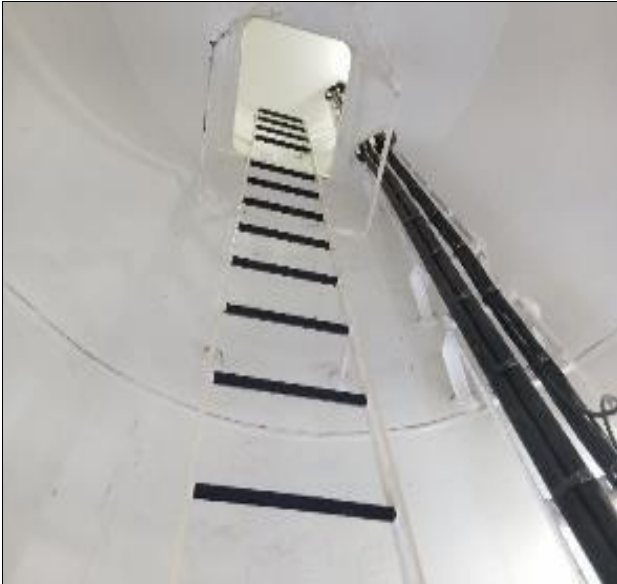
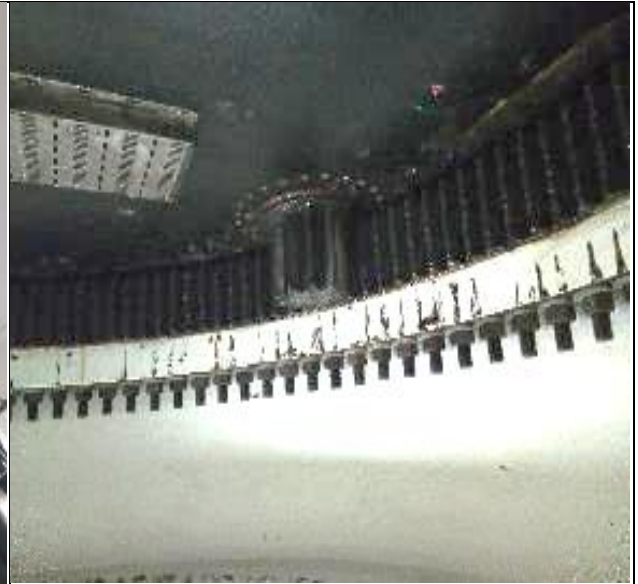
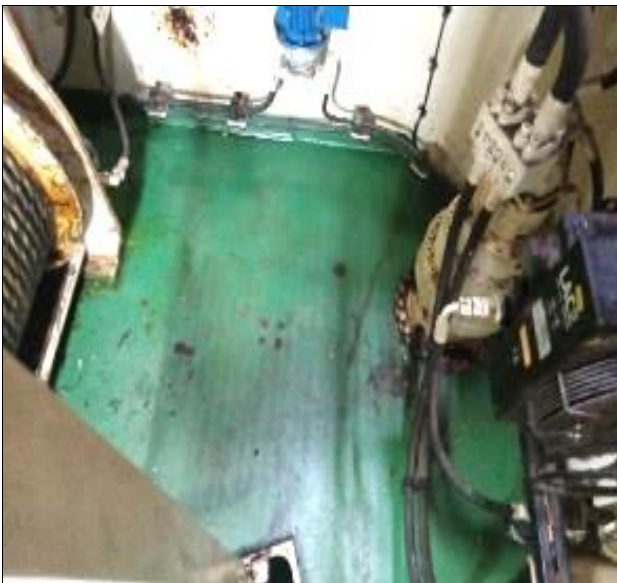
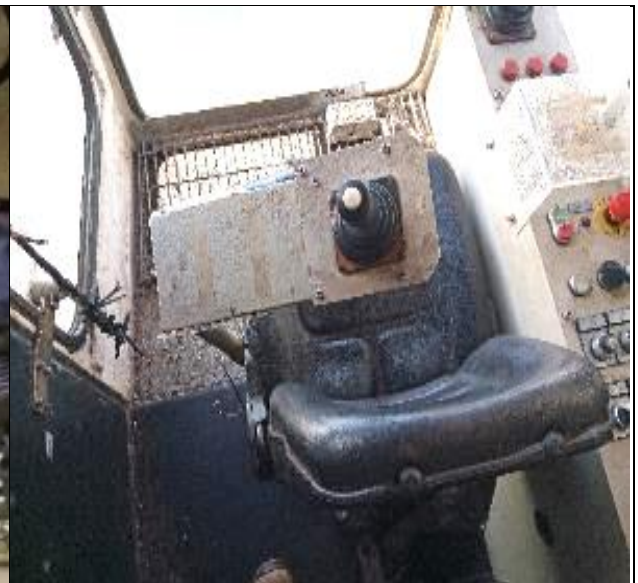
- Cranes were observed, apparently, in good structural conditions, no relevant damages were observed.

Nr. 1: The windshield wiper rubber was observed be in poor condition.

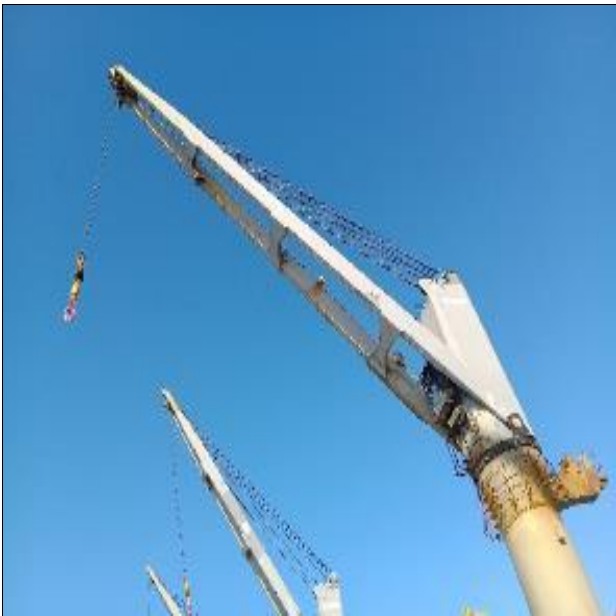
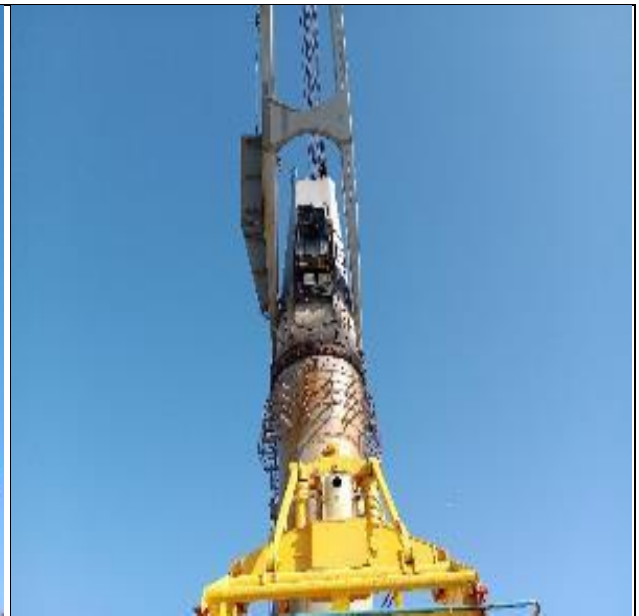
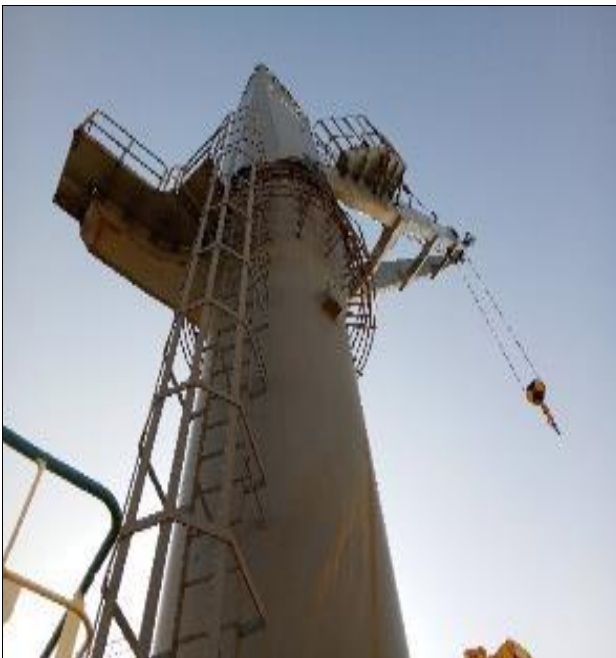
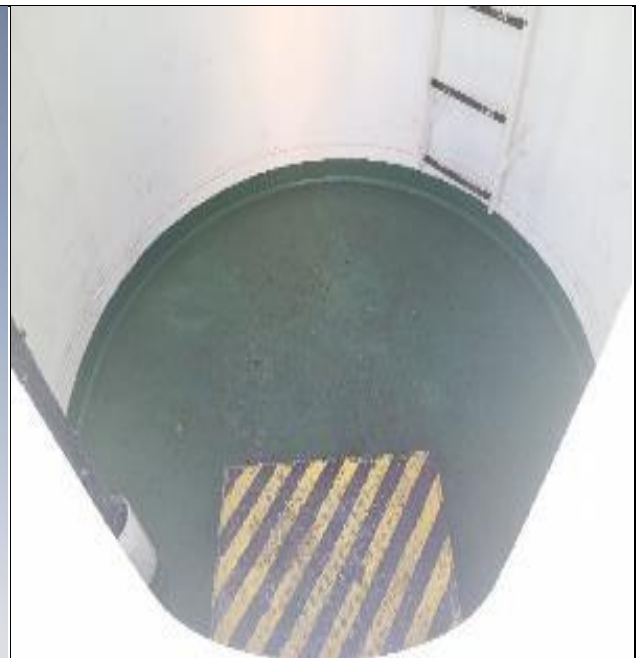
- Cranes were observed, apparently, in good structural conditions, no relevant damages were observed.

Nr. 1: The windshield wiper rubber was observed be in poor condition.

Nr. 2: Without ventilation and heating in the cabin.

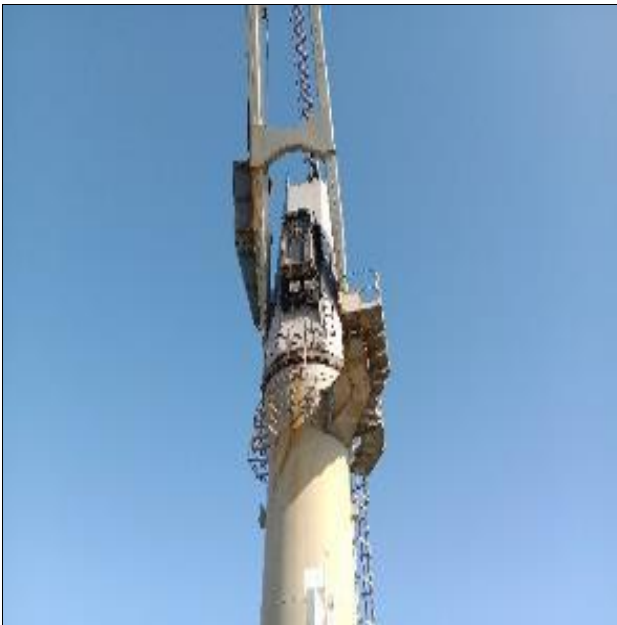
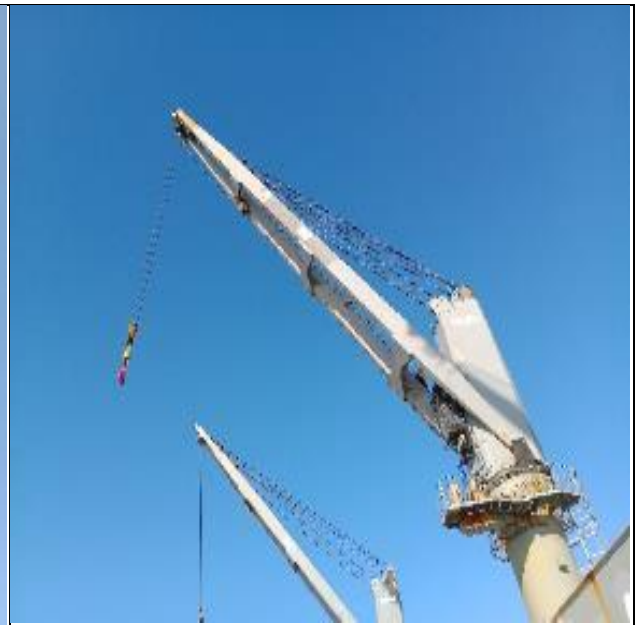
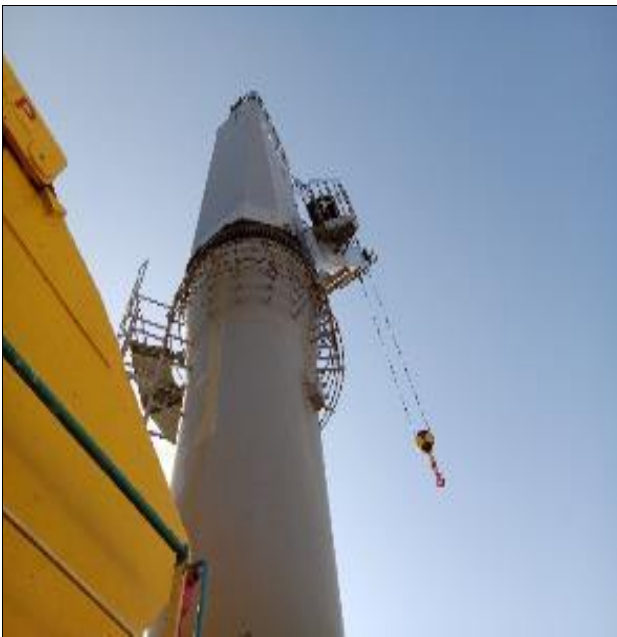
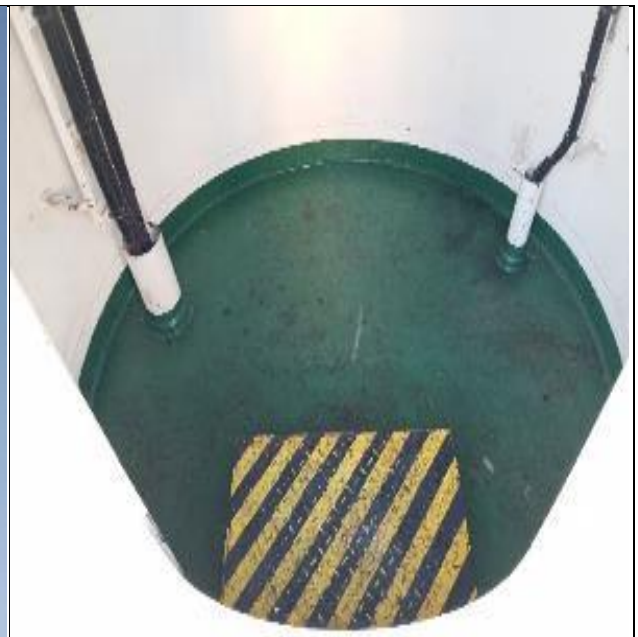
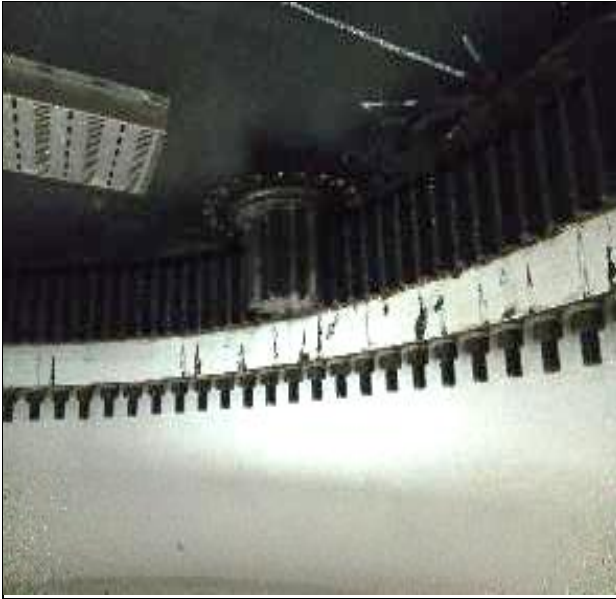
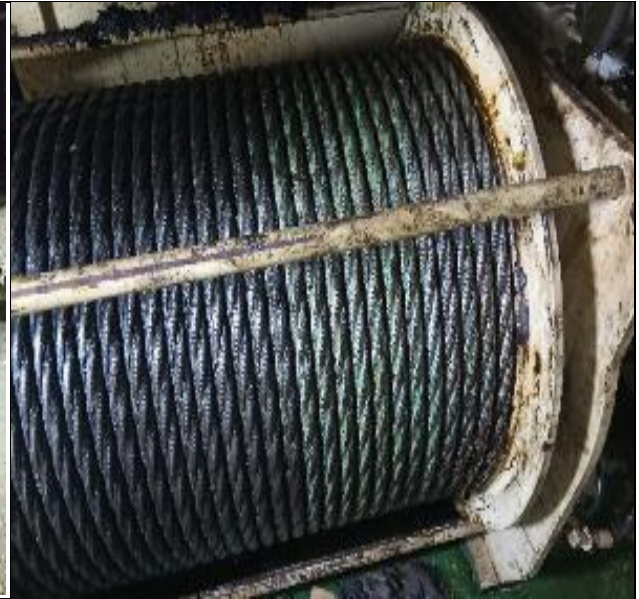
- Cranes were observed, apparently, in good structural conditions, no relevant damages were observed.

Nr. 1: The windshield wiper rubber was observed be in poor condition.

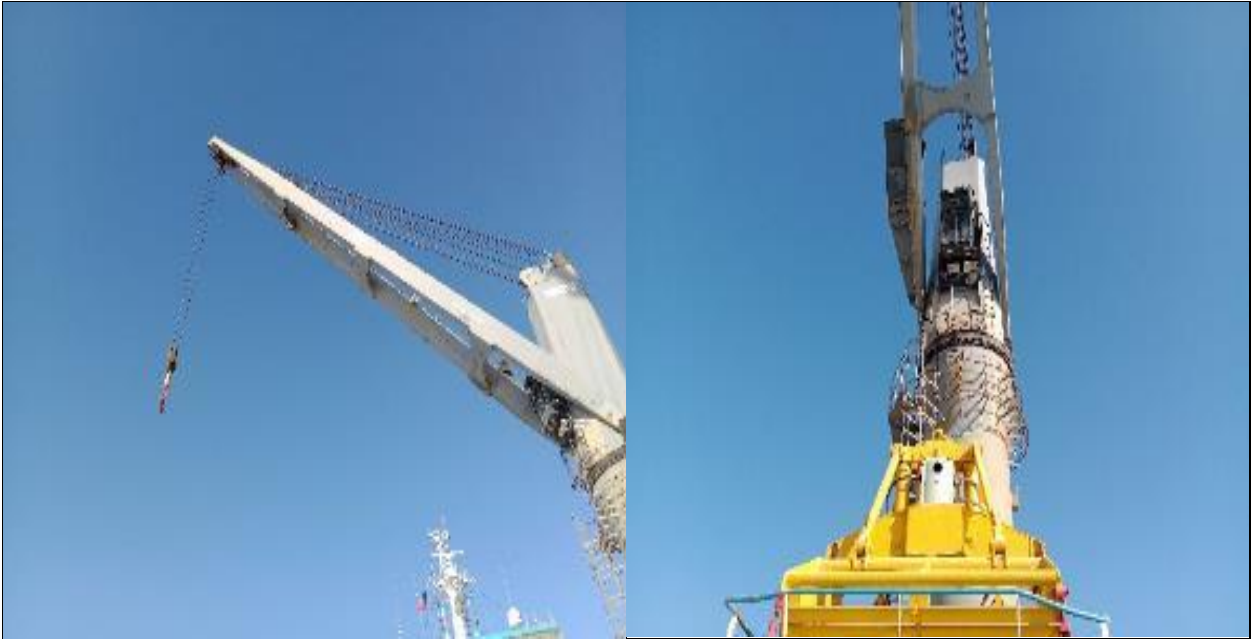
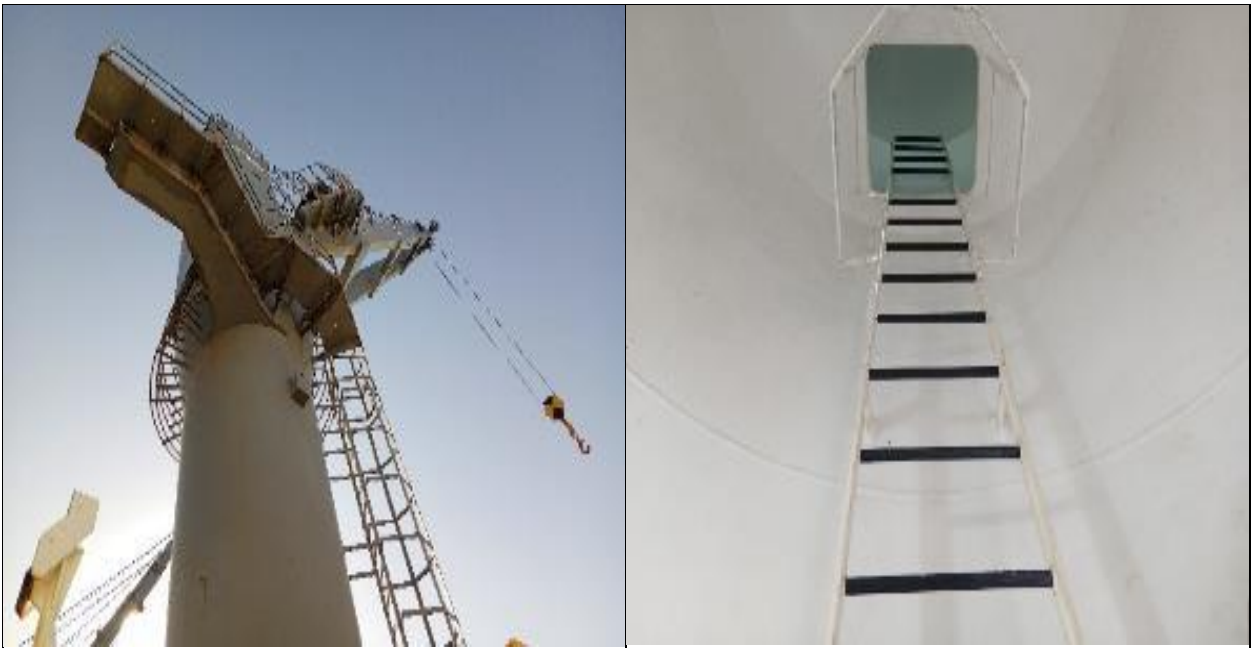
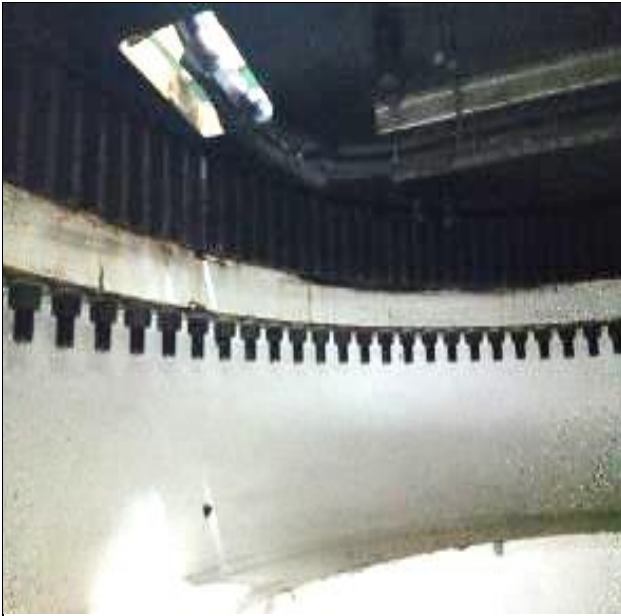
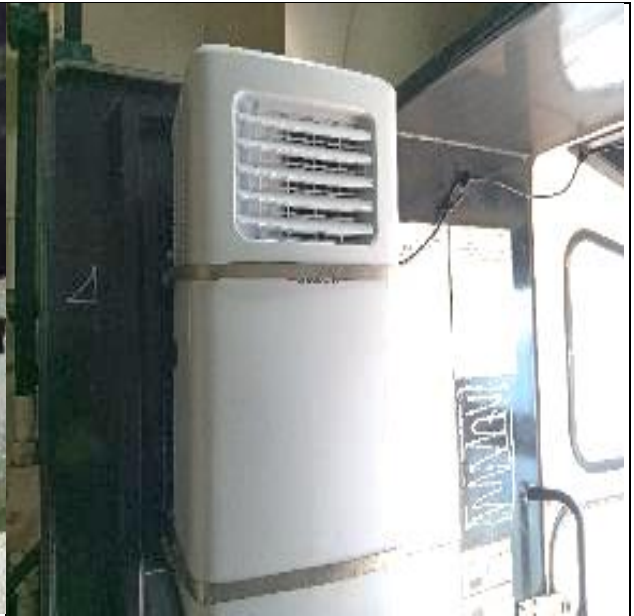
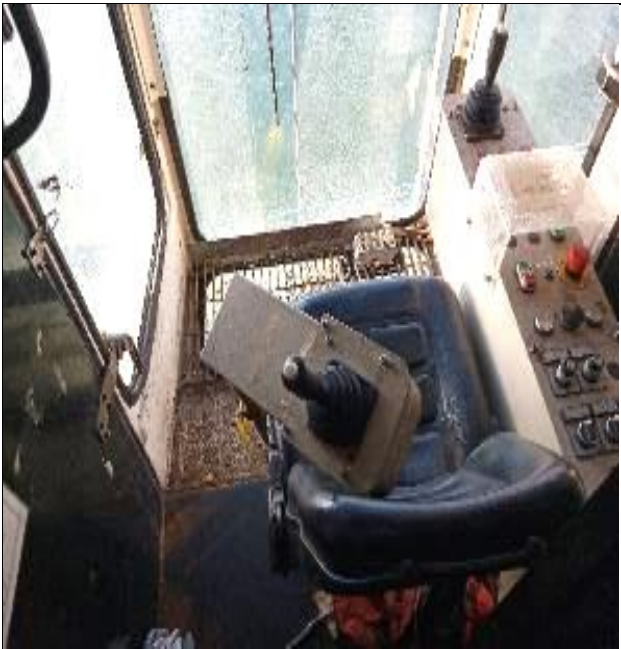
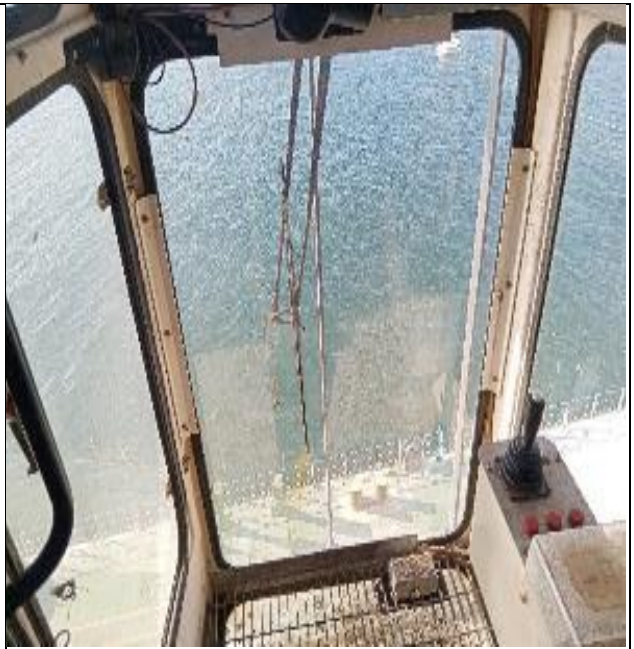
- Crane were observed, apparently, in good structural conditions, no relevant damages were observed.

Nr. 1: The windshield wiper rubber was observed be in poor condition.

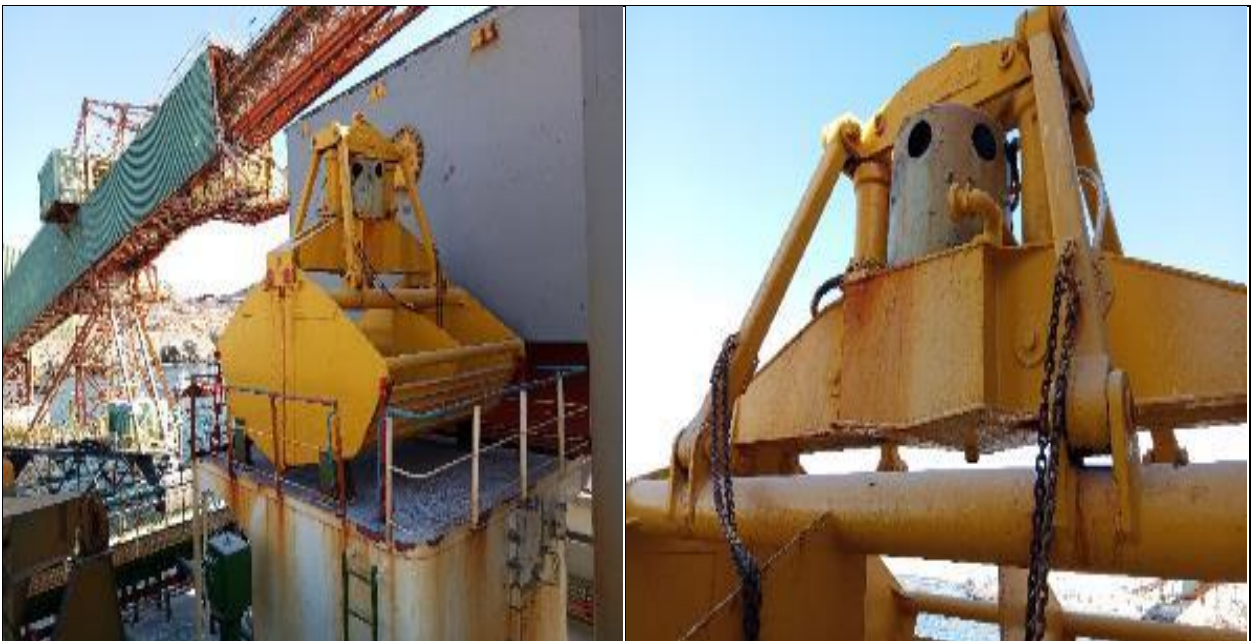
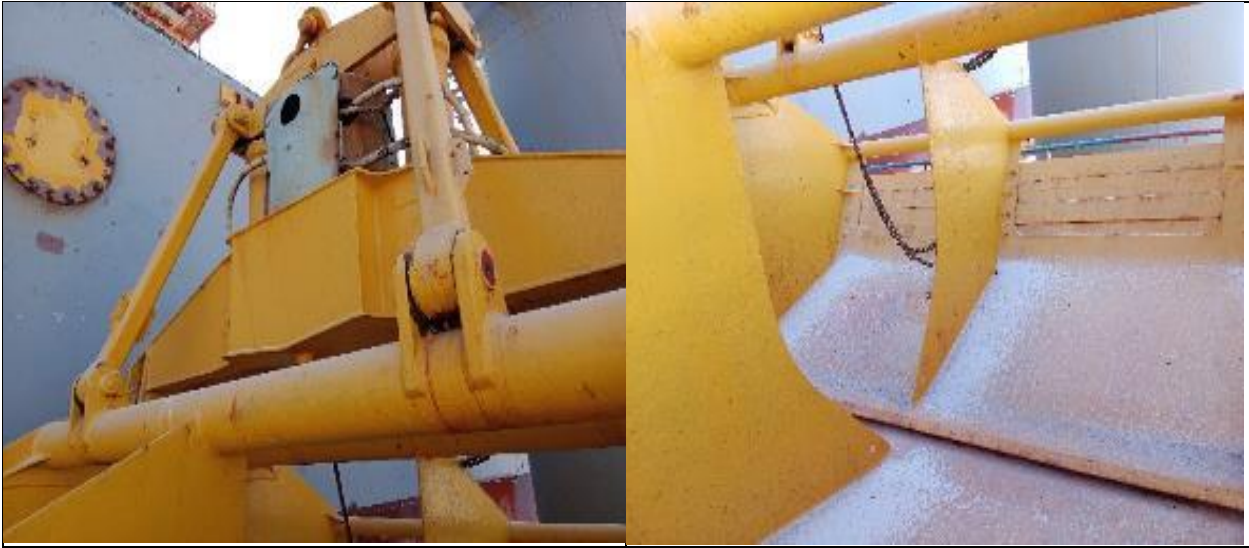
GRAB NR. 1	G	F	P	U	Obs Nr
Grab head	✓				
Transverse frame	✓				
Trough beam	✓				
Press rods	✓				
Scoops	✓				
Control valve group	✓				
Cylinders	✓				
Steel wire	✓

- Grab were observed, apparently, in good structural conditions, no relevant damages were observed.

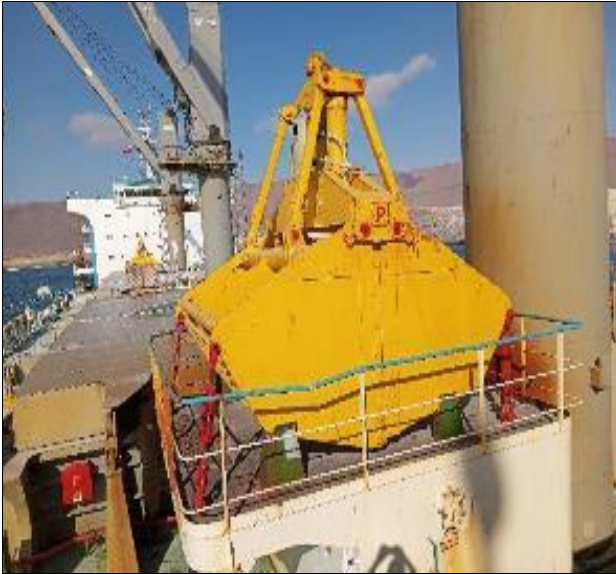
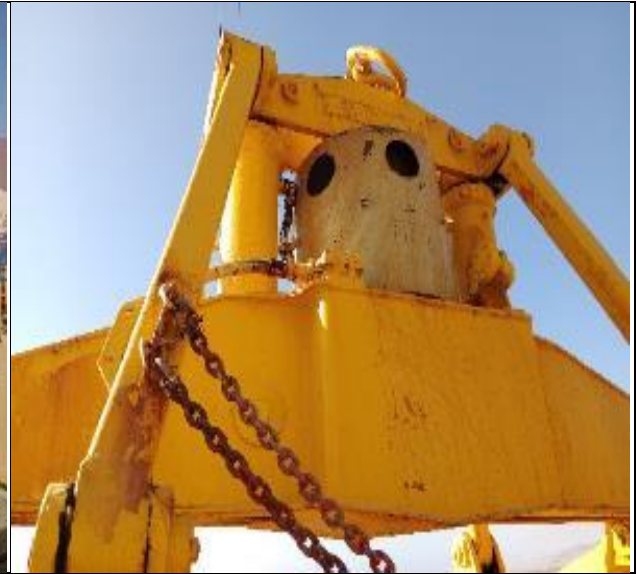
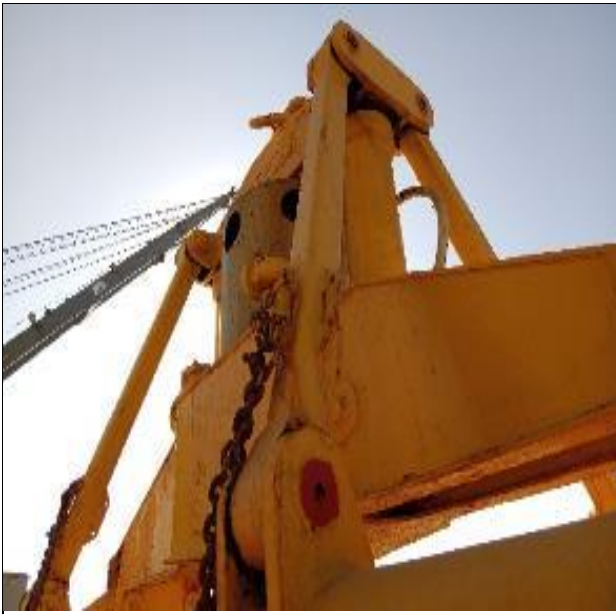
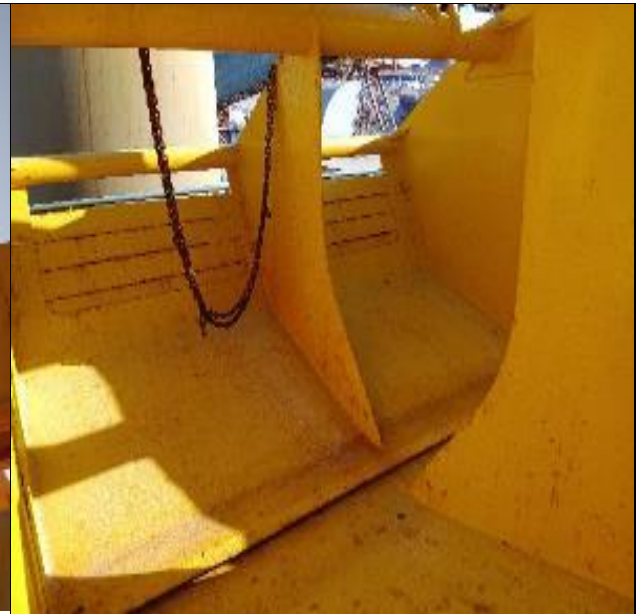
GRAB NR. 2	G	F	P	U	Obs Nr	
Grab head	✓					
Transverse frame	✓					
Trough beam	✓					
Press rods	✓					
Scoops	✓					
Control valve group	✓					
Cylinders	✓					
Steel wire	✓

- Grab were observed, apparently, in good structural conditions, no relevant damages were observed.

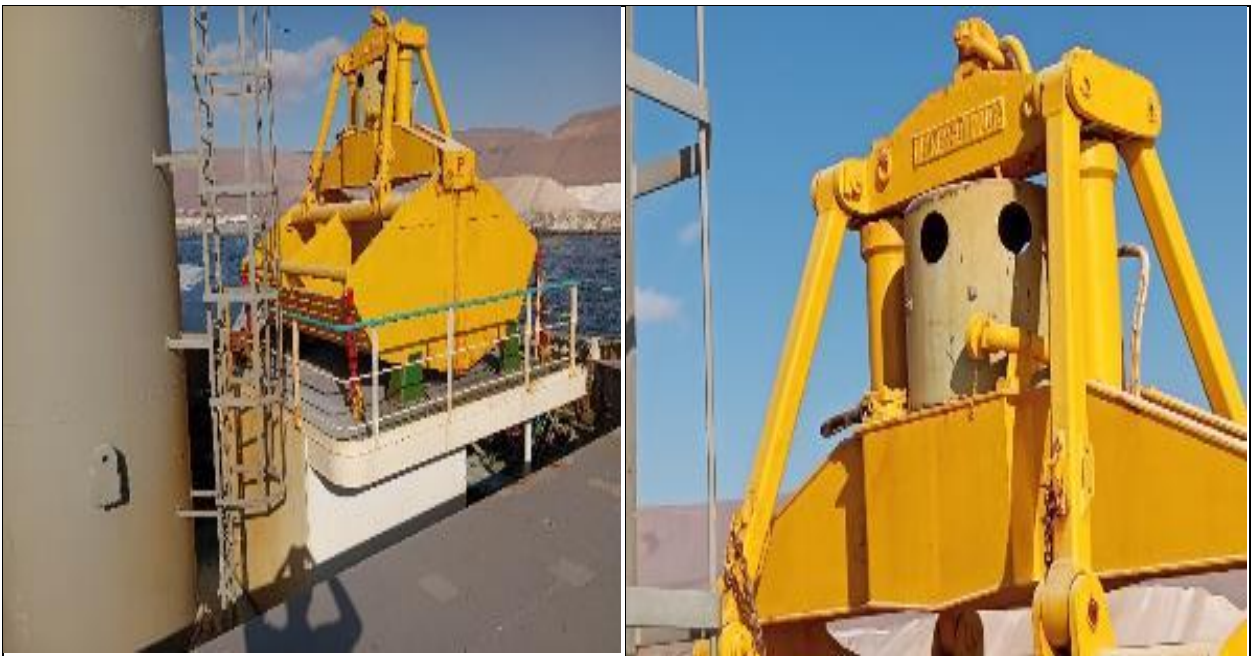
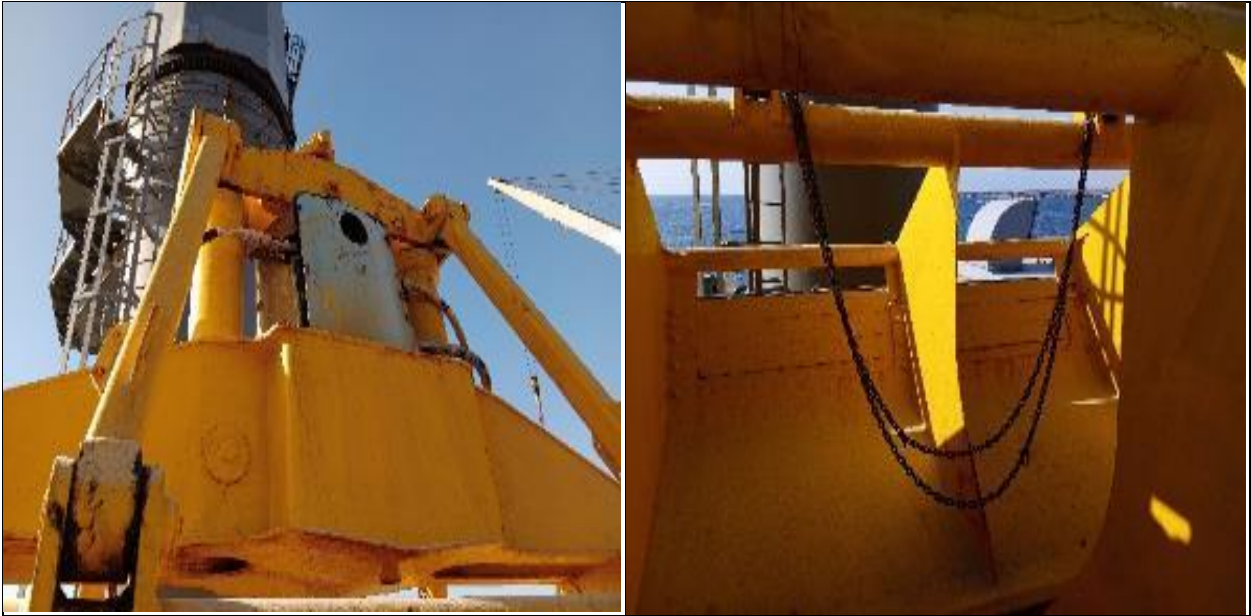
GRAB NR. 3	G	F	P	U	Obs Nr
Grab head	✓				
Transverse frame	✓				
Trough beam	✓				
Press rods	✓				
Scoops	✓				
Control valve group	✓				
Cylinders	✓				
Steel wire	✓

➤ Grab were observed, apparently, in good structural conditions, no relevant damages were observed.

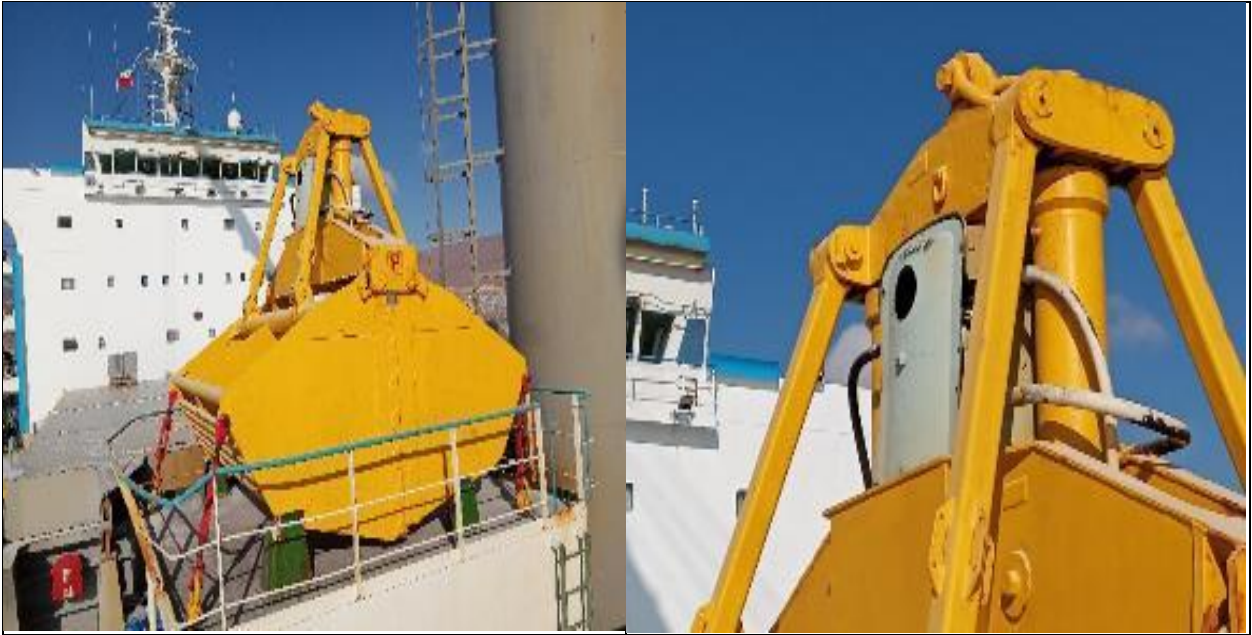
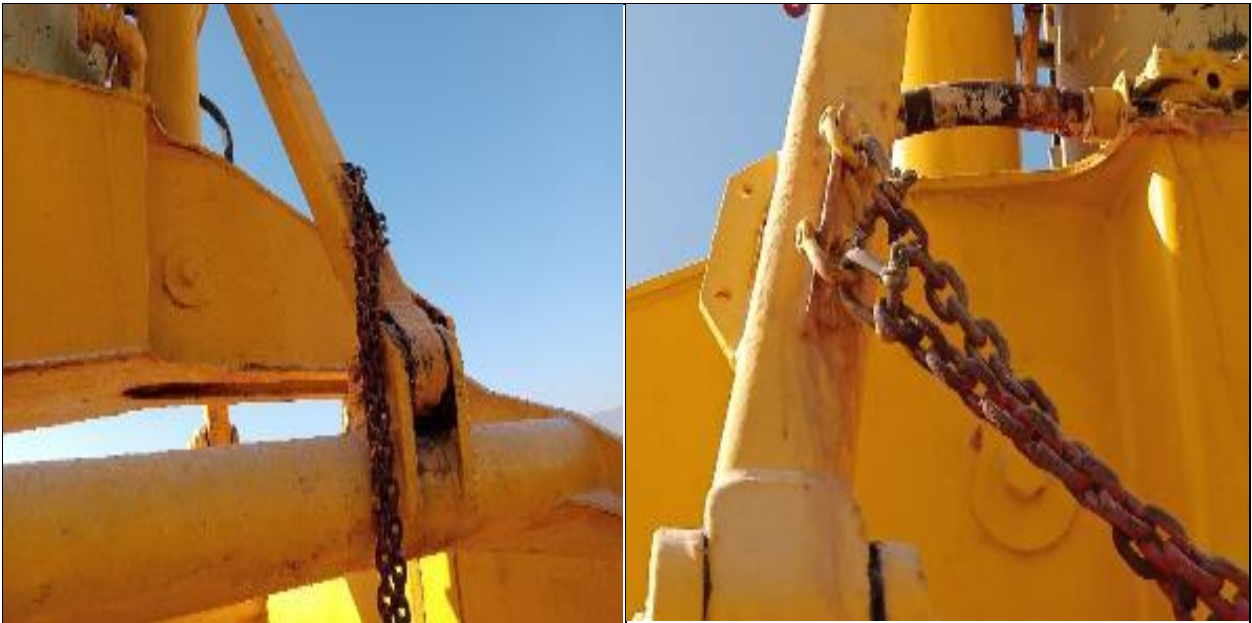
GRAB NR. 4	G	F	P	U	Obs Nr
Grab head	✓				
Transverse frame	✓				
Trough beam	✓				
Press rods	✓				
Scoops	✓				
Control valve group	✓				
Cylinders	✓				
Steel wire	✓

- Grab were observed, apparently, in good structural conditions, no relevant damages were observed.

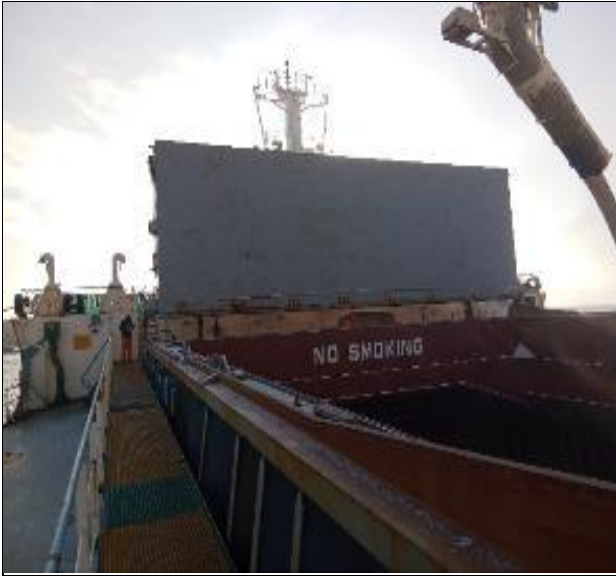
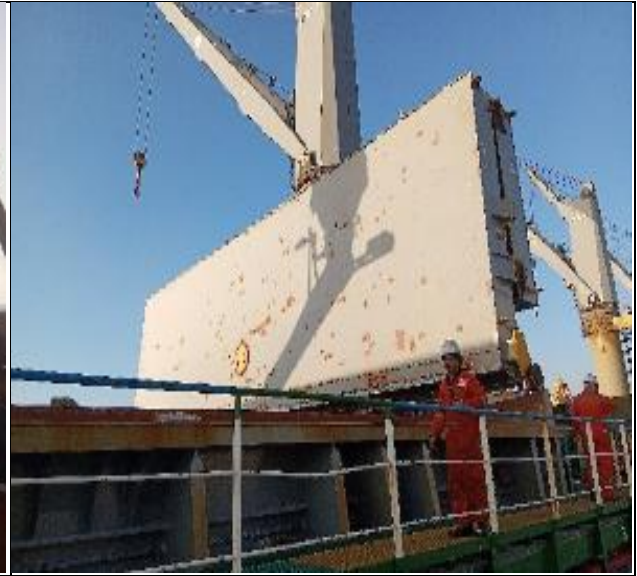
Hold Nr.1

All cargo holds, closing system were inspected, drain hole, compression bar, rubber gasket, hydraulic system, action cleats and non-return valve, all of them were found in good conditions.
