Report: ANF-2602-0447-A
Date: February 06, 2026

INSPECTION OF STRUCTURAL CONDITION, LINED WITH PLYWOOD AND STUFFING OPERATION ON CONTAINER

HPPU 200037- 2

Orica's EHM Plant, Antofagasta/Chile

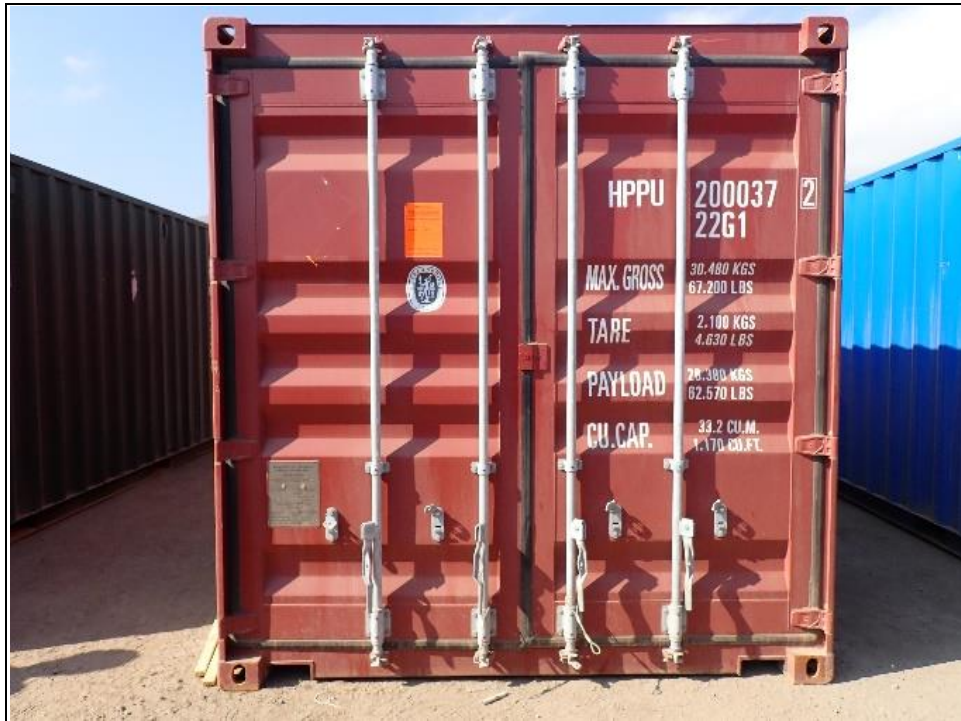
Container HPPU 200037-2 at Orica's EHM Plant, Antofagasta, Chile.

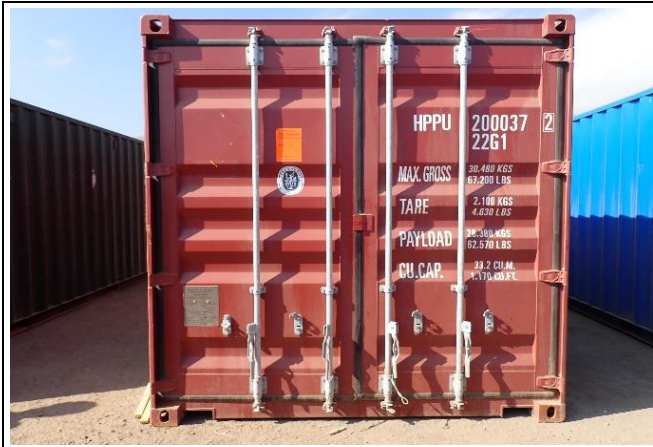
1. General view of unit 20".

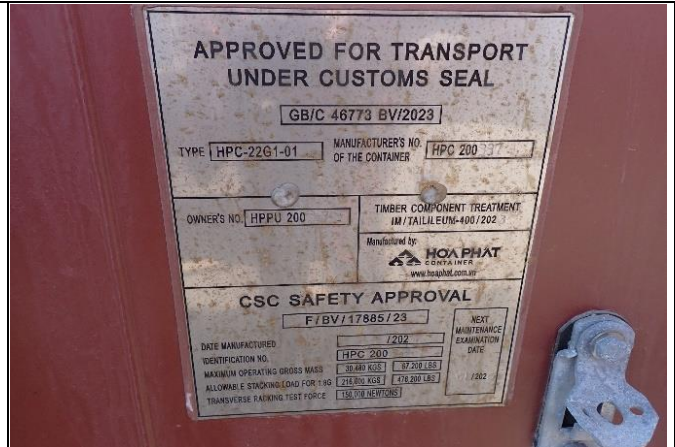
2. CSC Plate

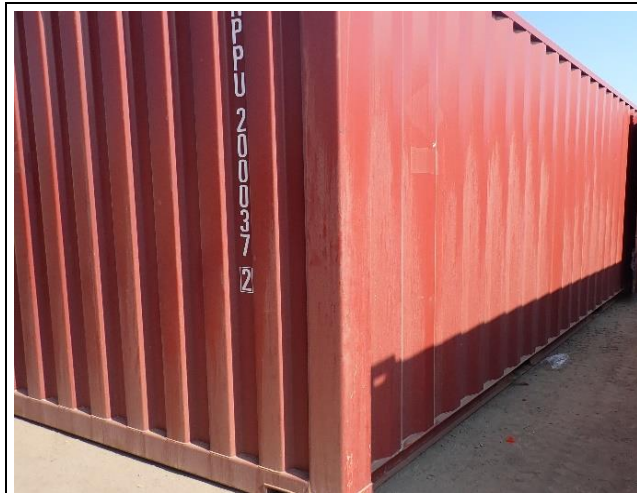
3. Side panel in good condition.

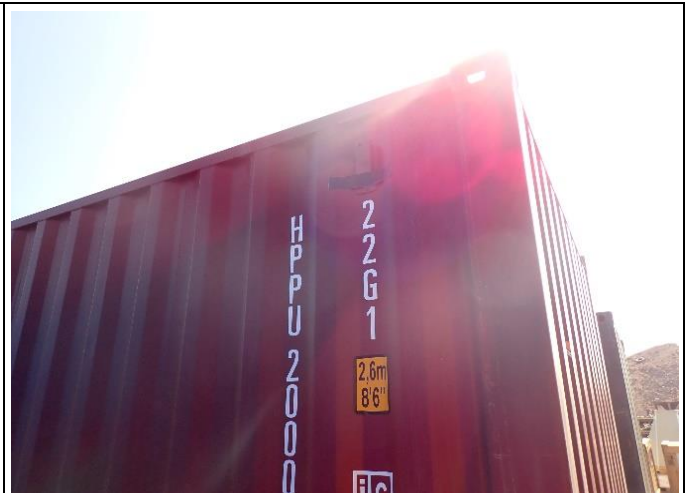
4. Corner fitting and frontal panel in good condition.

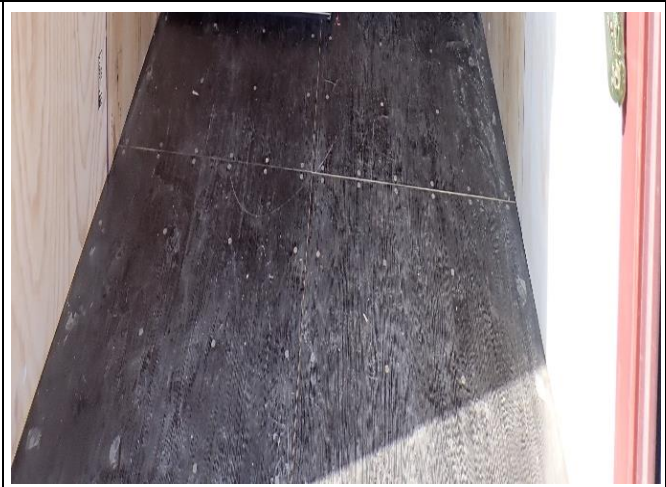
6. Container floor in good condition.

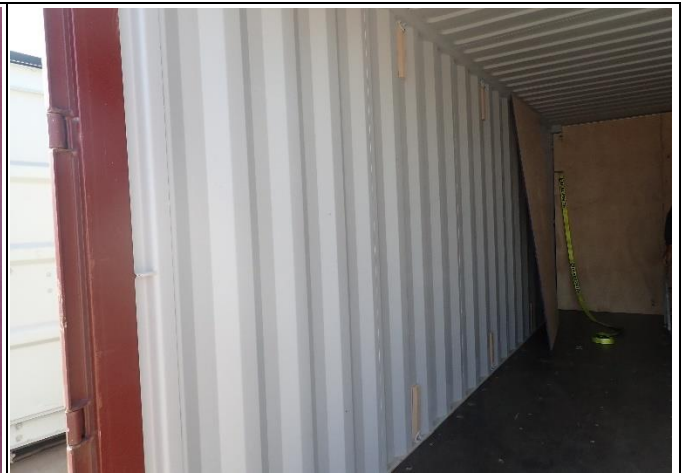
10. **Wooden used in the lined.**

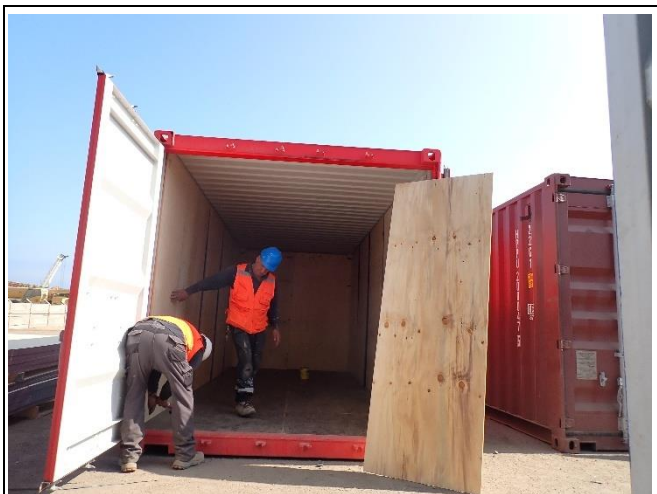
11. Wooden used in the lined.

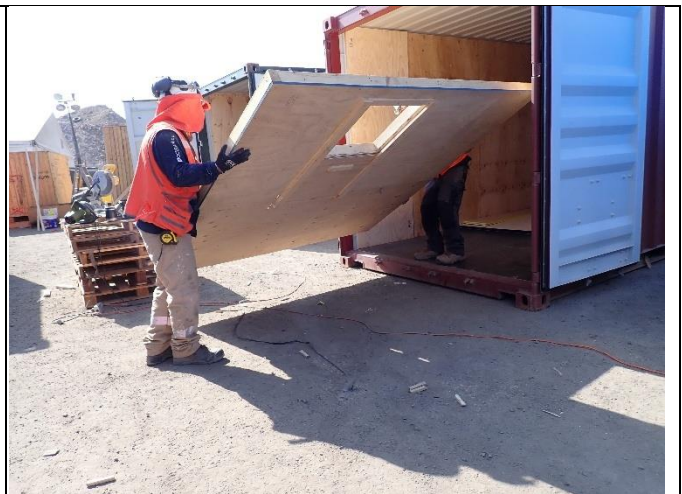
12. Wooden used in the lined.

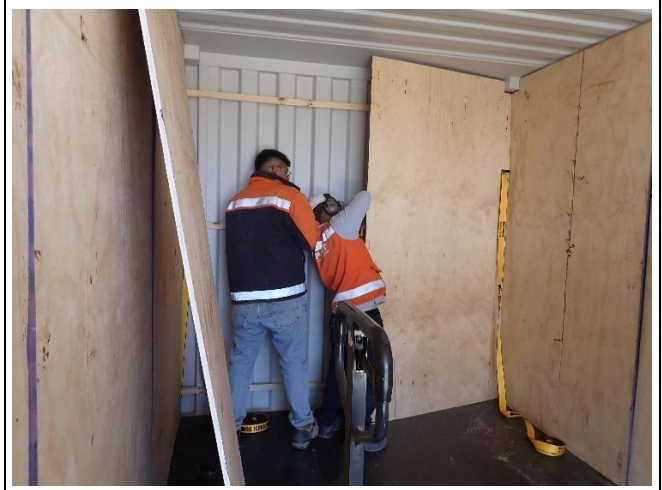
14. Lined operation.

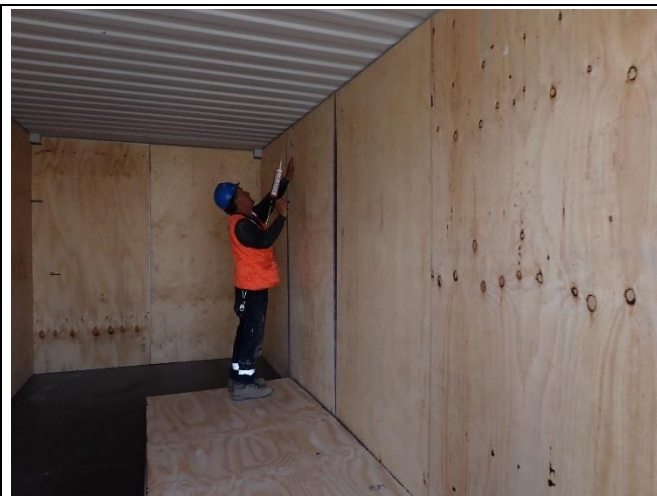
15. Silicone to isolate nails.

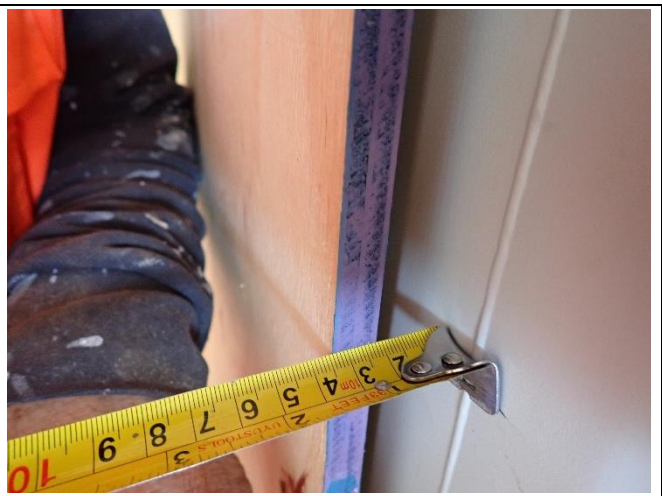
16. Measure of wood 12 mm.

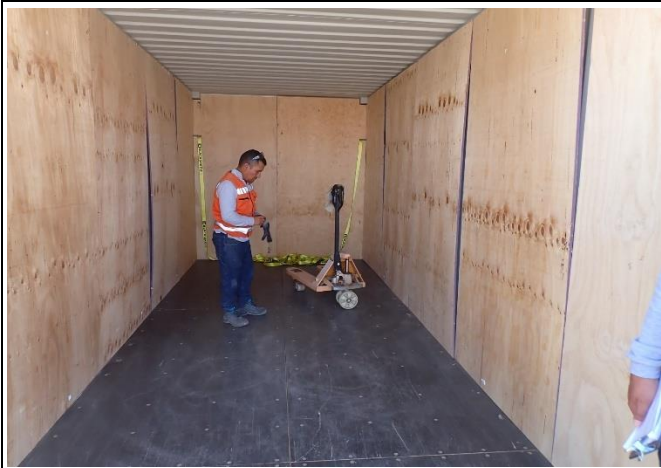
17. Start of stuffing commenced

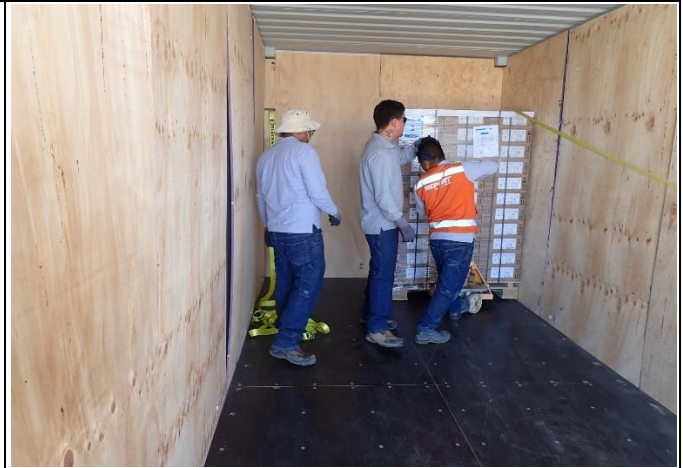
18. Stuffing operation.

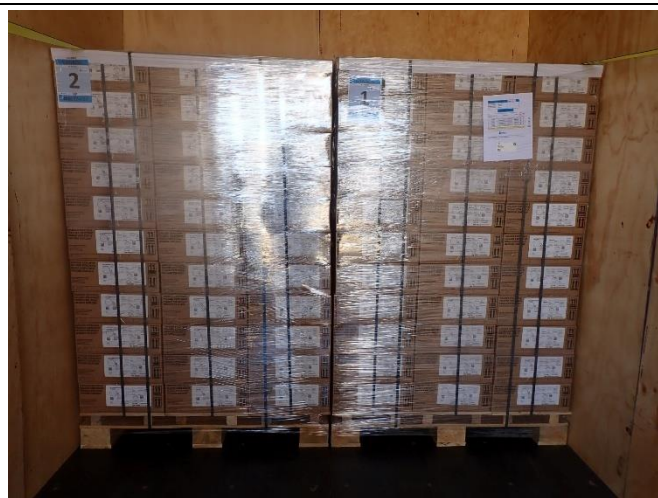
51. Stowage condition of two pallets

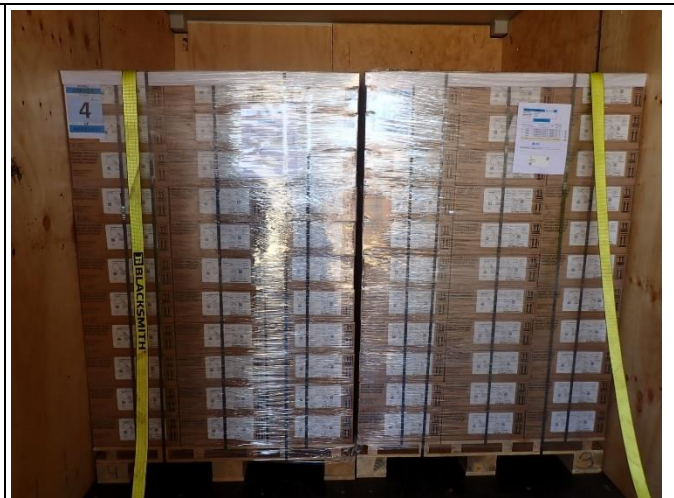
52. View of stowage condition fourth pallet

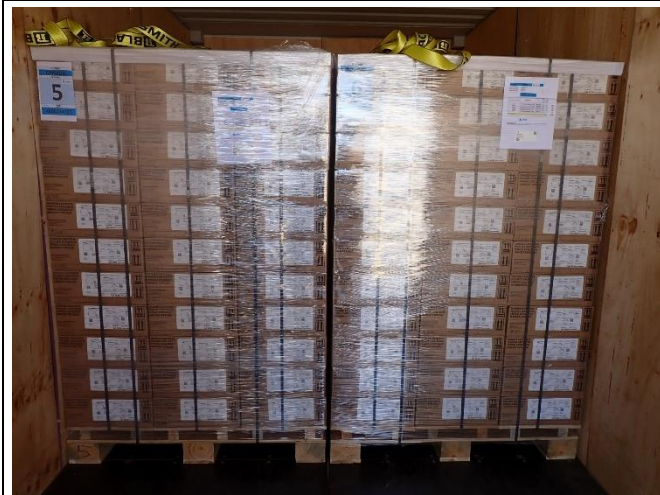
53. View of stowage condition six pallet

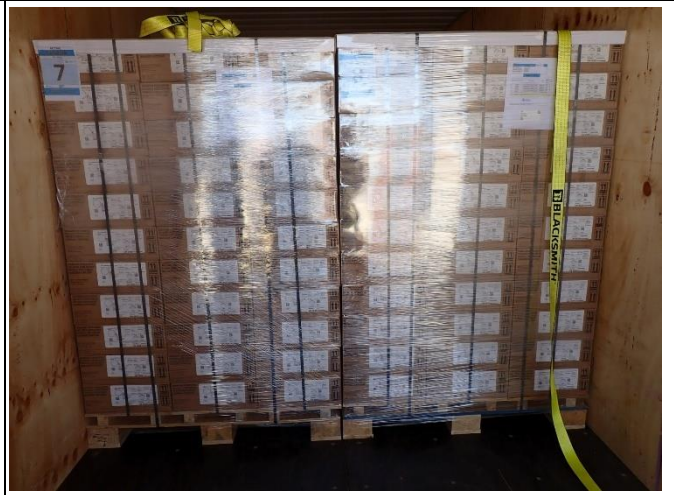
54. View of stowage condition eight pallet

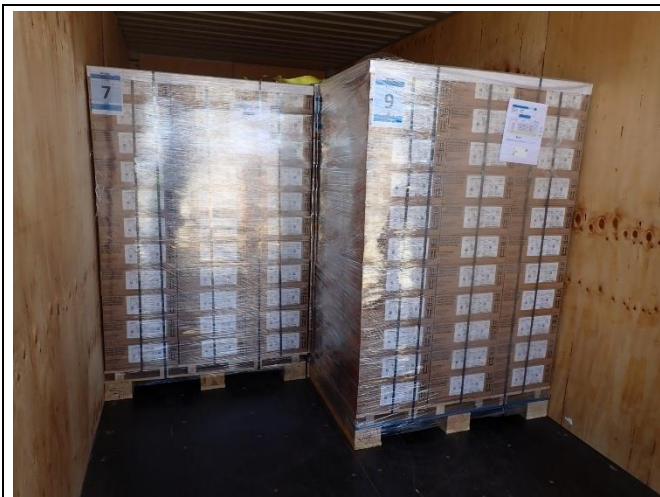
55. View of stowage condition nine pallet

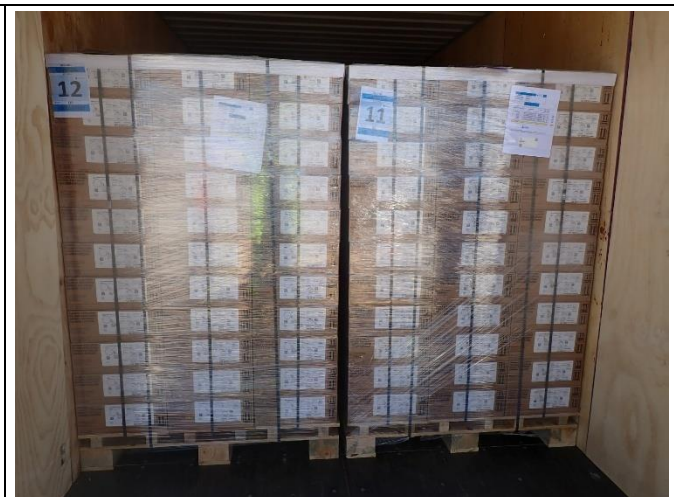
56. View of stowage condition twelve pallet

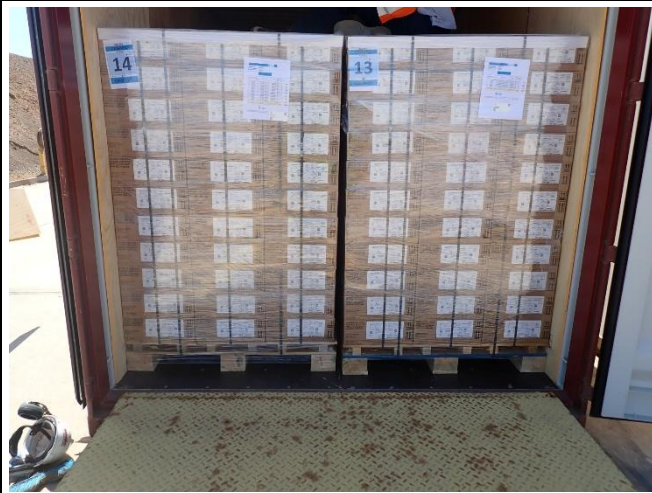
57. View of stowage condition fourteen pallet

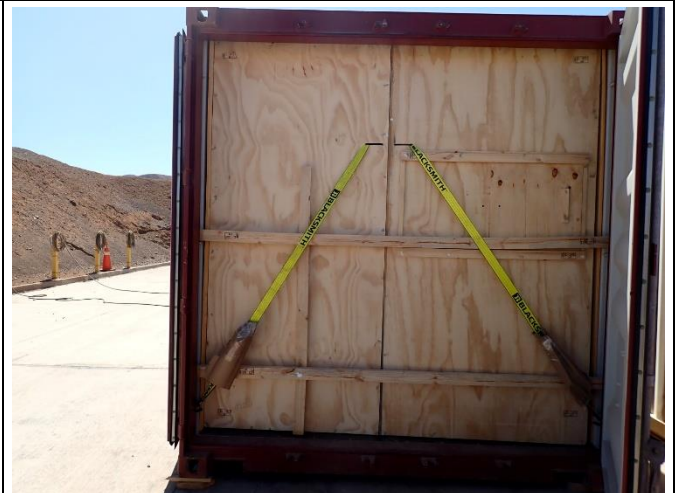
58. View of lashing of container using polypropylene sling and wooden

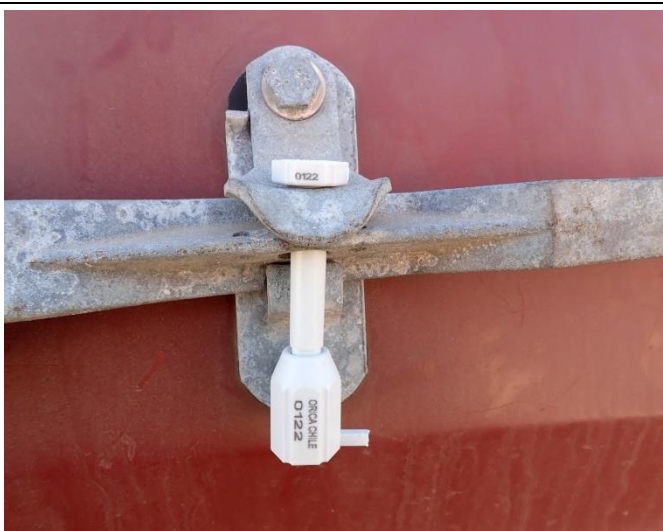
59. Seal of Orica (0122)

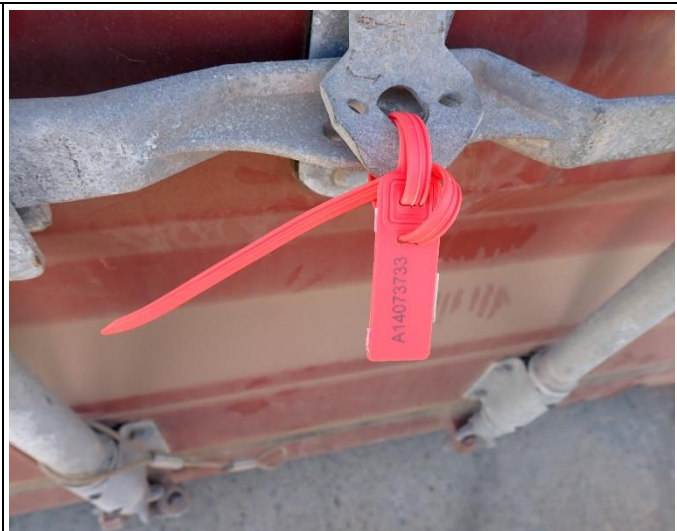
60. Seal of customs (A14073733)

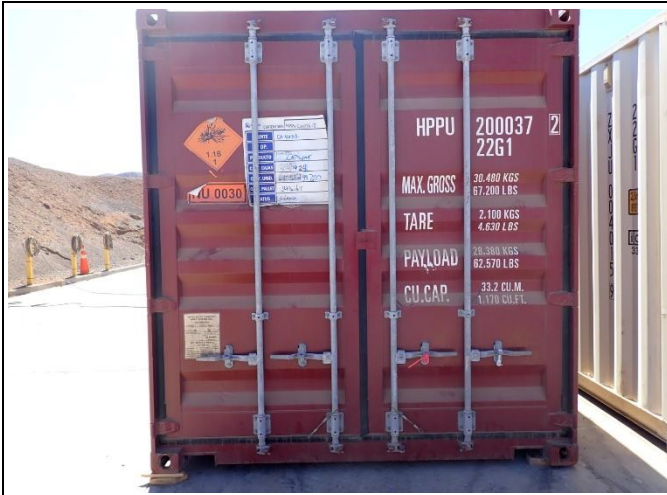
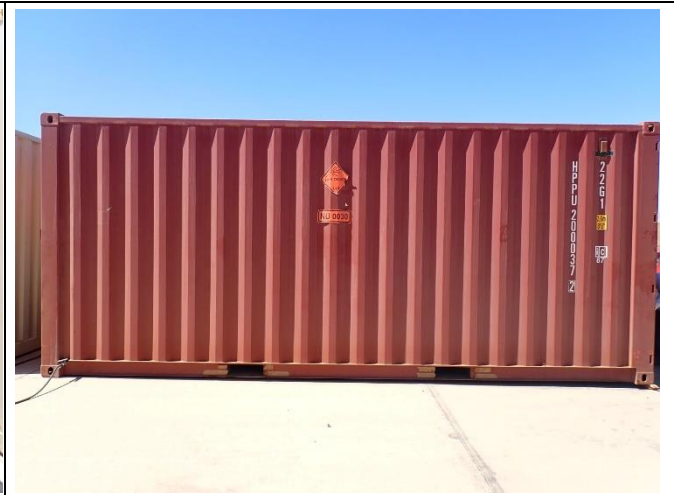
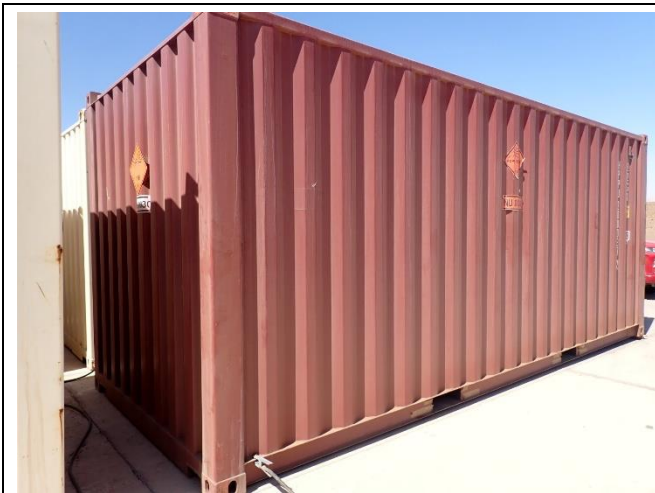
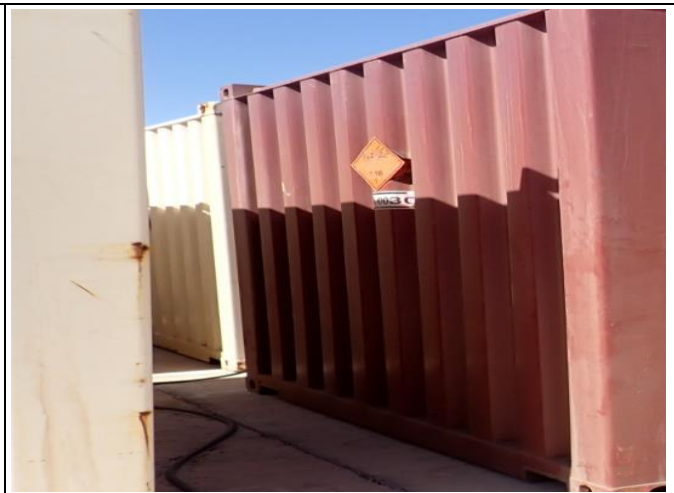
61. View of container with IMO labels.

62. View of container with IMO labels.

63. View of container with IMO labels.

64. View of container with IMO labels.
