Report: ANF-2603-0935

MV "CONDOR MAGALLANES"

"ARRIVAL INSPECTION AND DISCHARGE SUPERVISION OF THREE BOILERS"

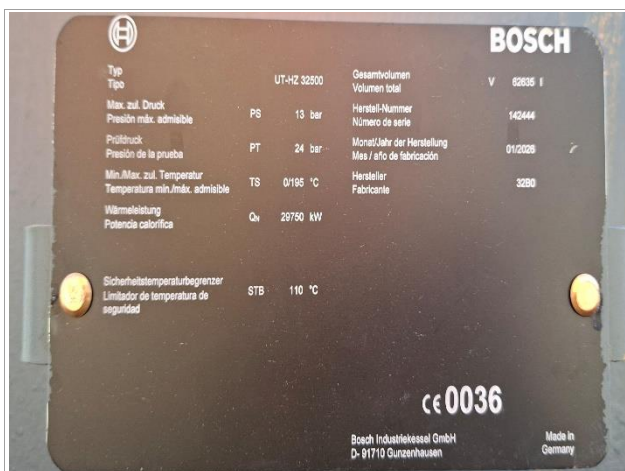
1. Package ID 142444

ITEM	SERIAL NUMBER	TYPE OF DAMAGE
Boiler UT-HZ IE	142444	Scratches and external frame dented and rusted
Boiler UT-HZ IE	142443	Frame reinforcement bent

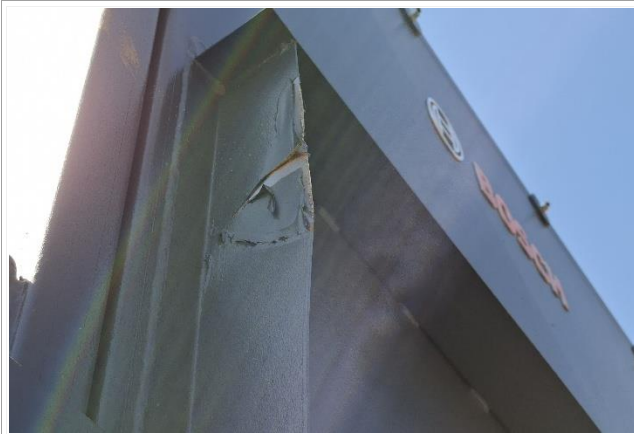
3. External frame dented, scratched and rusty.

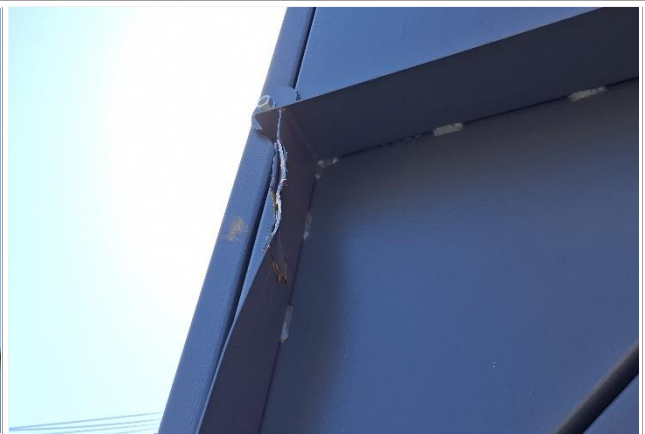
4. Another view of the above

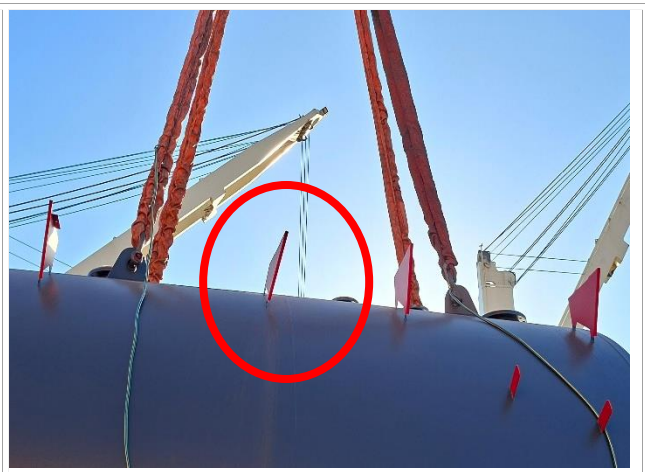
6. Frame reinforcement bent
