## MOORING WINCHES REPORT

<b>SURVEY</b>	<b>TERMINAL GUACOLDA II.</b>
<b>TO</b>	<b>ULTRAMAR AGENCIA MARITIMA</b>
<b>FROM</b>	<b>ALS INSPECTION CHILE SPA.</b>
<b>CLIENT REF</b>	<b>ULTRAMAR AGENCIA MARITIMA</b>
<b>ALS REF</b>	<b>ANF-2605-1783.</b>
<b>SCOPE OF SURVEY</b>	<b>VISUAL INSPECTION OF 7 MOORING WINCHES.</b>
<b>VESSEL NAME</b>	<b>PAN GLOBAL.</b>
<b>PLACE OF SURVEY</b>	<b>HUASCO, BAY.</b>
<b>DATE OF SURVEY</b>	<b>MAY.16, 2026</b>
<b>TIME OF SURVEY</b>	<b>14:30 HRS. TO 17:45 HRS.</b>

Report: ANF-2605-1783

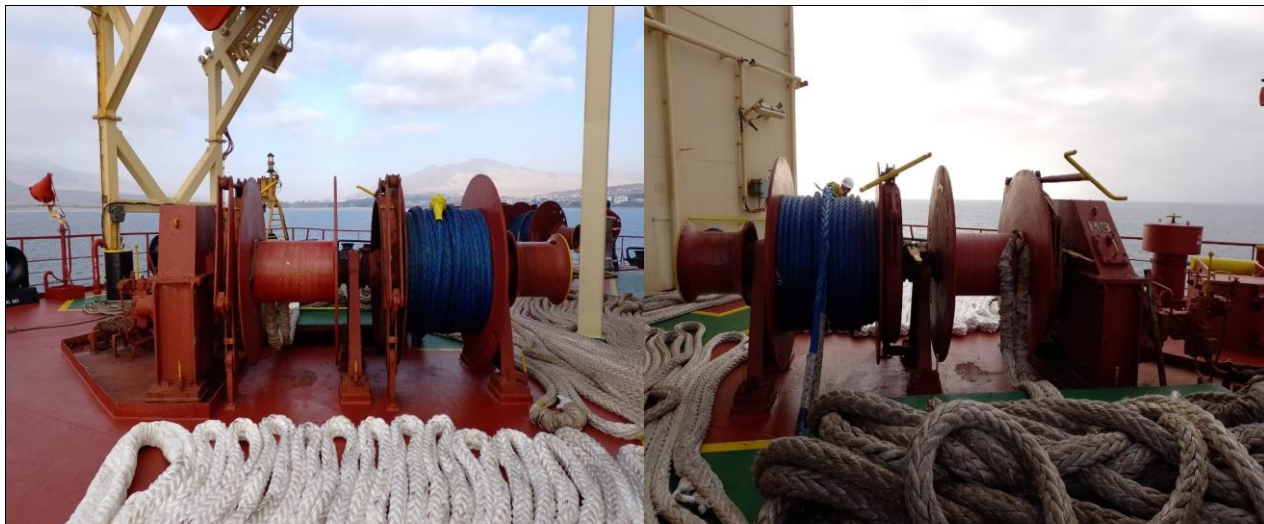
1. View of Ps. stern winch.

2. View of Ps. stern winch.

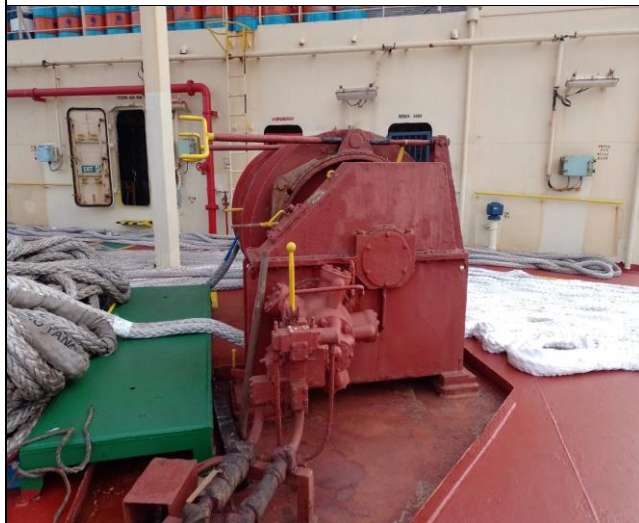
3. Additional view of Ps. stern winch.

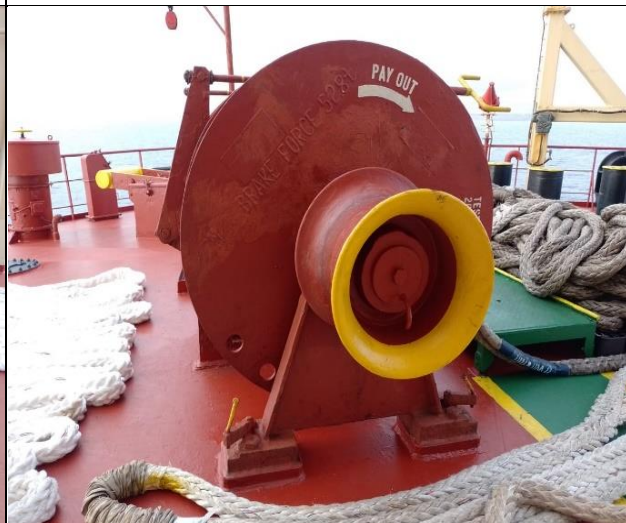
4. View of warping drum/head on Ps. stern winch

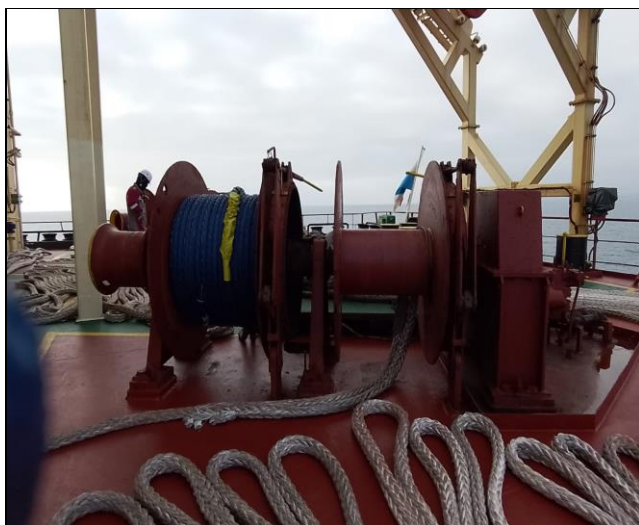
5. View of Stb. stern winch.

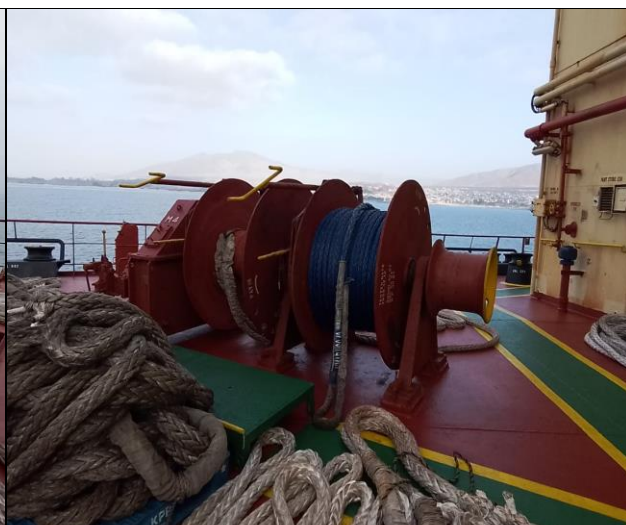
6. View of Stb. stern winch.

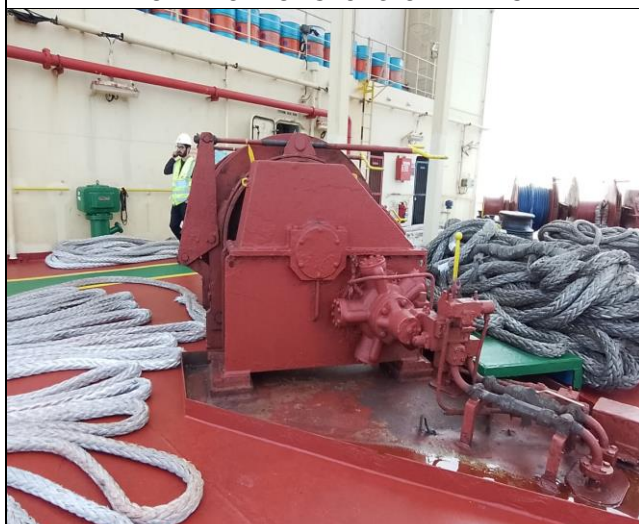
7. Additional view of Stb. stern winch.

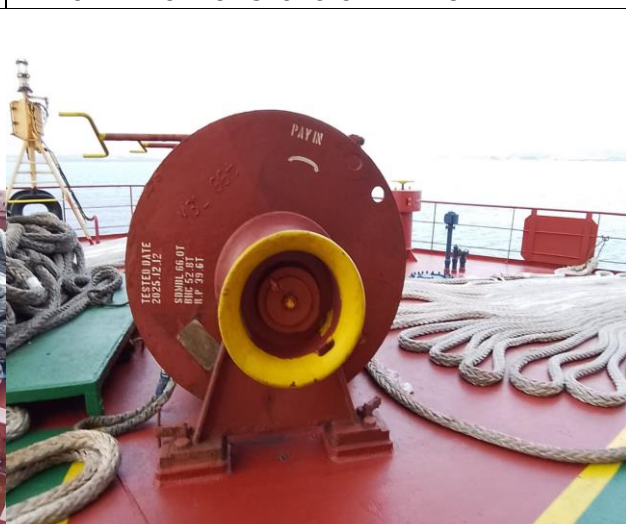
8. View of warping drum.

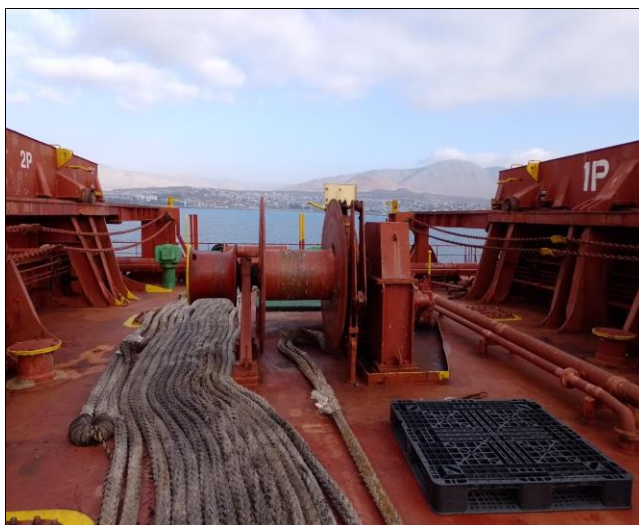
9. View of spring Aft. winch BTW H1-H2.

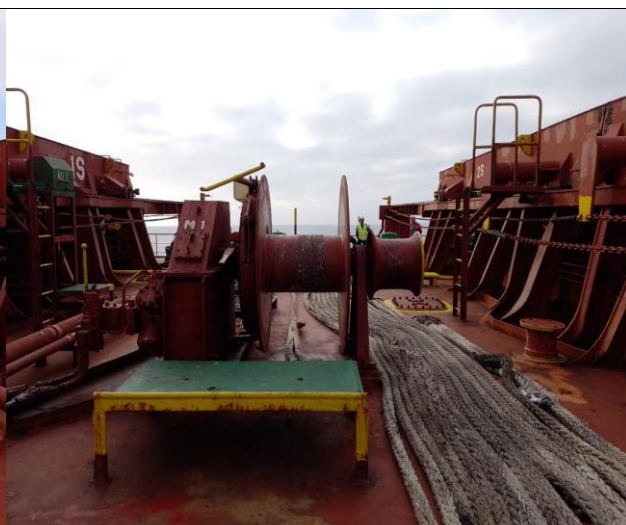
10. View of spring Aft. winch BTW H1-H2.

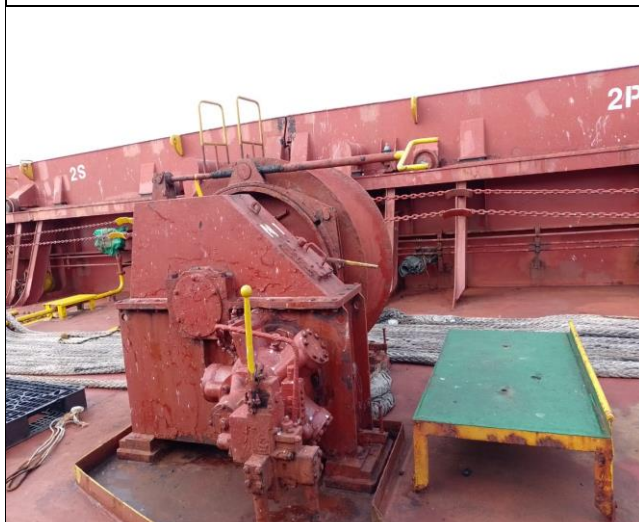
11. Additional view of spring Aft. winch BTW H1-H2.

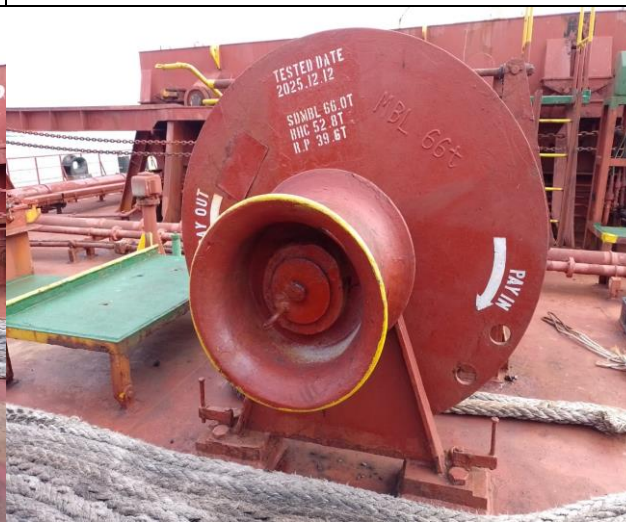
12. View of warping drum.

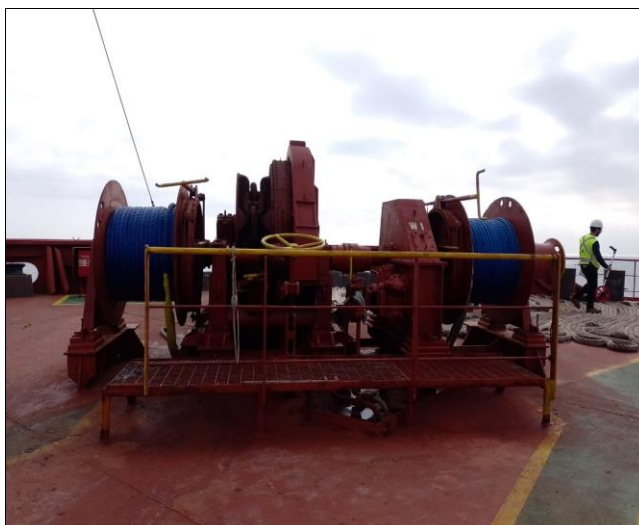
13. View of Ps. Fwd winch.

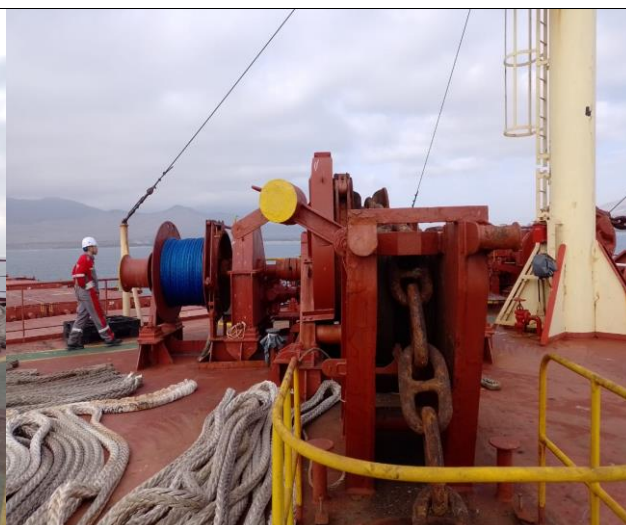
14. View of Ps. Fwd winch.

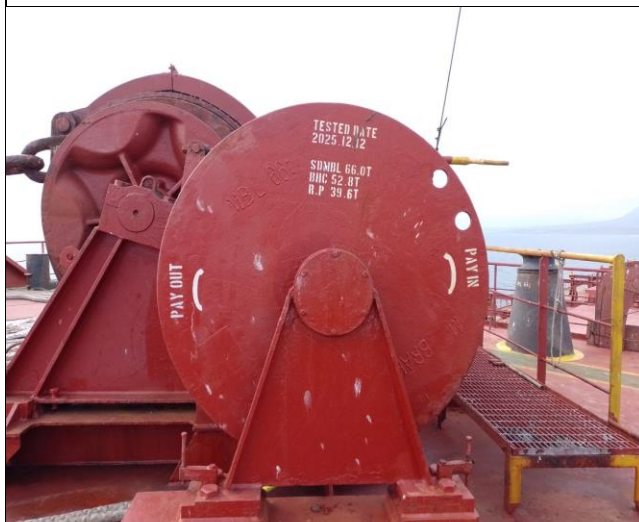
15. Additional view of Ps. Fwd winch

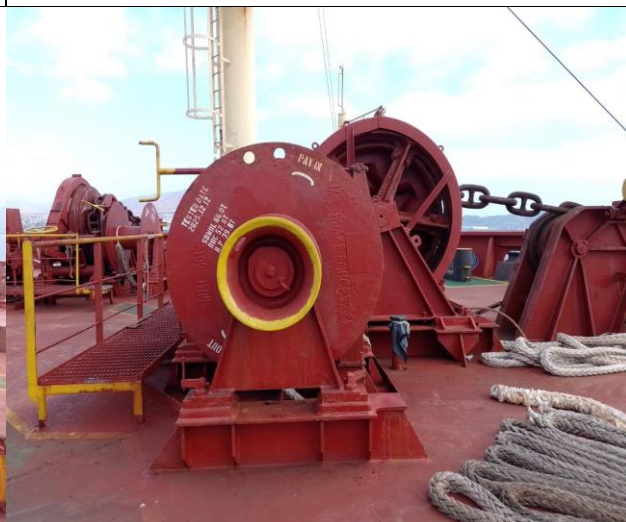
16. View of warping drum.

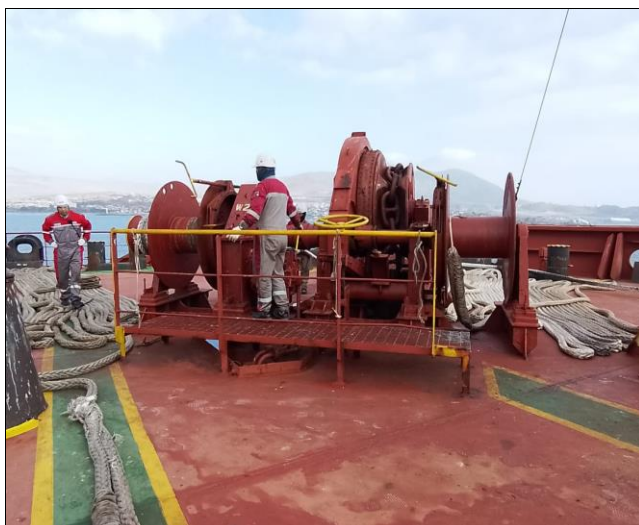
17. View of Stb. Fwd winch.

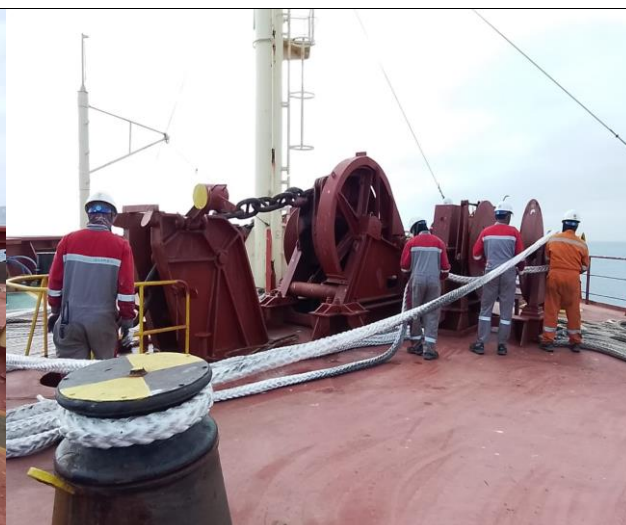
18. View of Stb, Fwd winch.

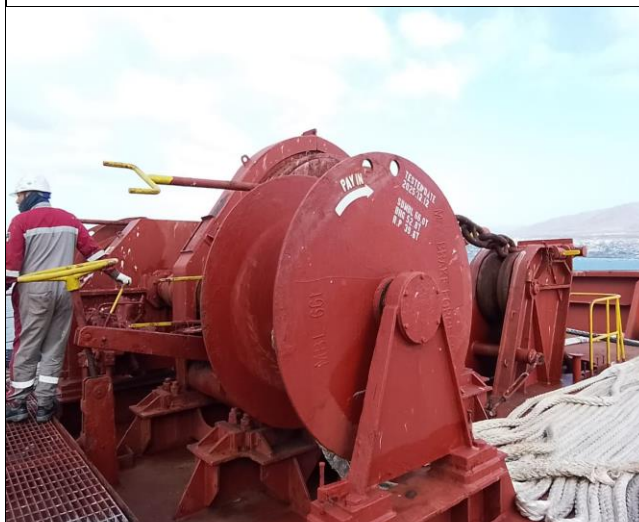
19. Additional view of Stb. Fwd winch

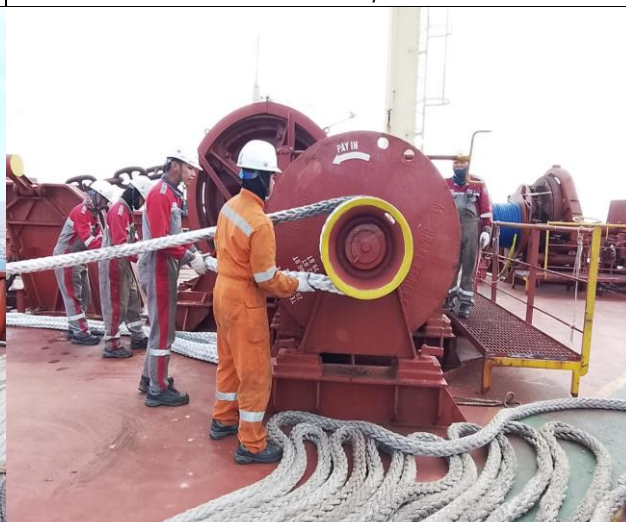
20. View of warping drum.

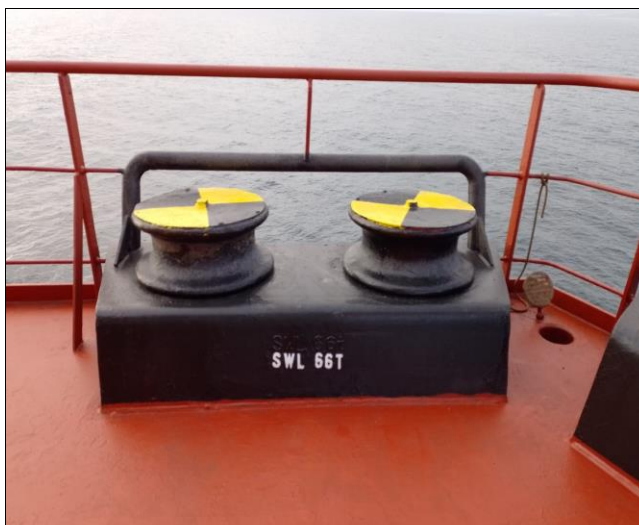
21. View of Ps. Stern rollers.

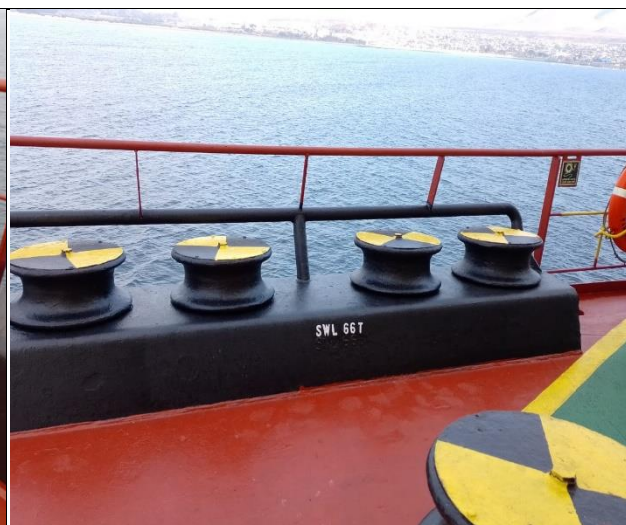
22. View of Stb. Stern rollers.

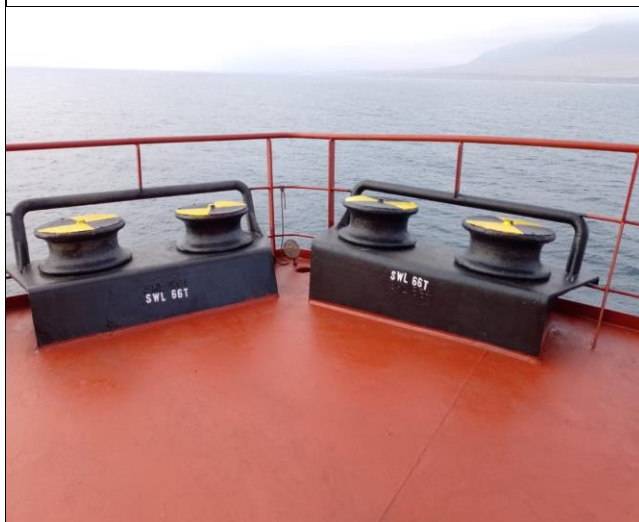
23. View of Ps center Stern rollers.

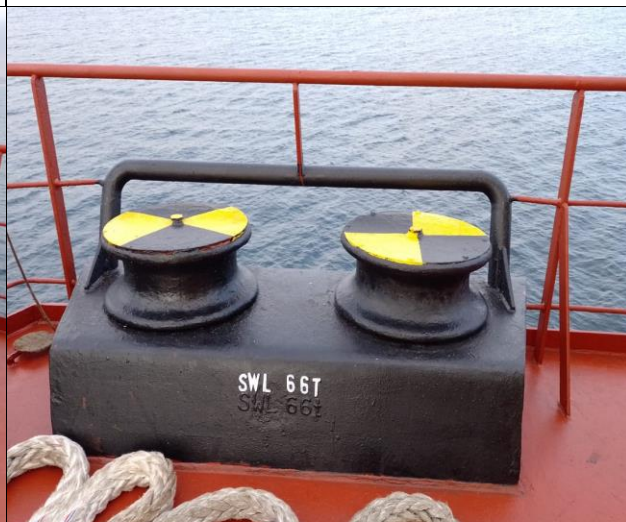
24. View of Stb center Stern rollers.

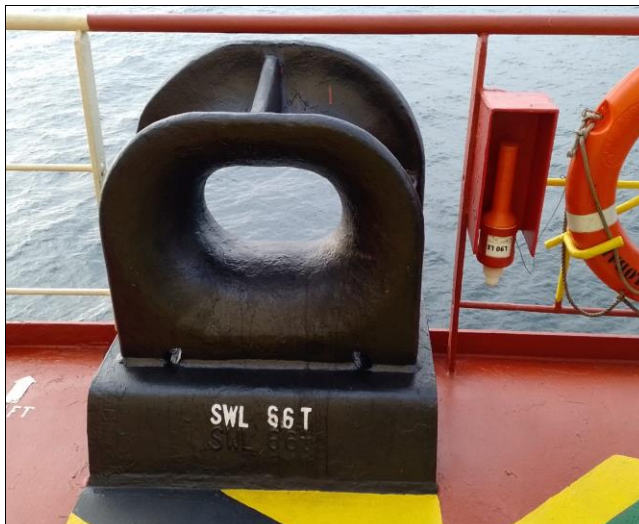
25.View of Stern chock.

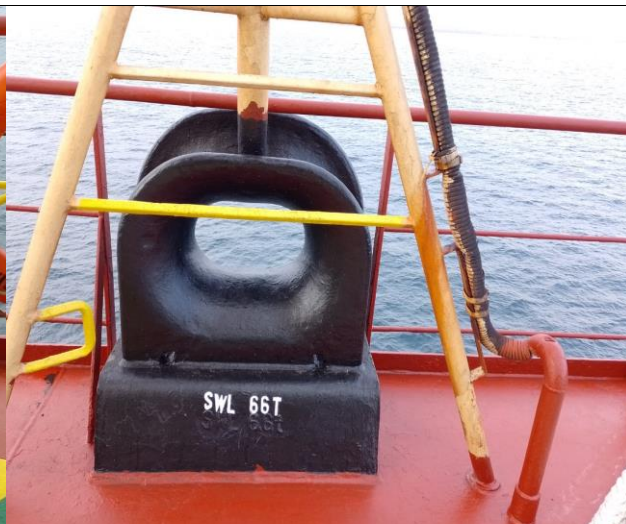
26.Additional view of Stern chock.

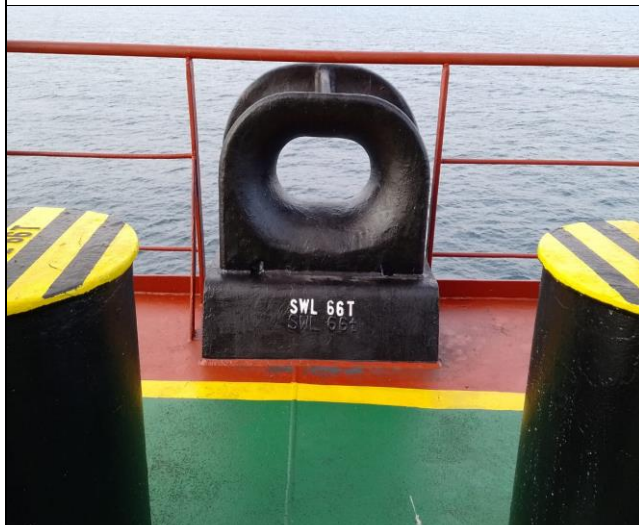
27.View of Stern chock.

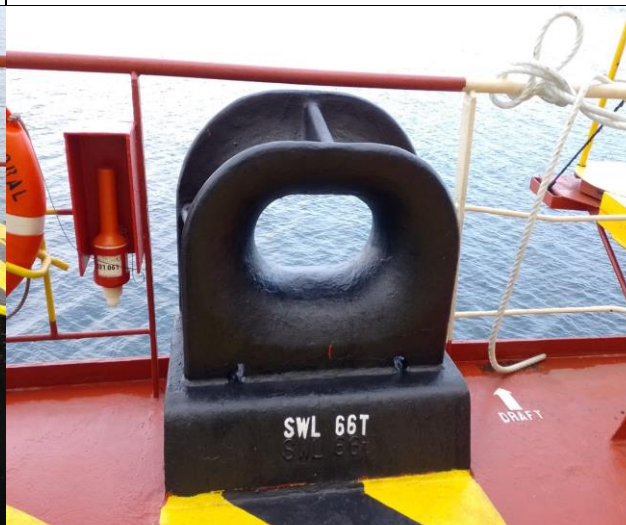
28.Additional view of Stern chock,

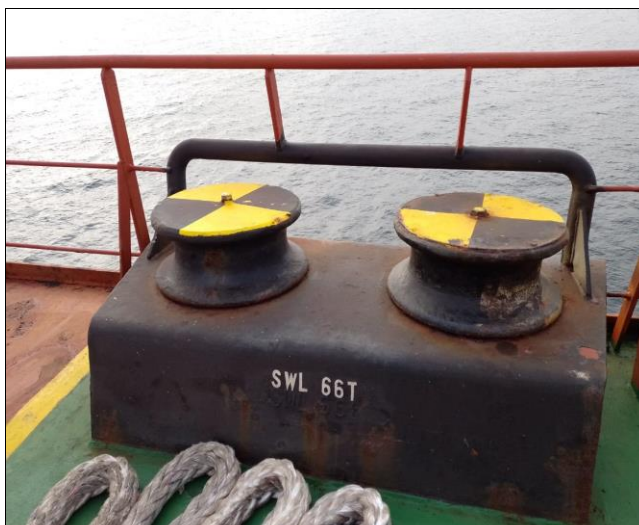
29. View of Spring Btw 1-2 rollers.

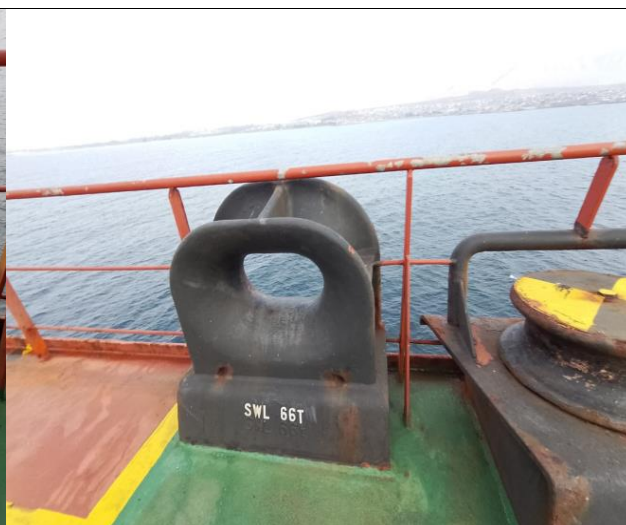
30. View of Spring Btw 1-2 rollers.

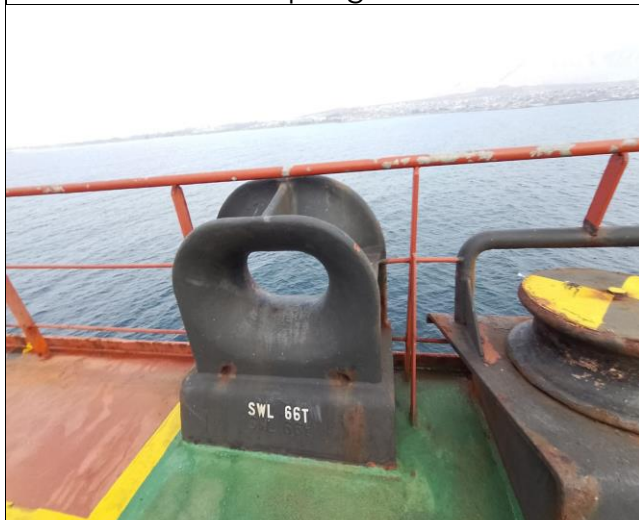
31. Additional view of Spring Btw 6-7 rollers.

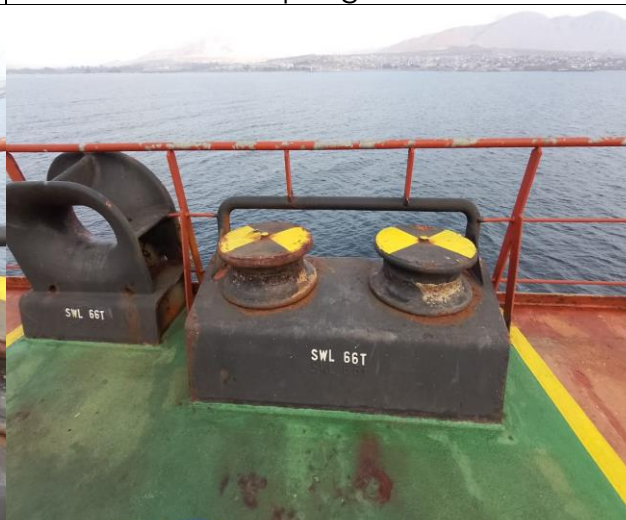
32. Additional view of Spring Btw 6-7 rollers.

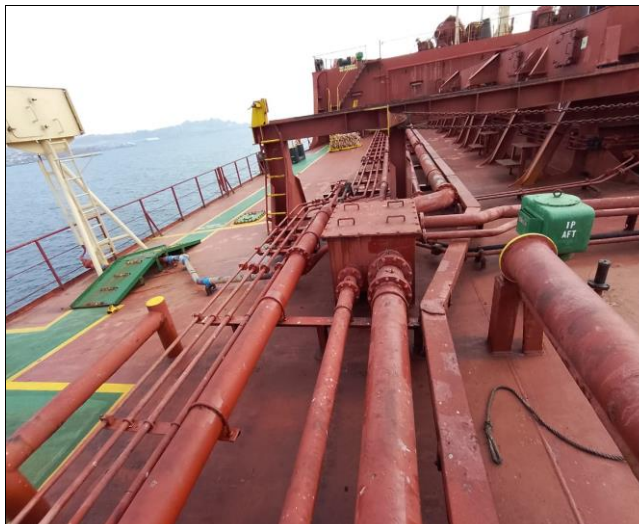
33. View of spring Btw 1-2 Pedestal Roller Guide.

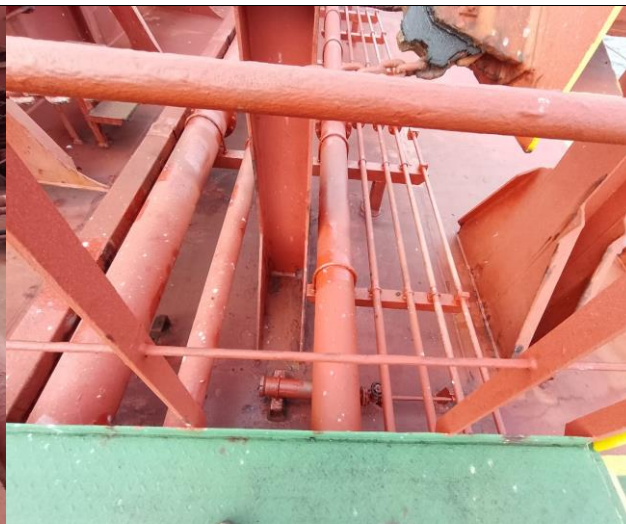
34. View of spring Btw 1-3 Pedestal Roller Guide.

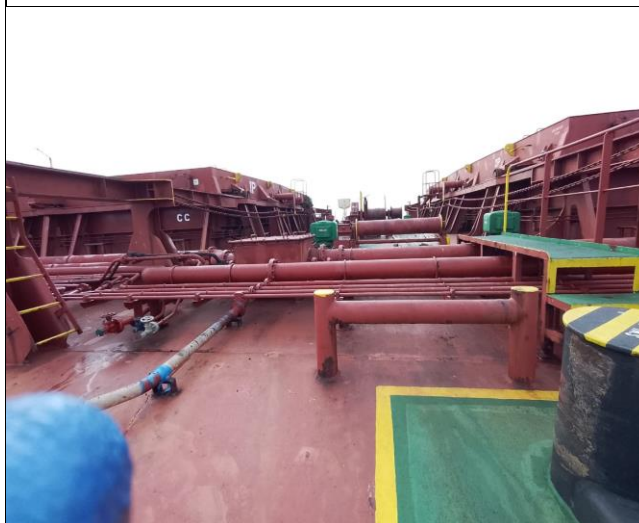
35. View of spring Btw 1-3 Pedestal Roller Guide.

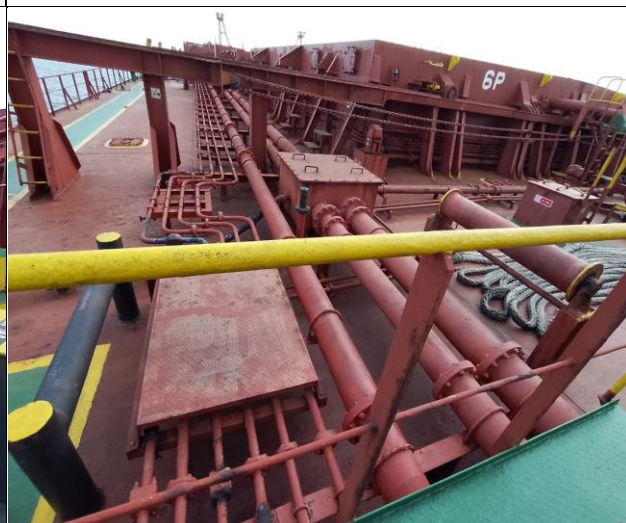
36. View of spring Btw 1-2 Pedestal Roller Guide.

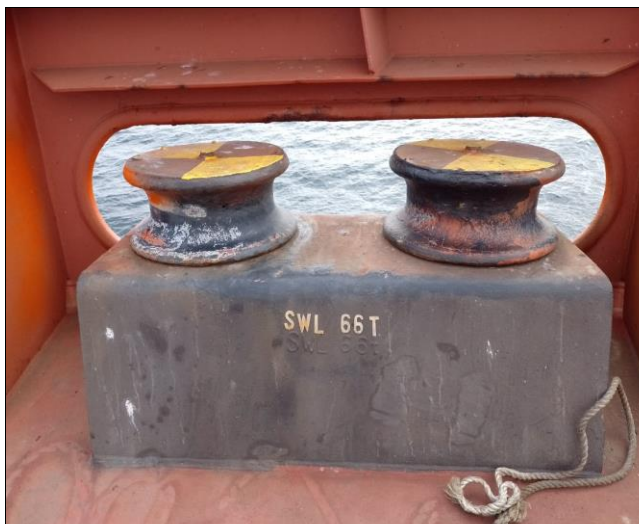
37. View of Ps. Fwd rollers.

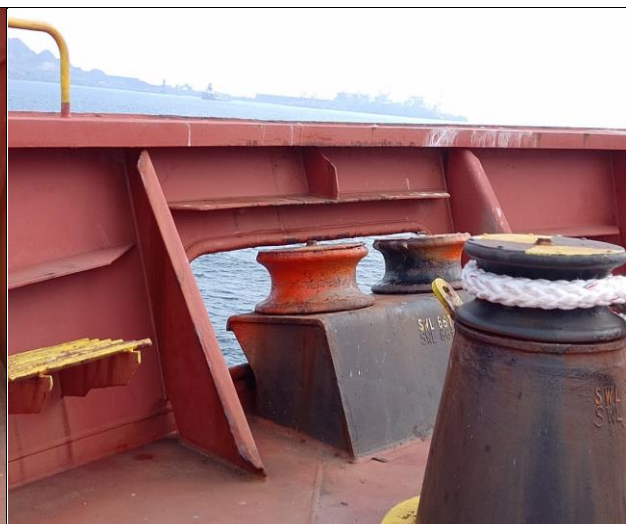
38. View of Stb. Fwd rollers.

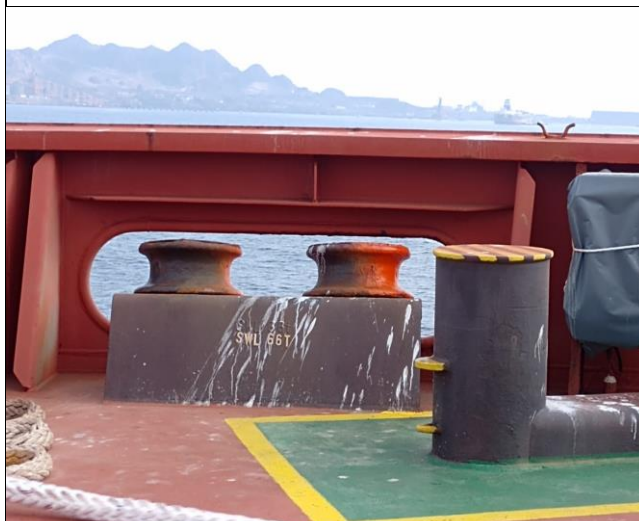
39. View of Ps center Fwd rollers

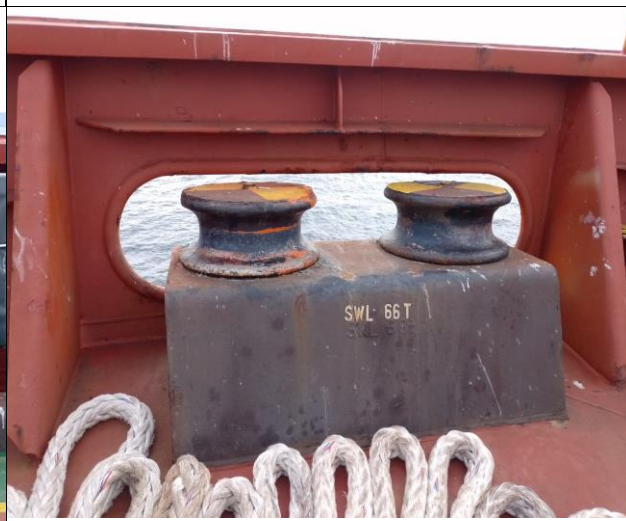
40. View of Stb center Fwd rollers.

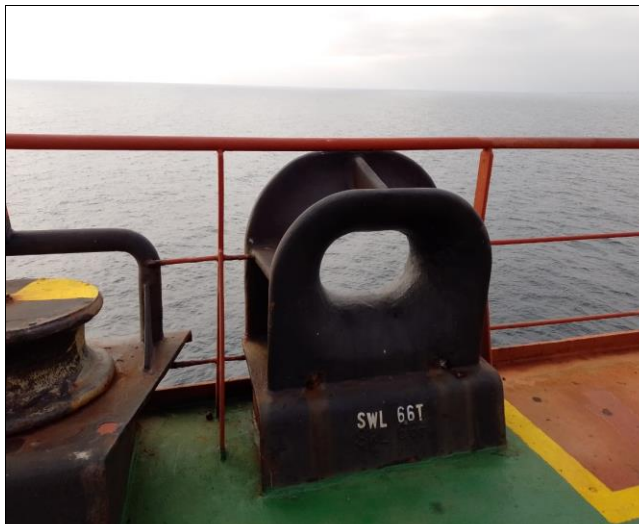
41.View of Fwd chock.

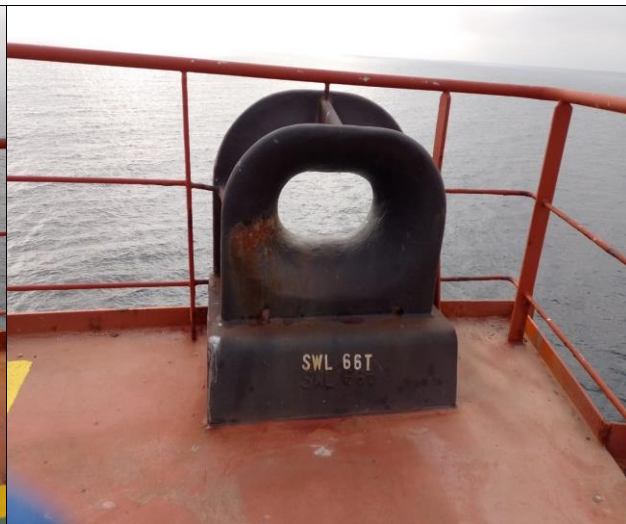
42.View of Fwd chock.

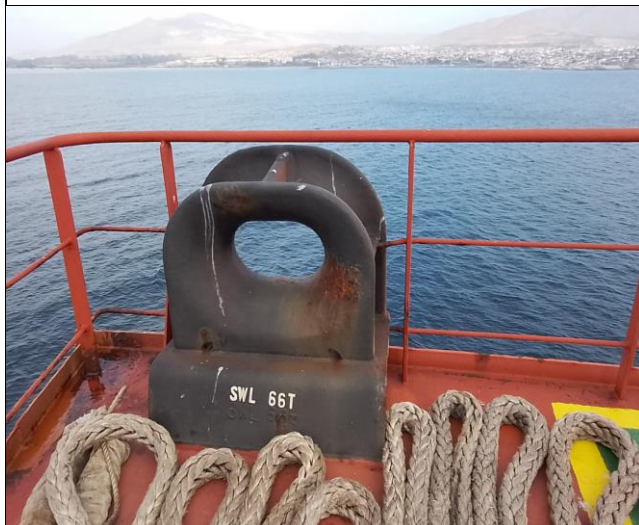
43.View of Fwd chock.

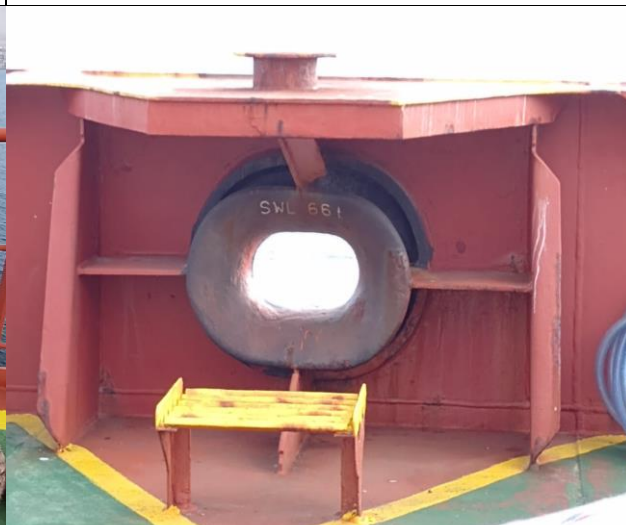
44.View of Fwd chock.
