MOORING WINCHES REPORT

SURVEY	VISUAL CONDITIONS OF MOORING WINCHES
TO	MR. NICOLAS PALMA.
FROM	ALS INSPECTION CHILE SPA.
CLIENT REF	N/A.
ALS REF	ANF-2605-1973.
SCOPE OF SURVEY	VISUAL INSPECTION OF 08 MOORING WINCHES.
VESSEL NAME	JIN MEI.
PLACE OF SURVEY	CALDERA BAY.
DATE OF SURVEY	JUNE 1, 2026.
TIME OF SURVEY	09:42 HRS, TO 13:30 HRS.

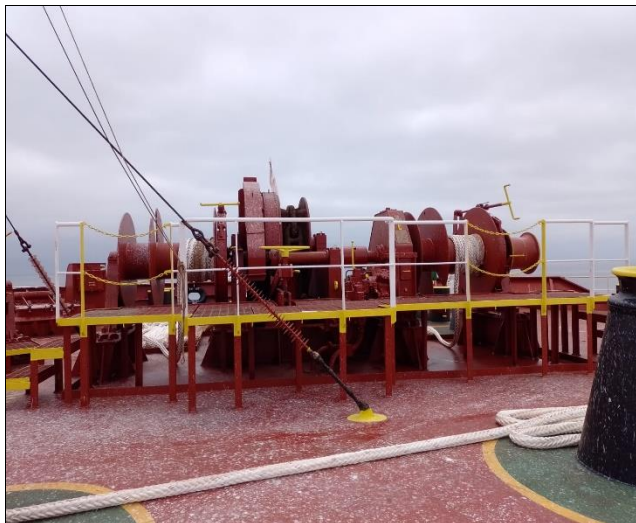
1. View of Ss, Fwd, winch.

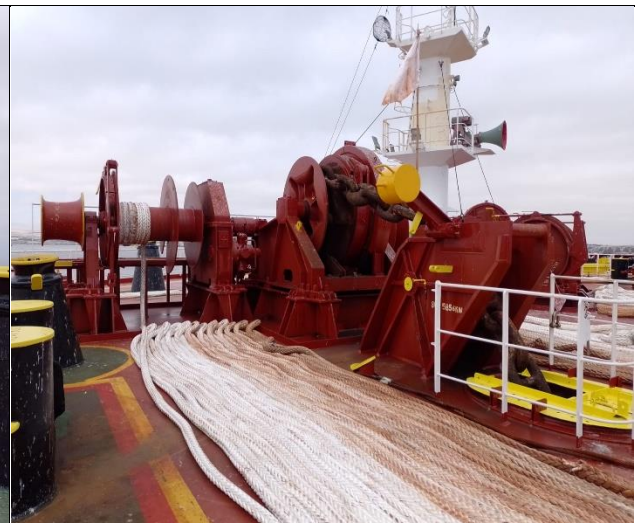
2. View of Ss, Fwd, winch.

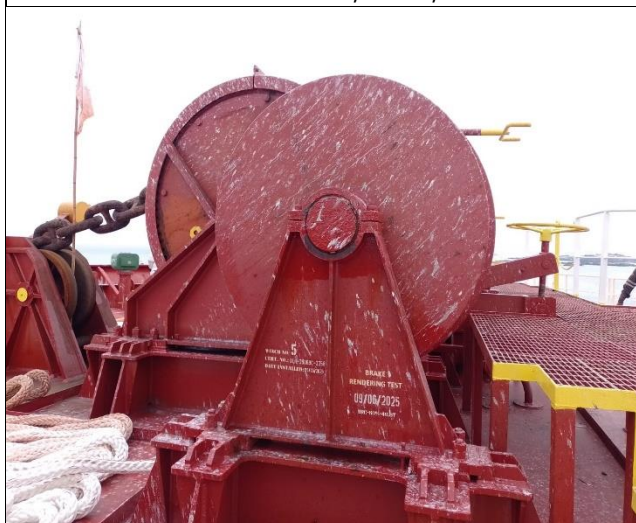
3. Another view as previous one.

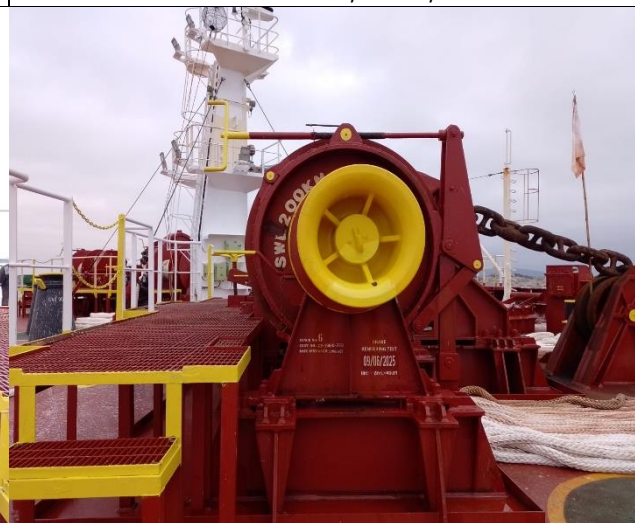
4. View of warping drum.

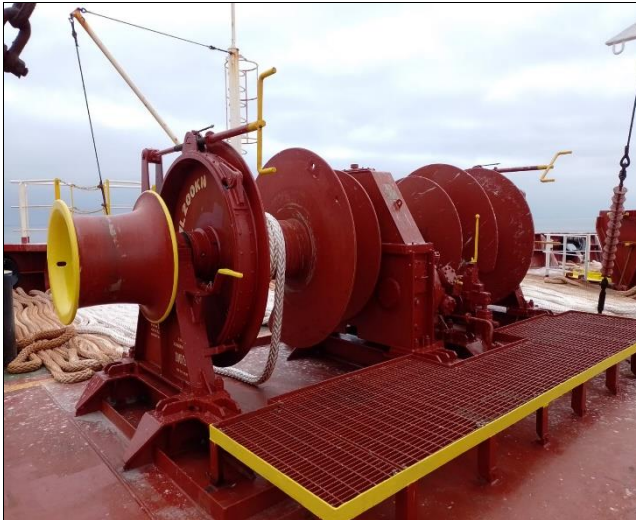
5. View of Mid, Fwd, winch.

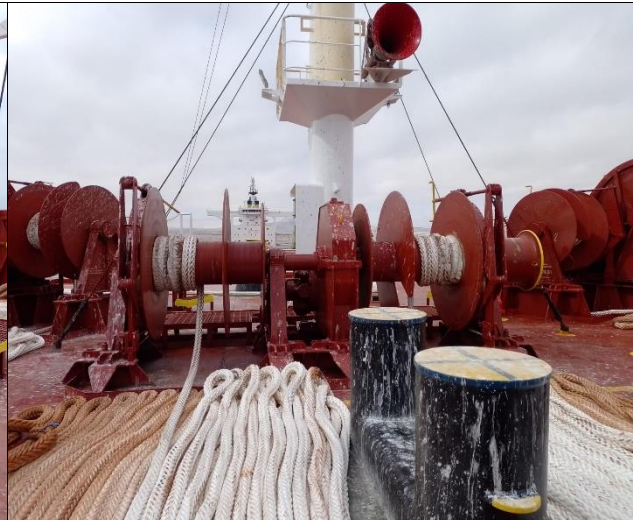
6. View of Mid, Fwd, winch.

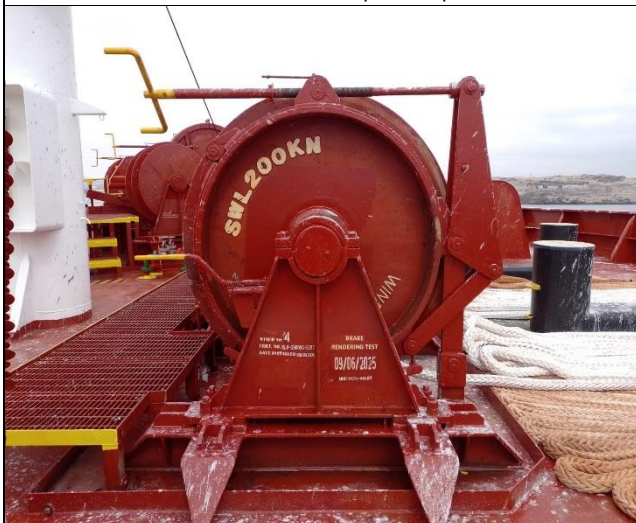
7. View of Mid, Fwd, winch

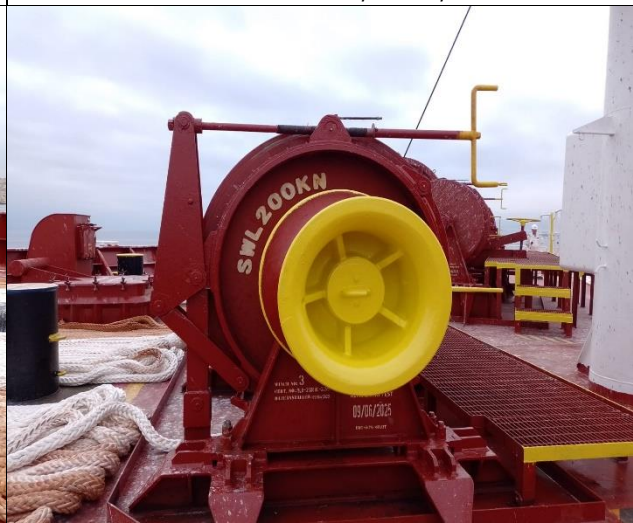
8. View of winch for brest line.

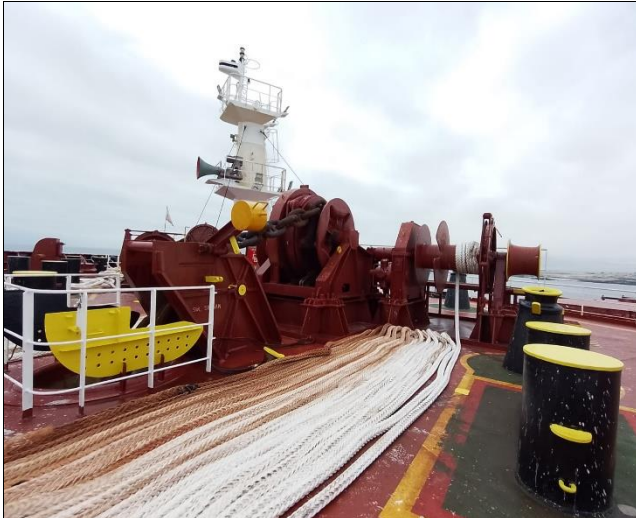
9. View of Ps, Fwd, winch.

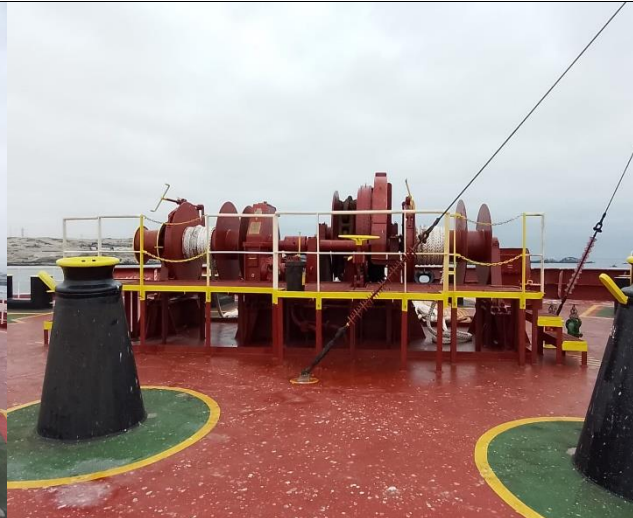
10. View of Ps, Fwd, winch.

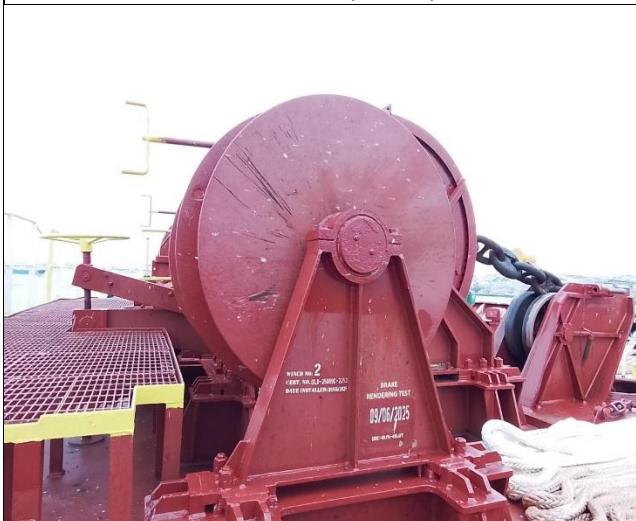
11. Another view as previous one.

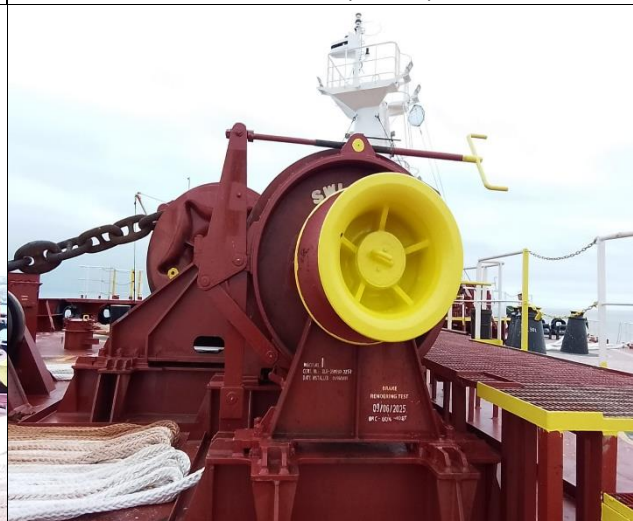
12. View of warping drum.

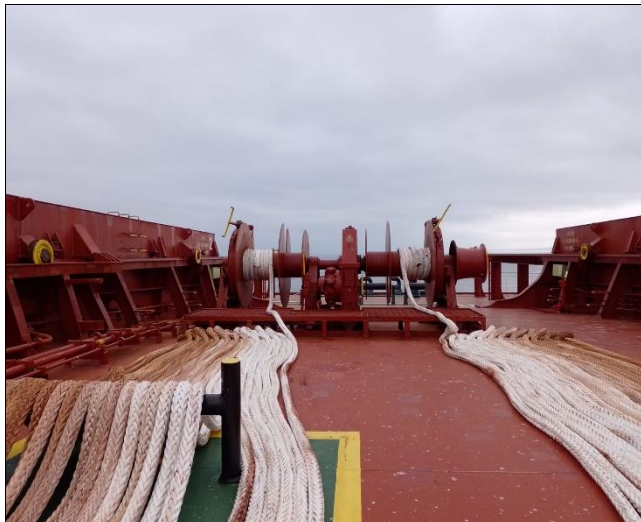
13. View of winch Between H2 & H3.

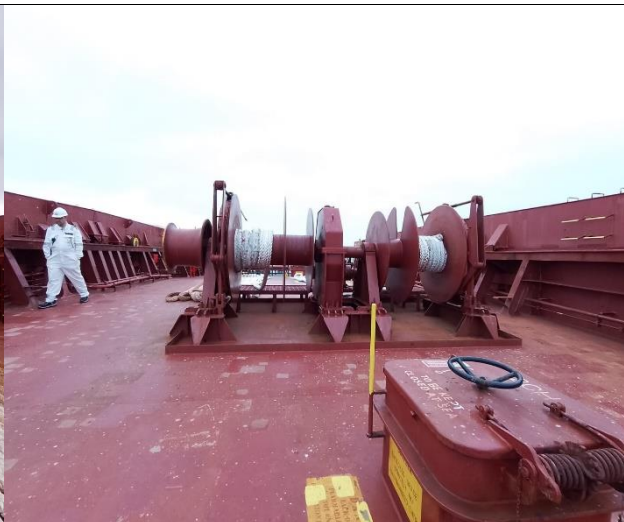
14. View of winch Between H2 & H3.

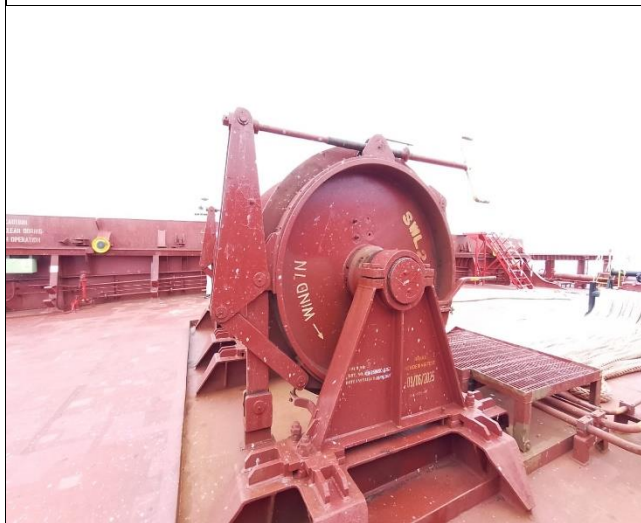
15. Another view as previous one.

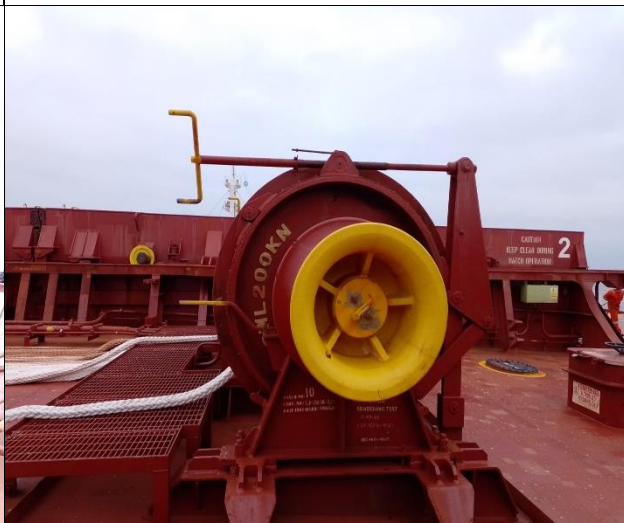
16. View of warping drum.

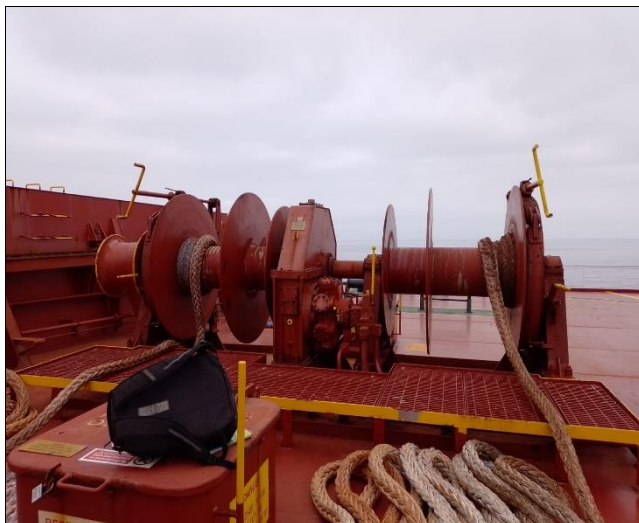
17.View of winch Between H8 & H9.

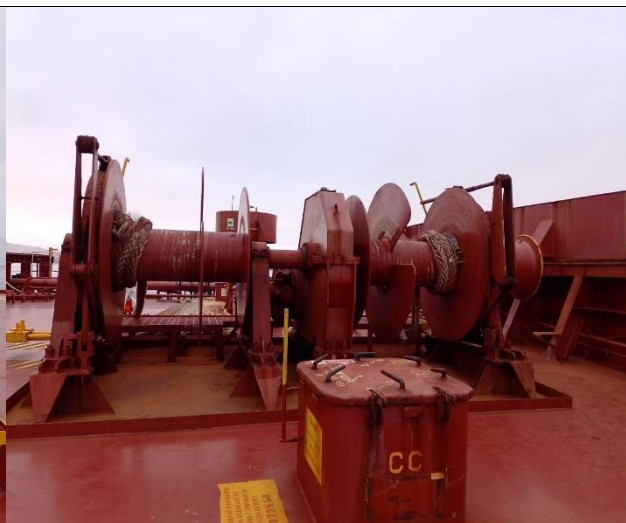
18.View of winch Between H8 & H9.

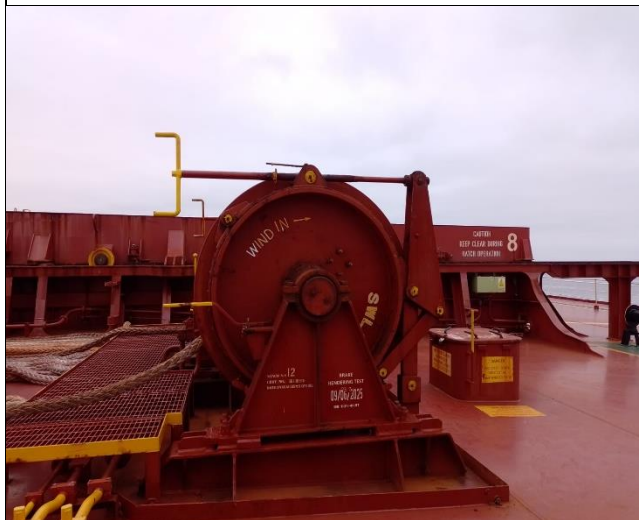
19.Another view as previous one.

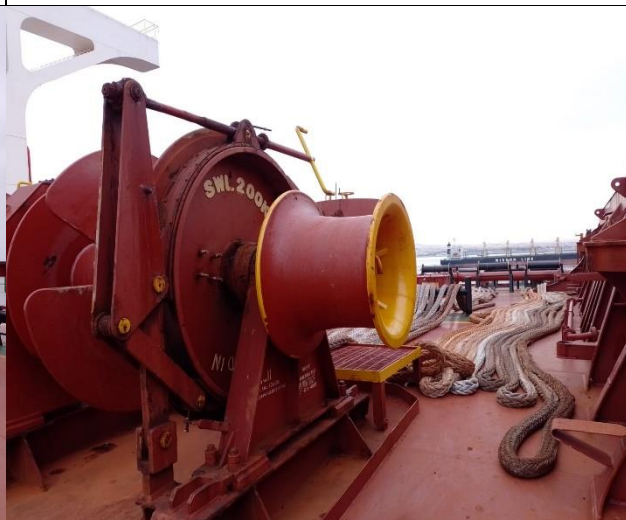
20.View of winches.

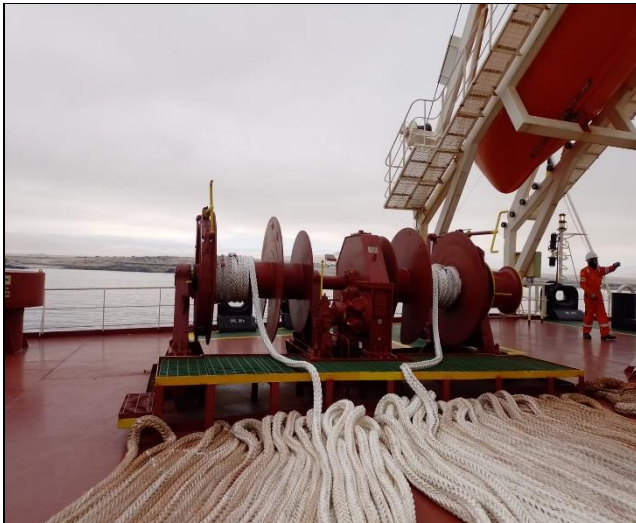
21.View of Ss, Aft, winch.

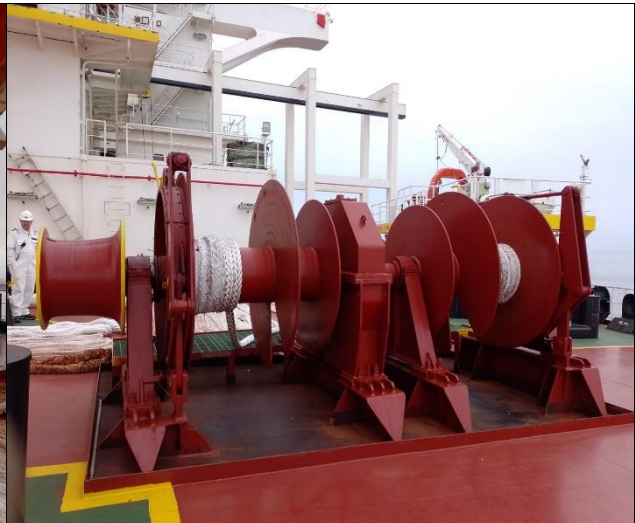
22.View of Ss, Aft, winch.

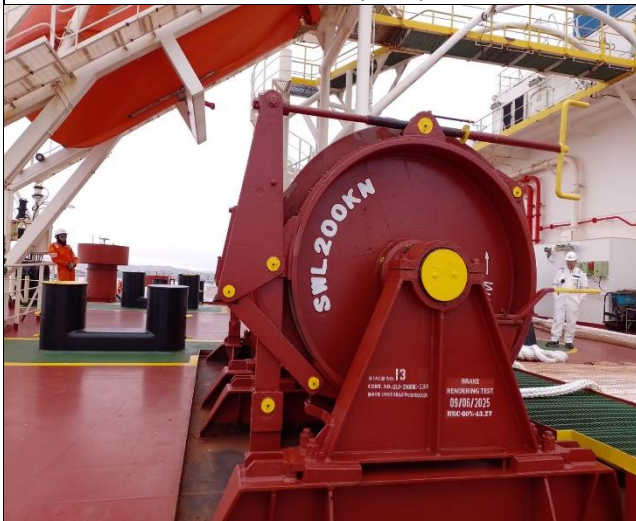
23.Another view as previous one.

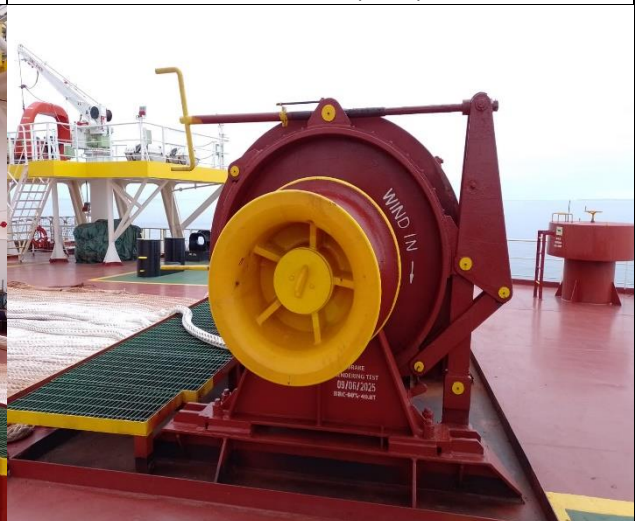
24.View of warping drum.

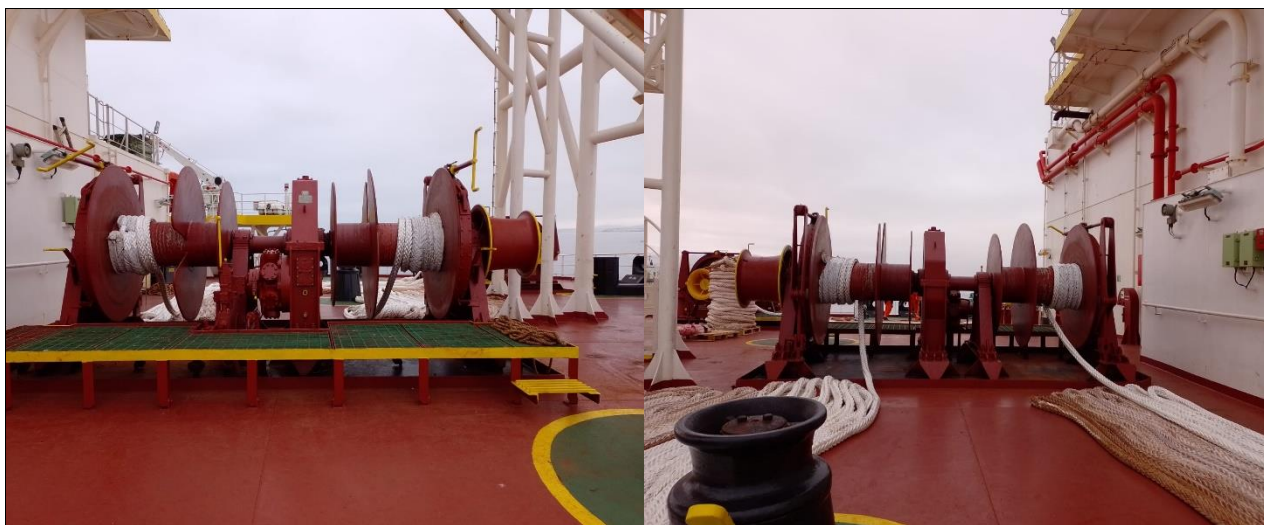
25.View of Mid, Aft, winch.

26.View of Mid, Aft, winch.

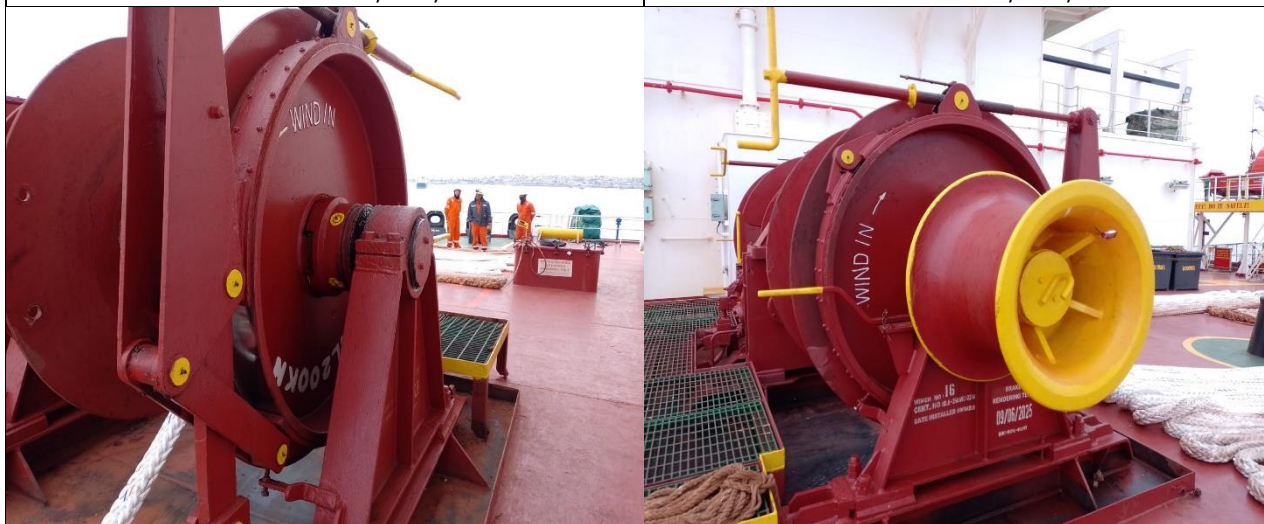
27.Another view as previous one.

28.View of warping drum.

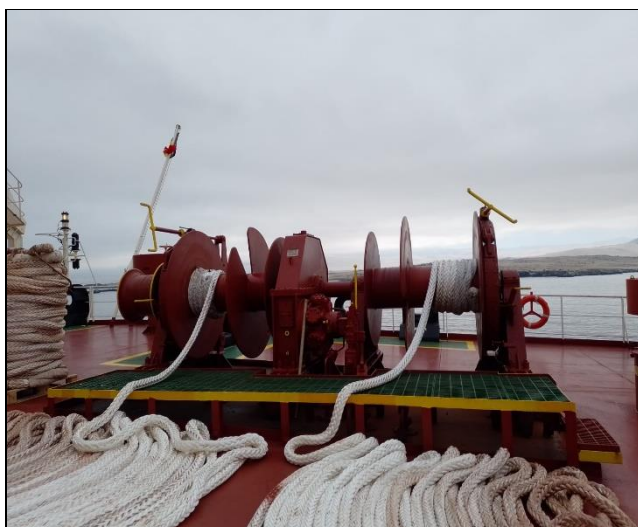
29.View of Ps, Aft, winch.

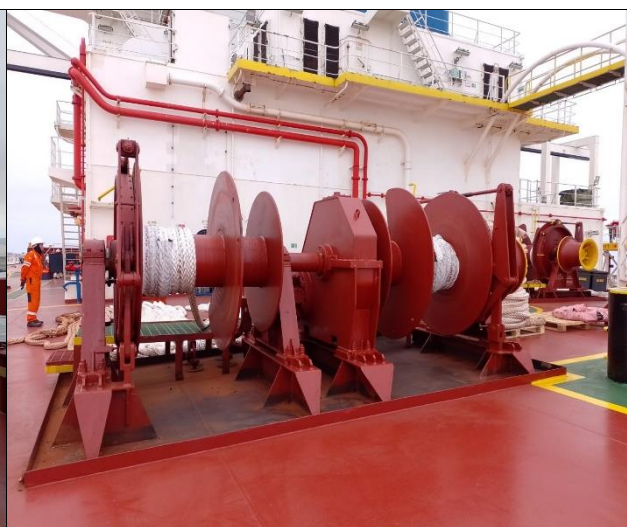
30.View of Ps, Aft, winch.

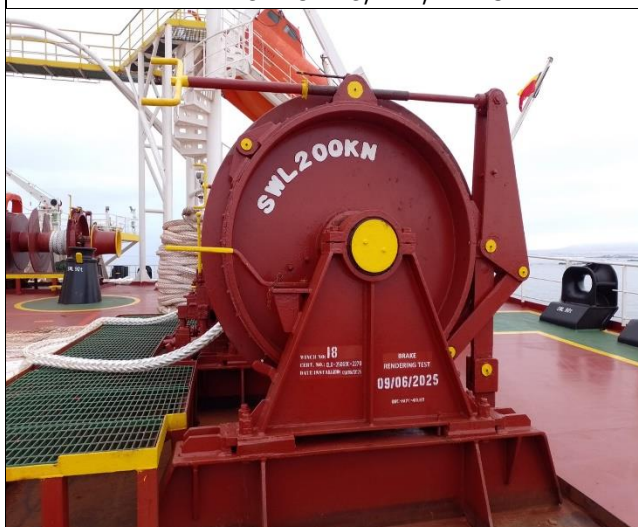
31.Another view as previous one

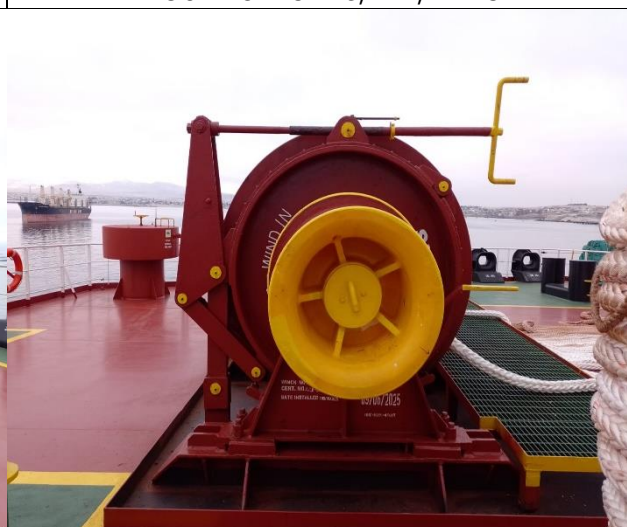
32.View of warping drum.
