MV "ASL SAKURA"

FULL OFF HIRE & BUNKER SURVEY

Report: SAI-2603-1081

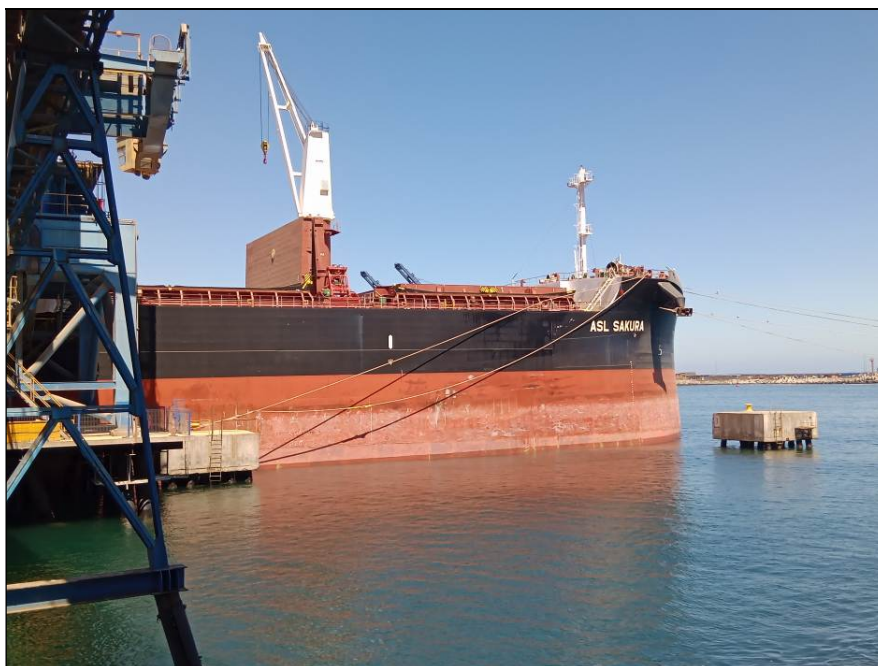
No. 1: Hull Plating, Starboard side noted with paint scratched, stained and rusty. (See photos from No. 1 to No.12)

1. General view of Hull Forward Ss.

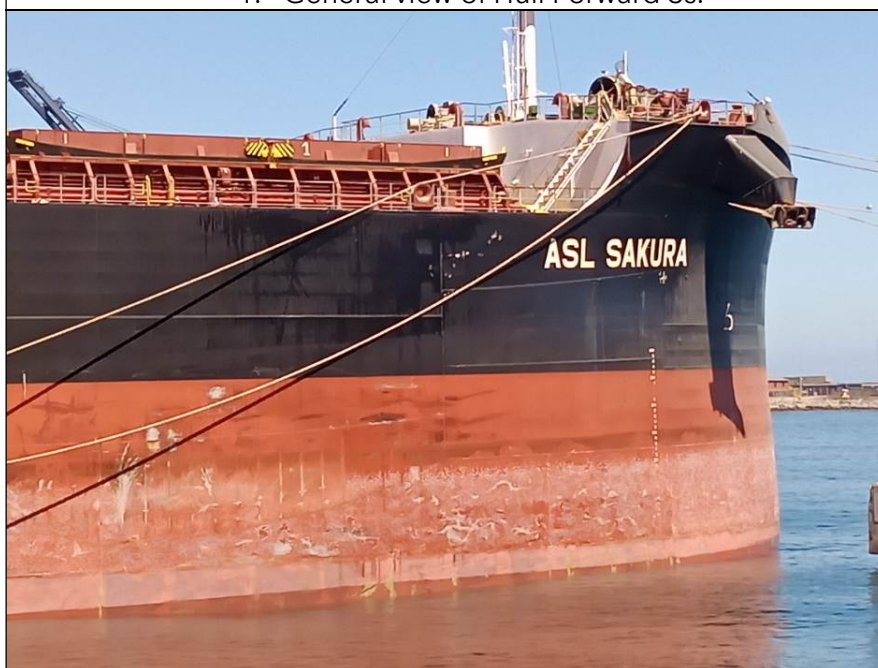
2. Paint scratched and stained were observed at fwd.

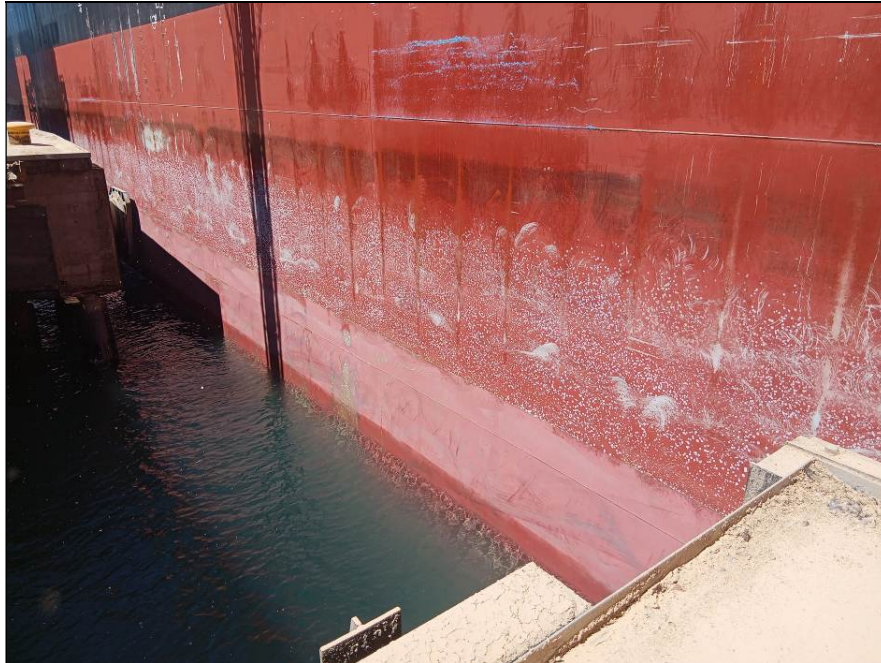
5. Hull, Mid. section; paint scratched and rusty.

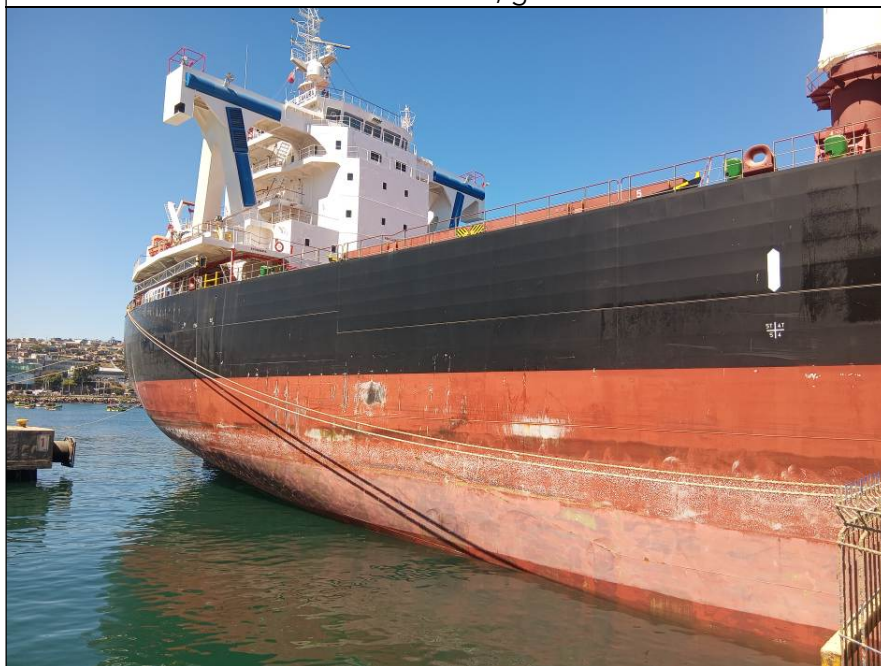
10. Hull with paint scratched & stained.

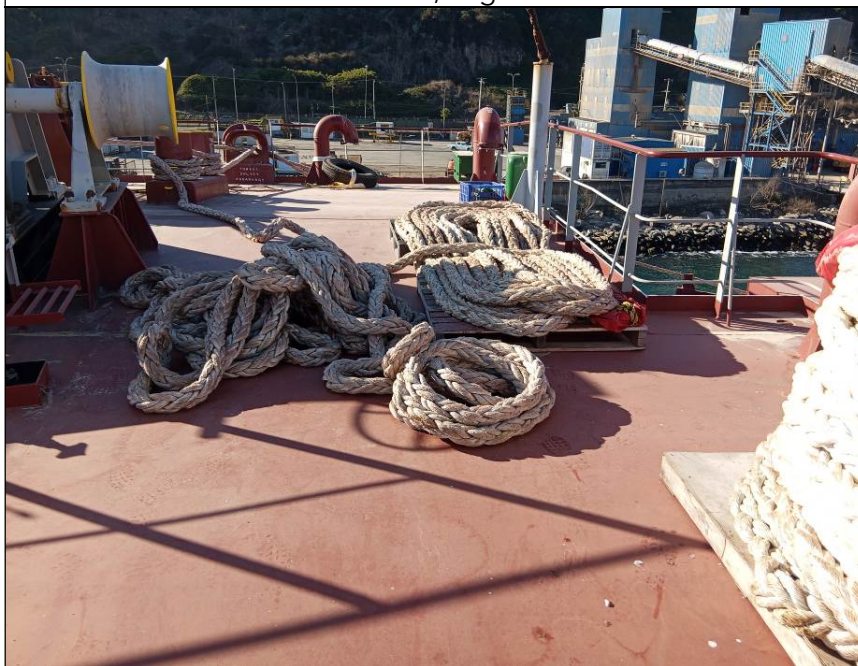
No. 2: Forward mooring lines stained and worn out (See photos from No. 20)

20. Forward mooring lines stained and worn out.

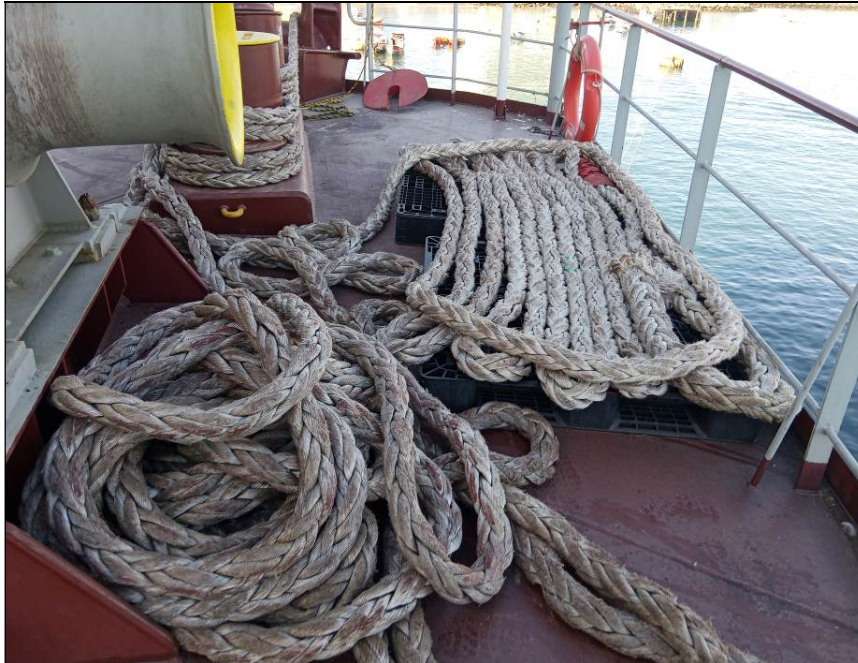
No. 3: Aft mooring lines stained and worn out (See photos from No. 25)

25. Aft mooring lines stained and worn out.

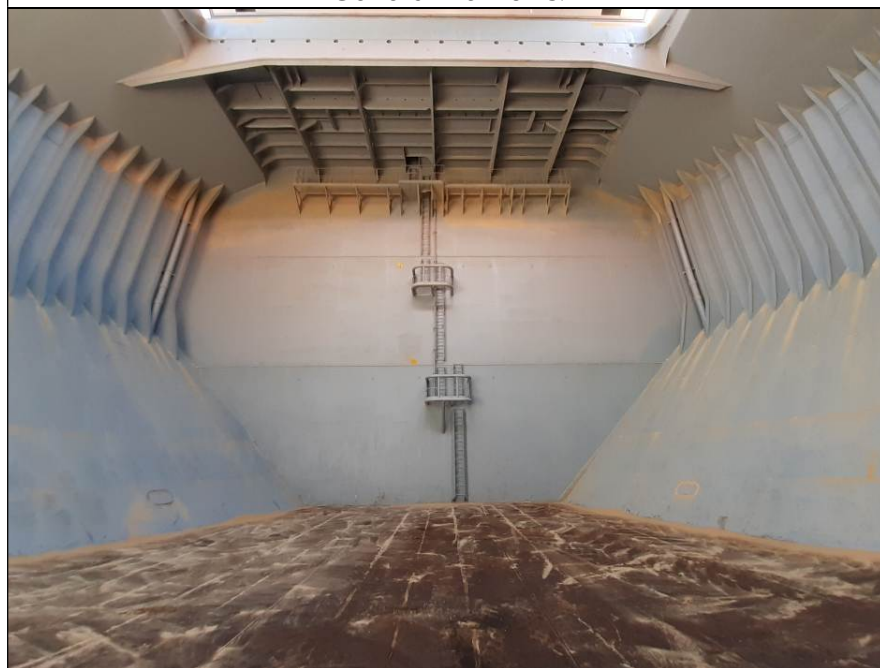
No. 4: Forward bulkhead with paint scratched and rust (See photo No. 28)

28. Fwd bulkhead with paint scratched and rust.

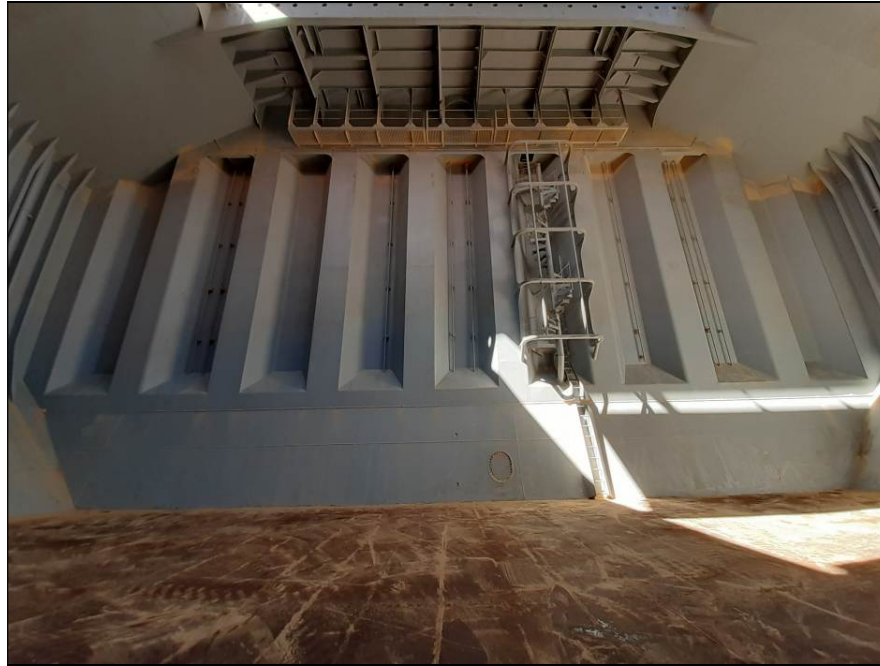
No. 5: After bulkhead with paint scratched and rust (See photo No. 29)

29. Aft bulkhead with paint scratched and dust.

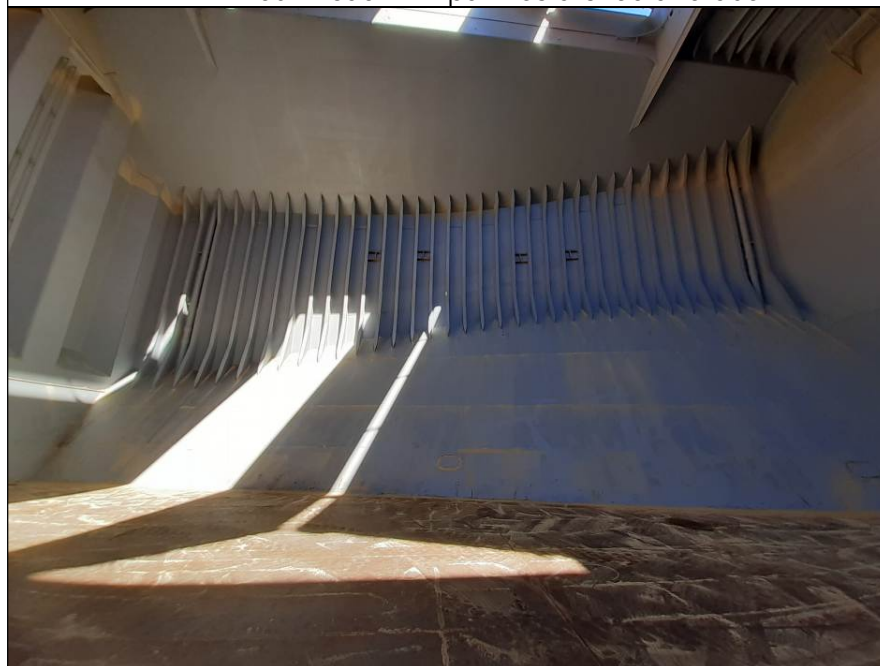
No. 6: Side/shell plating Ps with paint scratched and rust (See photo No. 30)

30. Side/shell plating Ps with paint scratched.

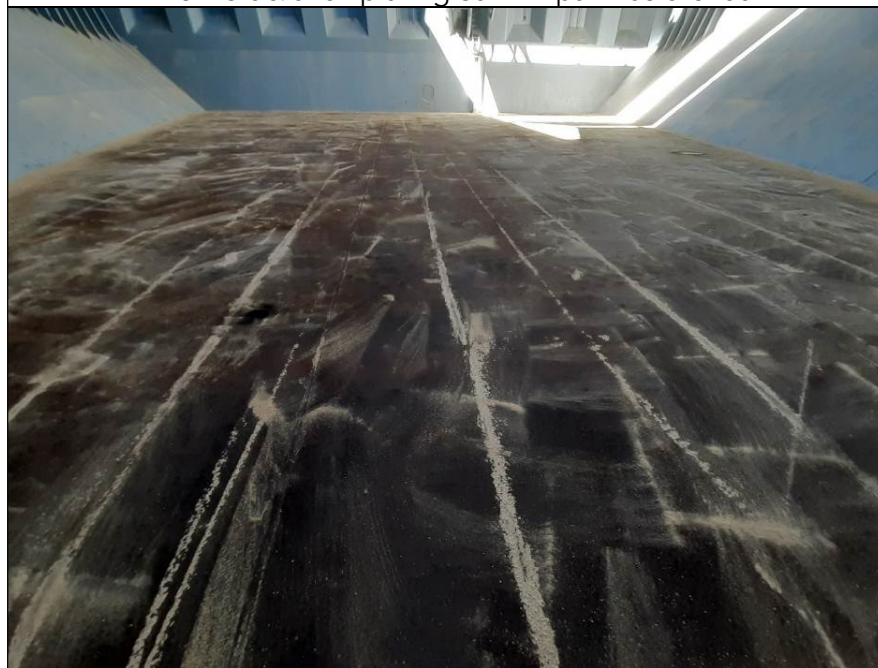
No. 8: Cargo hold with dust of cargo remaining (See photos No. 27 to 33)

32. Tank top plating with dust.

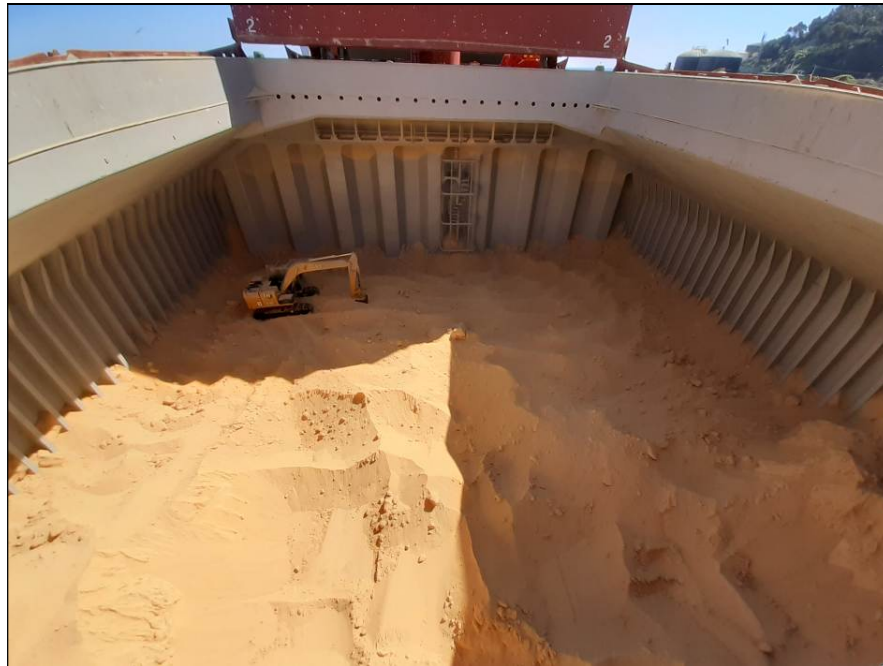
No. 9: Hold Nr.2 was inspected under discharging operations. (See photo No. 37-38-39)

37. General view of C/H N° 2,

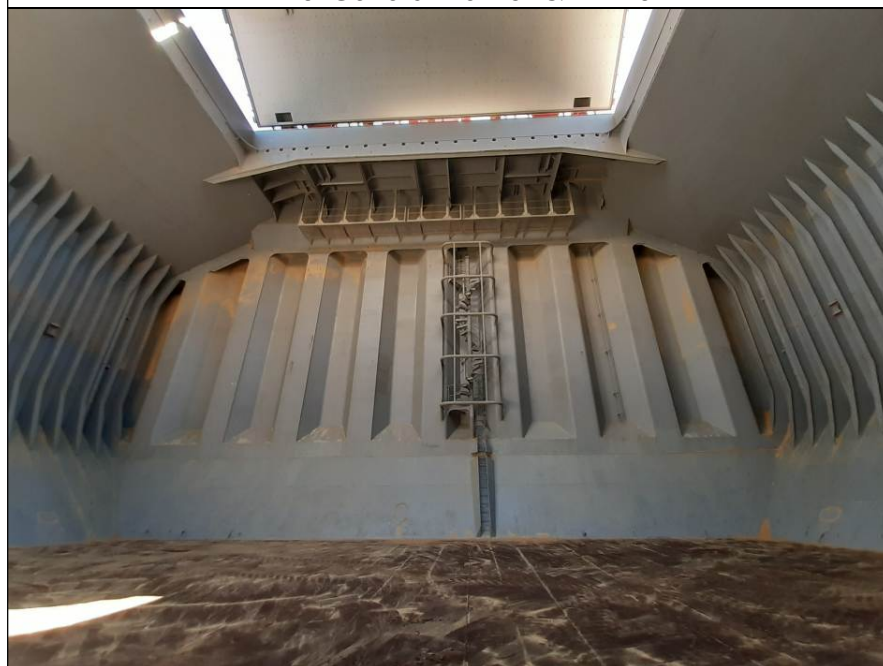
No. 10: Forward bulkhead with paint scratched (See photo No. 46)

46. Fwd bulkhead, with paint scratched and dust.

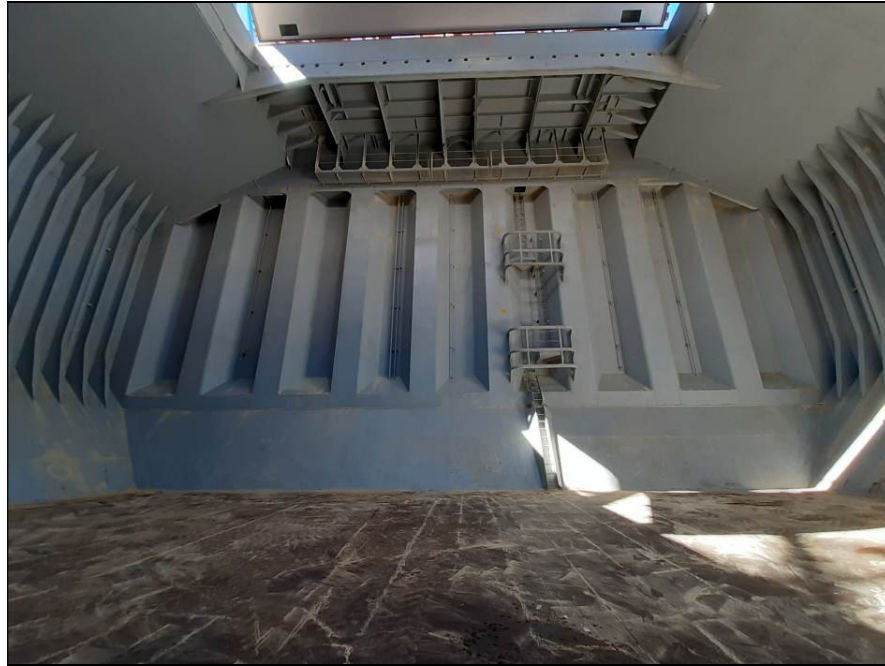
No. 11: After bulkhead with paint scratched (See photo No. 47)

47. Aft bulkhead, with paint scratched and dust.

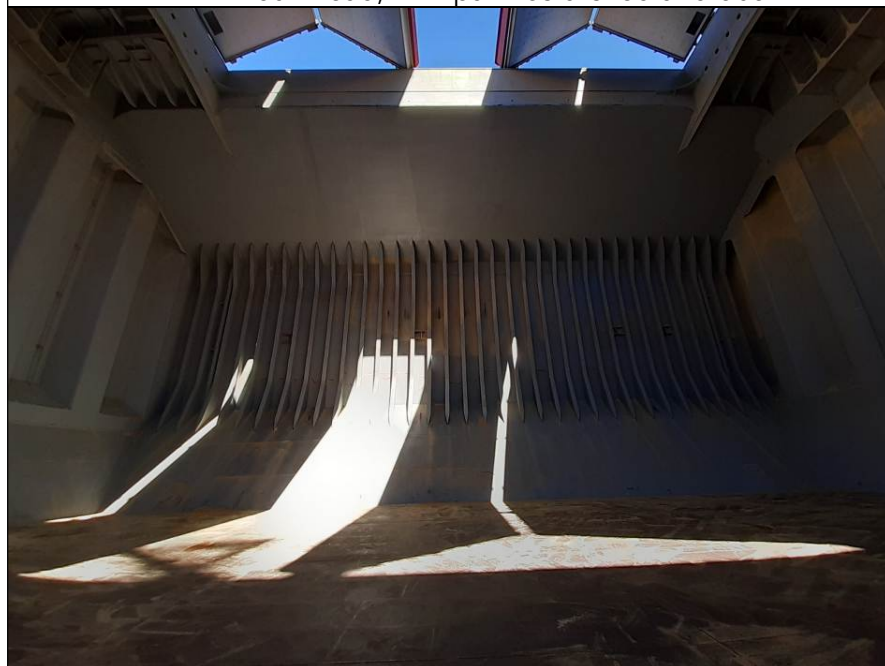
No. 12: Side/shell plating Ps with paint scratched (See photo No. 48)

48. Side/shell plating Ps, with paint scratched.

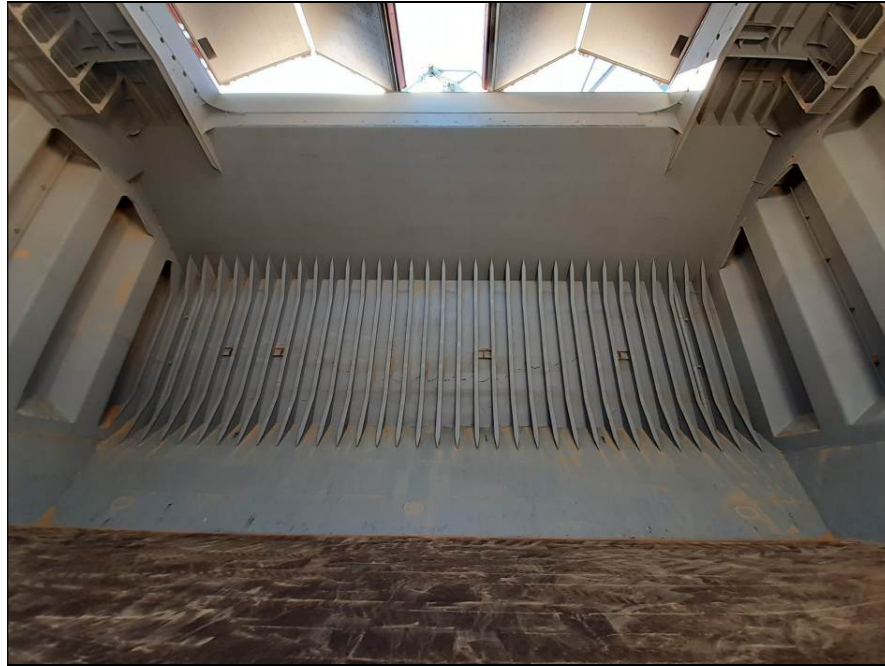
No. 13: Side/shell plating Ss with paint scratched (See photo No. 49)

49. Side/shell plating Ss, with paint scratched and rust.

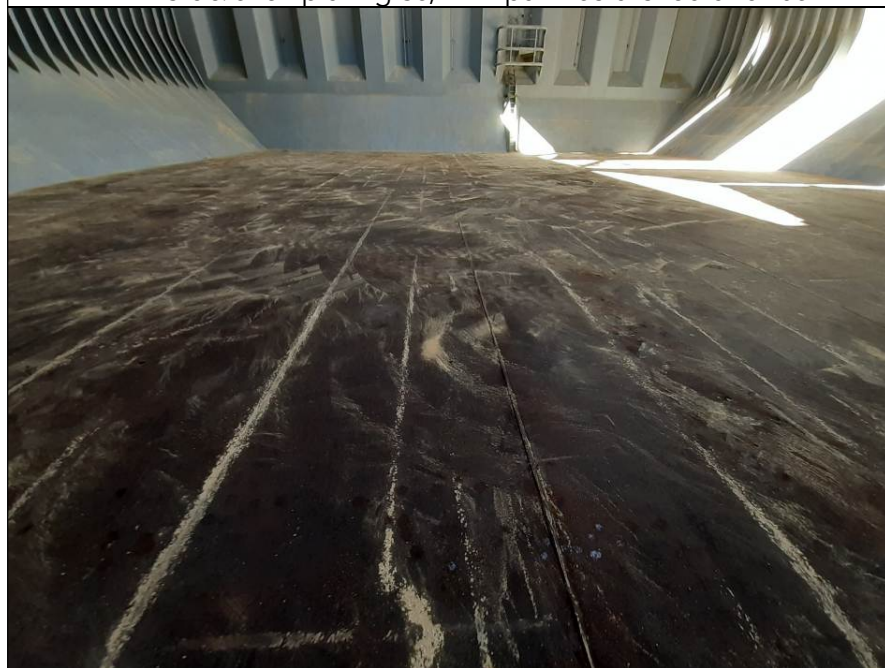
No. 14: Cargo hold with dust of cargo remaining (See photos No. 45 to 51)

50. Tank top plating with dust of cargo discharged.

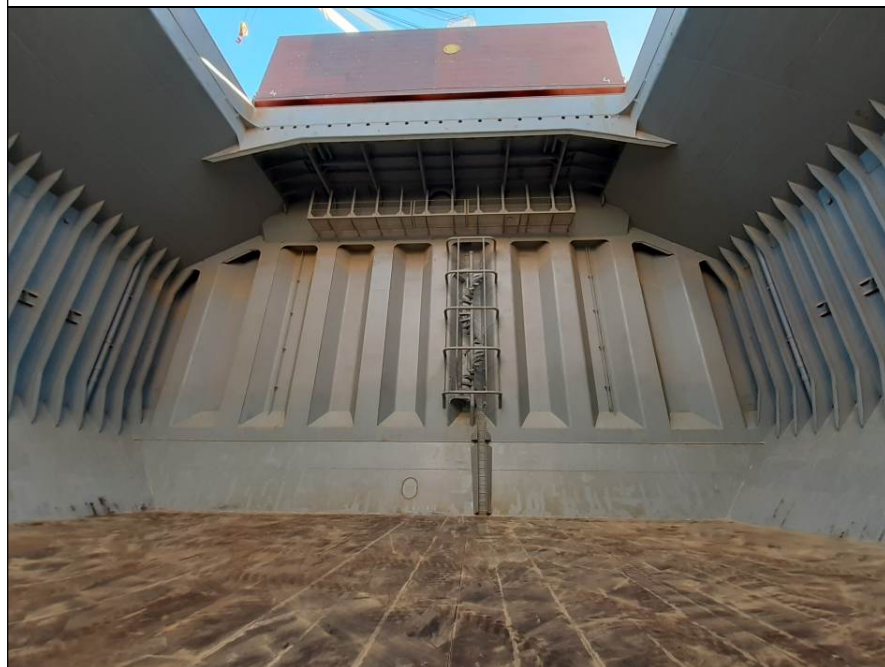
No. 15: Forward bulkhead with paint scratched (See photo No. 56)

56. Fwd bulkhead with paint scratched.

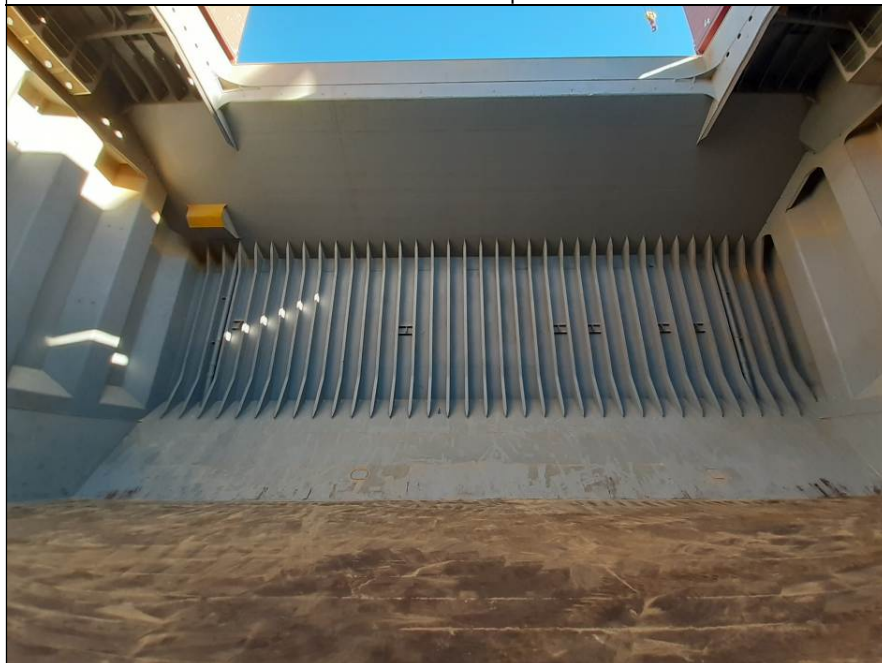
No. 17: Side/shell plating Ps with paint scratched (See photo No. 58)

58. Side/shell plating Ps, with paint scratched and rust.

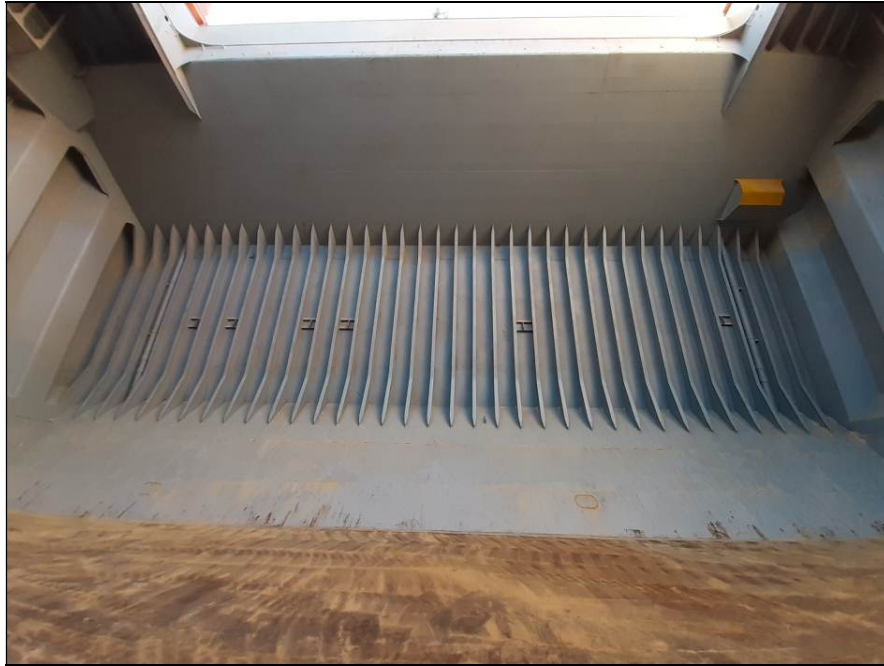
No. 18: Side/shell plating Ss with paint scratched (See photo No. 59)

59. Side/shell plating Ss, with paint scratched and rust.

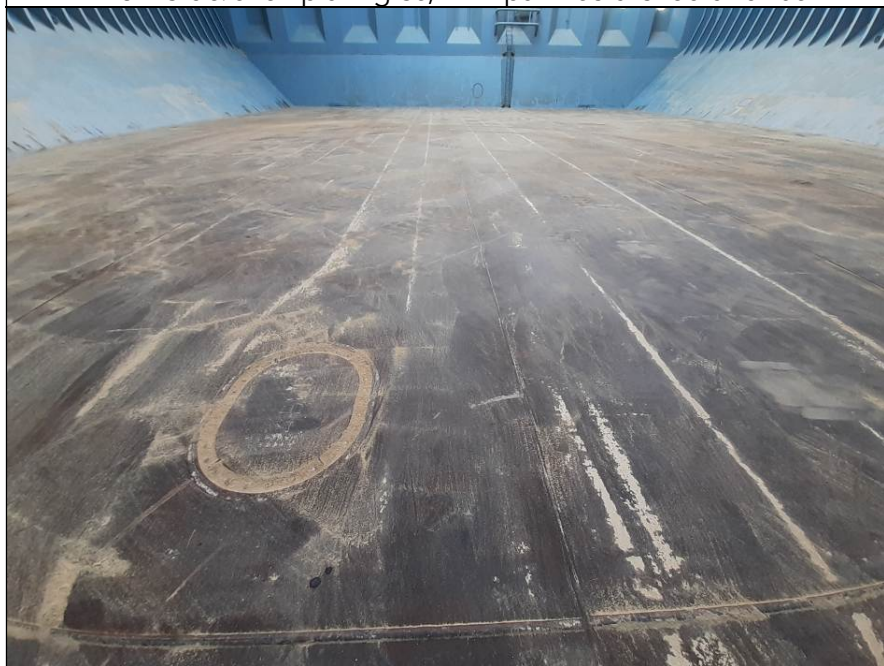
No. 19: Cargo hold with dust of cargo remaining (See photos No. 55 to 60)

60. Tank top plating rusty.

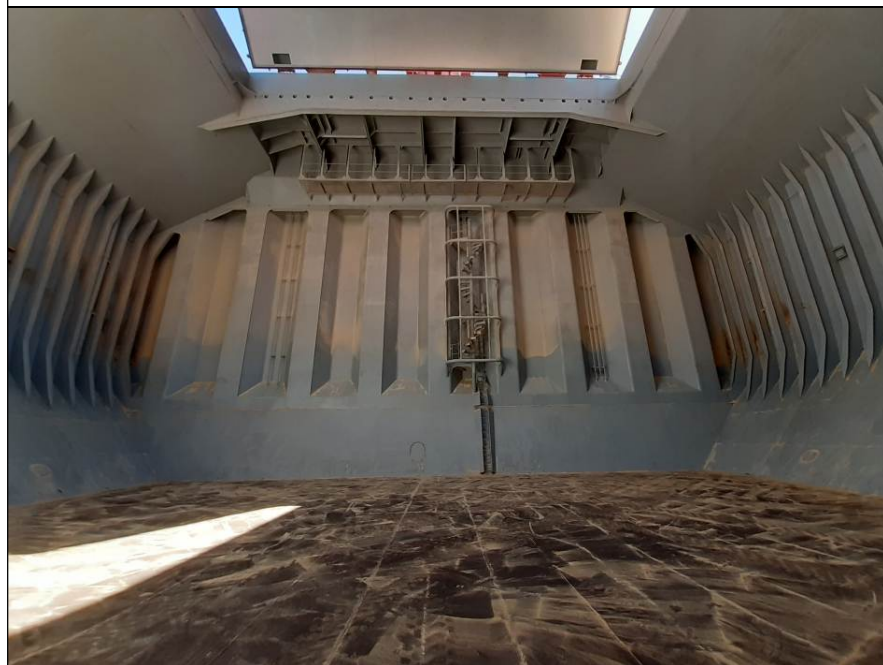
No. 21: After bulkhead with paint scratched and rust (See photo No. 66)

66. Fwd bulkhead with paint scratched.

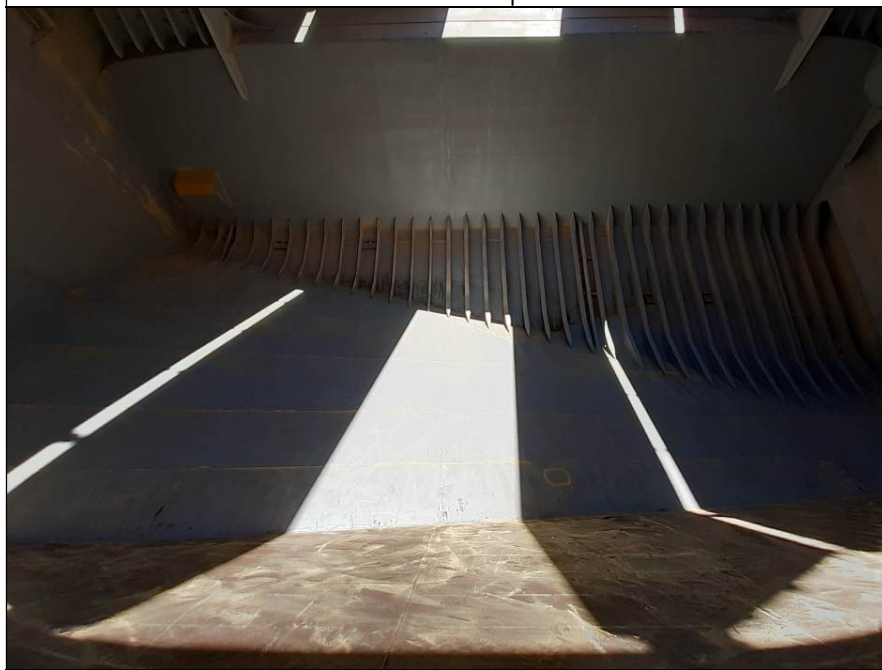
No. 23: Side/shell plating Ss with paint scratched and rust (See photo No. 68)

68. Side/shell plating Ps, with paint scratched and rust.

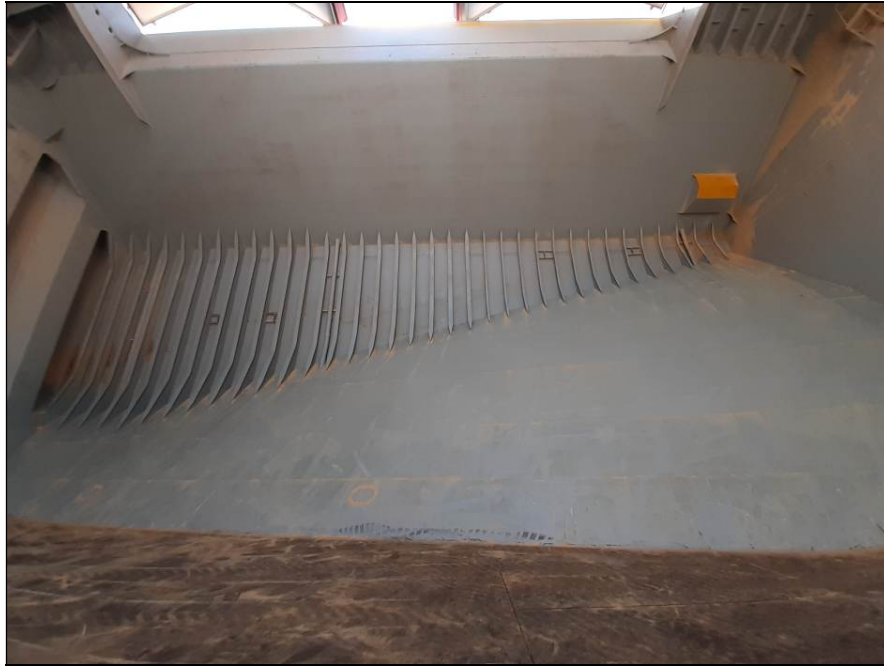
69. Side/shell plating Ss, with paint scratched and rust.

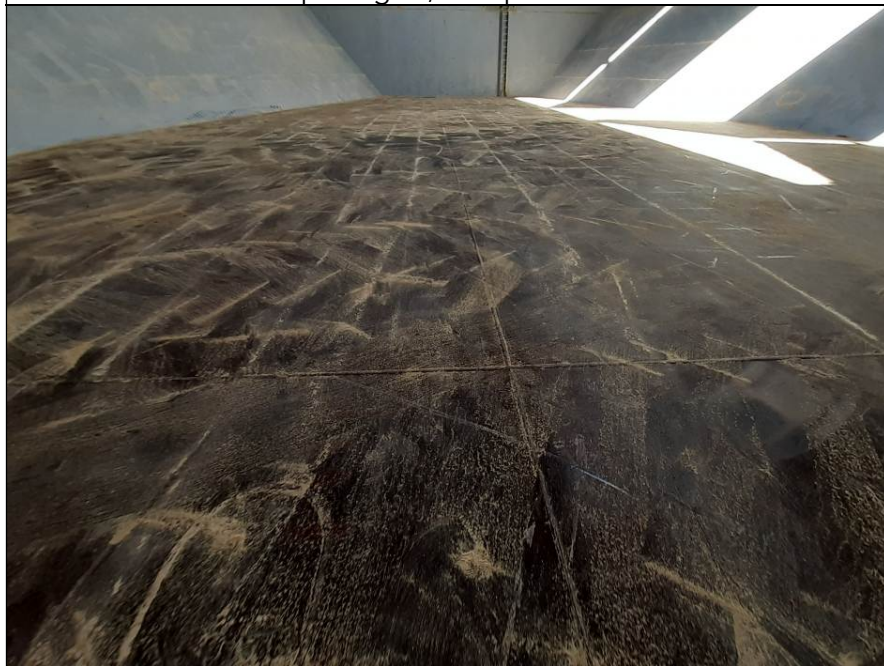
No. 24: Tank top plating rusty (See photos No. 65 to 70)

70. Tank top plating rusty, with dust of cargo discharged.
