Certificate No. B23615-3001-2026

Cargo Survey at Barranquilla (Palermo) – Colombia.

FINAL REPORT CARGO SURVEY

PHYSICAL INSPECTION OF THE EMPTYING OF TWO (02) CONTAINER X 40 TYPE OPEN TOP WITH EIGHTEEN (18) PIECES

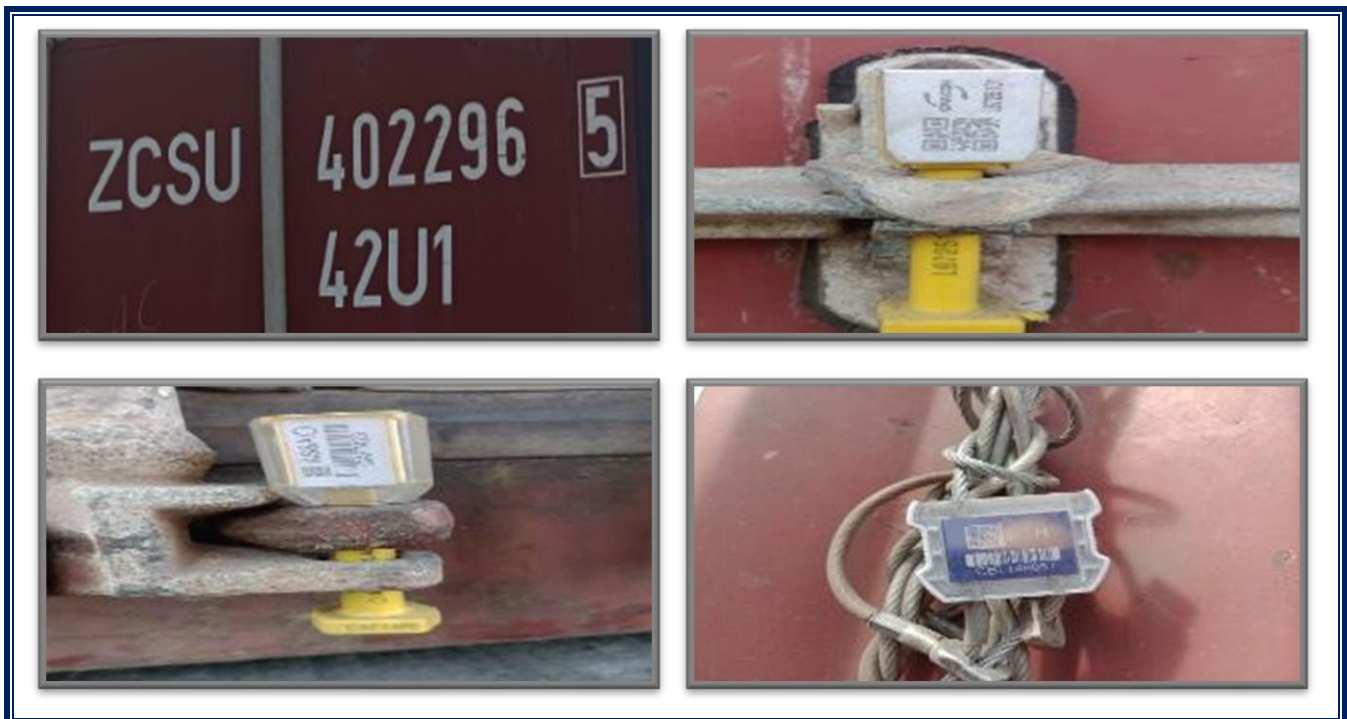
Item	Container Identification	Initial Container Seal	Initial condition and status of the external part of the container
1	<u>ZCSU 402296 - 5</u> <u>42U1</u>	<u>CAF7420</u> <u>L8725101</u> <u>CBL148857</u>	<ol style="list-style-type: none"> 1. Right and left side panels with oxidation, dented and scratches. 2. Rear, upper, and lower side rail with oxidation, dented and scratches. 3. Right and left doors with oxidation, dented and scratches. 4. Rear and front corner posts with oxidation, dented and scratches. 5. Door locking bars and closing hooks with oxidation, dented and scratches. 6. CSC plate and owner's emblem are visible in good condition. 7. Identification number and dimensional and type codes visible with oxidation. 8. Door Guide the bars bent.

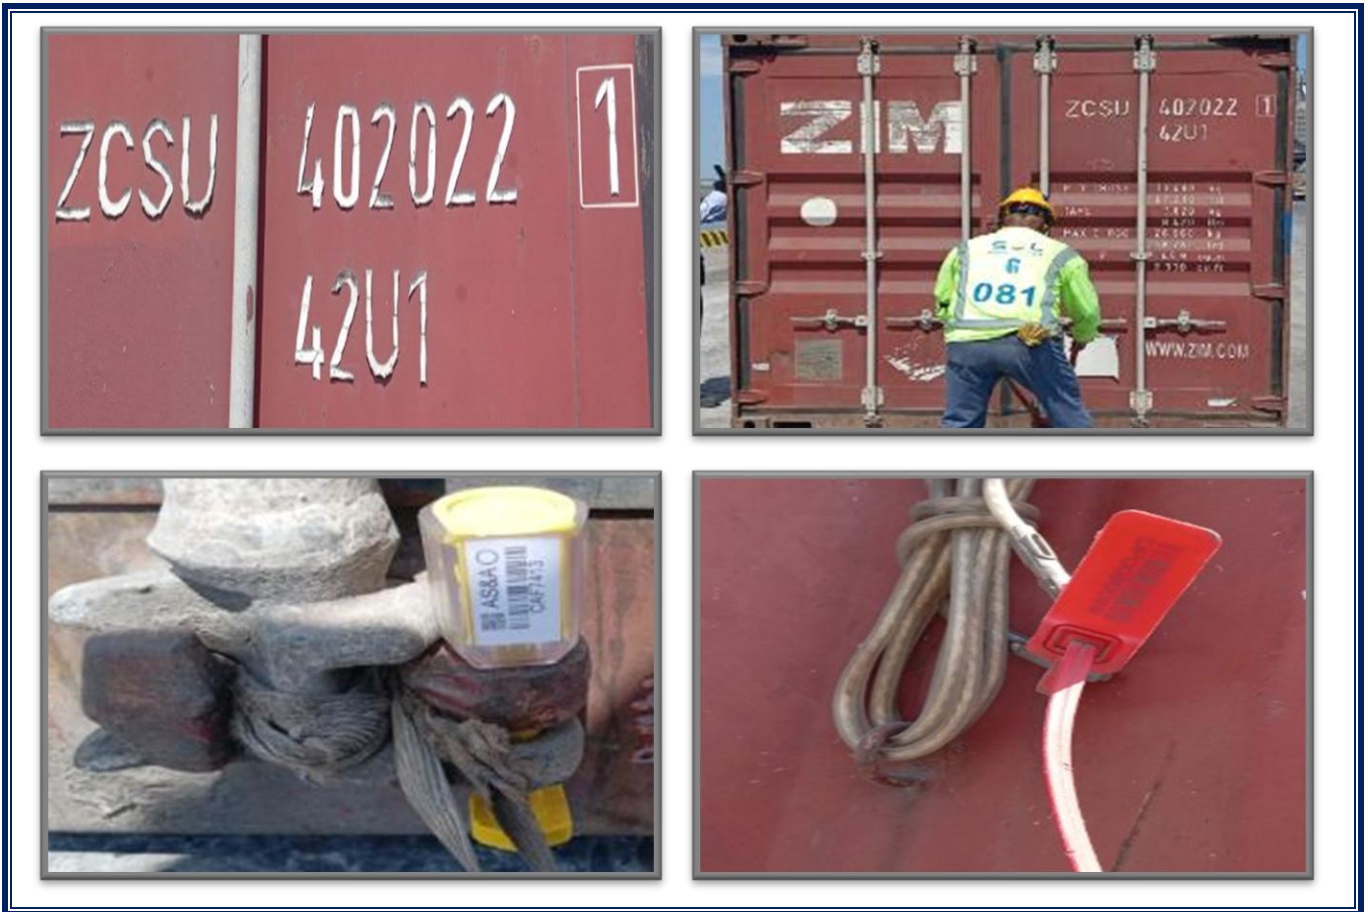
Item	Container Identification	Initial Container Seal	Initial condition and status of the external part of the container
2	<u>ZCSU 402022</u> <u>42U1</u>	<u>CAF7413</u> <u>0000099</u>	<ol style="list-style-type: none"> 1. Right and left side panels with oxidation, dented and scratches. 2. Rear, upper, and lower side rail with oxidation, dented and scratches. 3. Right and left doors with oxidation, dented and scratches. 4. Rear and front corner posts with oxidation, dented and scratches. 5. Door locking bars and closing hooks with oxidation, dented and scratches. 6. CSC plate and owner's emblem are visible in good condition. 7. Identification number and dimensional and type codes visible with oxidation. 8. Door Guide the bars bent.

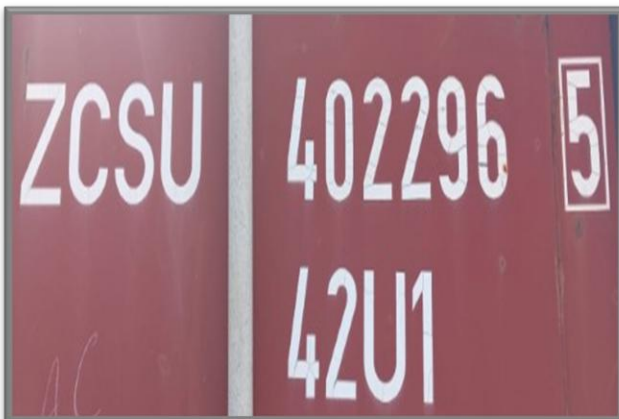
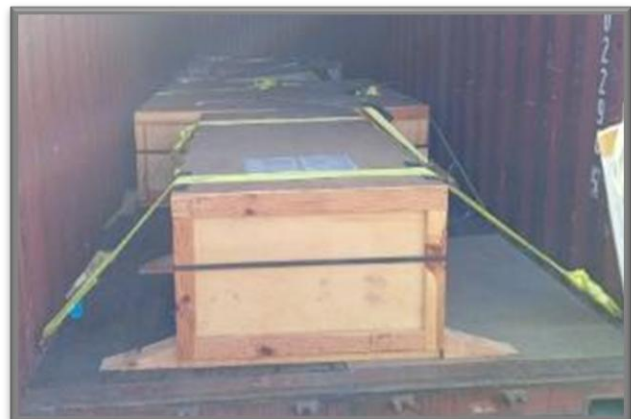
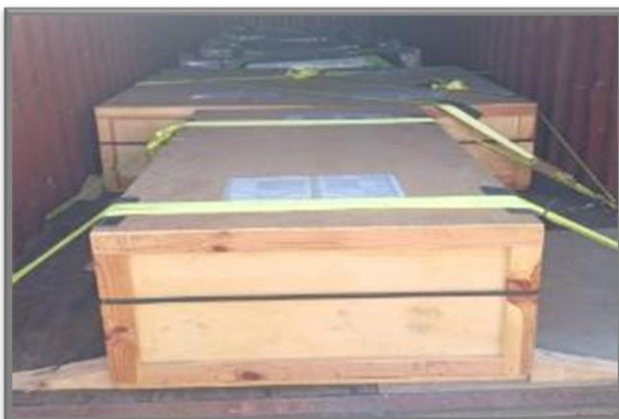
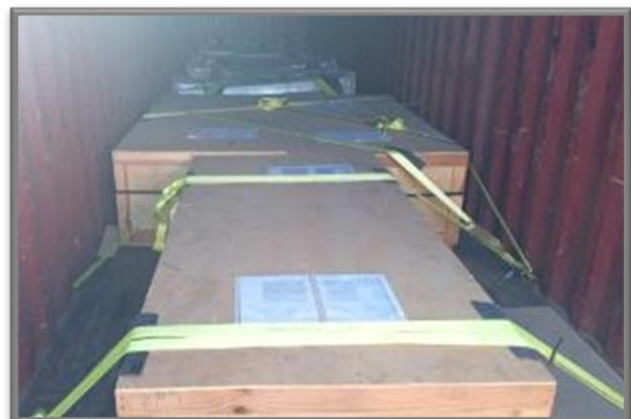
- ❖ No slippage / No evidence of moisture.
- ❖ The cargo was properly stowed with wooden wedges.
- ❖ The cargo was securely lashed with synthetic slings and properly tensioned ratchets.
- ❖ No visible damage to the cargo was apparent.

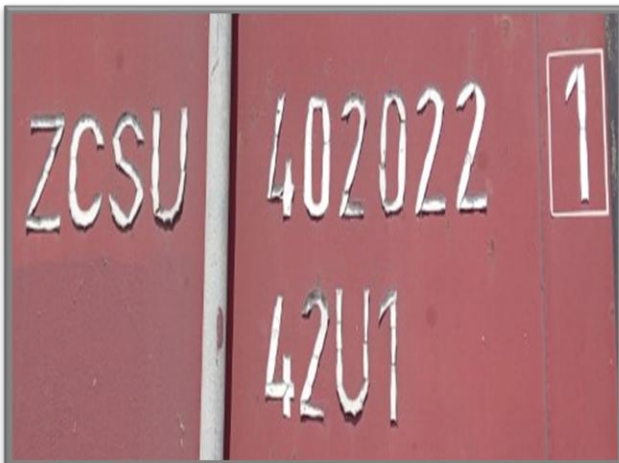
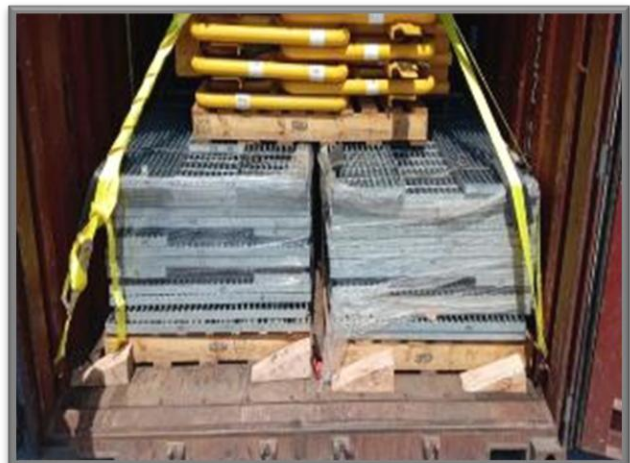
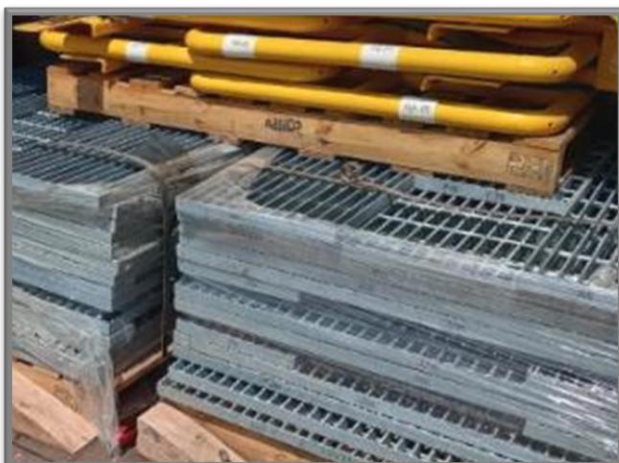
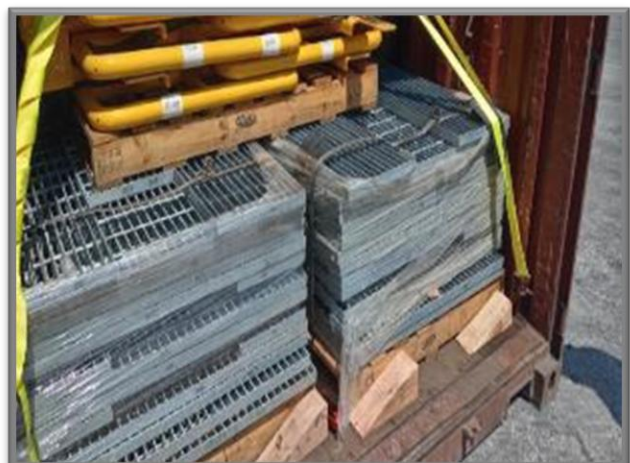
- ❖ No slippage / No evidence of moisture.
- ❖ The cargo was properly stowed with wooden wedges.
- ❖ The cargo was securely lashed with synthetic slings and properly tensioned ratchets.
- ❖ No visible damage to the cargo was apparent.

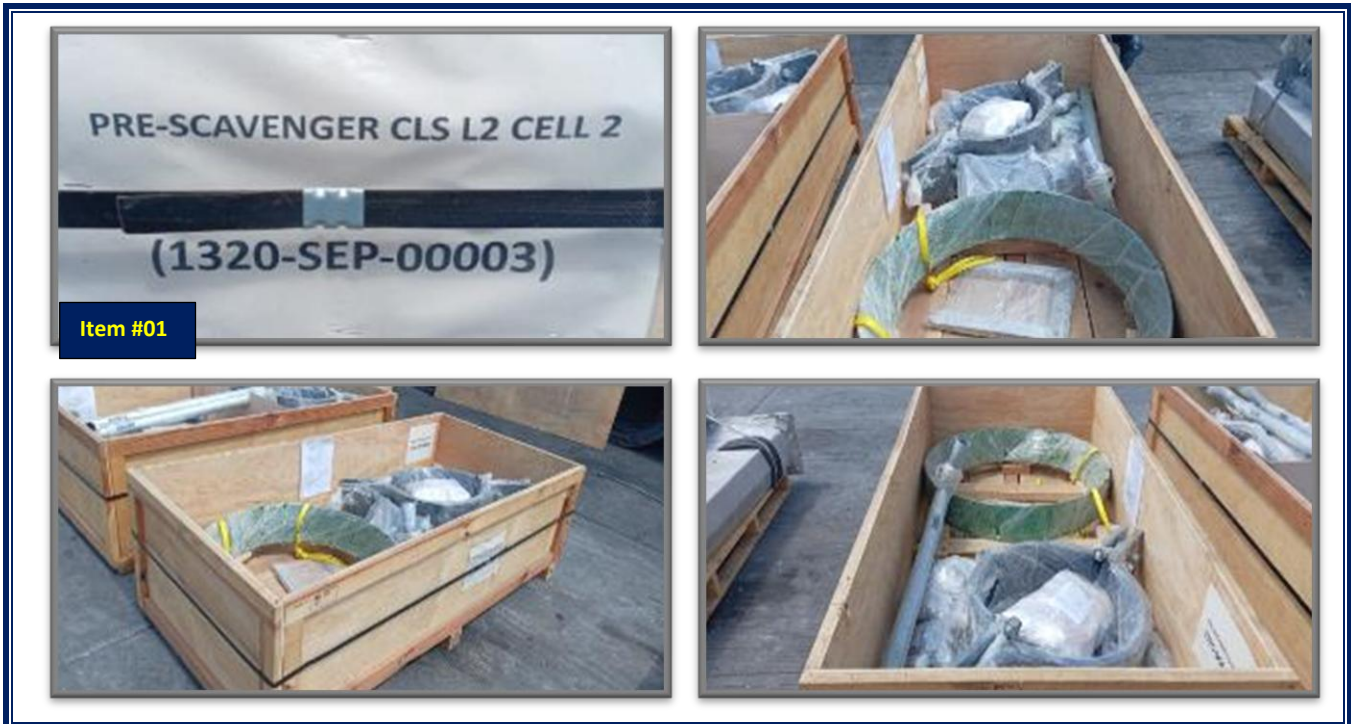
Item	Description	Gt Sap p/No. Of Tag No.	Length (Mts)	Heidt (Mts)	Width (Mts)	Quantity	Gross Weight (Kg)	Cause	Damage
1	Wooden Box	1320-Sep-00003	2,05	0,62	1,00	1	422,967	Origin	Ok
2	Wooden Box	0320-Sep-00001 0320-Sep-00002	2,05	0,62	1,00	1	820,934	Origin	Ok
3	Wooden Box	1320-Sep-00001 1320-Sep-00002	2,05	0,62	1,00	1	820,934	Origin	Ok
4	Radial Launder	1320-Sep-00003	1,8	0,68	1,35	1	282,000	Origin	Ok
5	Radial Launder	1320-Sep-00002	1,8	0,68	1,35	1	282,000	Origin	Pallet broken underneath
6	Radial Launder	1320-Sep-00001	1,8	0,68	1,35	1	282,000	Operation	Pallet broken underneath
7	Radial Launder	0320-Sep-00002	1,8	0,68	1,35	1	282,000	Origin	Pallet broken underneath
8	Radial Launder	0320-Sep-00001	1,8	0,68	1,35	1	282,000	Origin	Ok
Total,s						8	3051,868

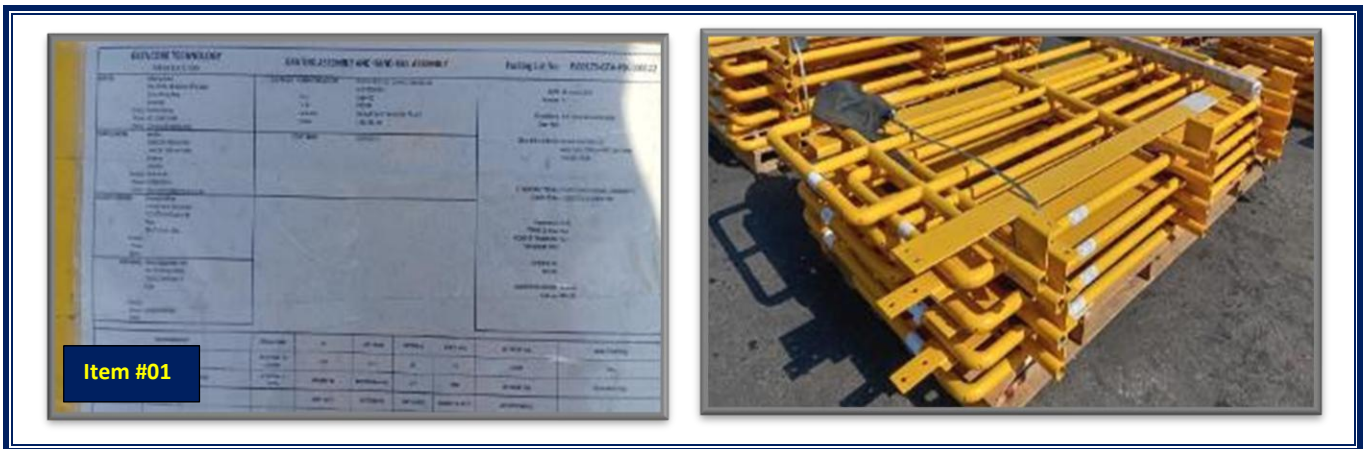
Item	Description	Gt Sap p/No. Of Tag No.	Length (Mts)	Heidt (Mts)	Width (Mts)	Quantity	Gross Weight (Kg)	Cause	Damage
1	Hand Rail Assembly	0320-SEP-00001	3,5	0,64	1,68	1	700,000	Origin	Ok
2	Hand Rail Assembly	0320-SEP-00002	3,5	0,64	1,68	1	700,000	Origin	Ok
3	Hand Rail Assembly	320-SEP-00001	3,5	0,64	1,68	1	700,000	Origin	Ok
4	Hand Rail Assembly	320-SEP-00002	3,5	0,64	1,68	1	700,000	Origin	Ok
5	Hand Rail Assembly	320-SEP-00003	3,5	0,64	1,68	1	700,000	Origin	Ok
6	Grating Assembly	0320-SEP-00001	2,35	0,64	1,05	1	1630,000	Origin	Ok
7	Grating Assembly	0320-SEP-00002	2,35	0,64	1,05	1	1630,000	Origin	Ok
8	Grating Assembly	320-SEP-00001	2,35	0,64	1,05	1	1630,000	Origin	Ok
9	Grating Assembly	320-SEP-00001	2,35	0,64	1,05	1	1630,000	Origin	Ok
10	Grating Assembly	320-SEP-00001	2,35	0,64	1,05	1	1630,000	Origin	Ok
Total's						10	11650,000

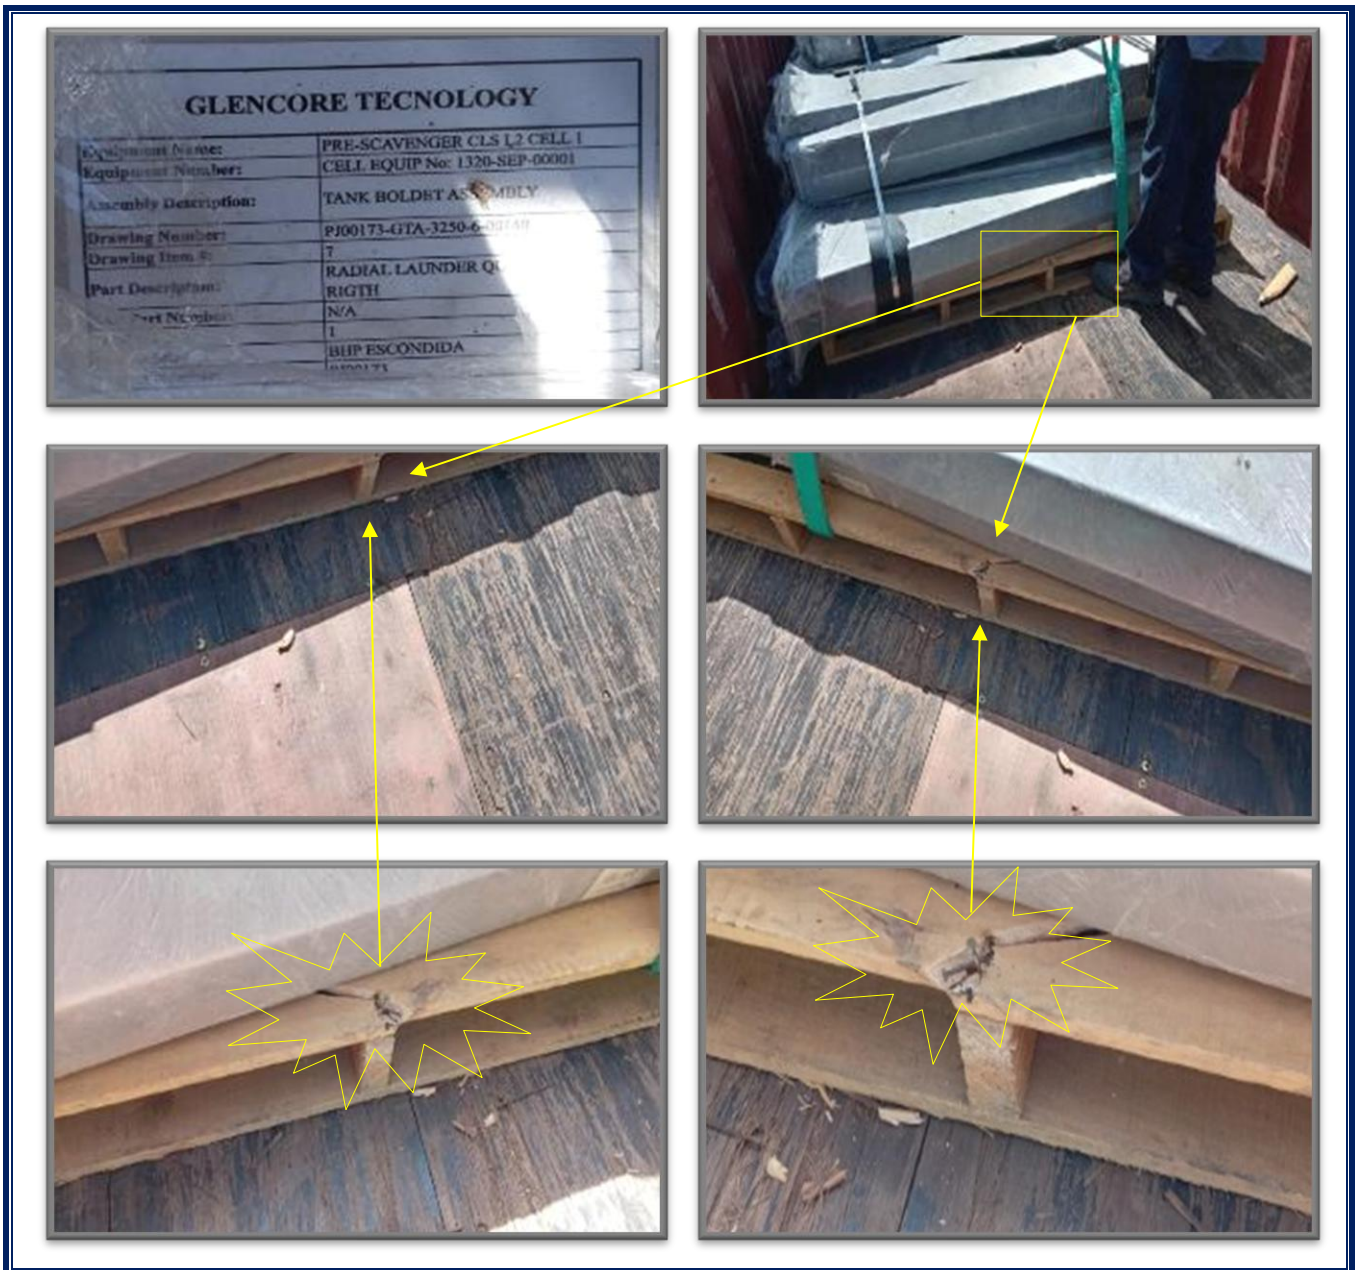
At **11:30 LT**, during the emptying of the **Container Id ZCSU 402296-5**, the forklift supplied by the port, when lifting the pallets, the stevedores placed the slings in the center of the pallets to slide it with the strong pressure it exerted, breaking the base of the pallet.

- ❖ During **the emptying process**, incidents occurred due to improper handling by the port operator, damages which are mentioned in item **"Item 8.2 Damages Due to Operation."**

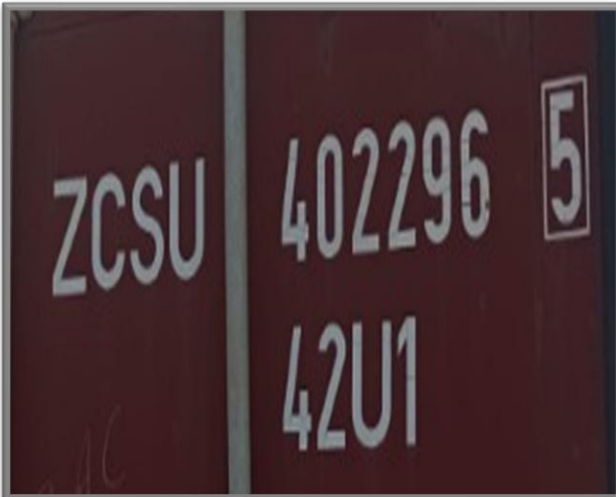
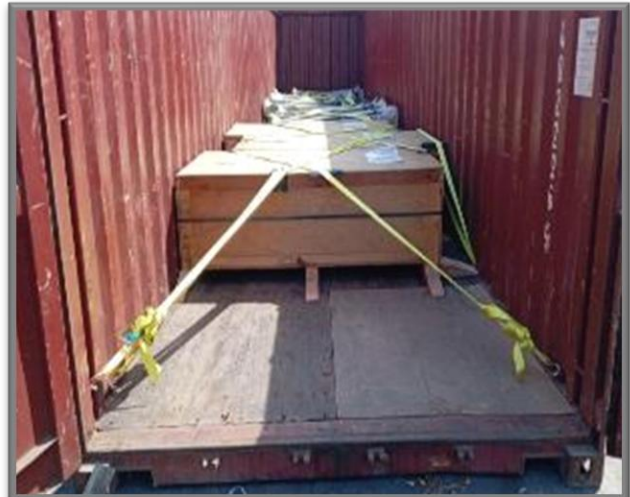
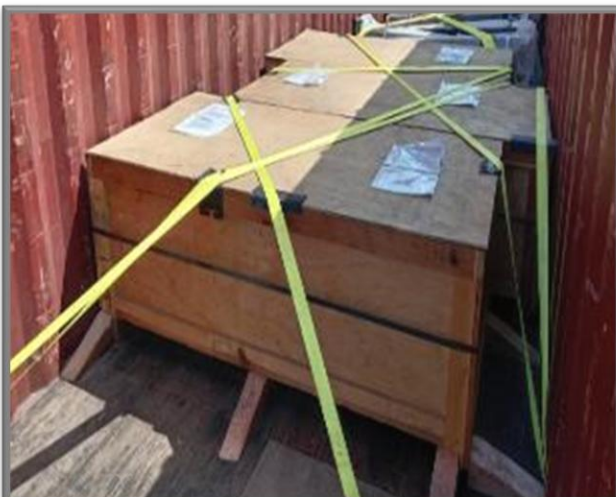
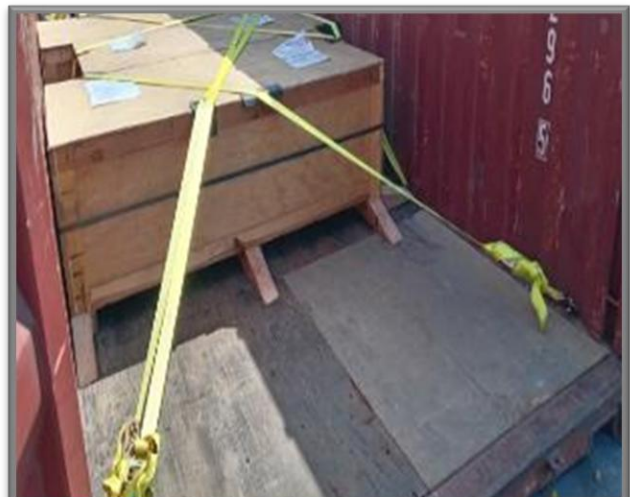
- ❖ No slippage / No evidence of moisture.
- ❖ Cargo properly stowed.
- ❖ Cargo secured with synthetic slings and ratchets.

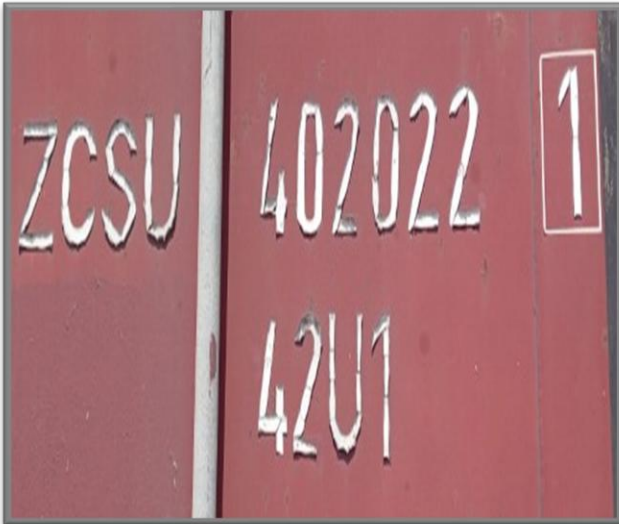
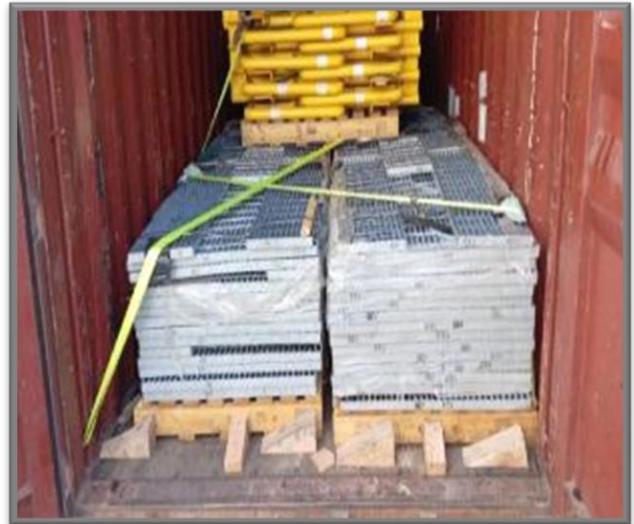
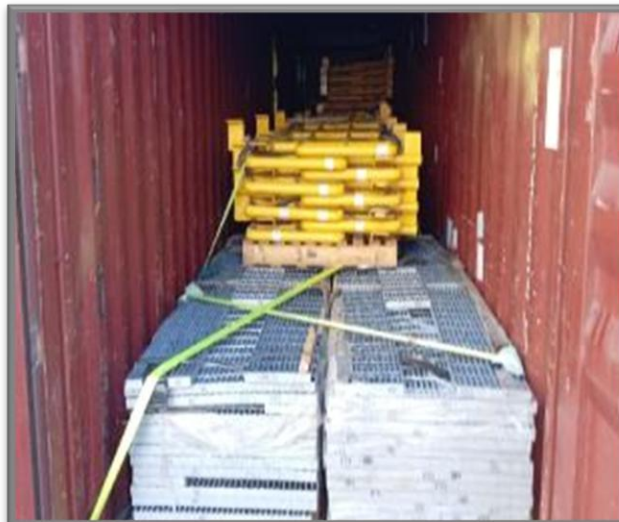
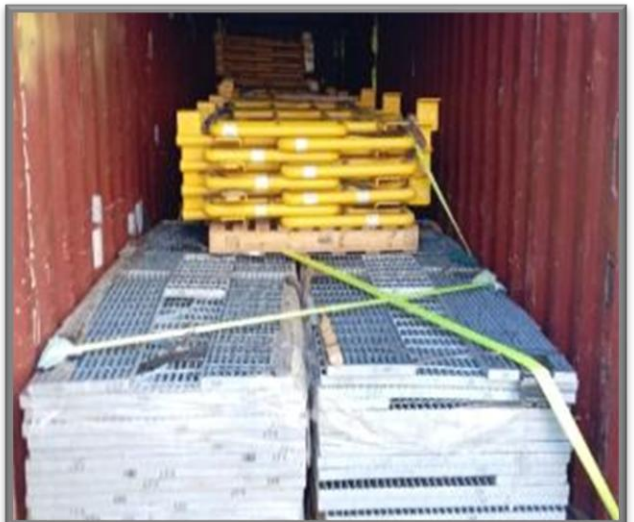
- ❖ No slippage / No evidence of moisture.
- ❖ Cargo properly stowed.
- ❖ Cargo secured with synthetic slings and ratchets.
