# INSPECTION REPORT

<b>ALS REFERENCE NO.</b>	ANF-2601-0326			
<b>DATE OF SURVEY</b>	<b>COMMENCED</b>	14-02-2026	<b>COMPLETED</b>	14-02-2026
<b>REPORT ISSUE DATE</b>	14-02-2026			
<b>PORT OF SURVEY</b>	ANTOFAGASTA, CHILE			
<b>CARGO P.O.L.</b>	LE HAVRE, FRANCIA			
<b>SHIP</b>	LITTLE GRACE	<b>VOYAGE</b>	607S	
<b>CLIENT</b>	ESO	<b>REF.:</b>	N/A	
<b>REQUESTED BY</b>	KARINA CELEDÓN			
<b>TYPE OF CARGO</b>	01 x 40" Reefer containers containing telescope components

<b>SHIPPER</b>	: ESO - EUROPEAN ORGANIZATION FOR ASTRONOMICAL RESEARCH
<b>CONSIGNEE</b>	: ESO EUROPEAN SOUTHERN OBSERVATORY
<b>Container</b>	: HLBU 617420-0
<b>Cargo Description</b>	: 01x40" reefer high-cube containers containing 18 packages: ELT M1 segment assembly +20 °C
<b>Port of Loading</b>	: LE HAVRE, FRANCIA
<b>Port of discharge</b>	: ANTOFAGASTA - CHILE

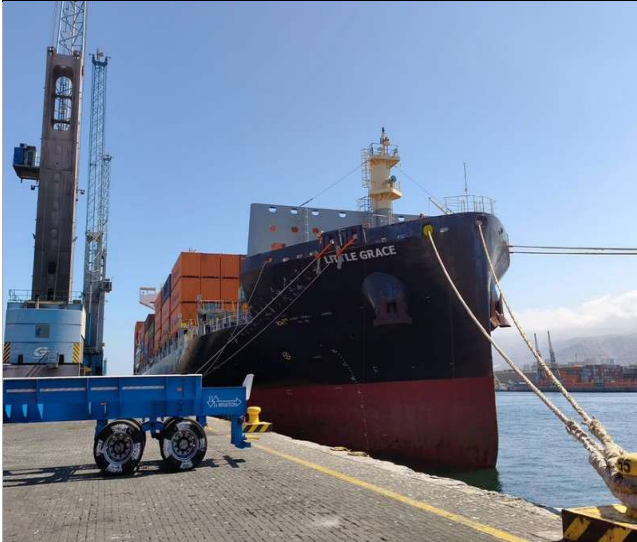
1. MV LITTLE GRACE berthed, pier Nr.7, Antofagasta port.

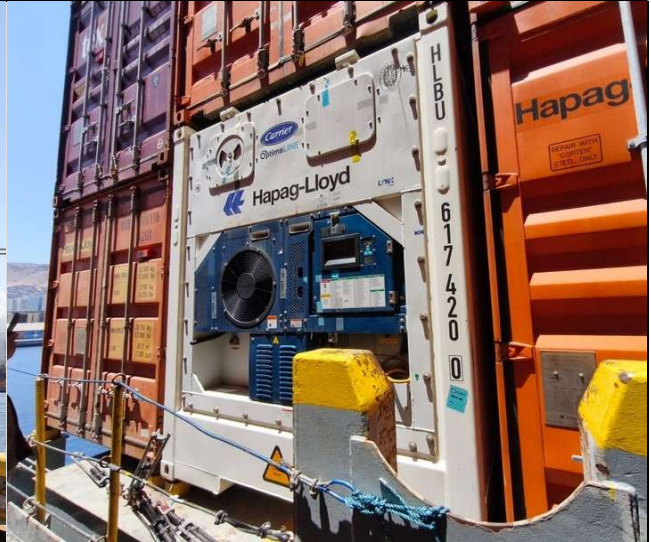
2. 1x40' RF HC HLBU 617420-0 stowed in bay 14.

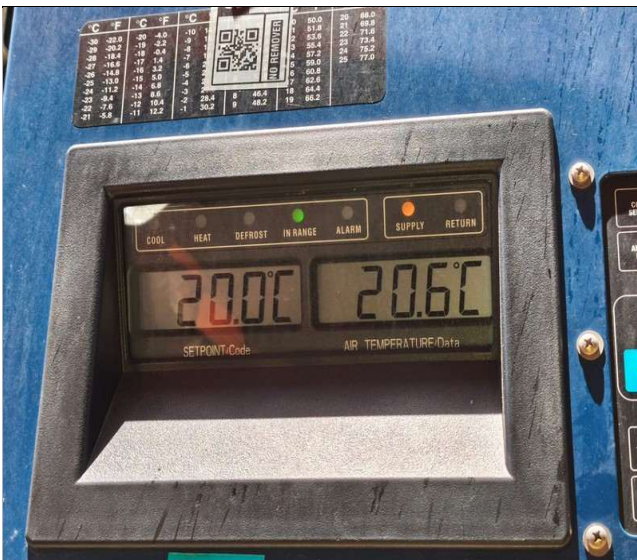
3. 1x40' RF HLBU 617420-0, temperature set point checked on board.

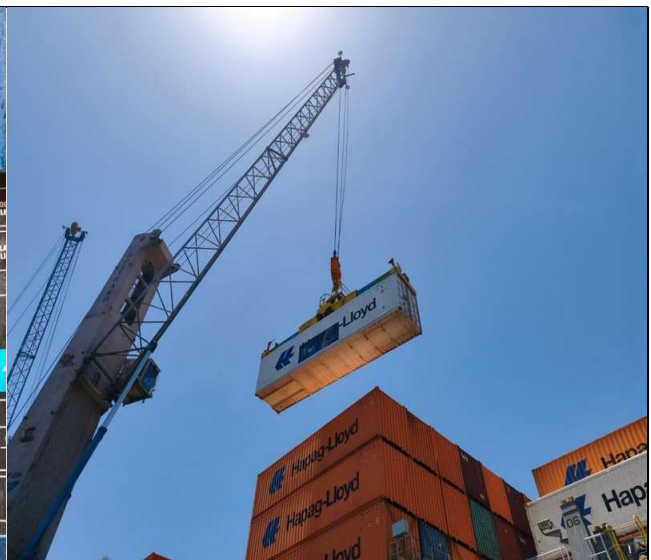
4. 1x40' RF HC HLBU 617420-0, being discharged.

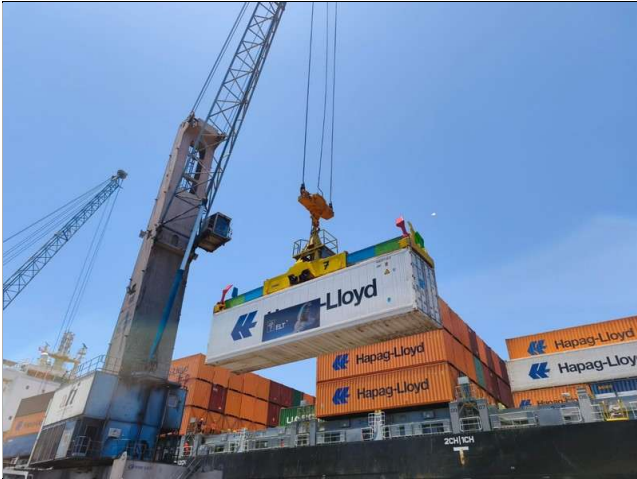
5. Container in discharging process.

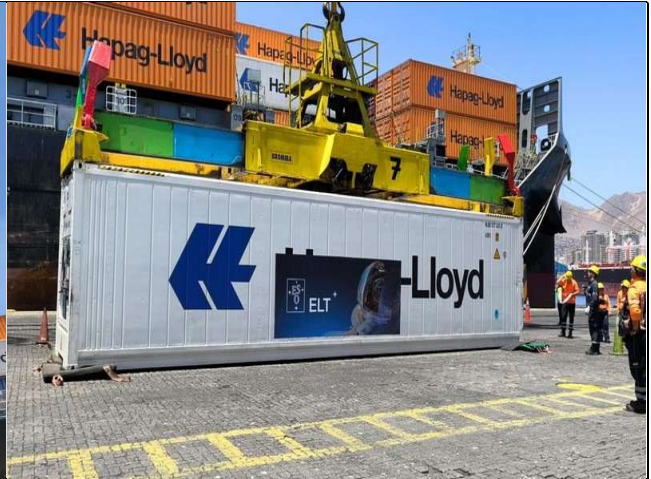
6. 1x40' RF HC HLBU 617420-0, already discharged alongside vessel.

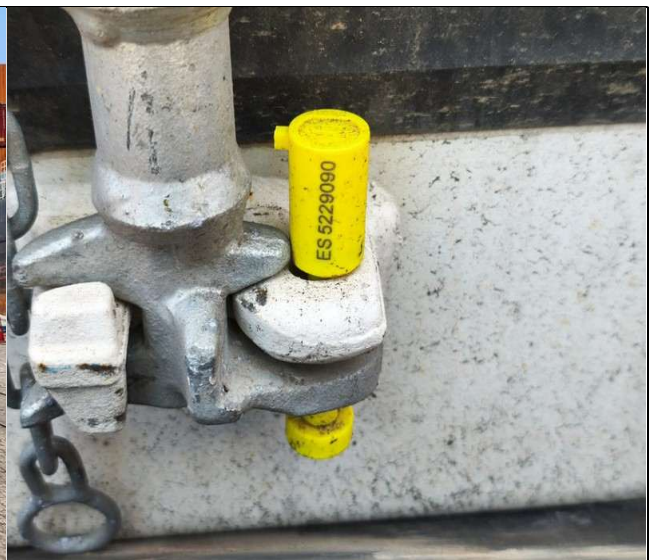
8. Stopper seal N° ES 5229090 of RF HC HLBU 617420-0, in good condition.

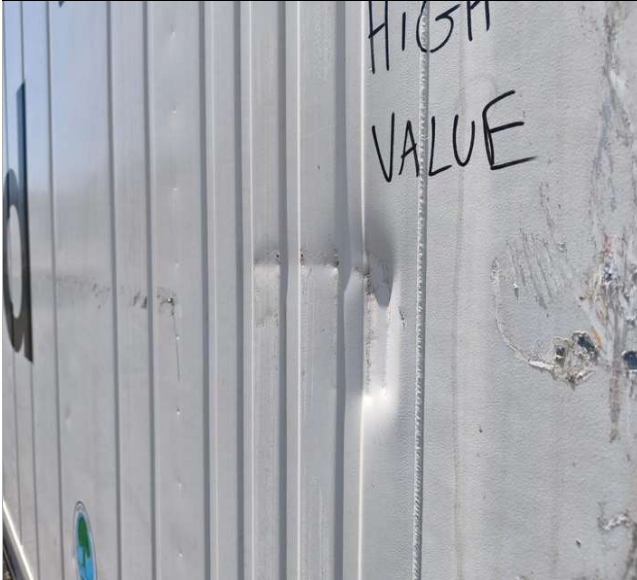
The HLBU 617420-0 container was then lifted by a stacker crane and loaded onto a truck for shipment on February 15, 2026. The container and truck were moved to the copper yard area and properly connected to the terminal's power supply. Scratches and dents were observed on the left panel of the container and scratches and dents on the right panel, which matched its condition upon arrival.

9. 1x40' RF HC HLBU 617420-0, left panel with scratches and dented. Section 1 middle part.

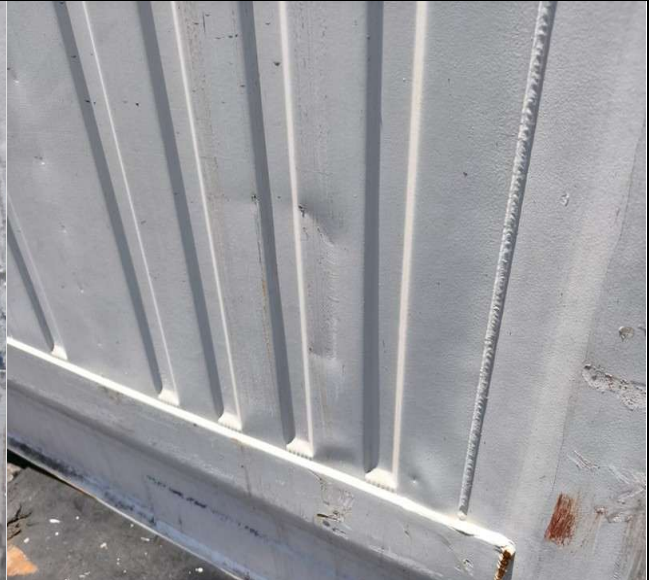
10. 1x40' RF HC HLBU 617420-0, left panel with scratches and dented. Section 1 lower part

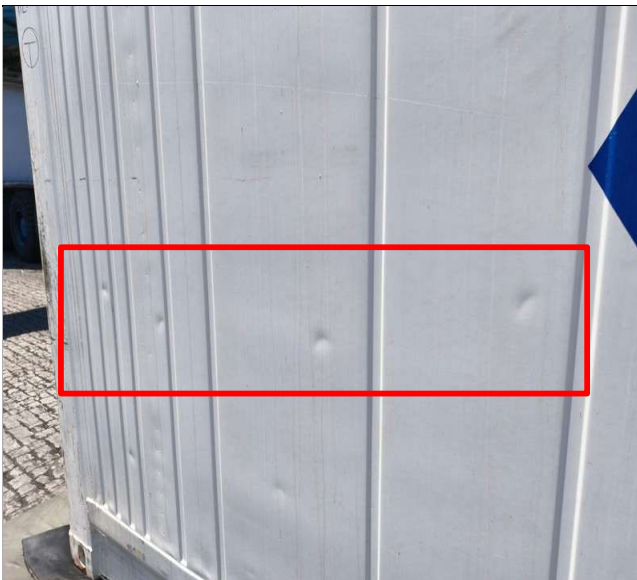
11. 1x40' RF HC HLBU 617420-0, left panel with dents. Section 9, middle part.

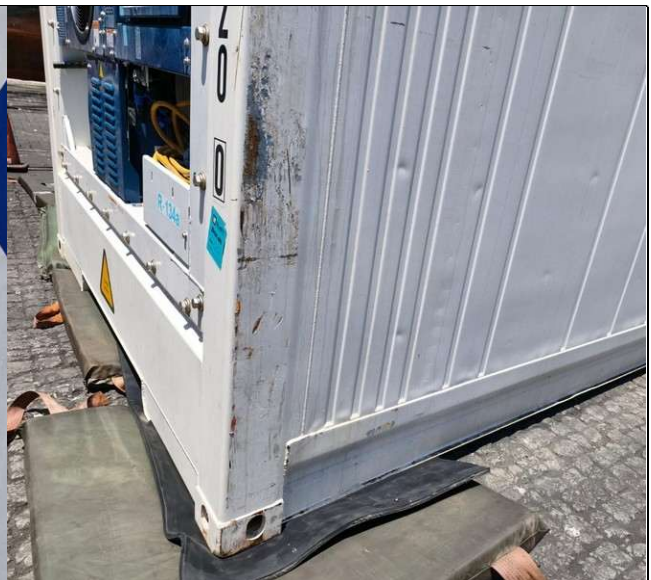
12. 1x40' RF HC HLBU 617420-0, left panel, with scratches on paint coating.

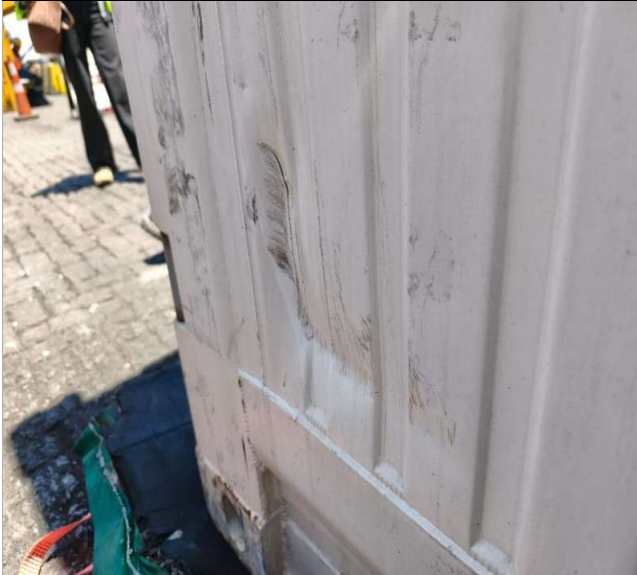
13. 1x40' RF HC HLBU 617420-0 right panel with scratches and dented. Section 0 lower part

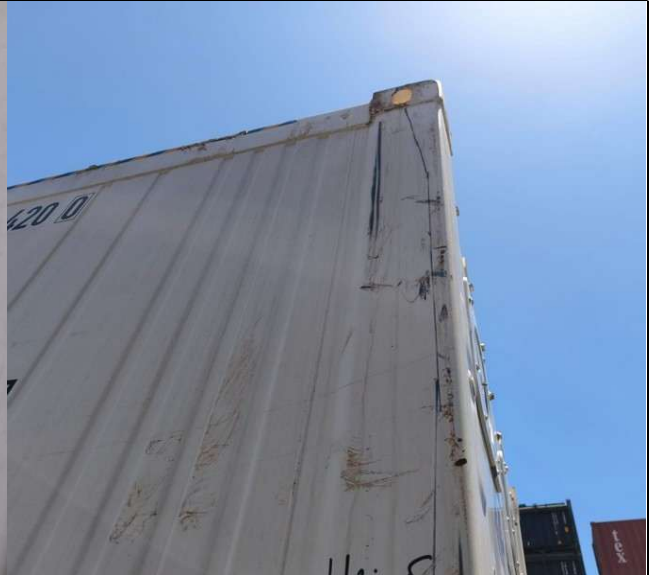
14. 1x40' RF HC HLBU 617420-0, right panel, with scratches on paint coating.

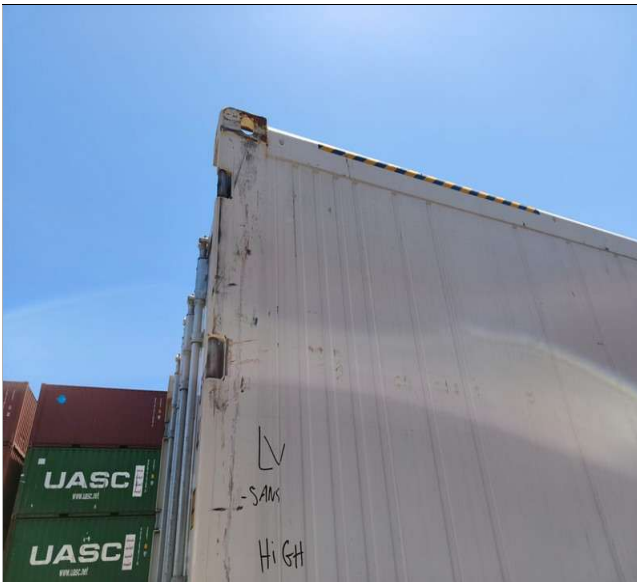
15. 1x40' RF HC HLBU 617420-0, right panel, with scratches on paint coating.

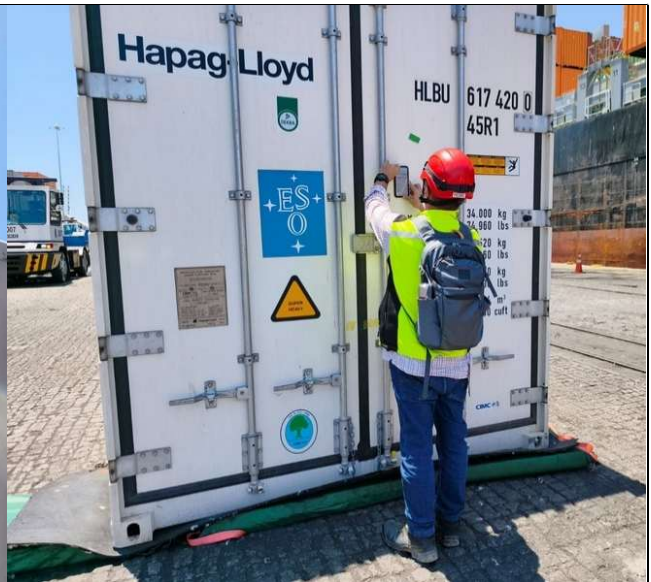
16. ESO personnel being performed sensor control.

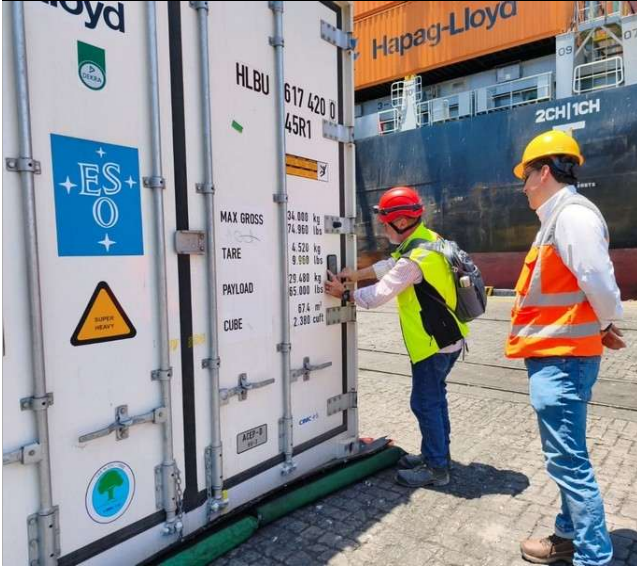
17. ESO personnel performed sensor control.

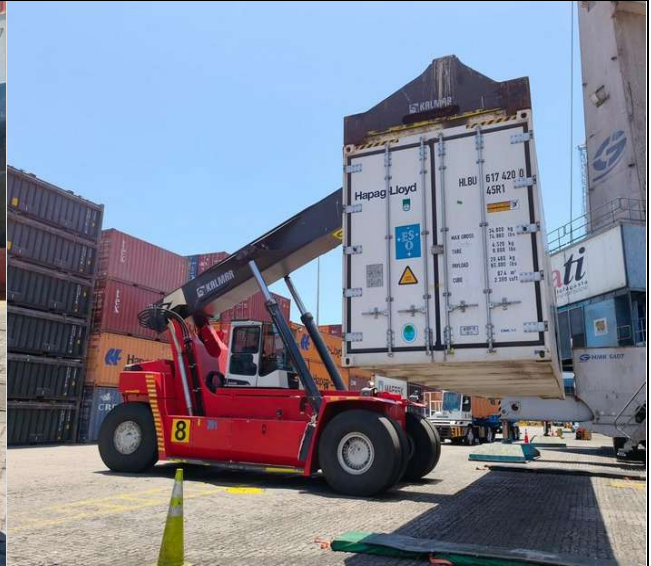
18. 1x40' RF HC HLBU 617420-0, being lifted for loading onto truck.

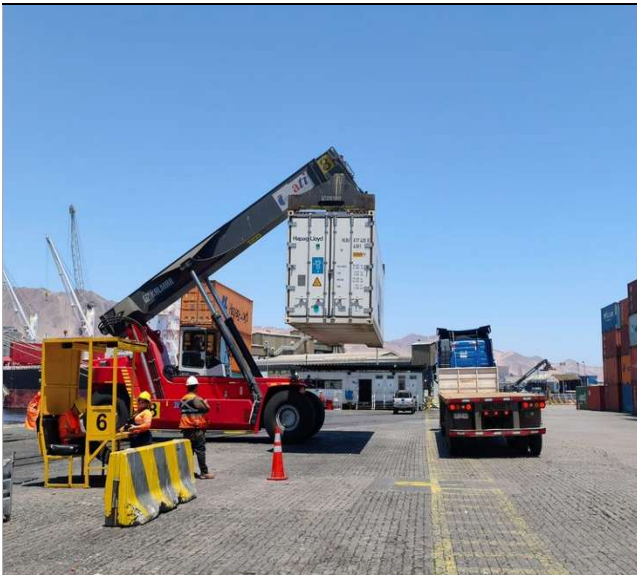
19. 1x40' RF HC 617420-0, being lifted for loading onto truck.

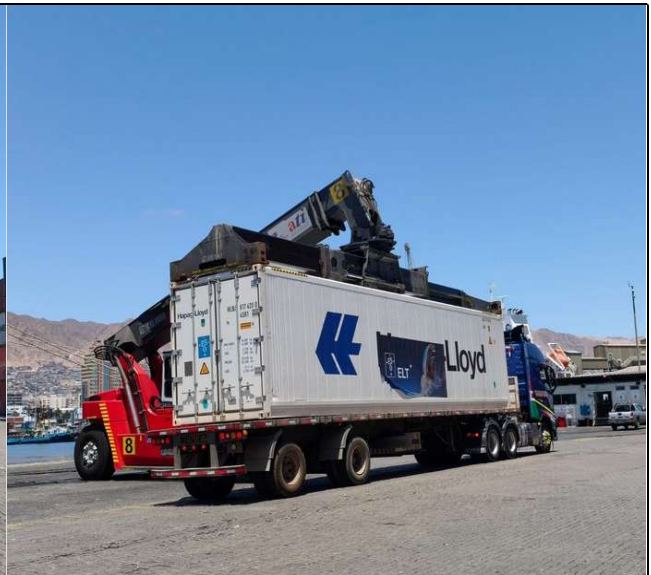
20. 1x40' RF HC HLBU 617420-0 already loaded onto truck.

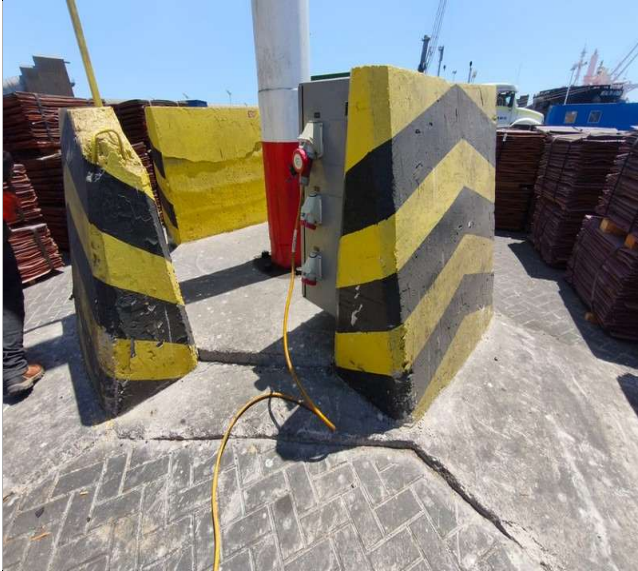
21. Container RF HC HLBU 617420-0 connected to terminal power supply.

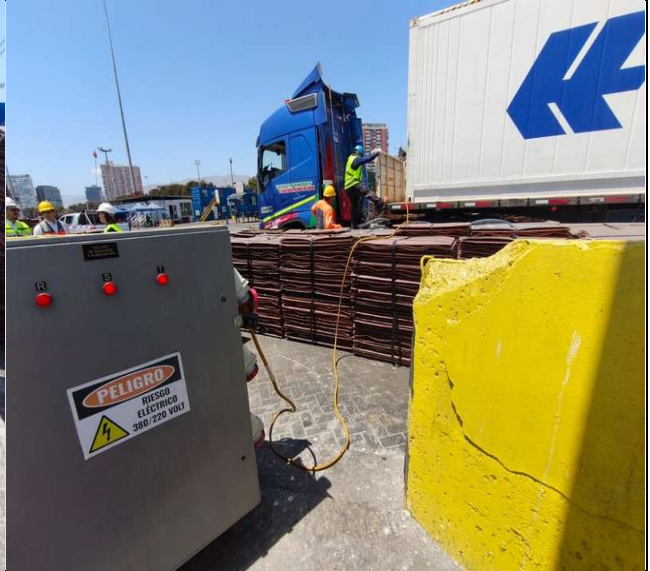
22. Container RF HC HLBU 617420-0 connected to terminal power supply.

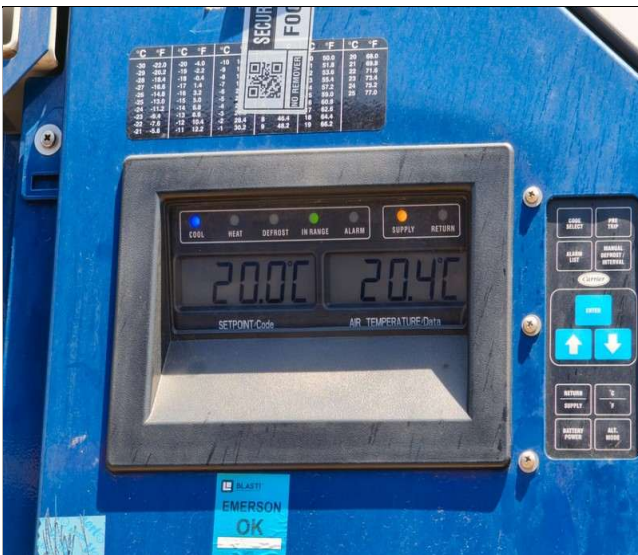
23. 1x40' RF HC HLBU 617420-0 setting temperature to 20°.

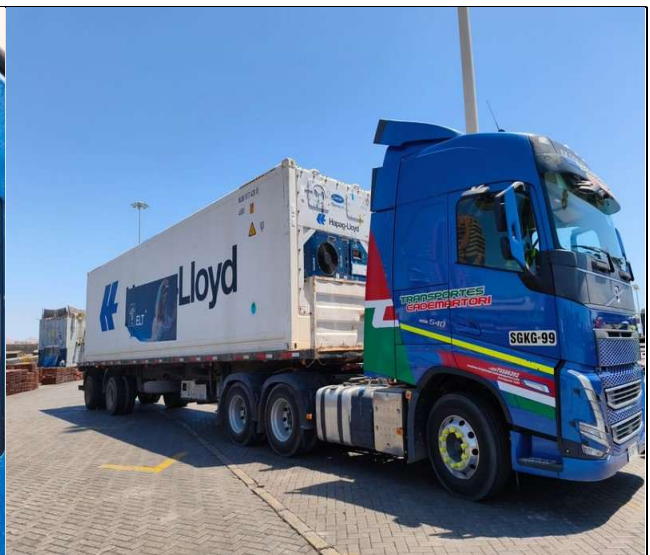
24. 1x40' RF HC HLBU 617420-0, container connected to terminal power supply.
