## FINAL REPORT

<b>SURVEY</b>	<b>MOORING ROPES INSPECTION</b>
<b>TO</b>	<b>ULTRAMAR</b>
<b>FROM</b>	<b>ALS INSPECTION CHILE SPA</b>
<b>CLIENT REF</b>	<b>N/A</b>
<b>ALS REF</b>	<b>ANF-2602-0830.</b>
<b>SCOPE OF SURVEY</b>	<b>INSPECTION OF 14 MOORING ROPES</b>
<b>VESSEL NAME</b>	<b>DELOS VOY 01</b>
<b>PLACE OF SURVEY</b>	<b>PUERTO TOTORALILLO/CALDERA</b>
<b>DATE OF SURVEY</b>	<b>FEBRUARY 27,2026</b>
<b>TIME OF SURVEY</b>	<b>15:20 Hrs to 16:40 Hrs</b>

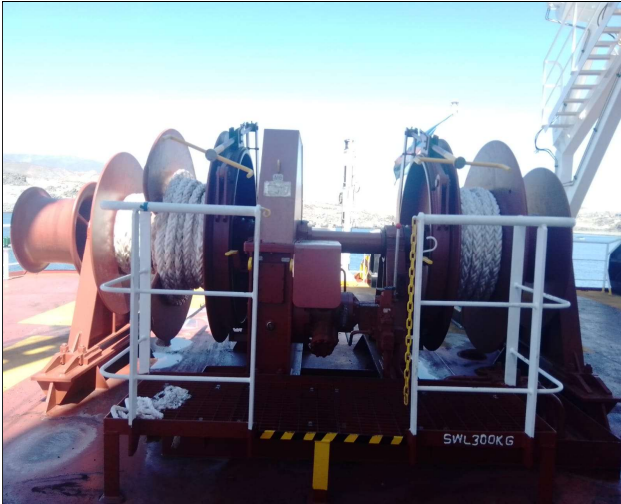
1. General view of rope into windlass

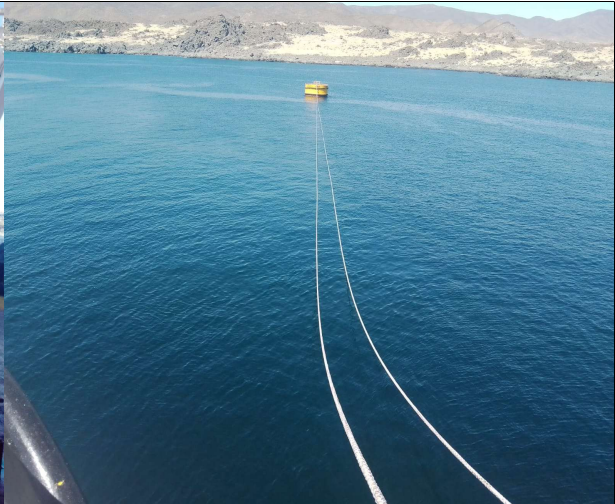
2. General view of rope.

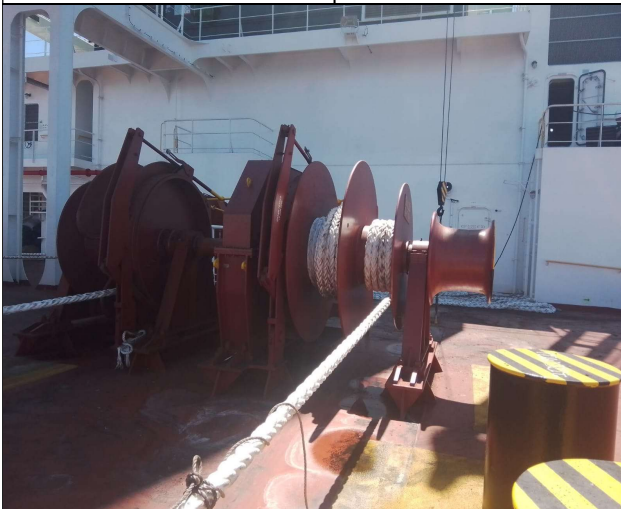
3. General view of rope located onto drum

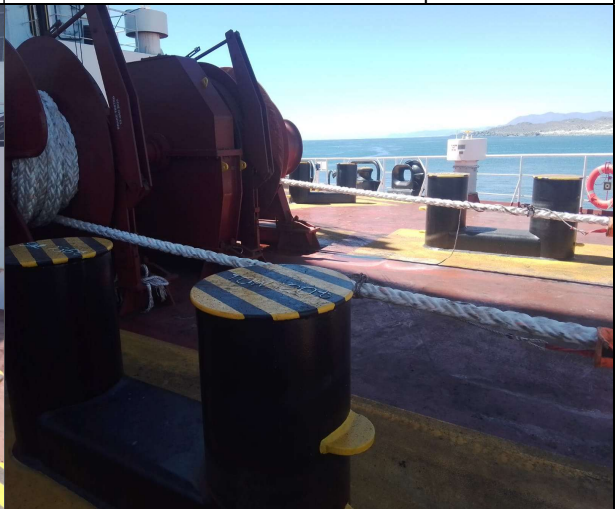
4. General view of rope into drums

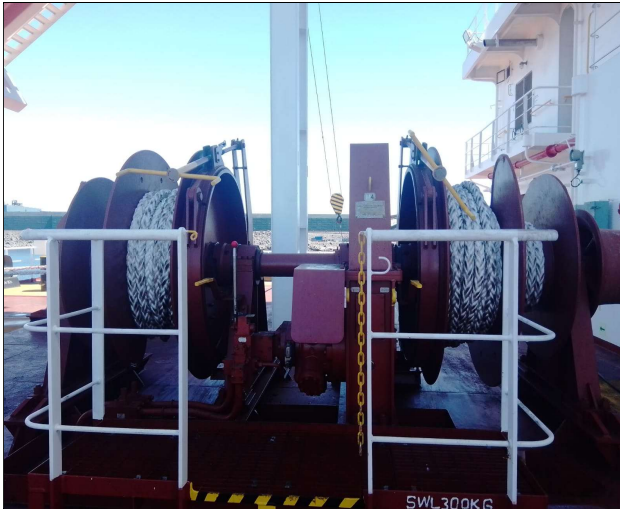
5. General view of rope.

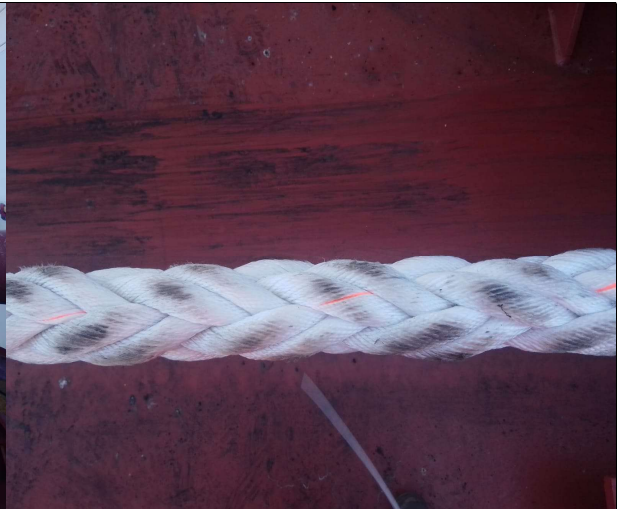
6. General view of rope on deck

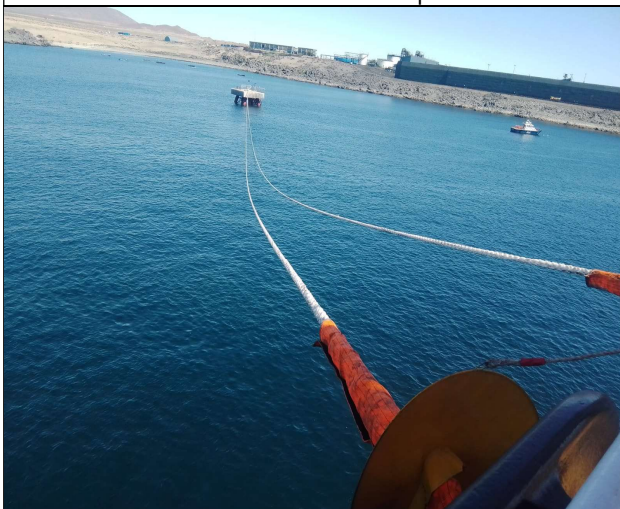
7. General view of rope in use

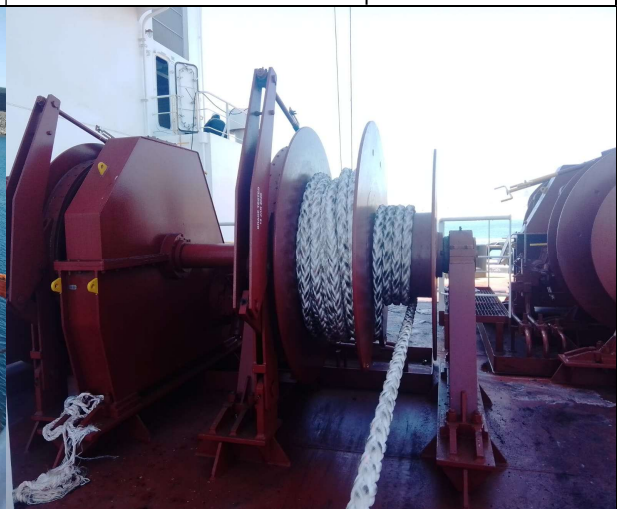
8. General view of rope from drum

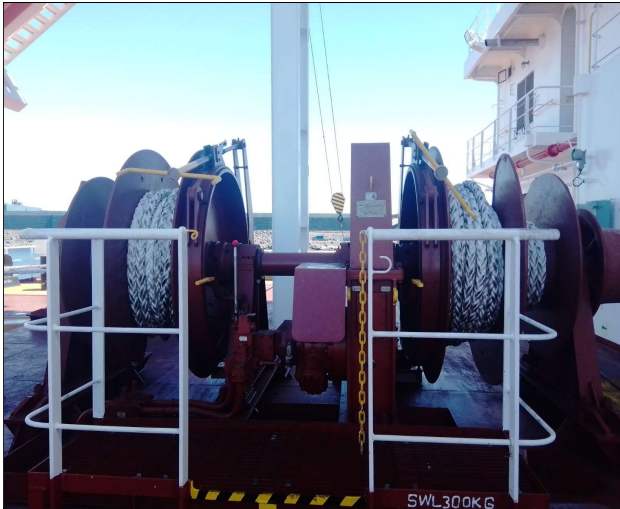
9. General view of rope.

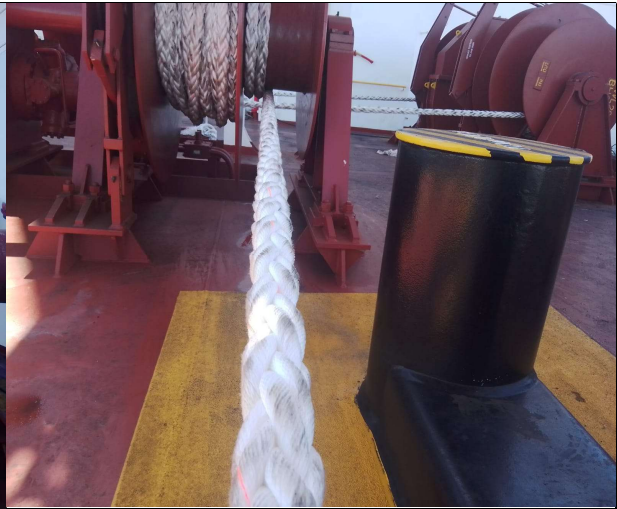
10. General view of rope into drums

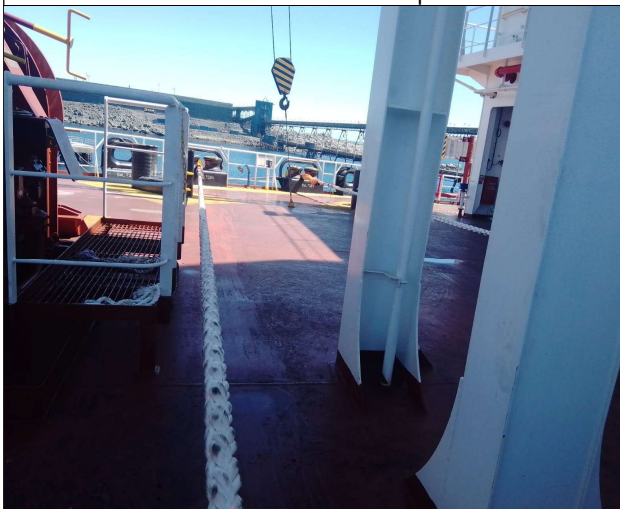
11. General view of rope in use

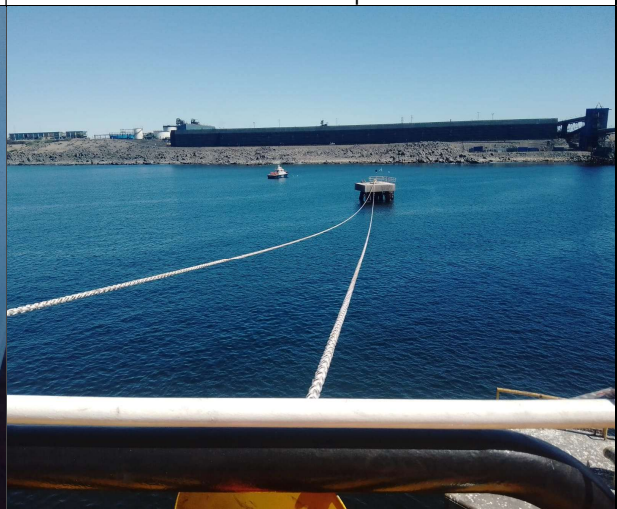
12. General view of being inspected in use

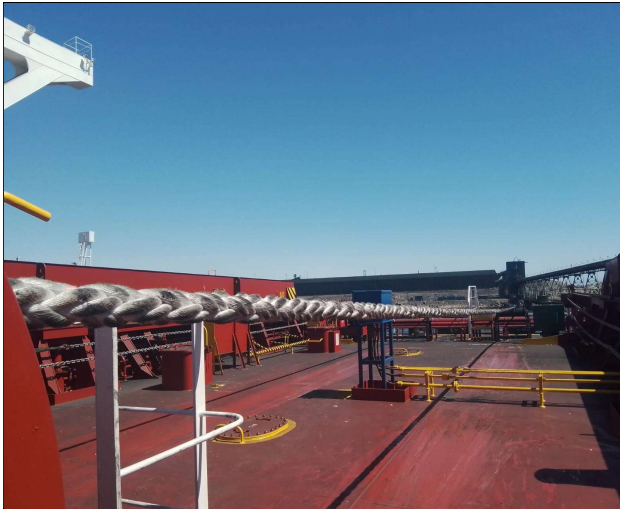
13. General view of rope.

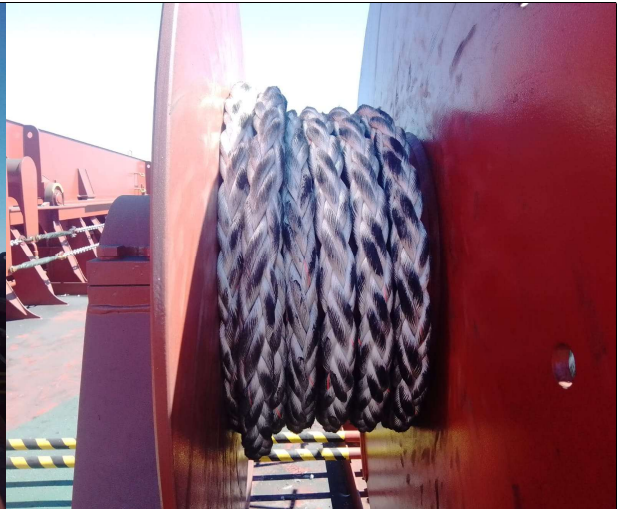
14. General view of rope into drums

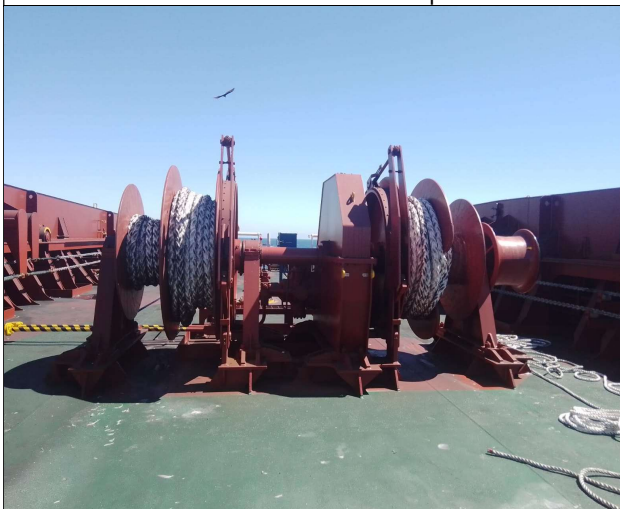
15. General view of rope in use into drum

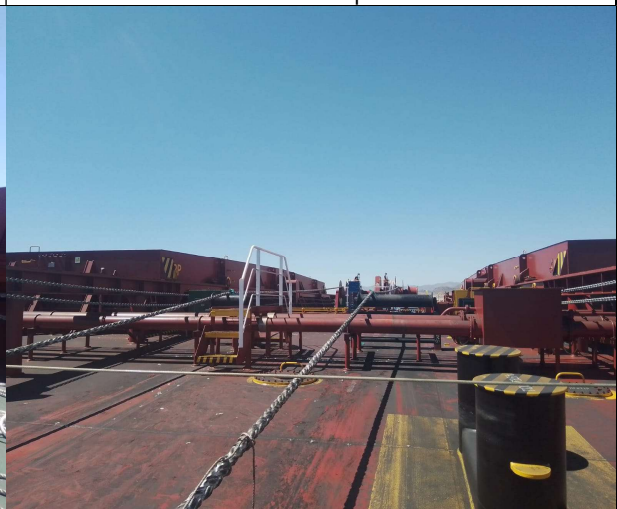
16. General view of rope in good conditions

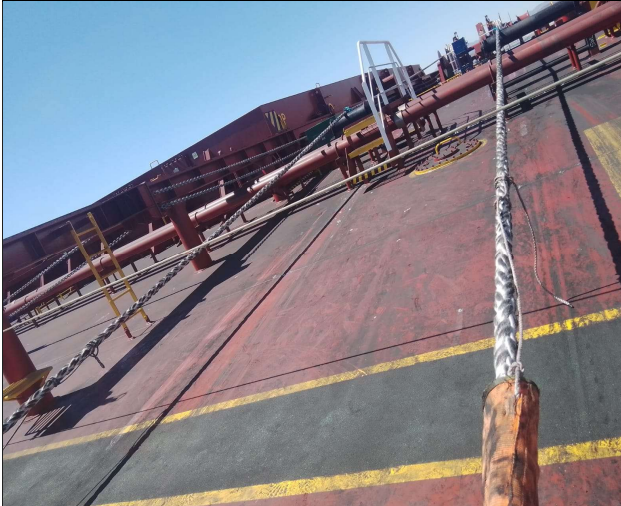
17. General view of rope in use

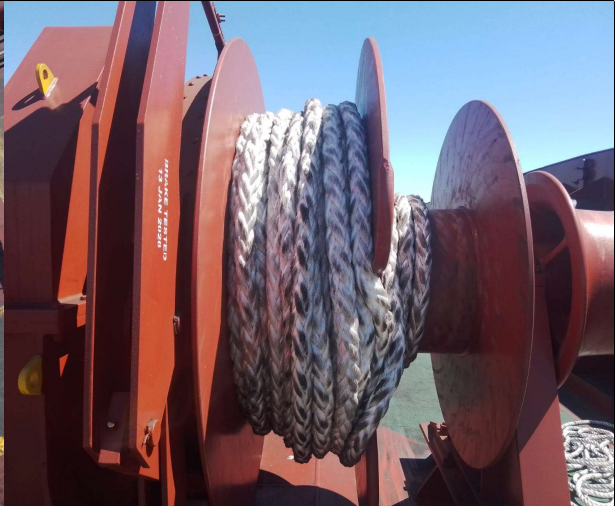
18. General view of rope conditions

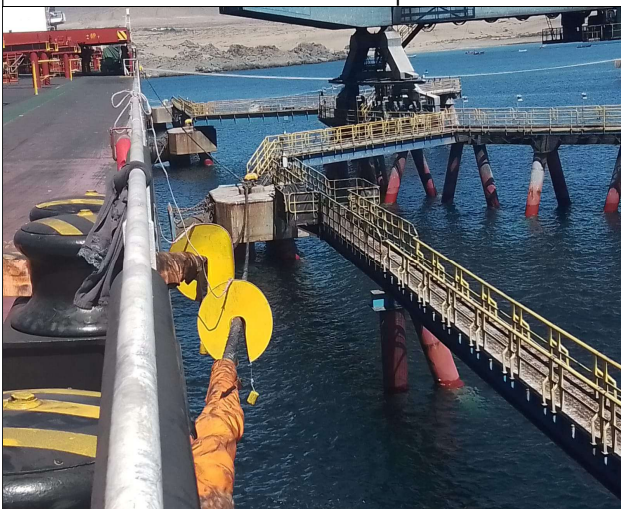
19. General view of rope in position

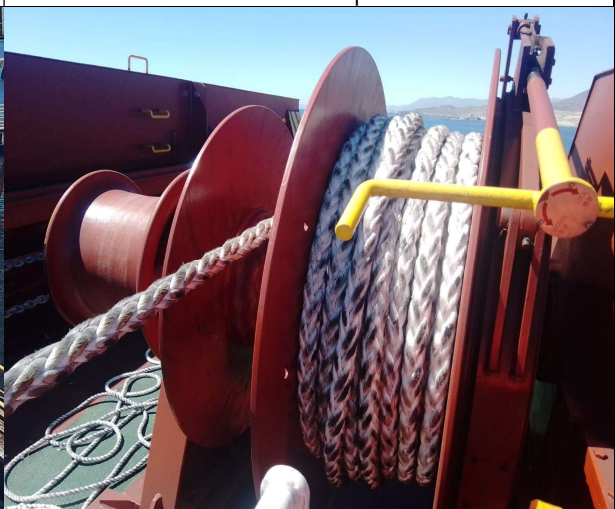
20. General view of rope into drums

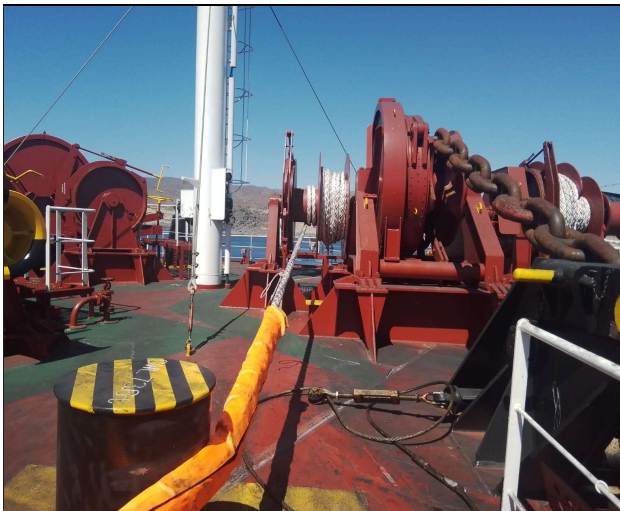
21. General view of rope.

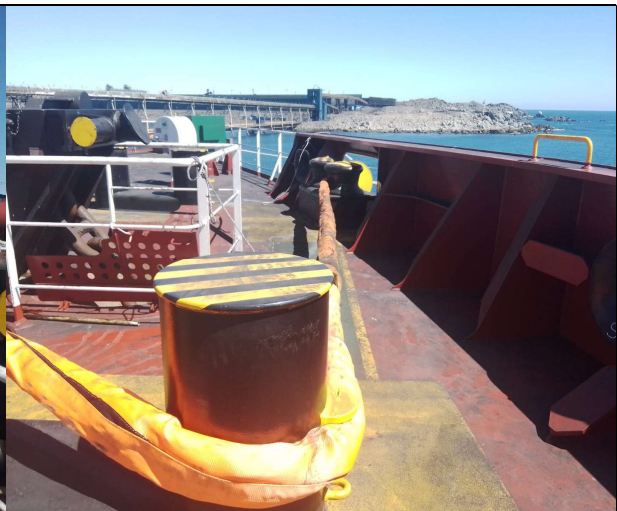
22. General view of rope in use

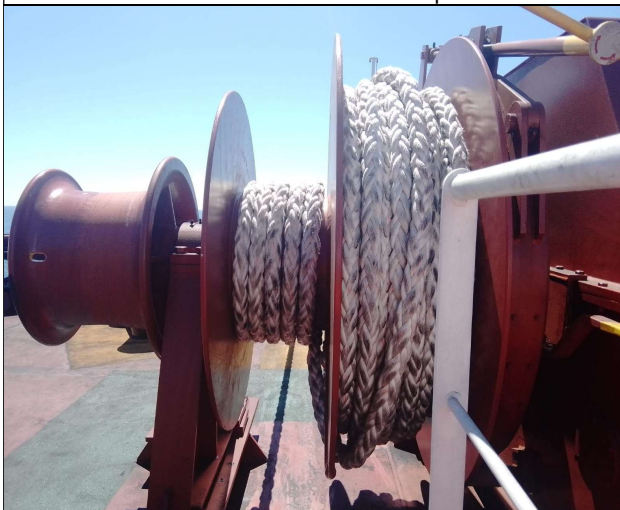
23. General view of rope into drum

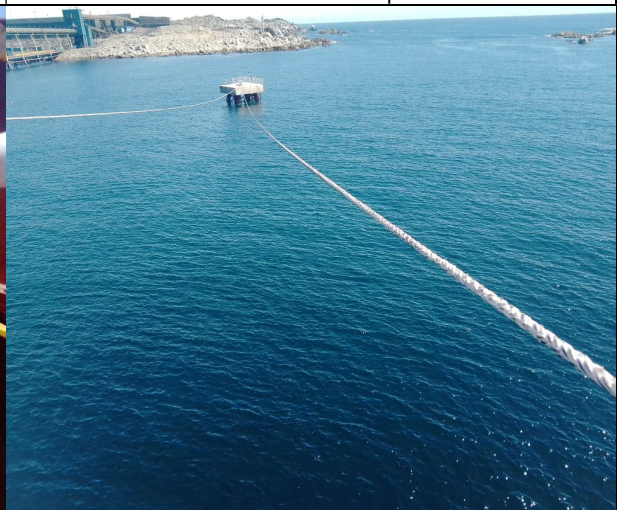
24. General view of being inspected in use

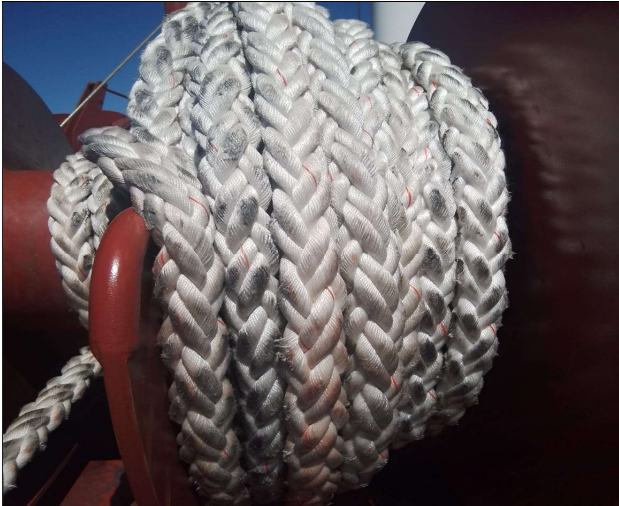
25. General view of rope.

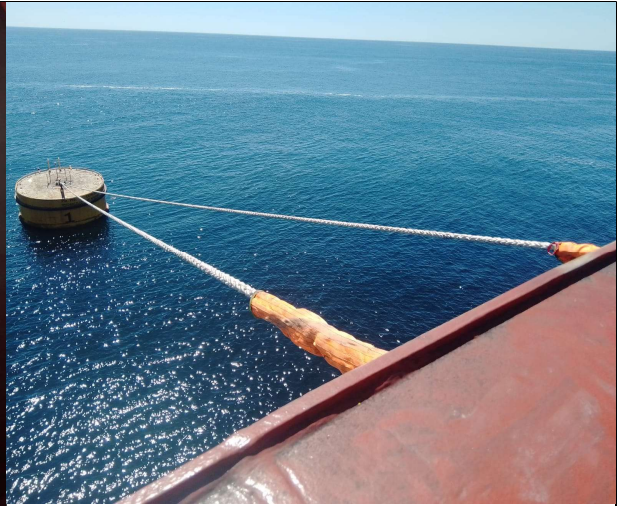
26. General view of rope in use

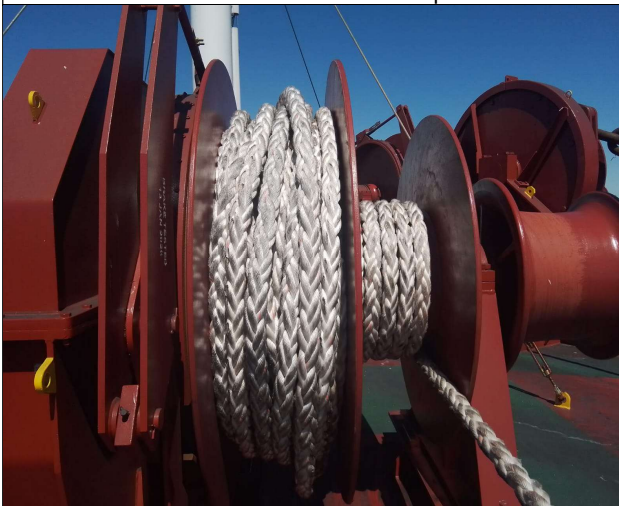
27. General view of rope into drum

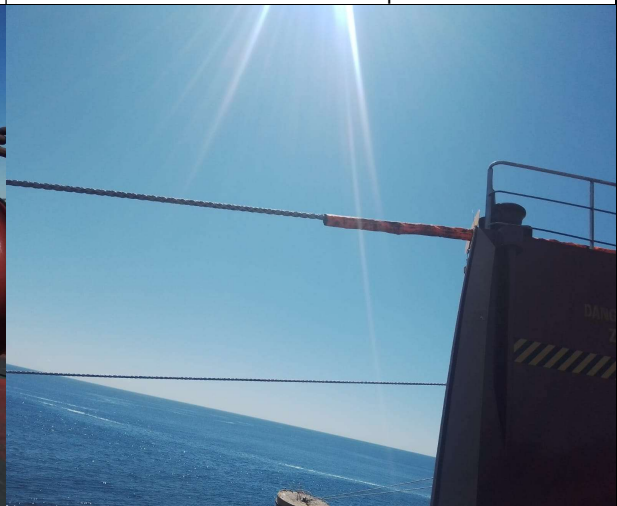
28. General view of being inspected in use
