FINAL REPORT

SURVEY	TERMINAL GUACOLDA II.
TO	ULTRAMAR AGENCIA MARITIMA
FROM	ALS INSPECTION CHILE SPA.
CLIENT REF	ULTRAMAR.
ALS REF	ANF-2603-0898
SCOPE OF SURVEY	INSPECTION OF 10 MOORING LINES.
VESSEL NAME	MV RANGIROA
OWNER	OCEANSURF OWNERS LIMITED
PLACE OF SURVEY	HUASCO BAY
DATE OF SURVEY	MARCH.05, 2026
TIME OF SURVEY	16:15 HRS. TO 20:50 HRS.

Report: ANF-2603-0898

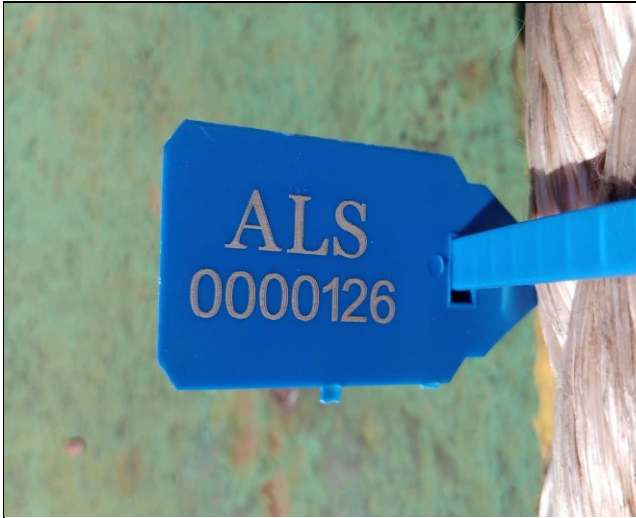
1. View of seal N° **0000126**.

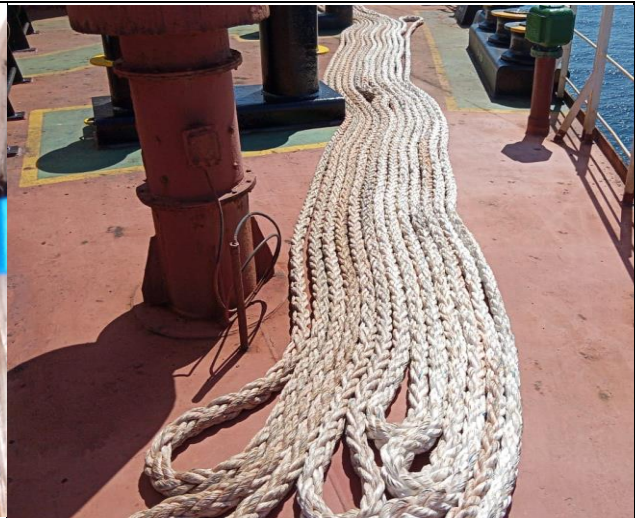
DAMAGE ITEM	GOOD	FAIR	POOR
Ext. Abrasion (max 25%)	<input checked="" type="checkbox"/>	<input type="checkbox"/>	Over 25% <input type="checkbox"/>
Int. Abrasion	<input checked="" type="checkbox"/>	<input type="checkbox"/>	<input type="checkbox"/>
Cut strands	<input checked="" type="checkbox"/>	<input type="checkbox"/>	<input type="checkbox"/>
Burn/ heated parts / fusion	<input checked="" type="checkbox"/>	<input type="checkbox"/>	<input type="checkbox"/>
Sun degradation /discoloration	<input checked="" type="checkbox"/>	<input type="checkbox"/>	<input type="checkbox"/>
Fiber broken	<input checked="" type="checkbox"/>	<input type="checkbox"/>	<input type="checkbox"/>
Black stains / dirty	<input type="checkbox"/>	<input checked="" type="checkbox"/>	<input type="checkbox"/>
Inconsistent diameter	<input checked="" type="checkbox"/>	<input type="checkbox"/>	<input type="checkbox"/>
Inconsistent flexibility	<input checked="" type="checkbox"/>	<input type="checkbox"/>	<input type="checkbox"/>

2. General view of the rope.

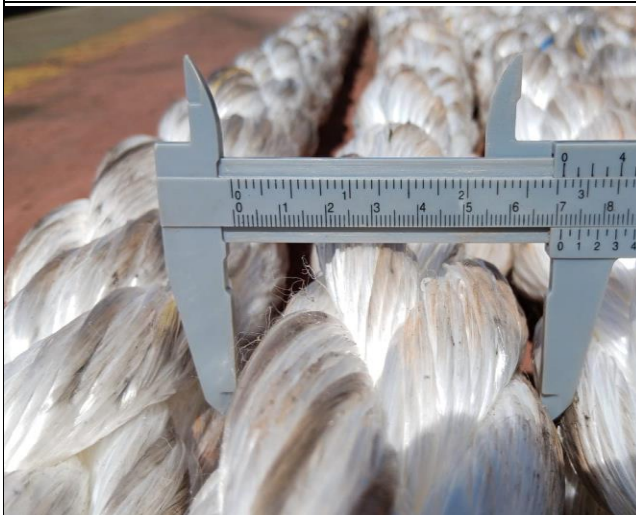
3. View of diameter measurement of the mooring lines.

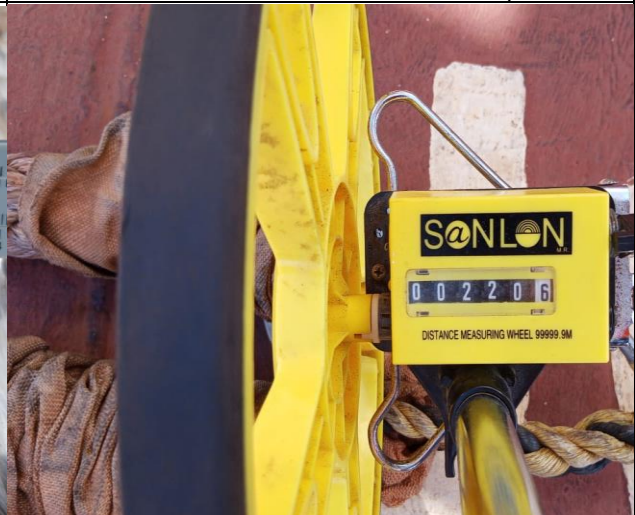
Length measured by surveyor: **220,6** Meters.

4. Length measured by surveyor.

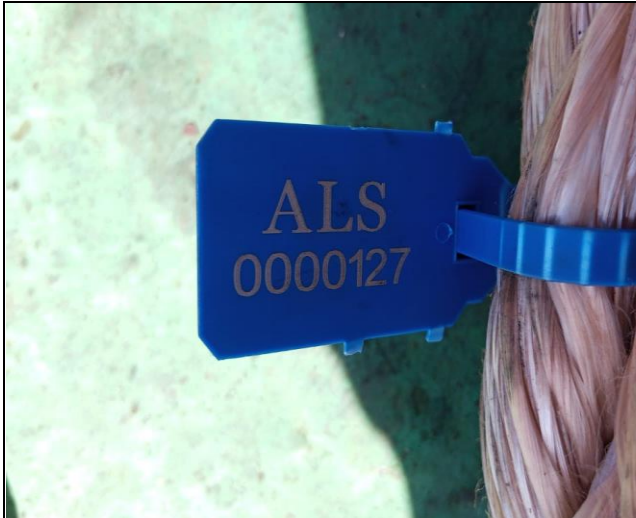
5. View of seal N° **0000127**.

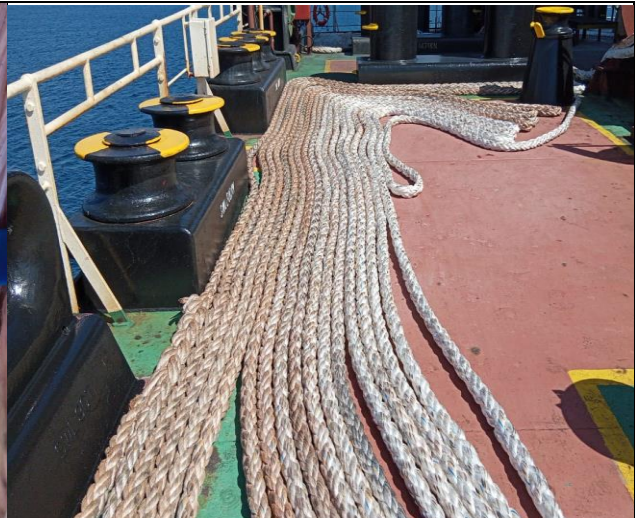
DAMAGE ITEM	GOOD	FAIR	POOR
Ext. Abrasion (max 25%)	<input checked="" type="checkbox"/>	<input type="checkbox"/>	Over 25% <input type="checkbox"/>
Int. Abrasion	<input checked="" type="checkbox"/>	<input type="checkbox"/>	<input type="checkbox"/>
Cut strands	<input checked="" type="checkbox"/>	<input type="checkbox"/>	<input type="checkbox"/>
Burn/ heated parts / fusion	<input checked="" type="checkbox"/>	<input type="checkbox"/>	<input type="checkbox"/>
Sun degradation /discoloration	<input checked="" type="checkbox"/>	<input type="checkbox"/>	<input type="checkbox"/>
Fiber broken	<input checked="" type="checkbox"/>	<input type="checkbox"/>	<input type="checkbox"/>
Black stains / dirty	<input type="checkbox"/>	<input checked="" type="checkbox"/>	<input type="checkbox"/>
Inconsistent diameter	<input checked="" type="checkbox"/>	<input type="checkbox"/>	<input type="checkbox"/>
Inconsistent flexibility	<input checked="" type="checkbox"/>	<input type="checkbox"/>	<input type="checkbox"/>

6. General view of the rope.

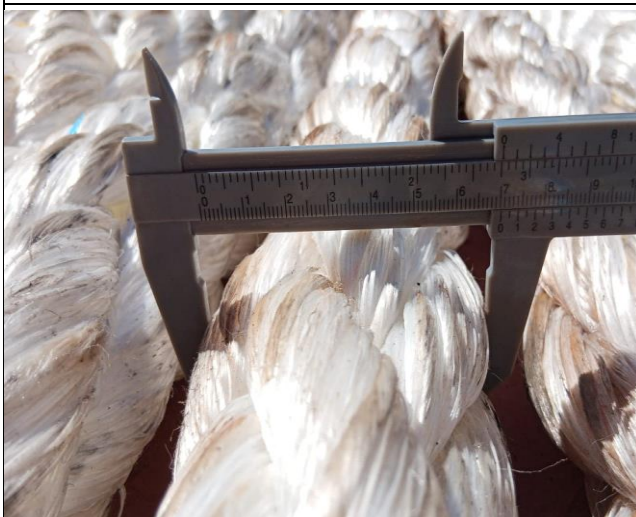
7. View of diameter measurement of the mooring lines.

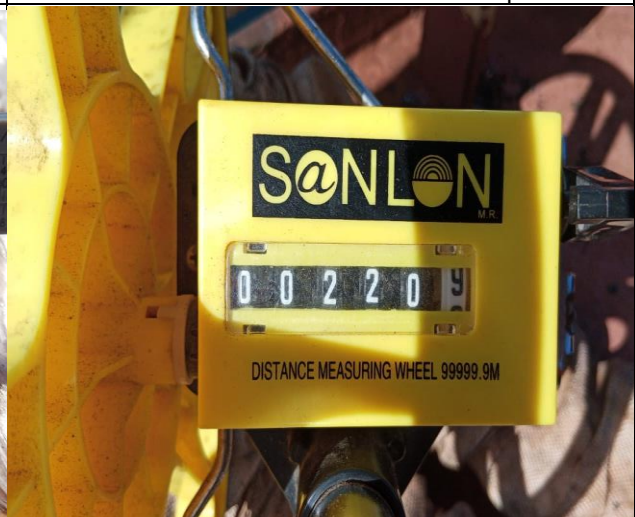
Length measured by surveyor: **220,9** Meters.

8. Length measured by surveyor.

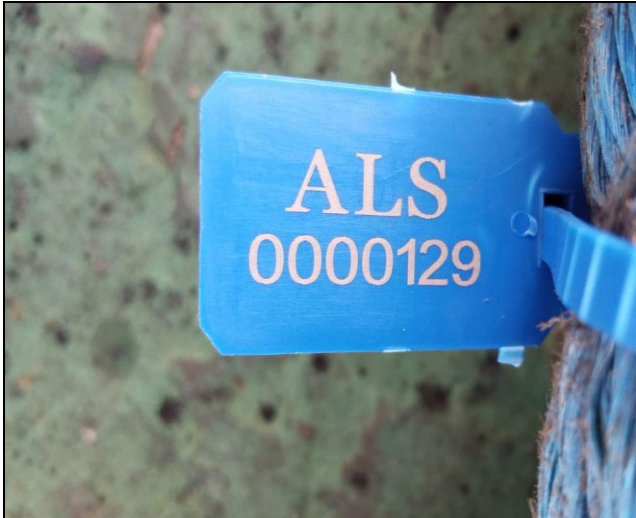
9. View of seal N° **0000129**.

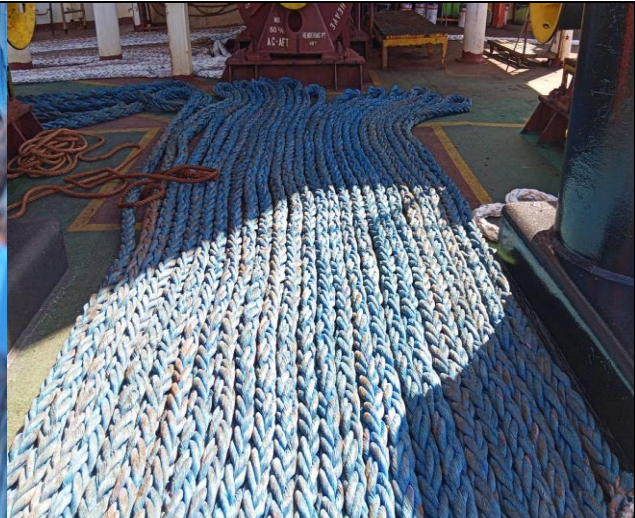
DAMAGE ITEM	GOOD	FAIR	POOR
Ext. Abrasion (max 25%)	<input checked="" type="checkbox"/>	<input type="checkbox"/>	Over 25% <input type="checkbox"/>
Int. Abrasion	<input checked="" type="checkbox"/>	<input type="checkbox"/>	<input type="checkbox"/>
Cut strands	<input checked="" type="checkbox"/>	<input type="checkbox"/>	<input type="checkbox"/>
Burn/ heated parts / fusion	<input checked="" type="checkbox"/>	<input type="checkbox"/>	<input type="checkbox"/>
Sun degradation /discoloration	<input checked="" type="checkbox"/>	<input type="checkbox"/>	<input type="checkbox"/>
Fiber broken	<input checked="" type="checkbox"/>	<input type="checkbox"/>	<input type="checkbox"/>
Black stains / dirty	<input type="checkbox"/>	<input checked="" type="checkbox"/>	<input type="checkbox"/>
Inconsistent diameter	<input checked="" type="checkbox"/>	<input type="checkbox"/>	<input type="checkbox"/>
Inconsistent flexibility	<input checked="" type="checkbox"/>	<input type="checkbox"/>	<input type="checkbox"/>

10. General view of the rope.

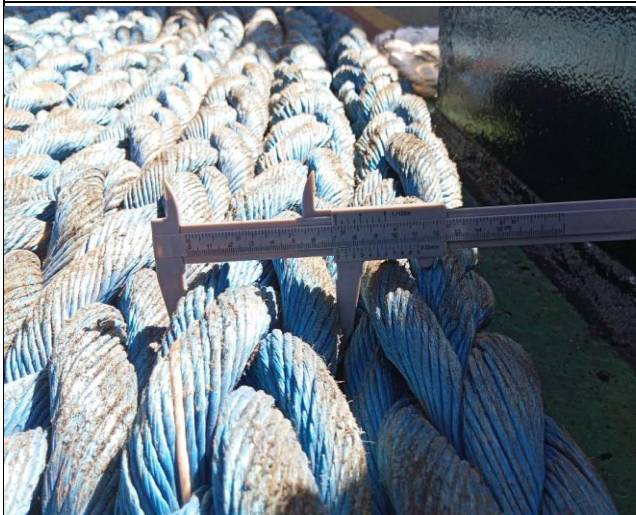
11. View of diameter measurement of the mooring lines.

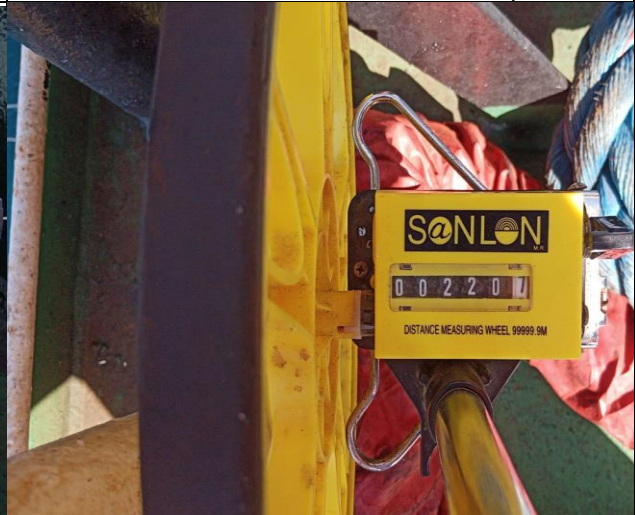
Length measured by surveyor: **220,7** Meters.

12. Length measured by surveyor.

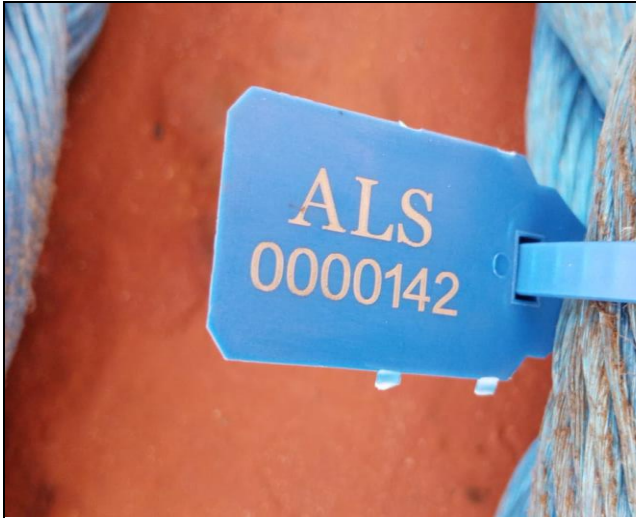
13. View of seal N° **0000142.**

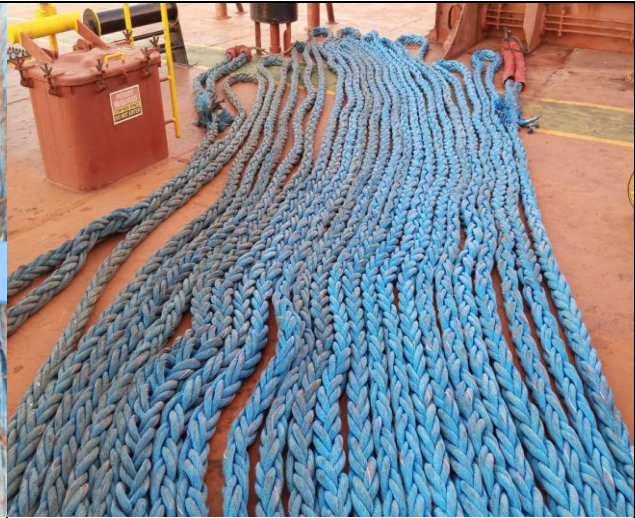
DAMAGE ITEM	GOOD	FAIR	POOR
Ext. Abrasion (max 25%)	<input checked="" type="checkbox"/>	<input type="checkbox"/>	Over 25% <input type="checkbox"/>
Int. Abrasion	<input checked="" type="checkbox"/>	<input type="checkbox"/>	<input type="checkbox"/>
Cut strands	<input checked="" type="checkbox"/>	<input type="checkbox"/>	<input type="checkbox"/>
Burn/ heated parts / fusion	<input checked="" type="checkbox"/>	<input type="checkbox"/>	<input type="checkbox"/>
Sun degradation /discoloration	<input checked="" type="checkbox"/>	<input type="checkbox"/>	<input type="checkbox"/>
Fiber broken	<input checked="" type="checkbox"/>	<input type="checkbox"/>	<input type="checkbox"/>
Black stains / dirty	<input type="checkbox"/>	<input checked="" type="checkbox"/>	<input type="checkbox"/>
Inconsistent diameter	<input checked="" type="checkbox"/>	<input type="checkbox"/>	<input type="checkbox"/>
Inconsistent flexibility	<input checked="" type="checkbox"/>	<input type="checkbox"/>	<input type="checkbox"/>

14. General view of the rope.

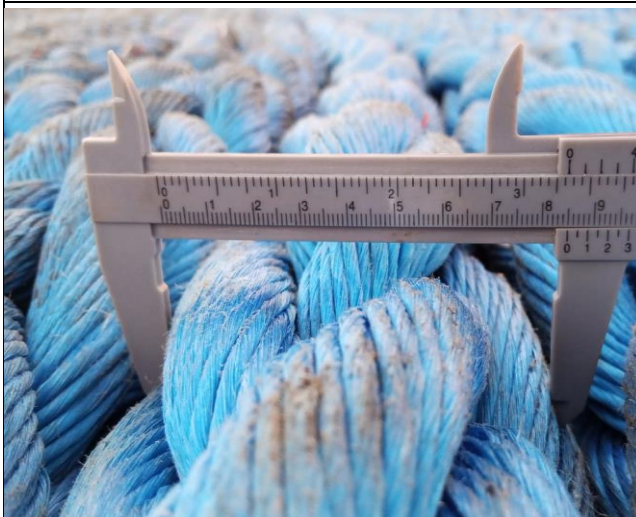
15. View of diameter measurement of the mooring lines.

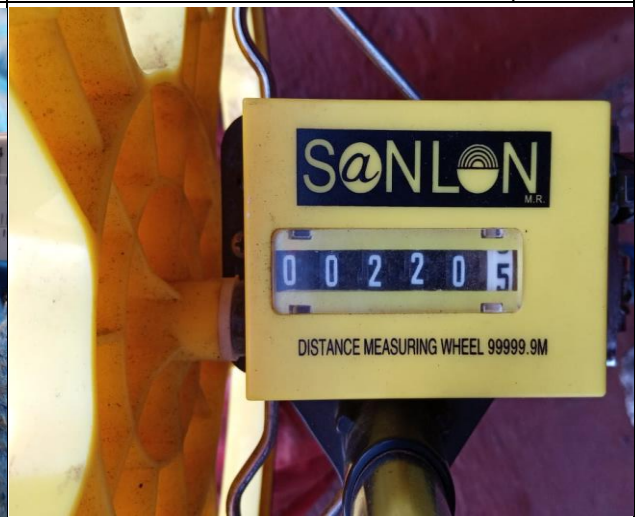
Length measured by surveyor: **220,5** Meters.

16. Length measured by surveyor.

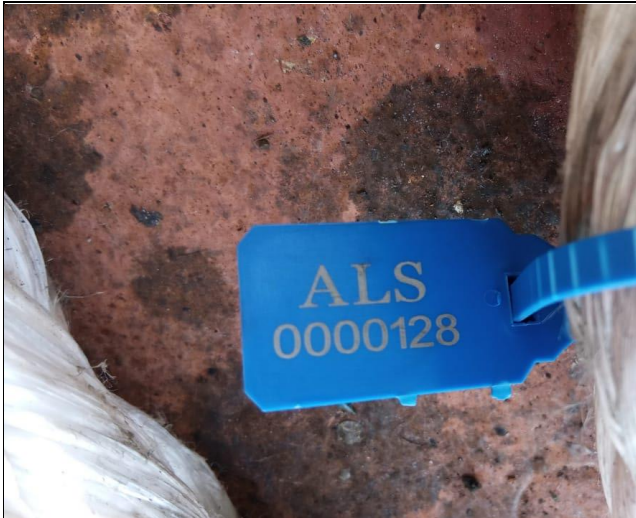
17. View of seal N° **0000128**.

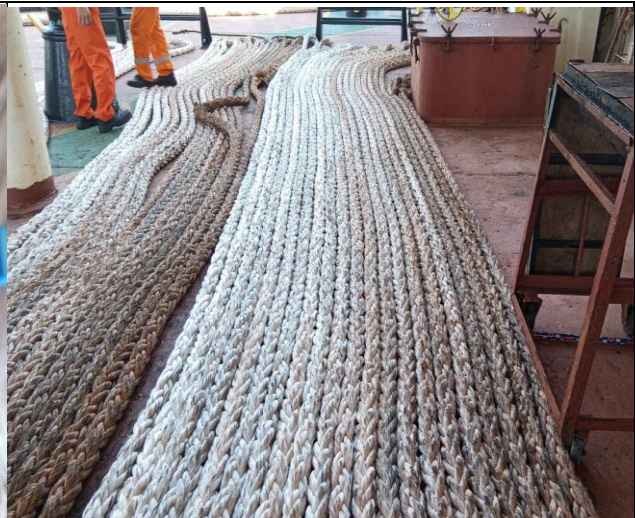
DAMAGE ITEM	GOOD	FAIR	POOR
Ext. Abrasion (max 25%)	<input checked="" type="checkbox"/>	<input type="checkbox"/>	Over 25% <input type="checkbox"/>
Int. Abrasion	<input checked="" type="checkbox"/>	<input type="checkbox"/>	<input type="checkbox"/>
Cut strands	<input checked="" type="checkbox"/>	<input type="checkbox"/>	<input type="checkbox"/>
Burn/ heated parts / fusion	<input checked="" type="checkbox"/>	<input type="checkbox"/>	<input type="checkbox"/>
Sun degradation /discoloration	<input checked="" type="checkbox"/>	<input type="checkbox"/>	<input type="checkbox"/>
Fiber broken	<input checked="" type="checkbox"/>	<input type="checkbox"/>	<input type="checkbox"/>
Black stains / dirty	<input type="checkbox"/>	<input checked="" type="checkbox"/>	<input type="checkbox"/>
Inconsistent diameter	<input checked="" type="checkbox"/>	<input type="checkbox"/>	<input type="checkbox"/>
Inconsistent flexibility	<input checked="" type="checkbox"/>	<input type="checkbox"/>	<input type="checkbox"/>

18. General view of the rope.

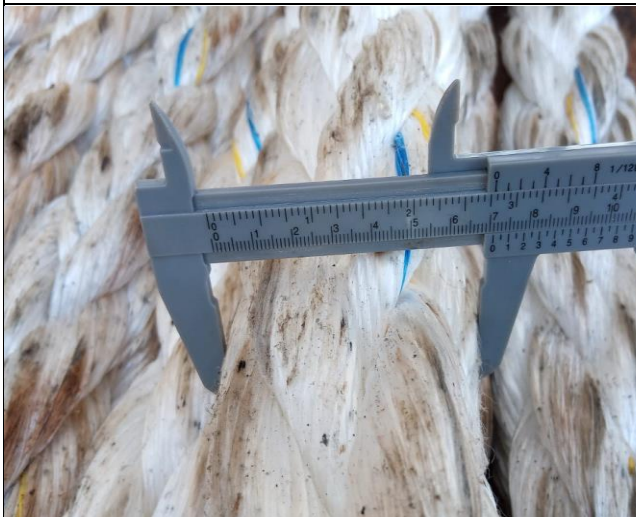
19. View of diameter measurement of the mooring lines.

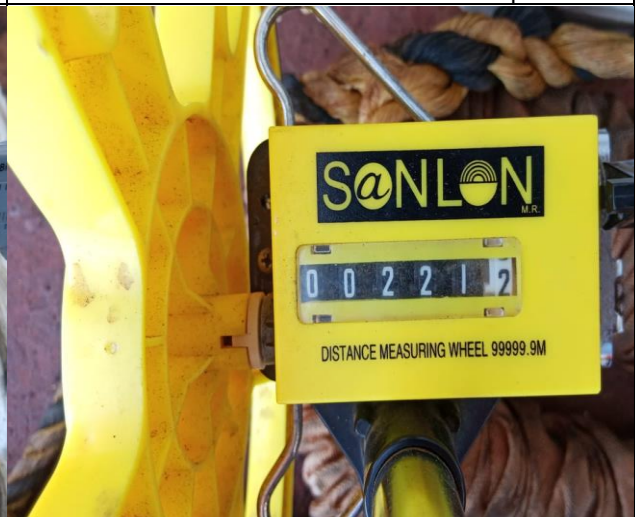
Length measured by surveyor: **221,2** Meters.

20. Length measured by surveyor.

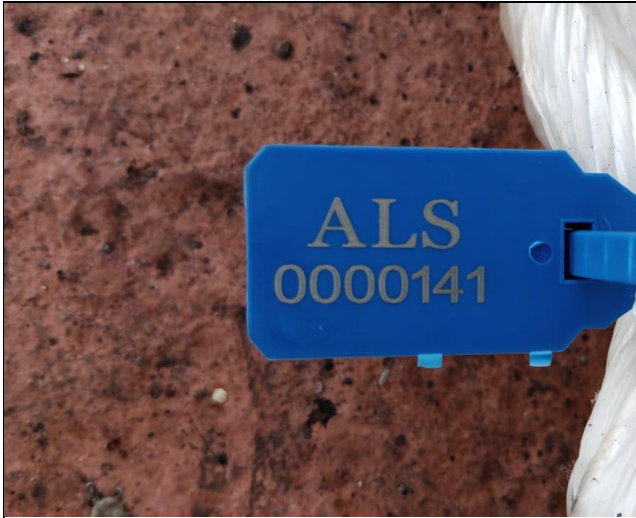
21. View of seal N° **0000141**.

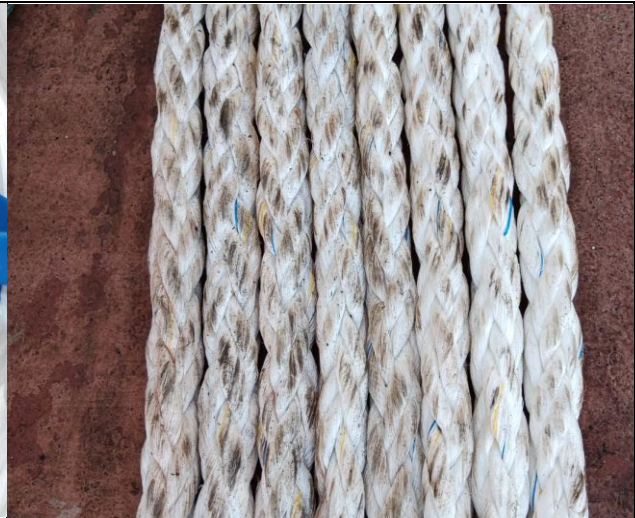
DAMAGE ITEM	GOOD	FAIR	POOR
Ext. Abrasion (max 25%)	<input checked="" type="checkbox"/>	<input type="checkbox"/>	Over 25% <input type="checkbox"/>
Int. Abrasion	<input checked="" type="checkbox"/>	<input type="checkbox"/>	<input type="checkbox"/>
Cut strands	<input checked="" type="checkbox"/>	<input type="checkbox"/>	<input type="checkbox"/>
Burn/ heated parts / fusion	<input checked="" type="checkbox"/>	<input type="checkbox"/>	<input type="checkbox"/>
Sun degradation /discoloration	<input checked="" type="checkbox"/>	<input type="checkbox"/>	<input type="checkbox"/>
Fiber broken	<input checked="" type="checkbox"/>	<input type="checkbox"/>	<input type="checkbox"/>
Black stains / dirty	<input type="checkbox"/>	<input checked="" type="checkbox"/>	<input type="checkbox"/>
Inconsistent diameter	<input checked="" type="checkbox"/>	<input type="checkbox"/>	<input type="checkbox"/>
Inconsistent flexibility	<input checked="" type="checkbox"/>	<input type="checkbox"/>	<input type="checkbox"/>

22. General view of the rope.

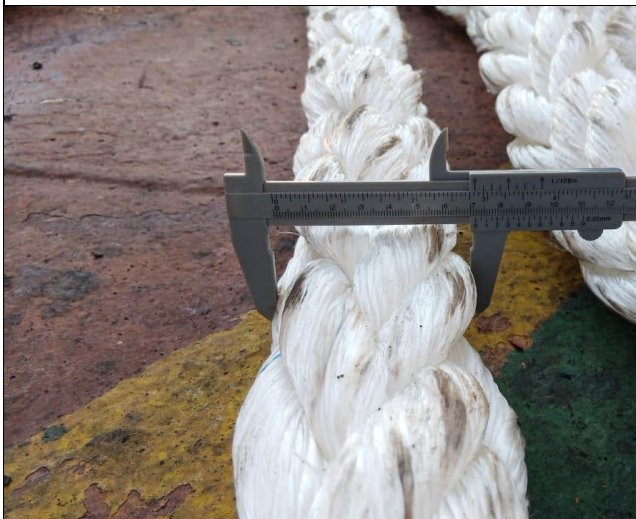
23. View of diameter measurement of the mooring lines.

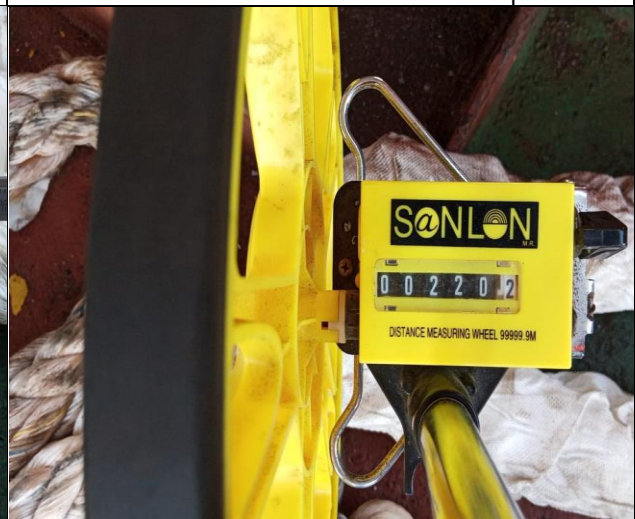
Length measured by surveyor: **220,2** Meters.

24. Length measured by surveyor.

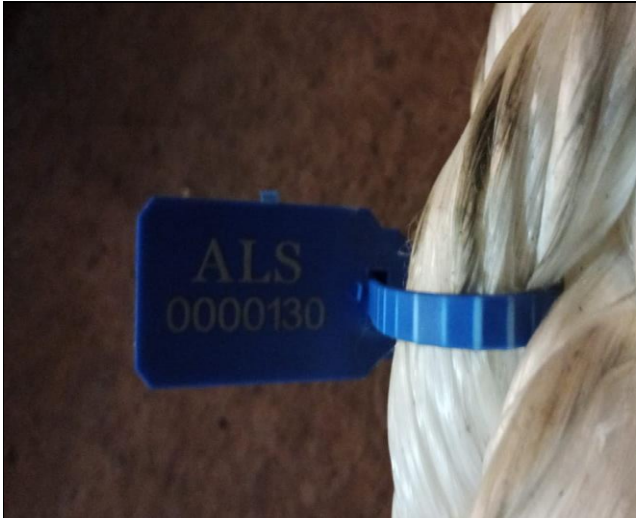
25. View of seal N° **0000130**.

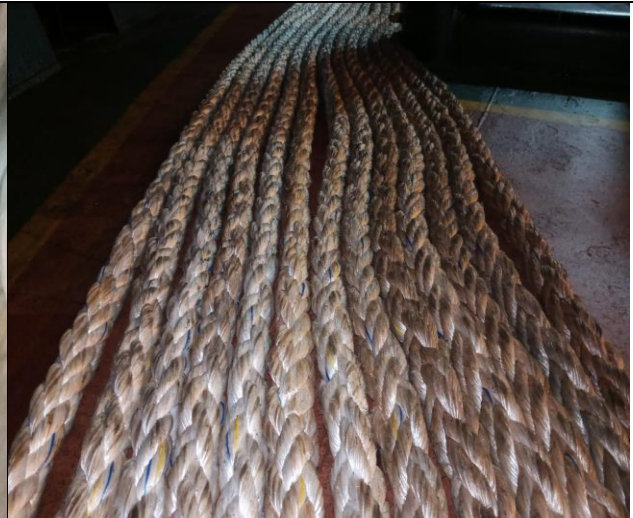
DAMAGE ITEM	GOOD	FAIR	POOR
Ext. Abrasion (max 25%)	<input checked="" type="checkbox"/>	<input type="checkbox"/>	Over 25% <input type="checkbox"/>
Int. Abrasion	<input checked="" type="checkbox"/>	<input type="checkbox"/>	<input type="checkbox"/>
Cut strands	<input checked="" type="checkbox"/>	<input type="checkbox"/>	<input type="checkbox"/>
Burn/ heated parts / fusion	<input checked="" type="checkbox"/>	<input type="checkbox"/>	<input type="checkbox"/>
Sun degradation /discoloration	<input checked="" type="checkbox"/>	<input type="checkbox"/>	<input type="checkbox"/>
Fiber broken	<input checked="" type="checkbox"/>	<input type="checkbox"/>	<input type="checkbox"/>
Black stains / dirty	<input type="checkbox"/>	<input checked="" type="checkbox"/>	<input type="checkbox"/>
Inconsistent diameter	<input checked="" type="checkbox"/>	<input type="checkbox"/>	<input type="checkbox"/>
Inconsistent flexibility	<input checked="" type="checkbox"/>	<input type="checkbox"/>	<input type="checkbox"/>

26. General view of the rope.

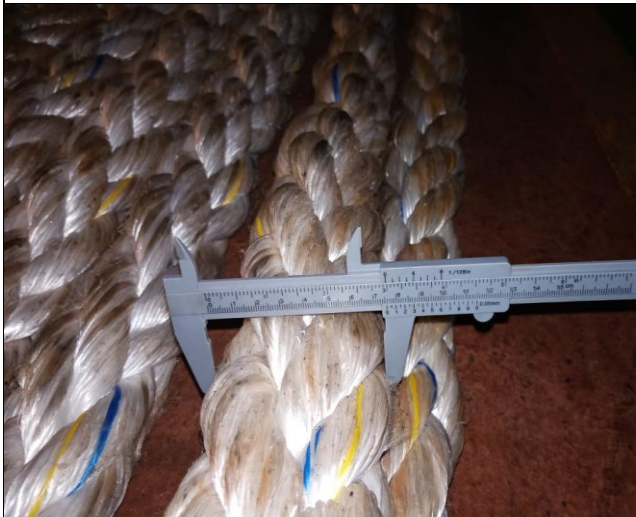
27. View of diameter measurement of the mooring lines.

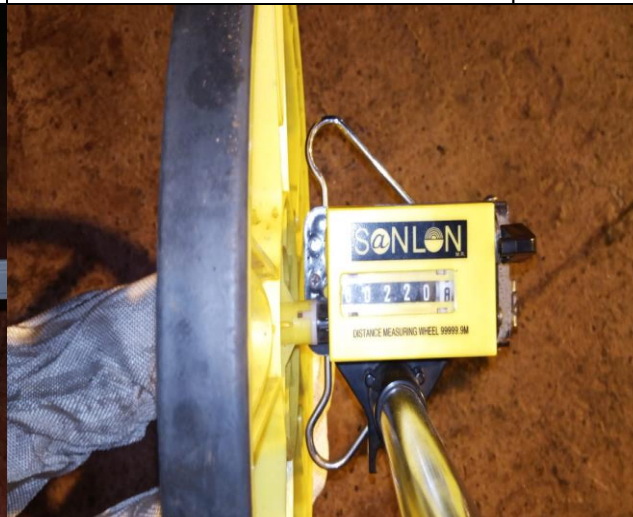
Length measured by surveyor: **220,8** Meters.

28. Length measured by surveyor.

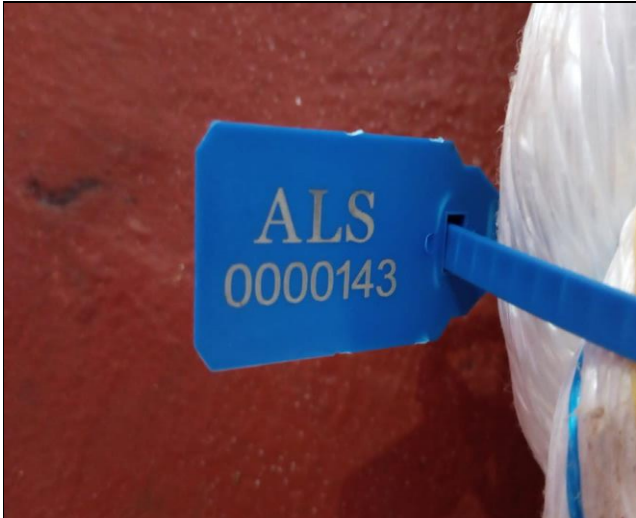
29. View of seal N° **0000143**.

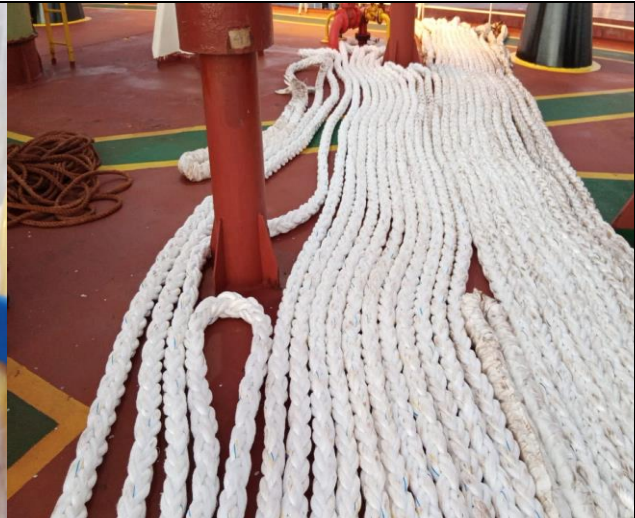
DAMAGE ITEM	GOOD	FAIR	POOR
Ext. Abrasion (max 25%)	<input checked="" type="checkbox"/>	<input type="checkbox"/>	Over 25% <input type="checkbox"/>
Int. Abrasion	<input checked="" type="checkbox"/>	<input type="checkbox"/>	<input type="checkbox"/>
Cut strands	<input checked="" type="checkbox"/>	<input type="checkbox"/>	<input type="checkbox"/>
Burn/ heated parts / fusion	<input checked="" type="checkbox"/>	<input type="checkbox"/>	<input type="checkbox"/>
Sun degradation /discoloration	<input checked="" type="checkbox"/>	<input type="checkbox"/>	<input type="checkbox"/>
Fiber broken	<input checked="" type="checkbox"/>	<input type="checkbox"/>	<input type="checkbox"/>
Black stains / dirty	<input type="checkbox"/>	<input checked="" type="checkbox"/>	<input type="checkbox"/>
Inconsistent diameter	<input checked="" type="checkbox"/>	<input type="checkbox"/>	<input type="checkbox"/>
Inconsistent flexibility	<input checked="" type="checkbox"/>	<input type="checkbox"/>	<input type="checkbox"/>

30. General view of the rope.

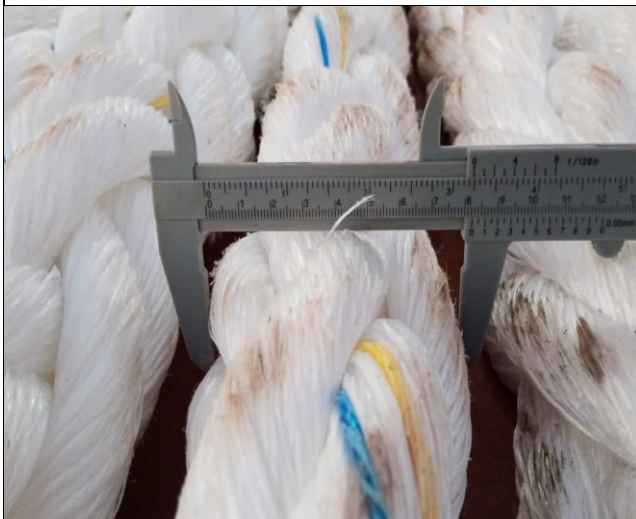
31. View of diameter measurement of the mooring lines.

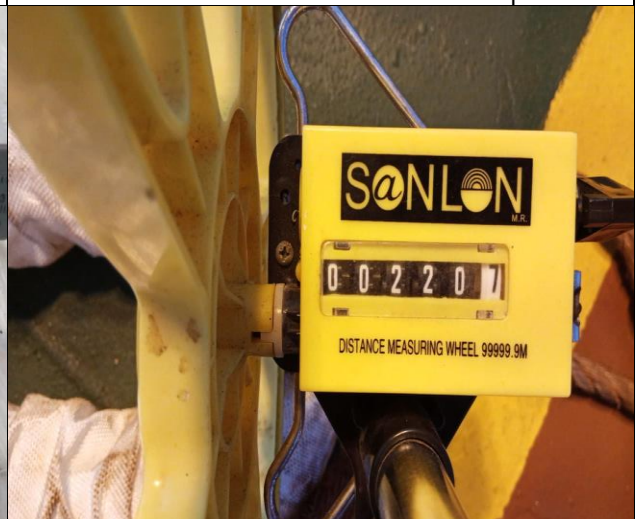
Length measured by surveyor: **220,7** Meters.

32. Length measured by surveyor.

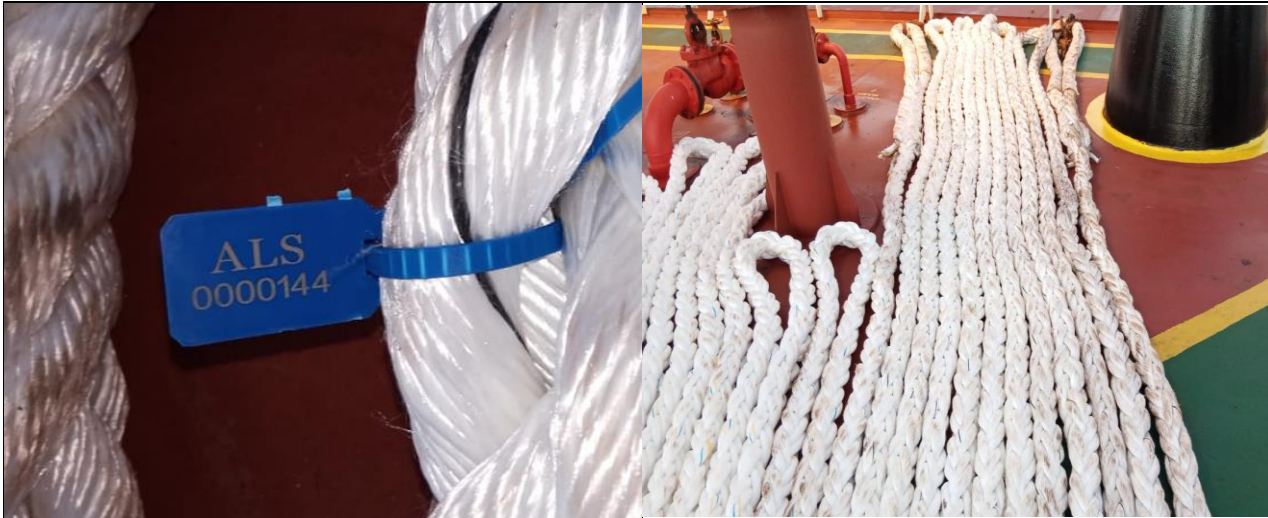
DAMAGE ITEM	GOOD	FAIR	POOR
Ext. Abrasion (max 25%)	<input checked="" type="checkbox"/>	<input type="checkbox"/>	Over 25% <input type="checkbox"/>
Int. Abrasion	<input checked="" type="checkbox"/>	<input type="checkbox"/>	<input type="checkbox"/>
Cut strands	<input checked="" type="checkbox"/>	<input type="checkbox"/>	<input type="checkbox"/>
Burn/ heated parts / fusion	<input checked="" type="checkbox"/>	<input type="checkbox"/>	<input type="checkbox"/>
Sun degradation /discoloration	<input checked="" type="checkbox"/>	<input type="checkbox"/>	<input type="checkbox"/>
Fiber broken	<input checked="" type="checkbox"/>	<input type="checkbox"/>	<input type="checkbox"/>
Black stains / dirty	<input type="checkbox"/>	<input checked="" type="checkbox"/>	<input type="checkbox"/>
Inconsistent diameter	<input checked="" type="checkbox"/>	<input type="checkbox"/>	<input type="checkbox"/>
Inconsistent flexibility	<input checked="" type="checkbox"/>	<input type="checkbox"/>	<input type="checkbox"/>

33. View of seal N° **0000144**.

34. General view of the rope.

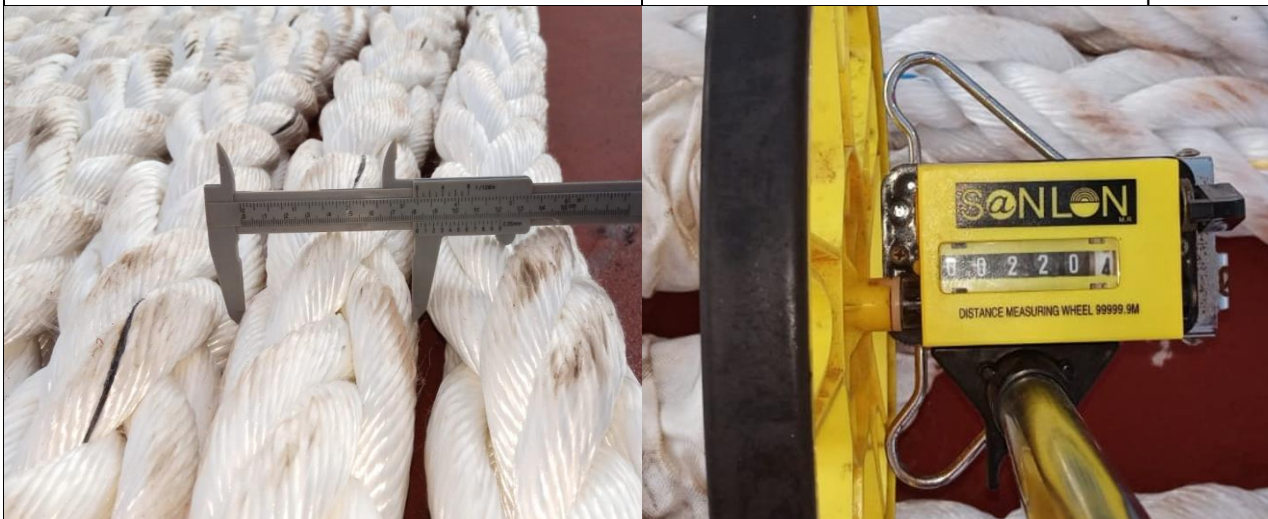
Length measured by surveyor: **220,4** Meters.

35. View of diameter measurement of the mooring lines.

36. Length measured by surveyor.

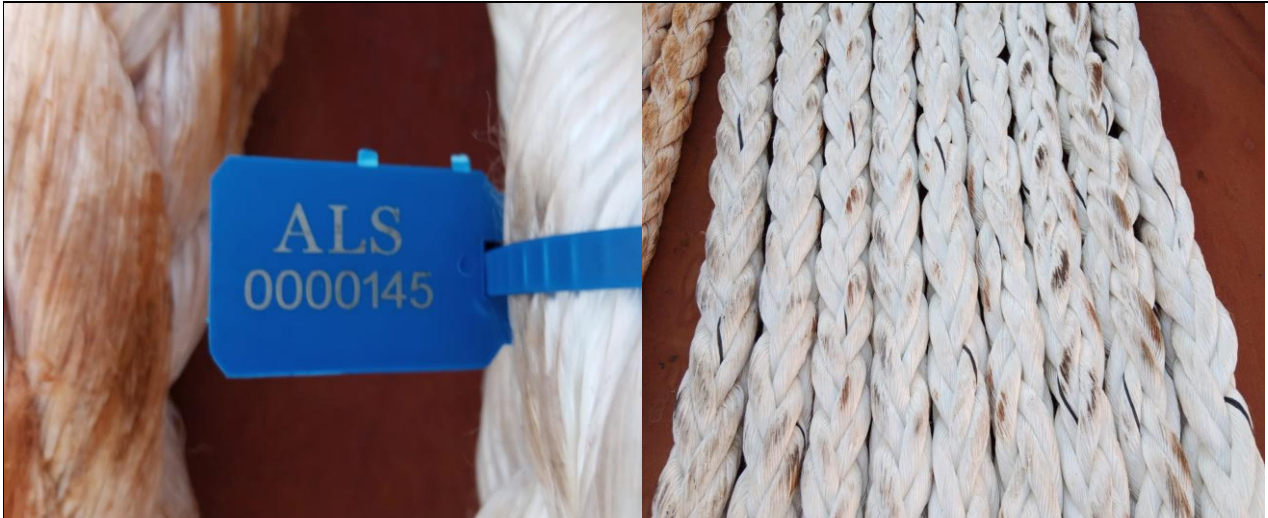
DAMAGE ITEM	GOOD	FAIR	POOR
Ext. Abrasion (max 25%)	<input checked="" type="checkbox"/>	<input type="checkbox"/>	Over 25% <input type="checkbox"/>
Int. Abrasion	<input checked="" type="checkbox"/>	<input type="checkbox"/>	<input type="checkbox"/>
Cut strands	<input checked="" type="checkbox"/>	<input type="checkbox"/>	<input type="checkbox"/>
Burn/ heated parts / fusion	<input checked="" type="checkbox"/>	<input type="checkbox"/>	<input type="checkbox"/>
Sun degradation /discoloration	<input checked="" type="checkbox"/>	<input type="checkbox"/>	<input type="checkbox"/>
Fiber broken	<input checked="" type="checkbox"/>	<input type="checkbox"/>	<input type="checkbox"/>
Black stains / dirty	<input type="checkbox"/>	<input checked="" type="checkbox"/>	<input type="checkbox"/>
Inconsistent diameter	<input checked="" type="checkbox"/>	<input type="checkbox"/>	<input type="checkbox"/>
Inconsistent flexibility	<input checked="" type="checkbox"/>	<input type="checkbox"/>	<input type="checkbox"/>

37. View of seal N° **0000145**.

38. General view of the rope.

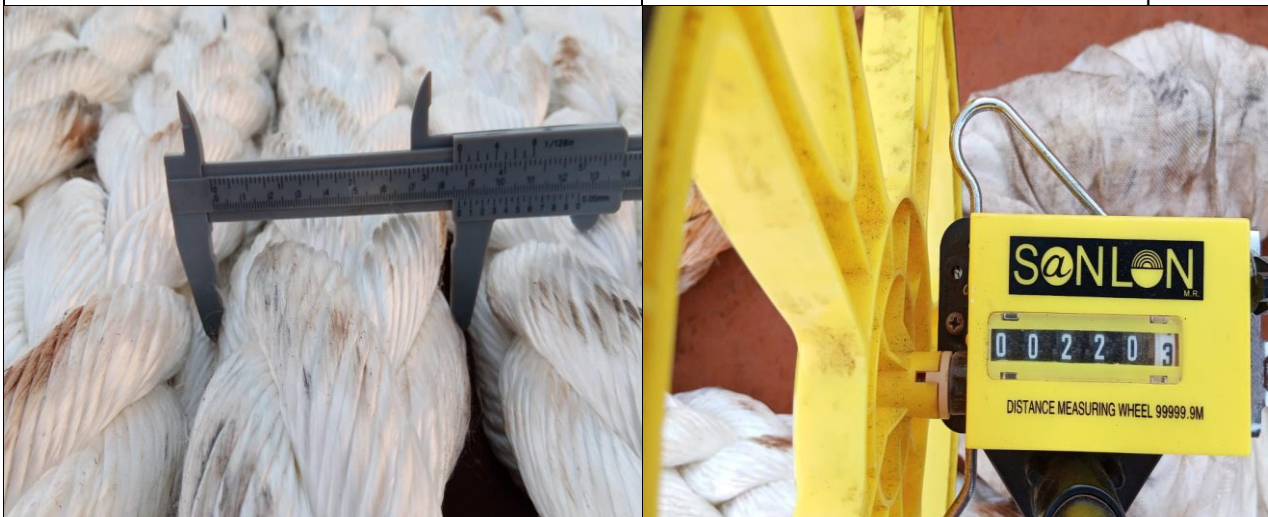
Length measured by surveyor: **220,3** Meters.

39. View of diameter measurement of the mooring lines.

40. Length measured by surveyor.
