Report: ANF 2604 1326

LASHING CERTIFICATE

Place of inspection : Mercosur 4, La Negra, Antofagasta.

Container : **HLBU 810327-3 / 1 x 40 OT Container**

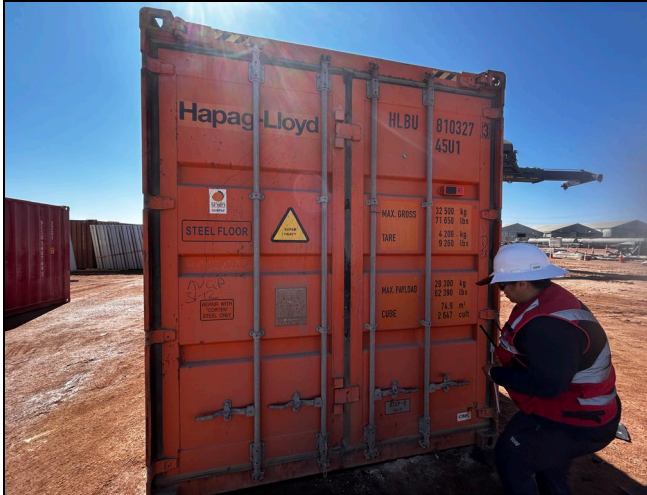
1. Identifications of container

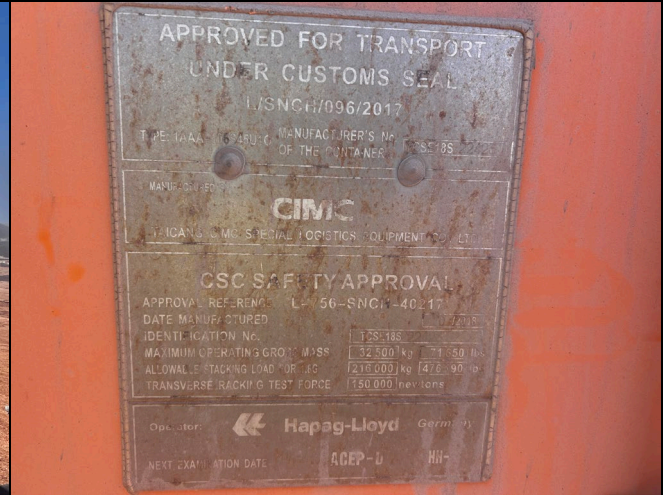
2. CSC Plate in good conditions

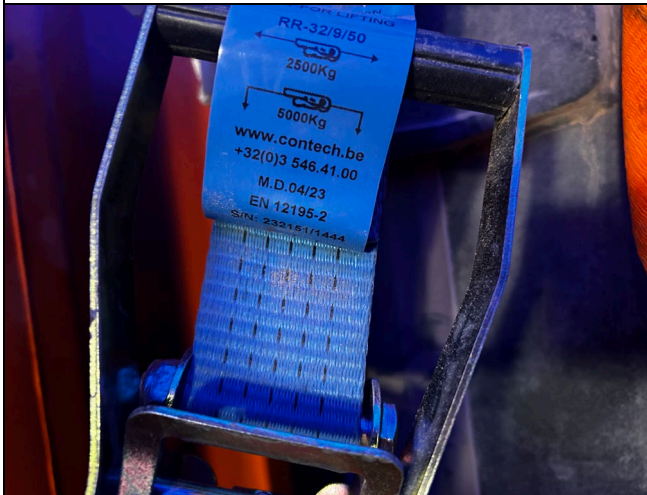
3. Lashing Band identifications

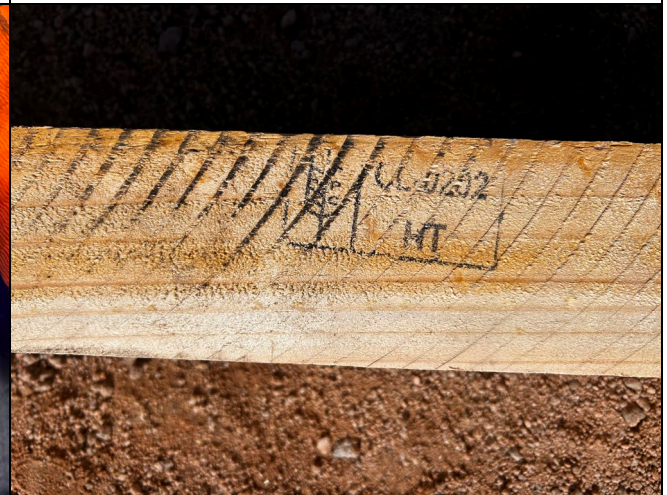
4. Wooden duly certified

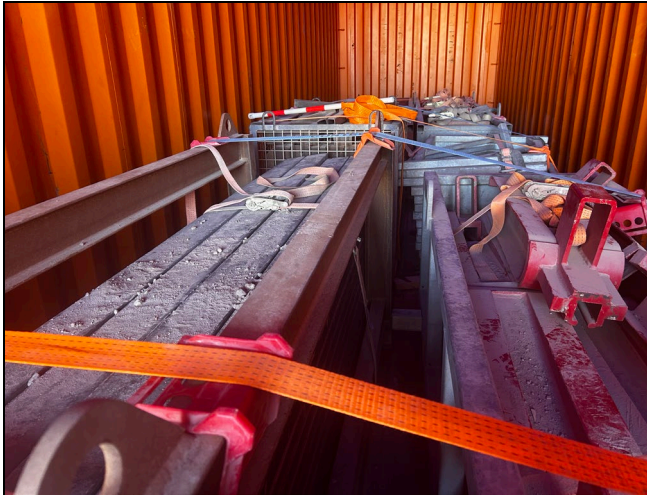
5. View of lashing bands and plastic protection

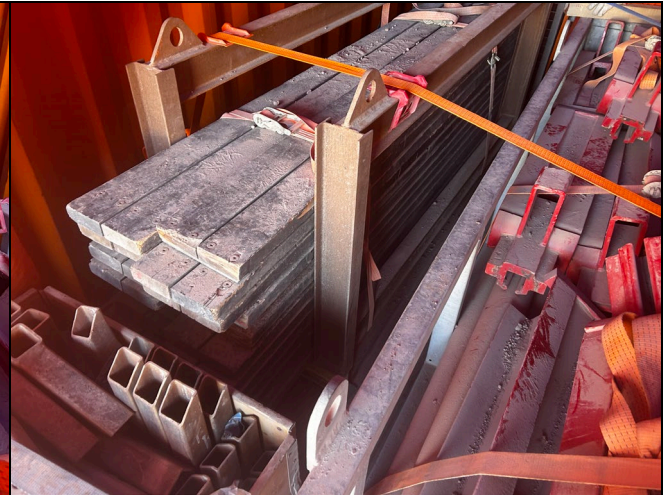
6. Another view of cargo duly lashed

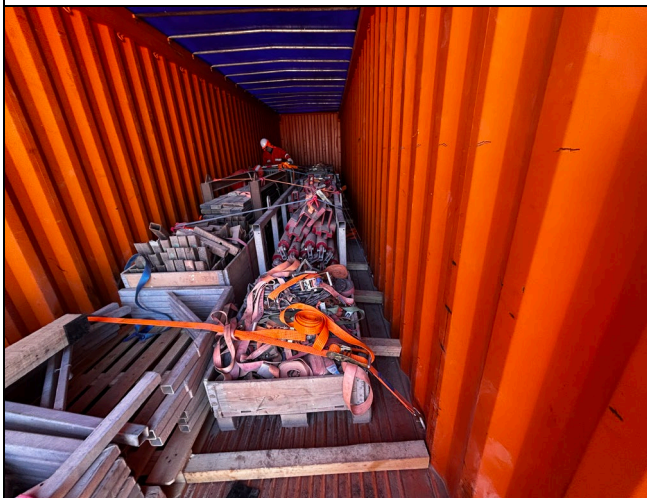
7. View of final lashing

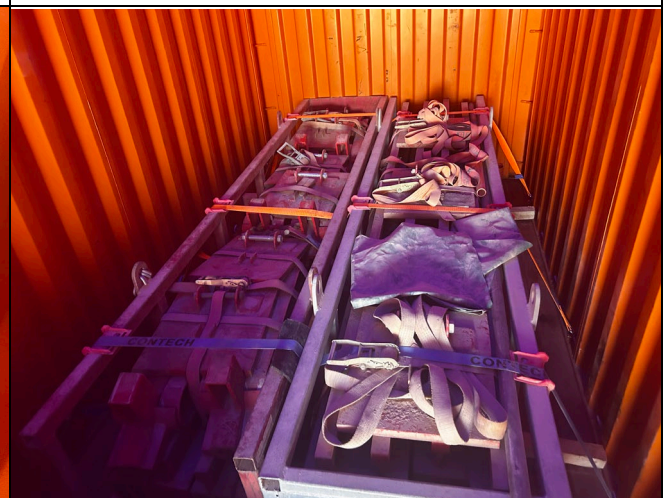
8. View of cargo duly lashed means lashing bands and edge protection.

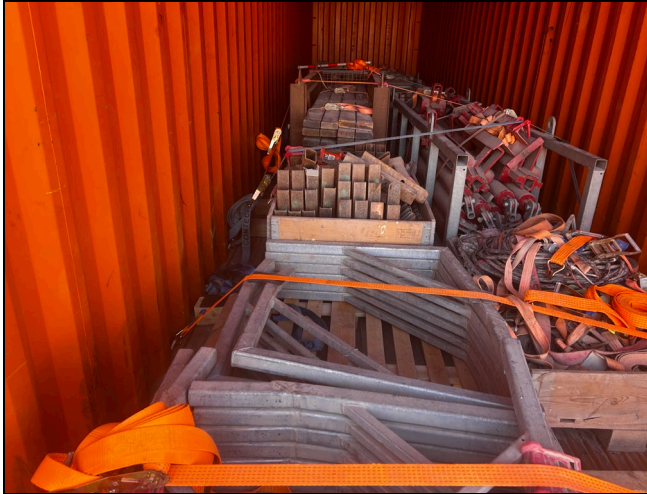
9. View of final cargo condition

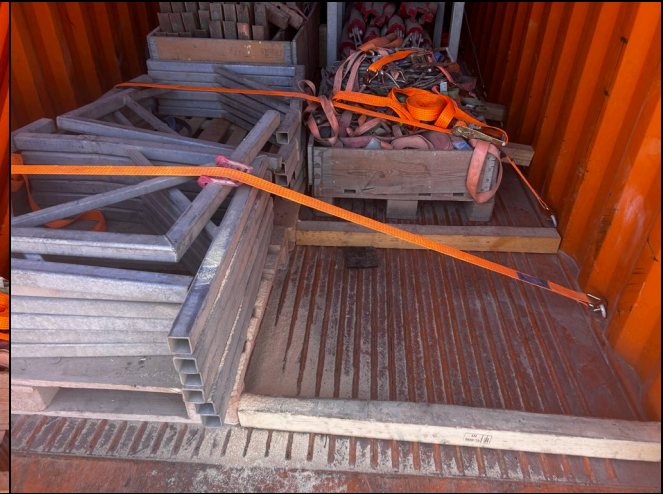
10. View of wooden located between cargo

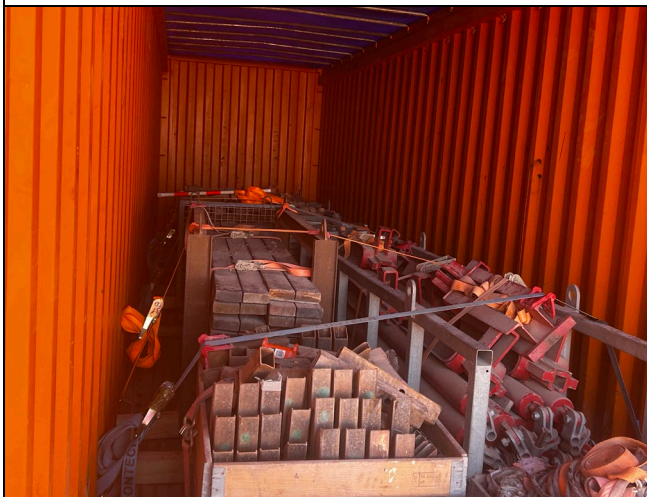
11. View of final lashing

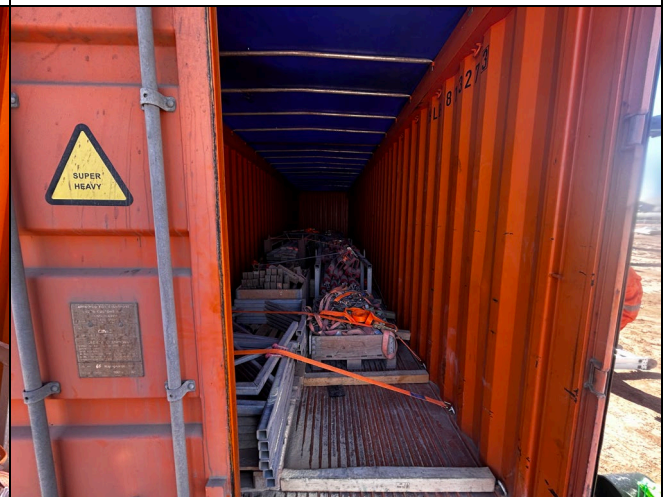
12. View of final conditions of cargo
