## FINAL REPORT

<b>SURVEY</b>	<b>MOORING ROPES INSPECTION</b>
<b>TO</b>	TERMINAL TOTOTALILLO.
<b>FROM</b>	ALS INSPECTION CHILE SPA.
<b>CLIENT REF</b>	N/A.
<b>ALS REF</b>	ANF-2605-1812.
<b>SCOPE OF SURVEY</b>	INSPECTION OF 16 MOORING LINES.
<b>VESSEL NAME</b>	MINERAL SEYCHELLES.
<b>OWNER</b>	XIAN T59 INTERNATIONAL SHIP LEASE CO., LIMITED.
<b>DISPONENT OWNER</b>	WIHELMSSEN SHIP MANAGEMENT SINGAPORE PTE.
<b>CHARTERERS</b>	CMBT.
<b>PLACE OF SURVEY</b>	CALDERA, BAY.
<b>DATE OF SURVEY</b>	MAY 14, 2026.
<b>TIME OF SURVEY</b>	11:40 HRS. TO 15:25 HRS.

### SUMMARY

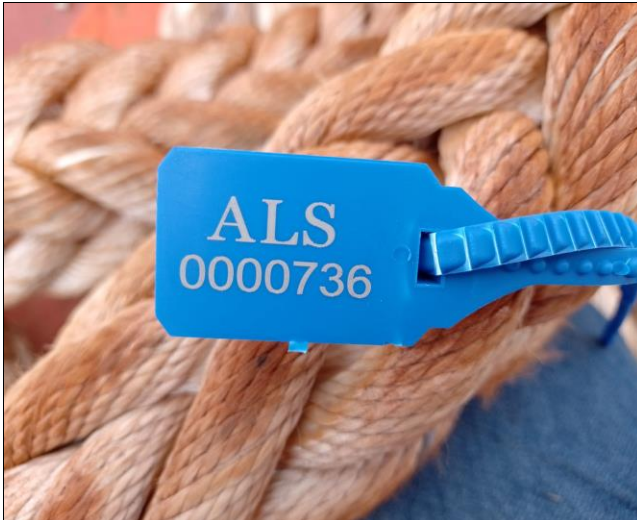
1. View of seal N° 0000736.

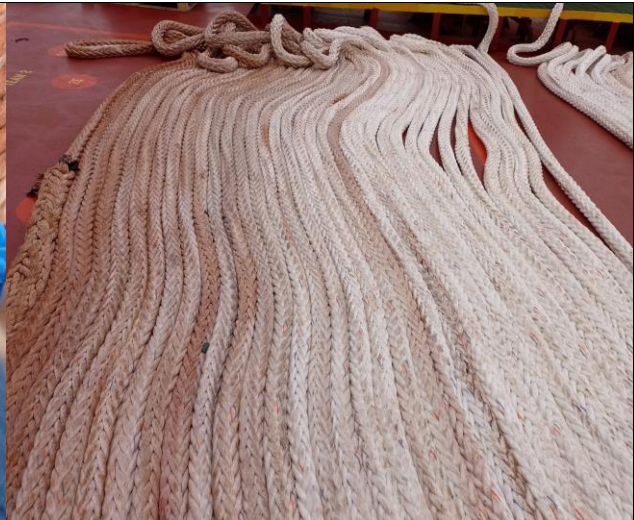
2. General view of the rope.

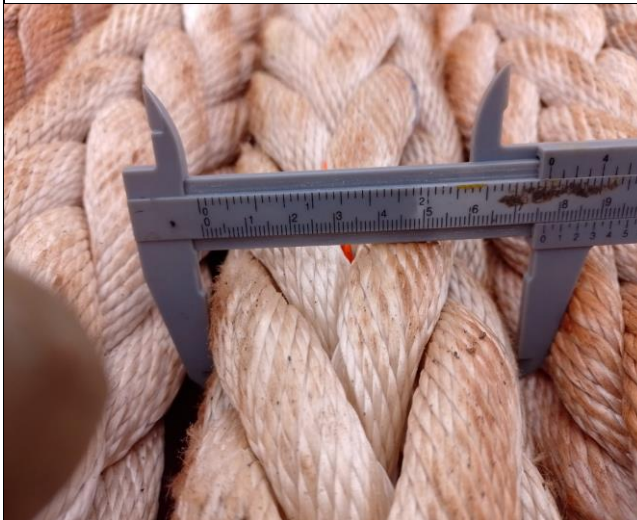
3. Diameter of the mooring rope.

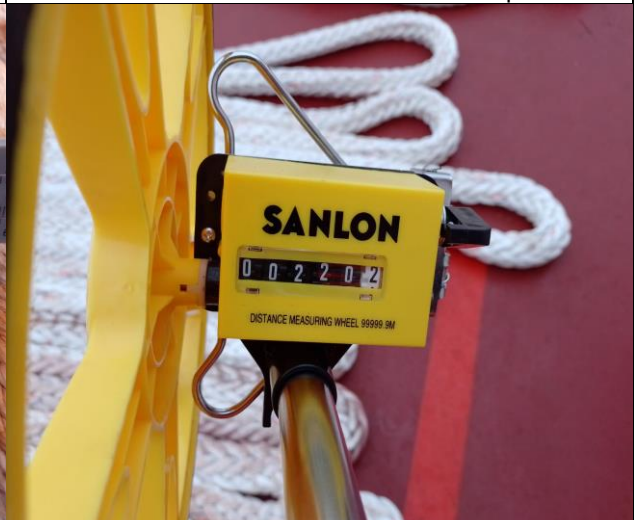
Length measured by surveyor: **220,2** meters.

4. Length measured by surveyor.

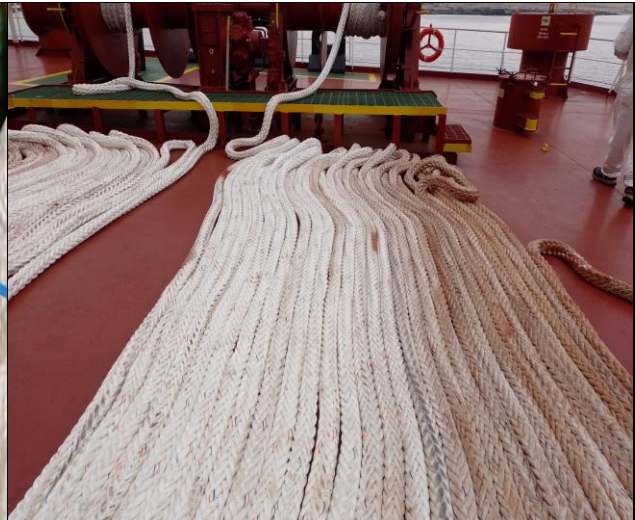
5. General view of the rope.

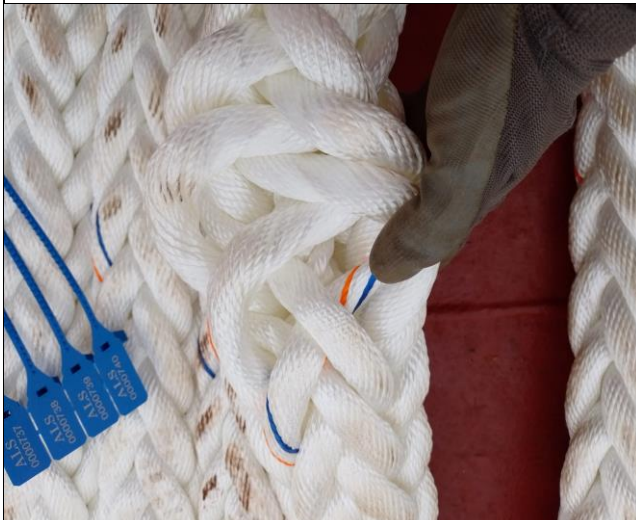
6. Internal view of ropes.

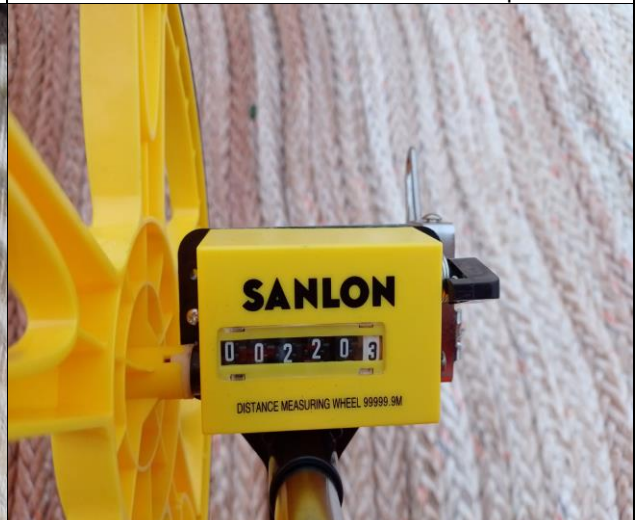
Length measured by surveyor: **220,3** meters.

7. Length measured by surveyor.

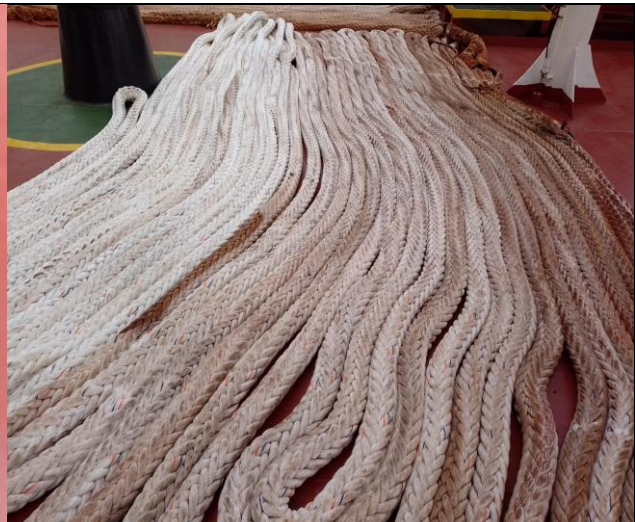
<b>DAMAGE ITEM</b>	<b>GOOD</b>	<b>FAIR</b>	<b>POOR</b>
Ext. Abrasion (max 25%)	<input type="checkbox"/>	<input checked="" type="checkbox"/>	Over 25% <input type="checkbox"/>
Int. Abrasion	<input checked="" type="checkbox"/>	<input type="checkbox"/>	<input type="checkbox"/>
Cut strands	<input checked="" type="checkbox"/>	<input type="checkbox"/>	<input type="checkbox"/>
Burn/ heated parts / fusion	<input checked="" type="checkbox"/>	<input type="checkbox"/>	<input type="checkbox"/>
Sun degradation /discoloration	<input checked="" type="checkbox"/>	<input type="checkbox"/>	<input type="checkbox"/>
Fiber broken	<input checked="" type="checkbox"/>	<input type="checkbox"/>	<input type="checkbox"/>
Black stains / dirty	<input type="checkbox"/>	<input checked="" type="checkbox"/>	<input type="checkbox"/>
Inconsistent diameter	<input checked="" type="checkbox"/>	<input type="checkbox"/>	<input type="checkbox"/>

9. General view of the rope.

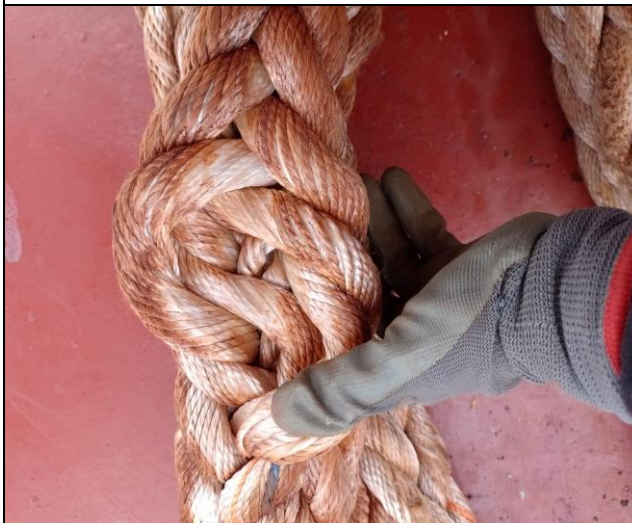
10. Internal view of ropes.

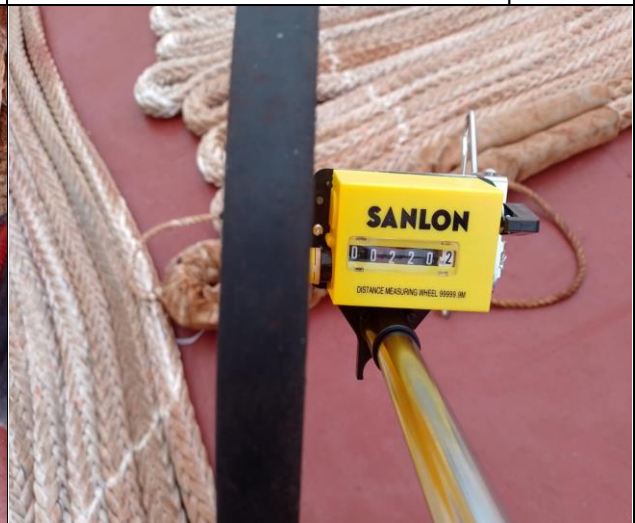
Length measured by surveyor: **220,2** meters.

11. Length measured by surveyor.
