NorthStandard Survey Report - Chemical Tanker

CLEAN RAIDER / 9425318 / OIL AND CHEMICAL TANKER /
STEALTH MARITIME CORPORATION S.A.

Country of build	BUSAN , SOUTH KOREA
GRT (t)	29563
Last 3 cargoes carried	UNLEADED GASOLINE, GASOIL, ULSD
Date of Survey	FEBRUARY 3,2026
Survey Location	GMQC+Q2 Arica, Chile (-18.4605625, -70.3299375)
Survey Company	ALS INSPECTION CHILE SPA
Surveyor Name	EDUARDO PARRA G.
Survey Number (As per survey instruction)	UKS-26-01-0081
Surveyor email and contact mobile number (including full international dialing code)	eduardo.parra@alsgobal.com / +56 9 79059813

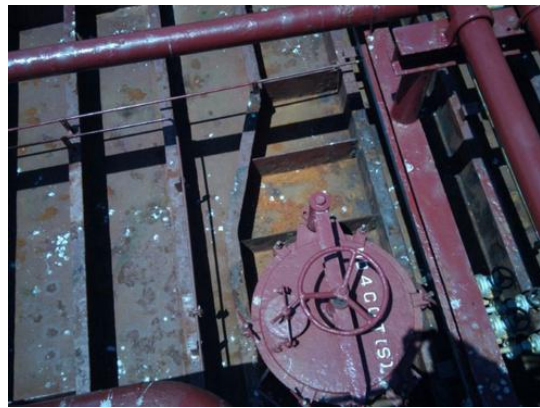
Photo 3

Deck plating in the way of cargo tanks nr.3 and 4 was noted with rust.

All elements on deck were found with coating in good condition, duly identified. Structurally, no abnormalities were observed. Deck plating in the way of cargo tank nr.3 and 4 was observed with rust; however, during the inspection, the other deck plating areas were noted in the maintenance process.
