## MOORING WINCHES REPORT

<b>SURVEY</b>	<b>VISUAL CONDITIONS OF MOORING WINCHES</b>
<b>TO</b>	MR. JULIO OLIVERO.
<b>FROM</b>	ALS INSPECTION CHILE SPA.
<b>CLIENT REF</b>	N/A.
<b>ALS REF</b>	ANF-2601-0118.
<b>SCOPE OF SURVEY</b>	VISUAL INSPECTION OF 8 MOORING WINCHES.
<b>VESSEL NAME</b>	FRONTIER NEIGE.
<b>PLACE OF SURVEY</b>	CALDERA BAY.
<b>DATE OF SURVEY</b>	JANUARY 10, 2026.
<b>TIME OF SURVEY</b>	15:34 HRS, TO 19:38 HRS.

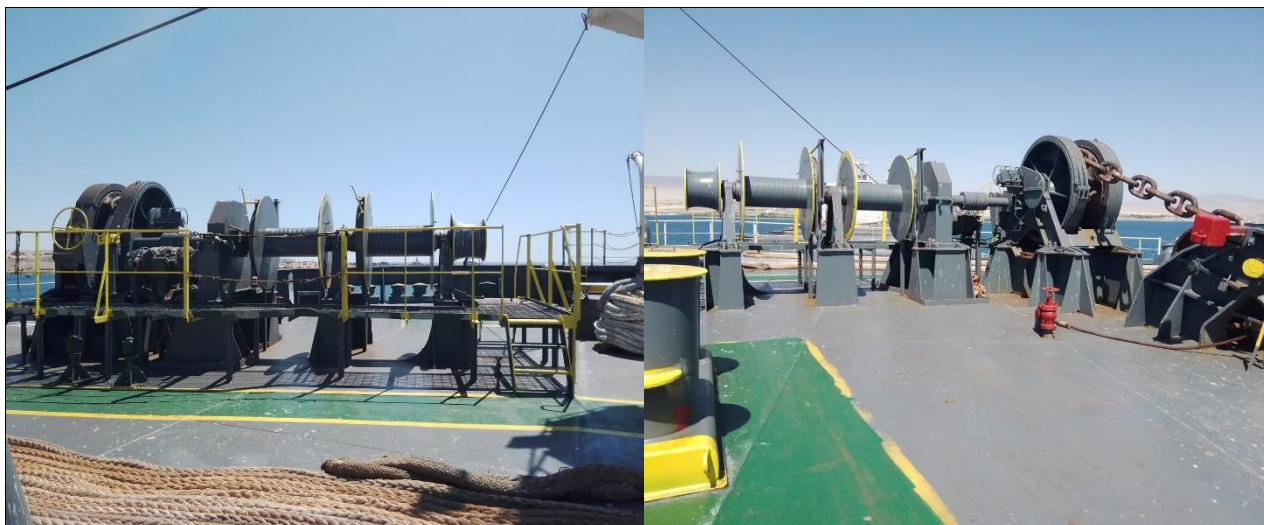
### 1.1.- Ss, Fwd, WINCH

1. View of Ss, Fwd, winch.

2. View of Ss, Fwd, winch.

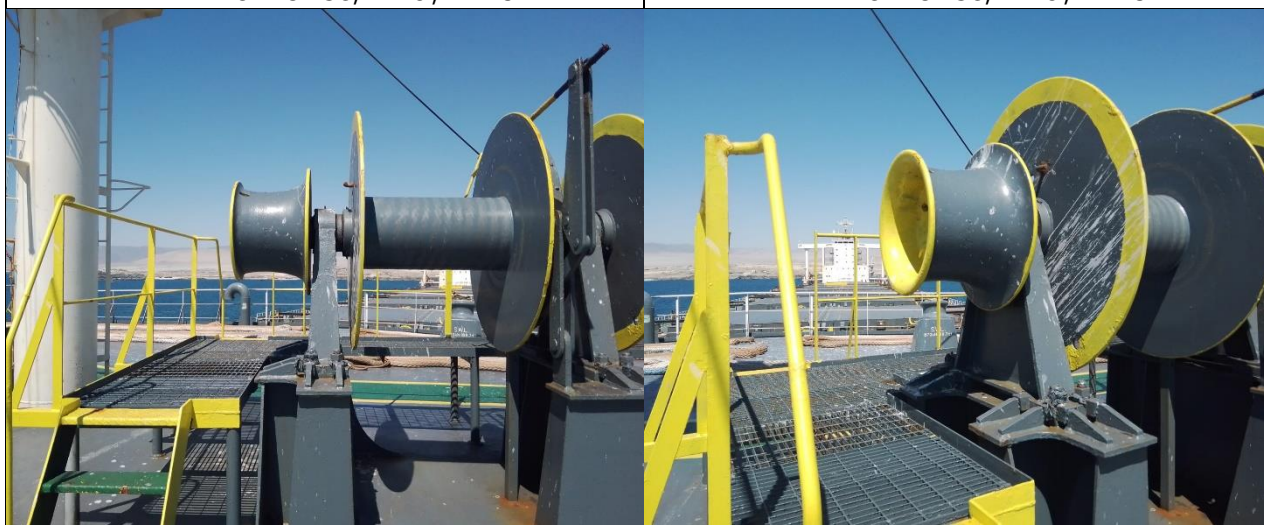
3. Another view as previous one.

4. View of warping drum.

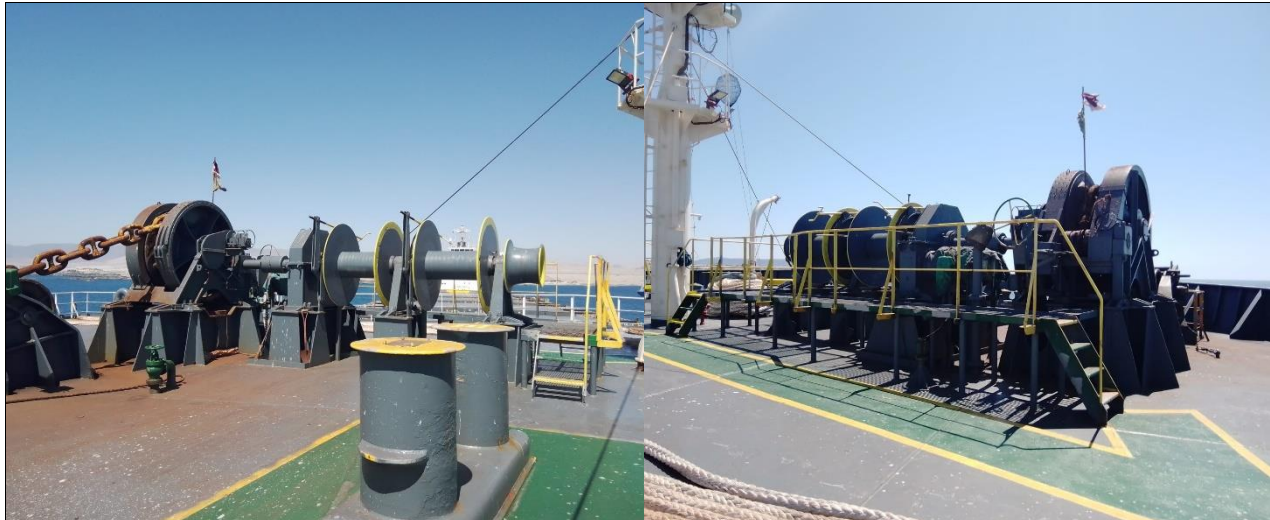
## 1.2.- Ps, Fwd, WINCH

1. View of Mid, Fwd, winch.

2. View of Mid, Fwd, winch.

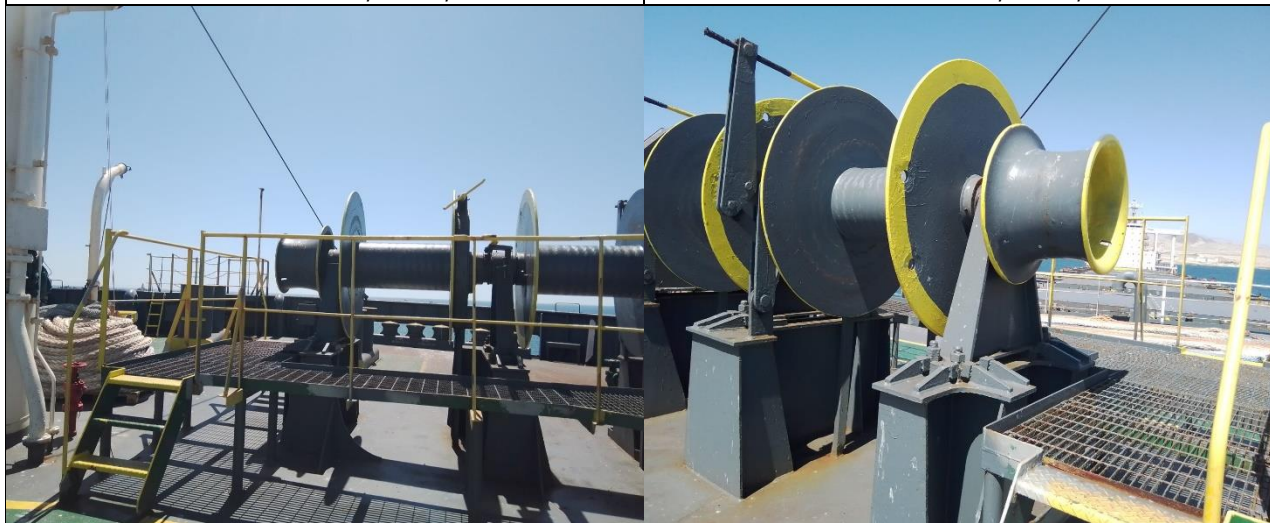
3. View of Mid, Fwd, winch

4. View of winch for brest line.

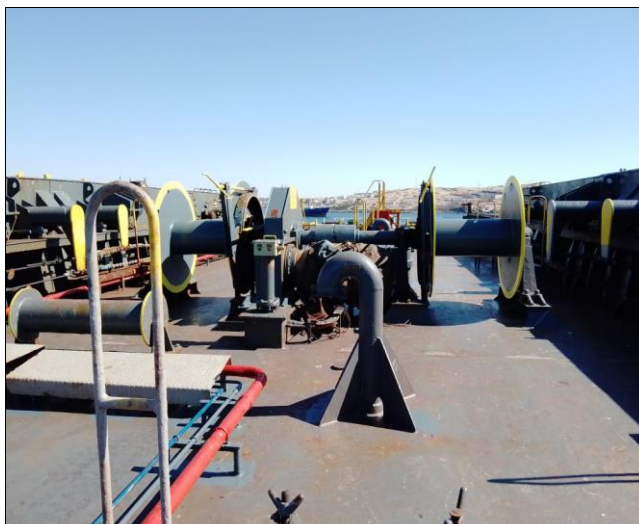
### 1.3.- WINCH BETWEEN H8 & H9

1. View of winch Between H8 & H9.

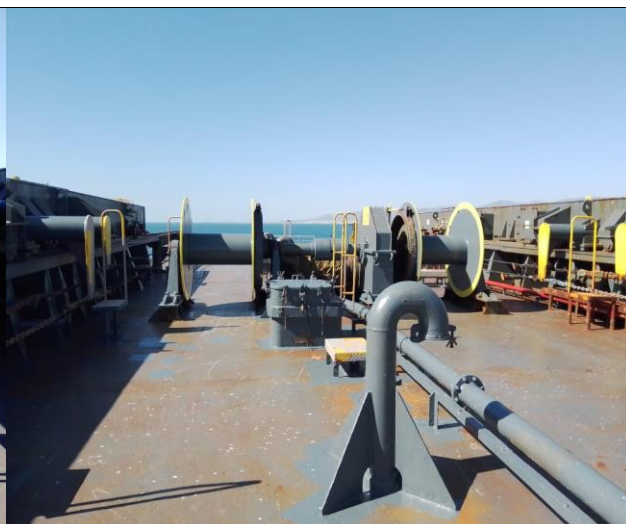
2. View of winch Between H8 & H9.

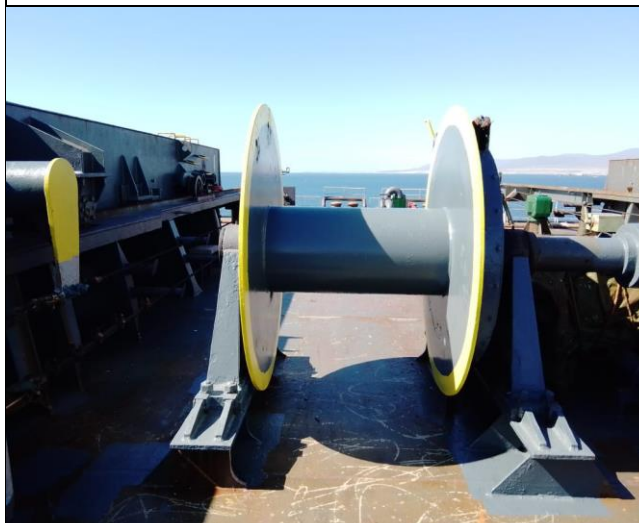
3. Another view as previous one.

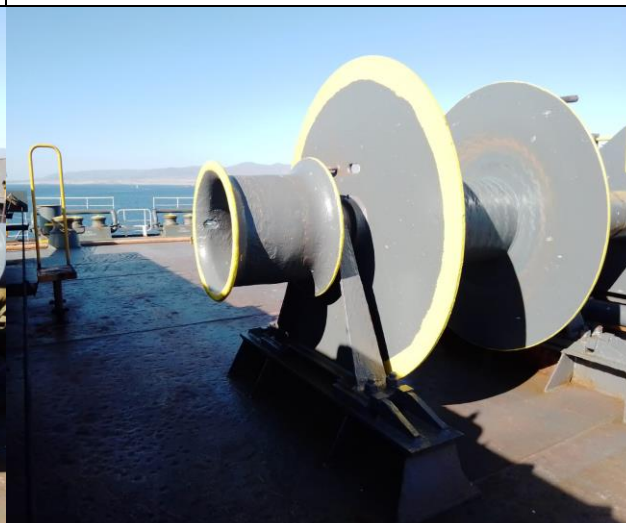
4. View of warping drum.

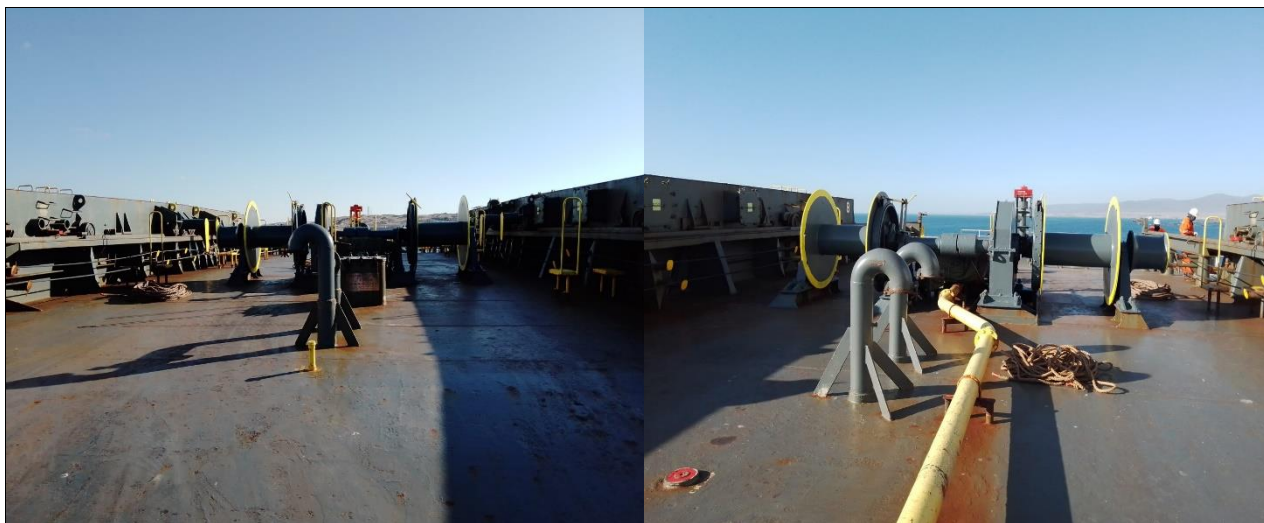
### 1.4.- WINCH BETWEEN H2 & H3

1. View of winch Between H2 & H3.

2. View of winch Between H2 & H3.

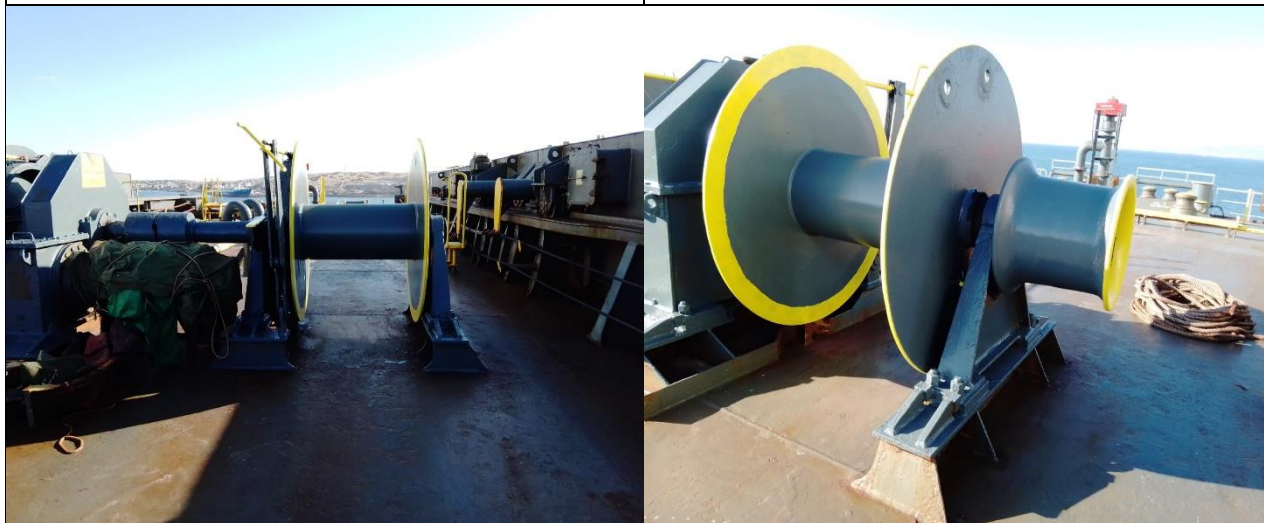
3. Another view as previous one.

4. View of warping drum.

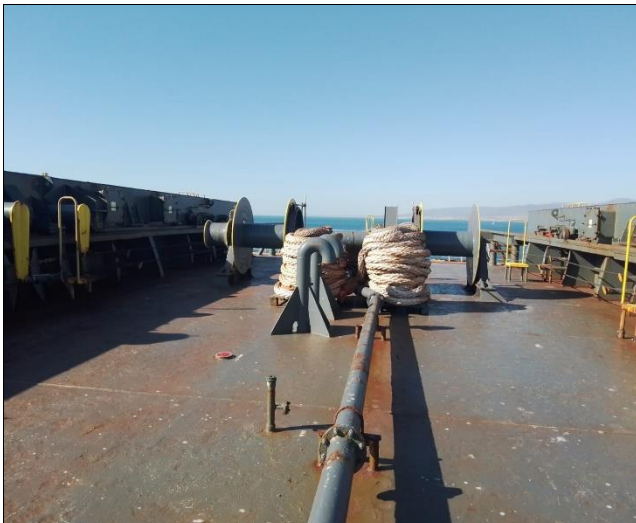
### 1.5.- WINCH BETWEEN H1 & H2

1. View of winch Between H1 & H2.

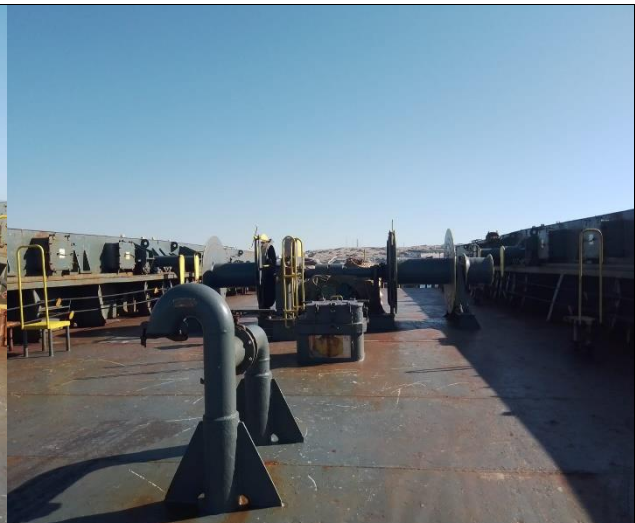
2. View of winch Between H1 & H2.

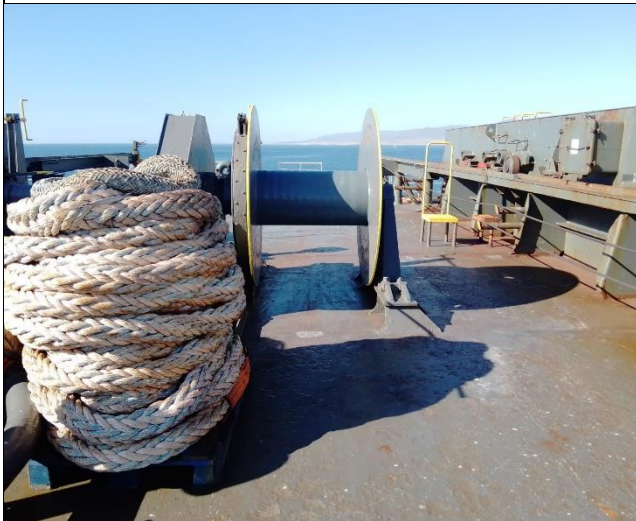
3. Another view as previous one.

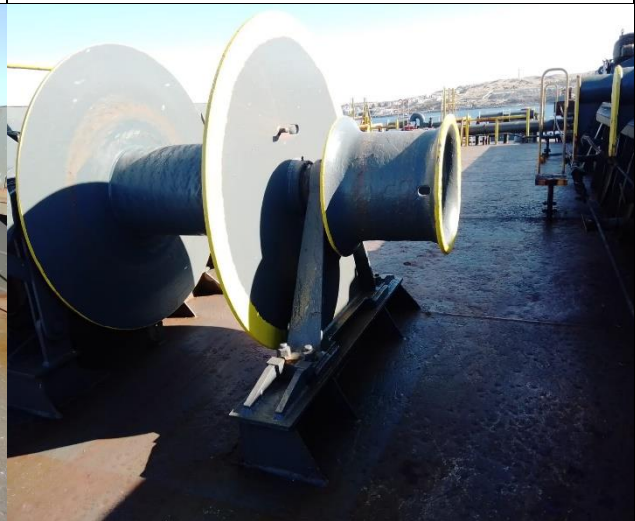
4. View of winches.

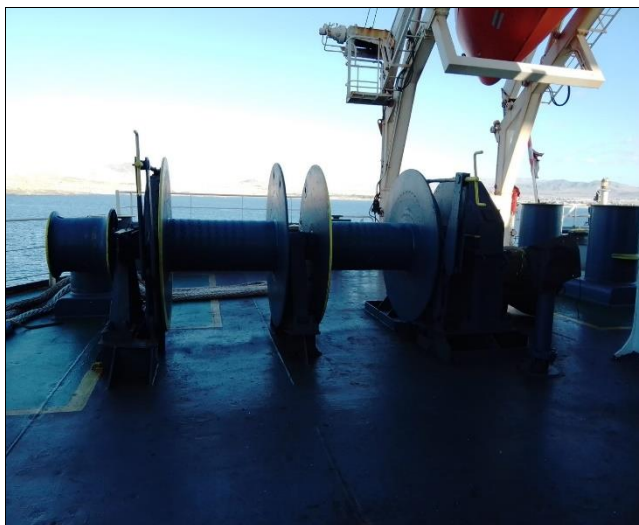
### 1.6.- Ss, Aft, WINCH

1. View of Ss, Aft, winch.

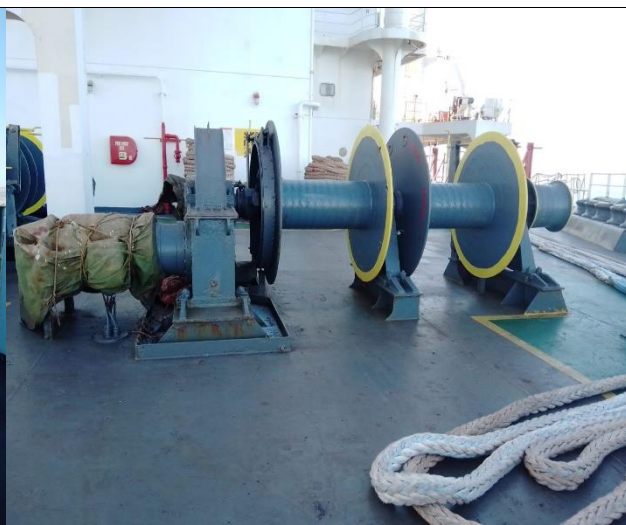
2. View of Ss, Aft, winch.

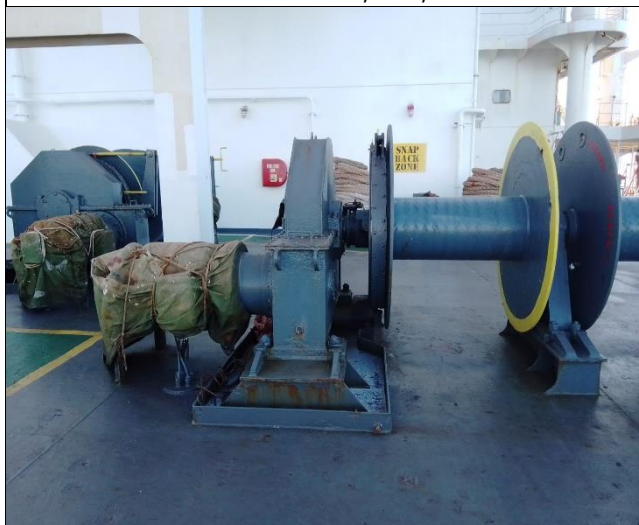
3. Another view as previous one.

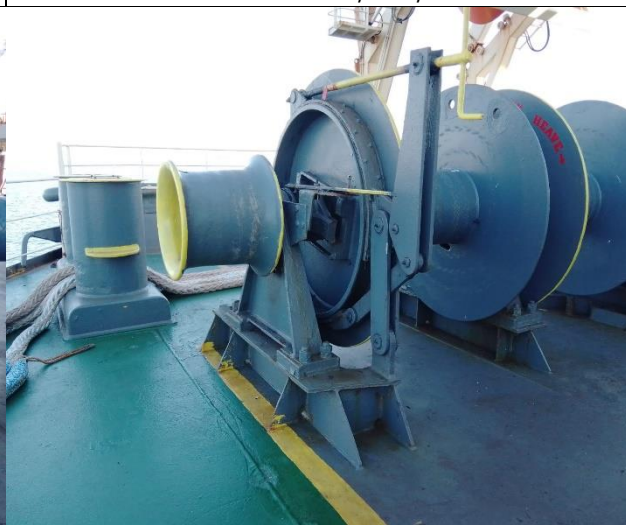
4. View of warping drum.

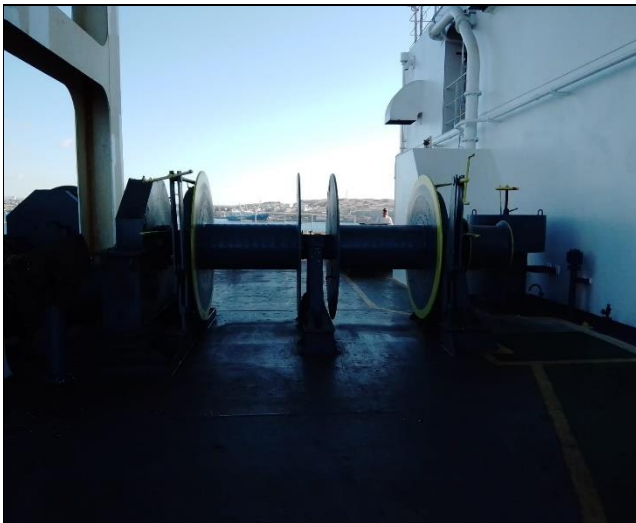
### 1.7.- Mid, AFT, WINCH

1. View of Mid, Aft, winch.

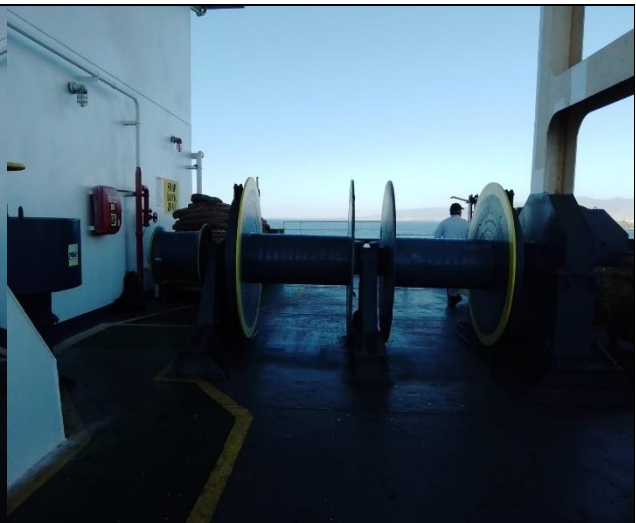
2. View of Mid, Aft, winch.

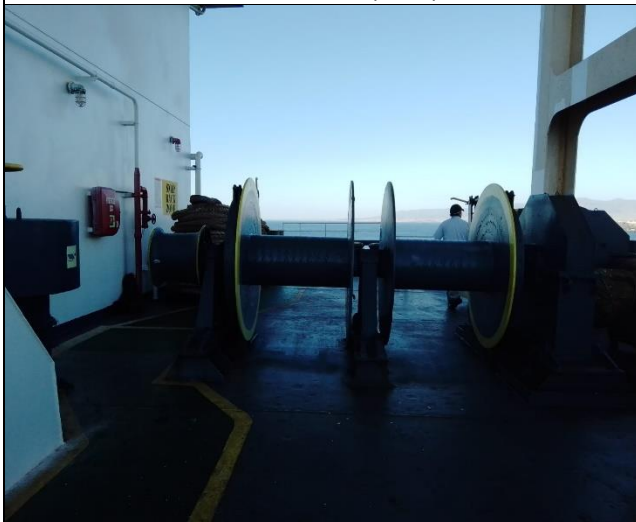
3. Another view as previous one.

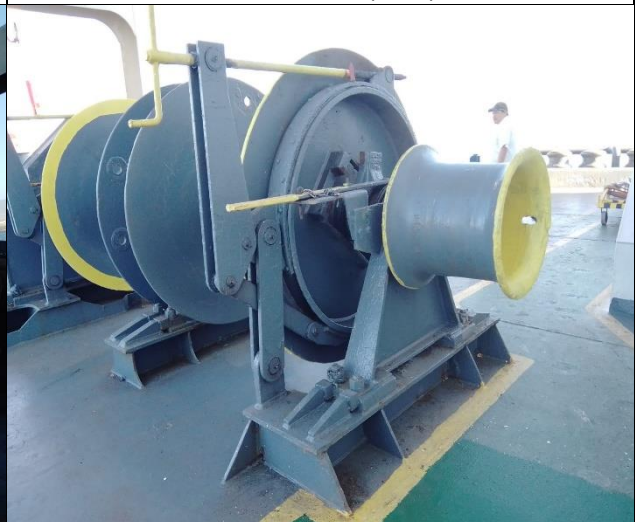
4. View of warping drum.

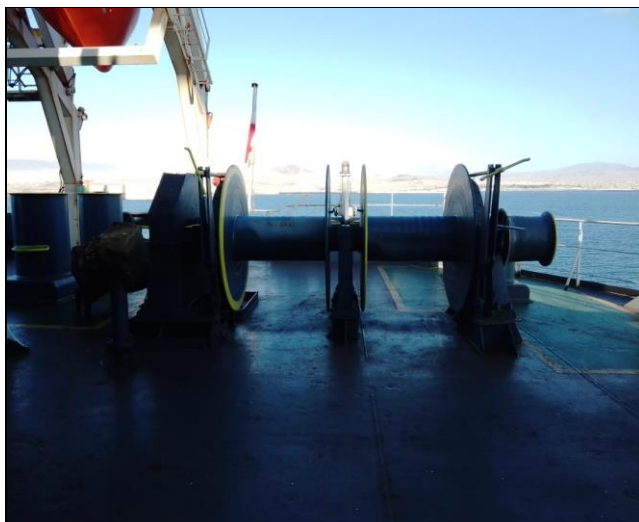
### 1.8.- Ps, Aft, WINCH

1. View of Ps, Aft, winch.

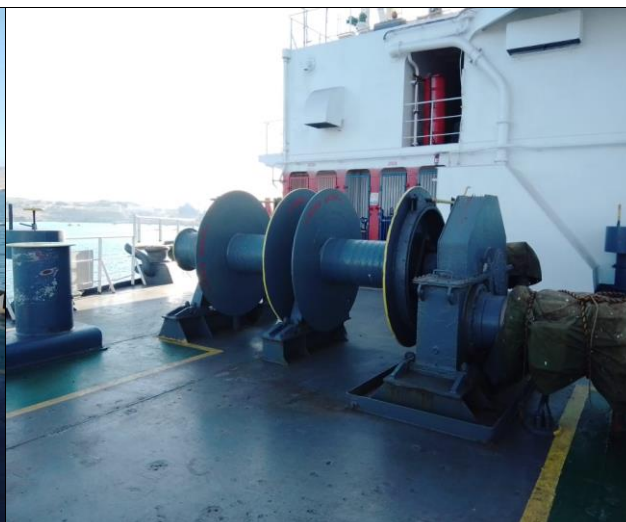
2. View of Ps, Aft, winch.

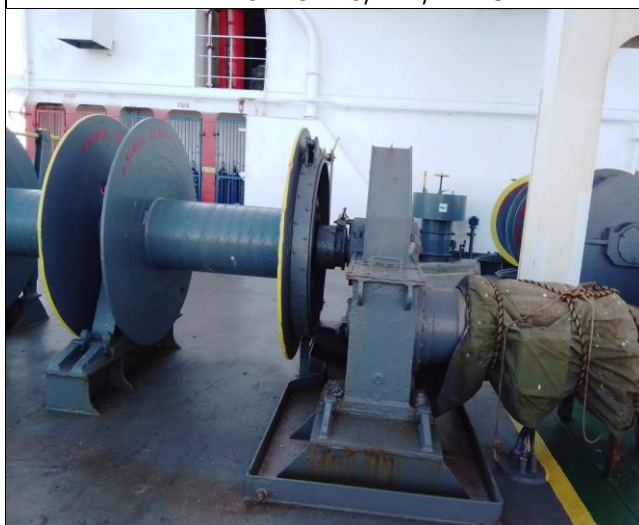
3. Another view as previous one

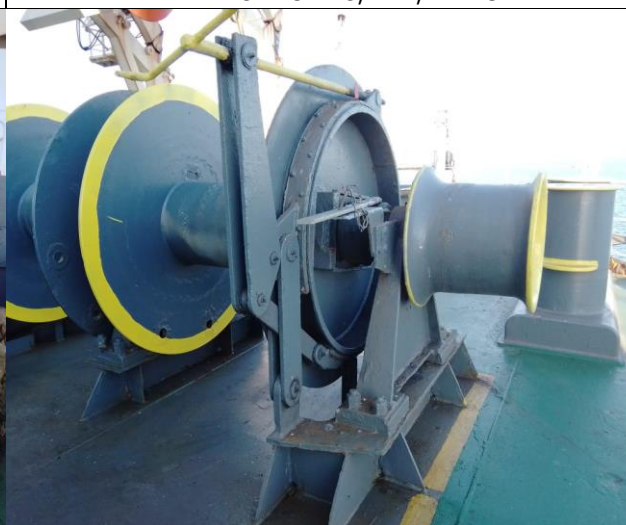
4. View of warping drum.
