# PRELIMINARY REPORT

<b>TO</b>	TERMINAL GUACOLDA II.
<b>FROM</b>	ALS INSPECTION CHILE SPA.
<b>PRELIMINARY ISSUE DATE</b>	JANUARY 25, 2026.
<b>CLIENT REF</b>	N/A.
<b>ALS REF</b>	ANF-2601-0304.
<b>SCOPE OF SURVEY</b>	INSPECTION OF 10 MOORING LINES.
<b>VESSEL NAME</b>	NORD AURUM.
<b>PLACE OF SURVEY</b>	HUASCO BAY
<b>DATE OF SURVEY</b>	JANUARY 25, 2026.
<b>TIME OF SURVEY</b>	01:40 HRS. TO 04:00 HRS.
Please find our preliminary report; this should be taken as an initial approach of the appointed inspection. Additional information, findings, photographs, and conclusions will be part of our final report.

## 1. SCOPE OF SURVEY

To perform a visual inspection to the condition of 10 mooring lines, measure its length and diameter, on board of **MV NORD AURUM**. at the HUASCO BAY

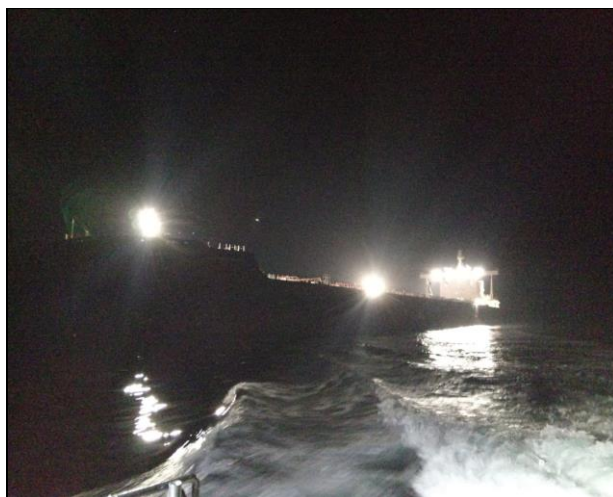
1 General view of vessel

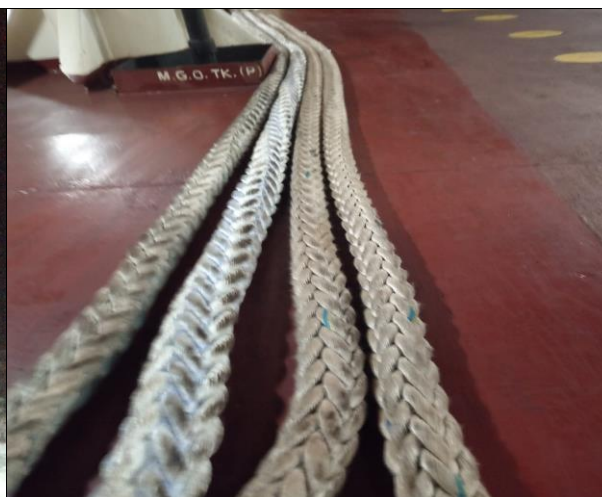
2. View of mooring lines arranged for its inspection.

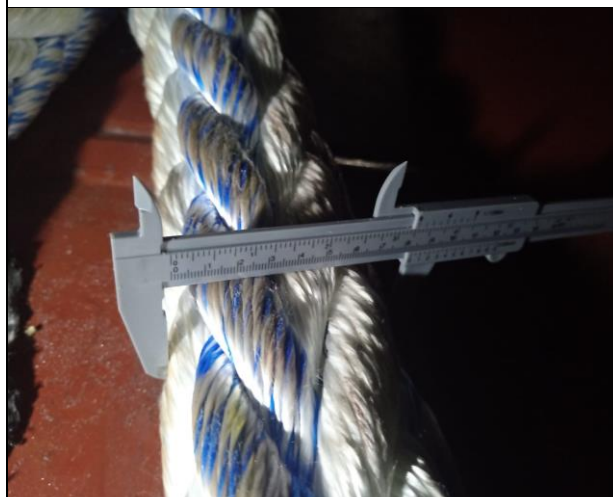
3. View of diameter measurement of the mooring lines.

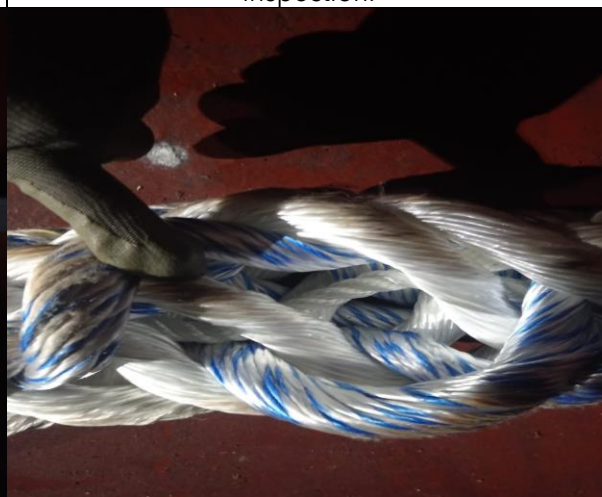
4. Internal condition.

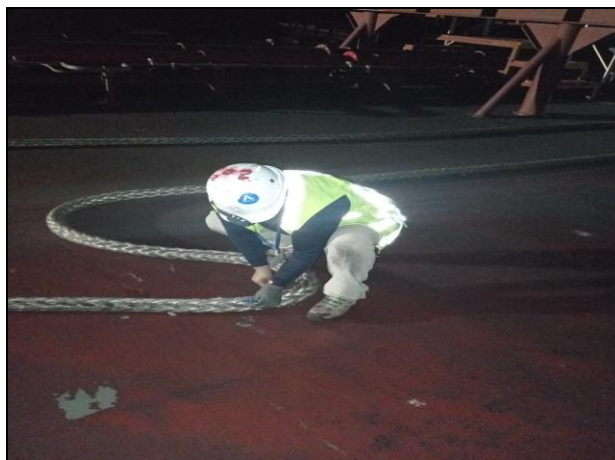
5. View of ALS inspector putting the seal.

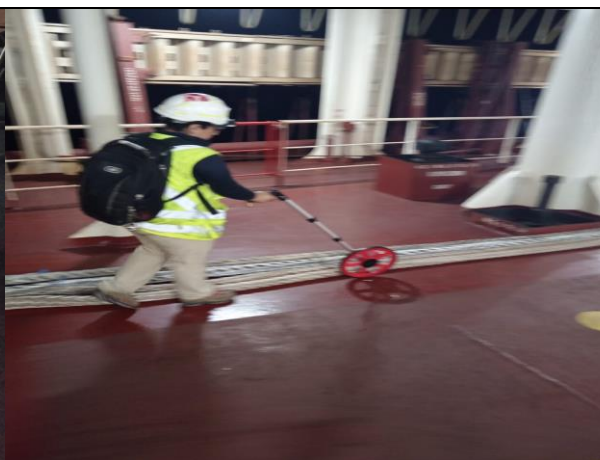
6. View of length measurement of the mooring lines.

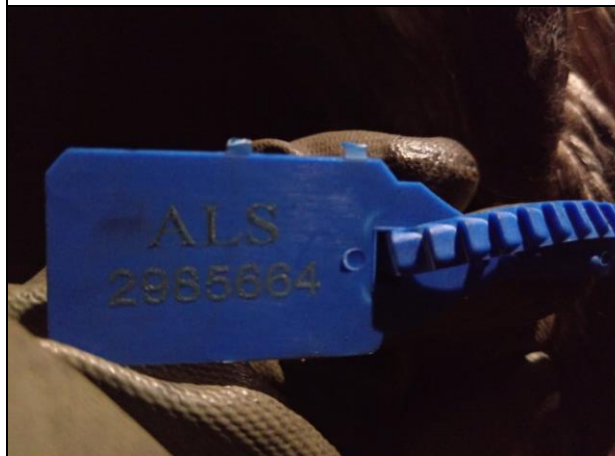
7. View of mooring line approved with ALS SEAL Nr. 2985664.

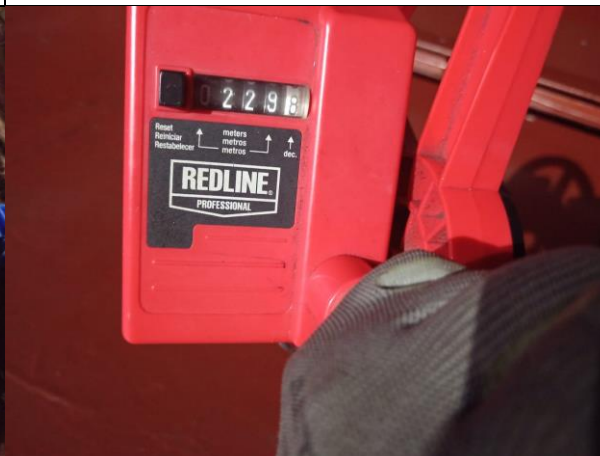
7. View of length measurement of mooring lines.
