# PRELIMINARY REPORT

<b>TO</b>	TERMINAL GUACOLDA II.
<b>FROM</b>	ALS INSPECTION CHILE SPA.
<b>PRELIMINARY ISSUE DATE</b>	JANUARY 15, 2026.
<b>CLIENT REF</b>	N/A.
<b>ALS REF</b>	ANF-2601-0133.
<b>SCOPE OF SURVEY</b>	INSPECTION OF 11 MOORING LINES.
<b>VESSEL NAME</b>	STAR ELENI.
<b>PLACE OF SURVEY</b>	HUASCO BAY
<b>DATE OF SURVEY</b>	JANUARY 15, 2026.
<b>TIME OF SURVEY</b>	15:30 HRS. TO 18:57HRS.
Please find our preliminary report; this should be taken as an initial approach of the appointed inspection. Additional information, findings, photographs, and conclusions will be part of our final report.

To perform a visual inspection to the condition of 11 mooring lines, measure its length and diameter, on board of **MV STAR ELENI**. at the HUASCO BAY

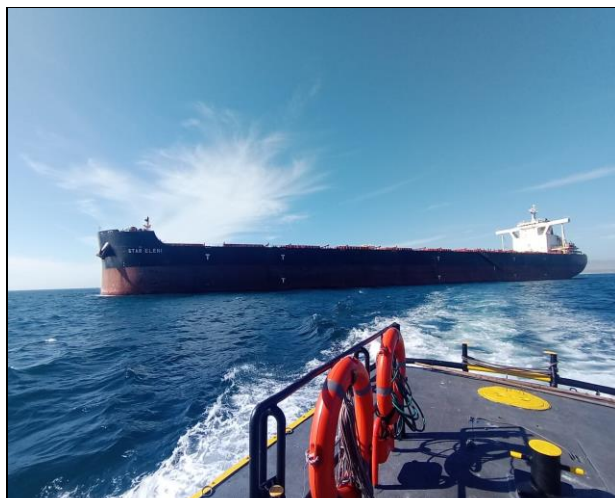
1 General view of vessel

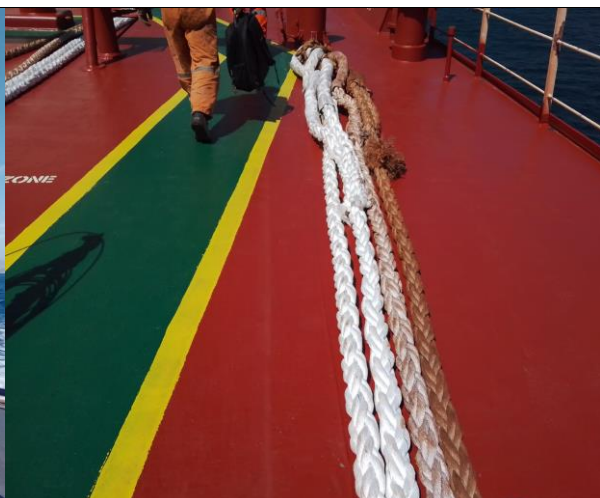
2. View of mooring lines arranged for its inspection.

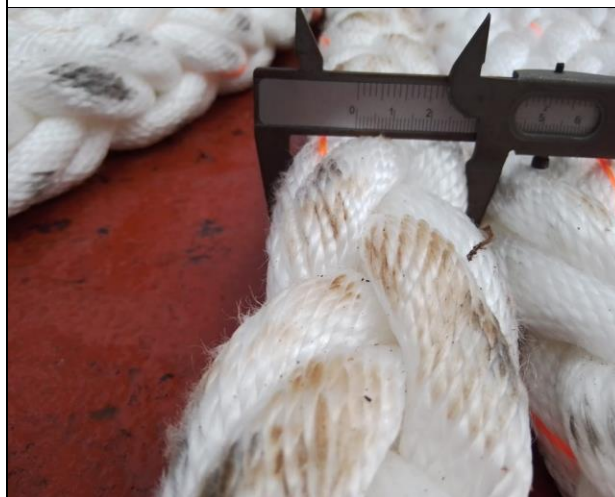
3. View of diameter measurement of the mooring lines.

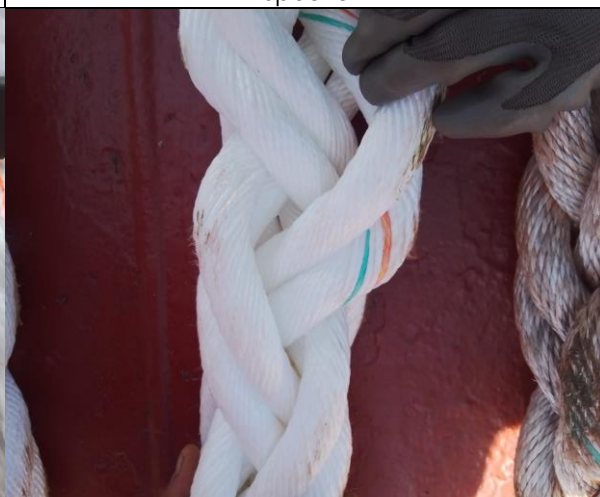
4. Internal condition.

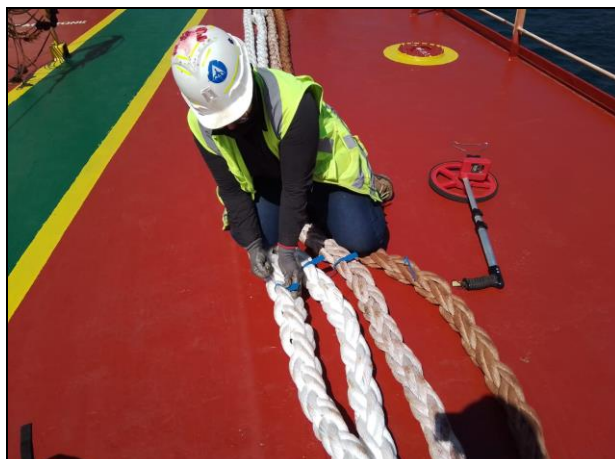
5. View of ALS inspector putting the seal.

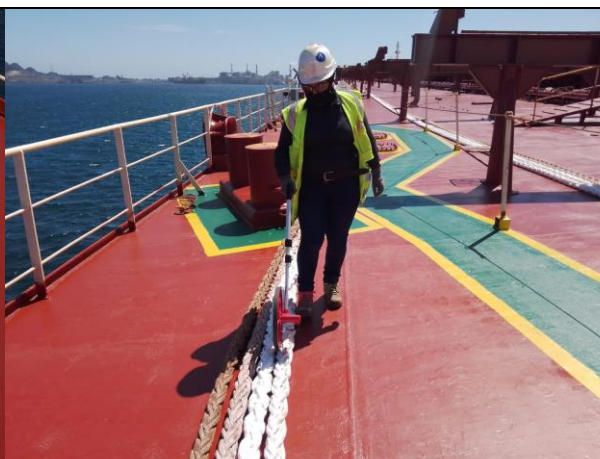
6. View of length measurement of the mooring lines.

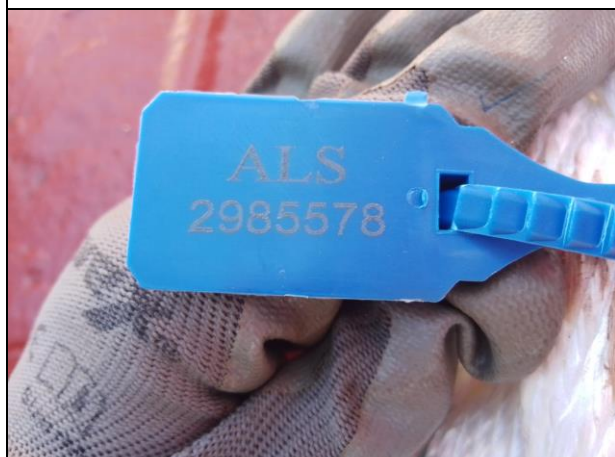
7. View of mooring line approved with ALS SEAL Nr. 2985578.

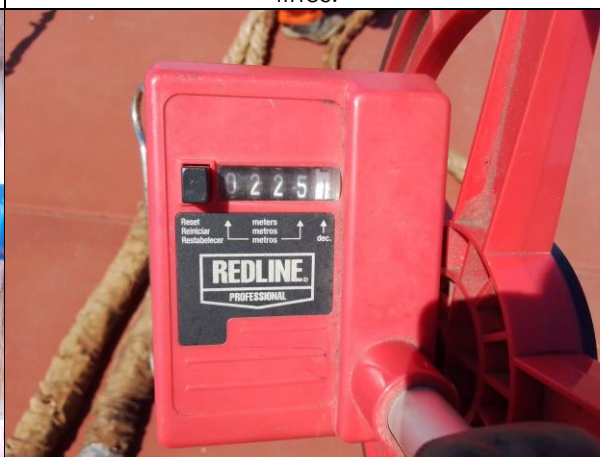
7. View of length measurement of mooring lines.
