MV "ULTRA FOREST"

FULL ON HIRE & BUNKER SURVEY

This is to certify that the undersigned representative of ALS Inspection Chile did, at the request of **Messrs. DAMPSKIBSSELSKABET NORDEN A/S**, attend on board motor vessel "**ULTRA FOREST**" with Master consent on May 31, 2026, while she was at berthed at **pier Nr. 8, Panul Port**, San Antonio, Chile, in order to carry out an On Hire, general condition survey and bunker survey, as follows:

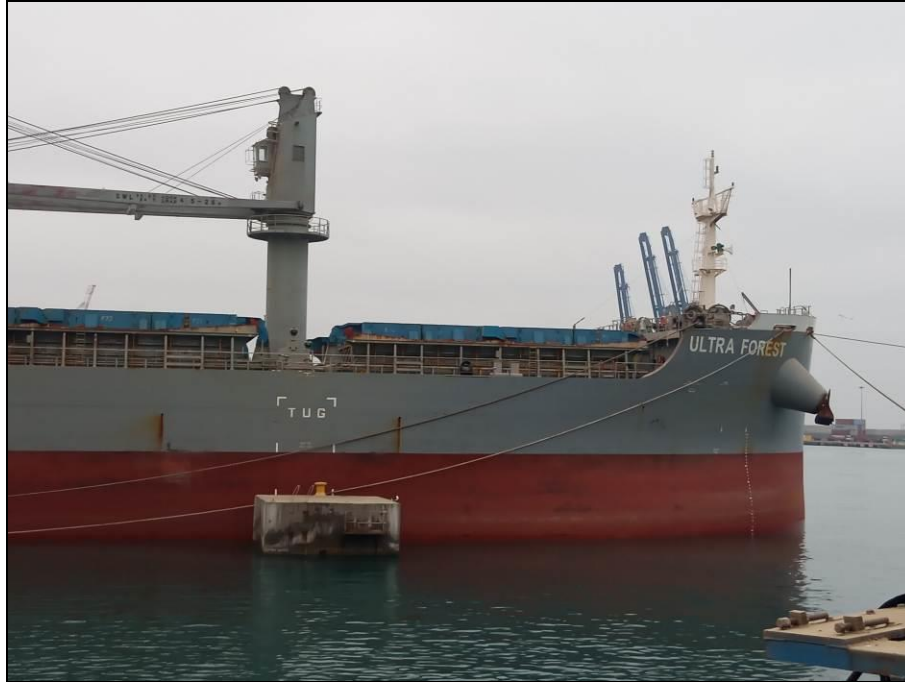
1. General view of Hull Forward Ss.

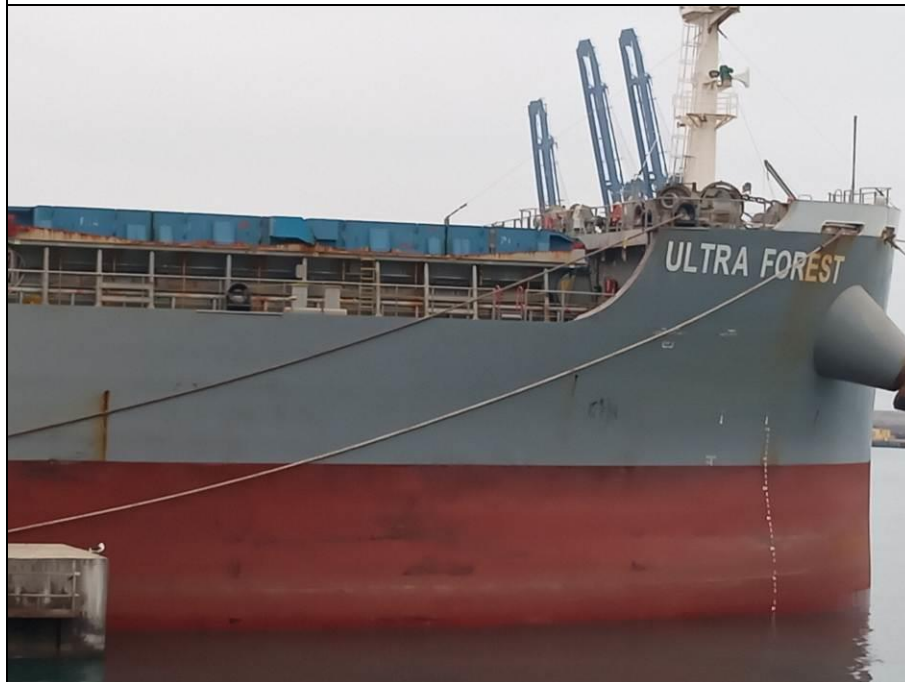
Hull Ps/Ss with paint scratched, stained and rusty (See photo Nr. 1, 2, 3, 4, 5, 7, 8, 9, 10, 11 and 12)

2. Paint scratched and stained were observed at fwd.

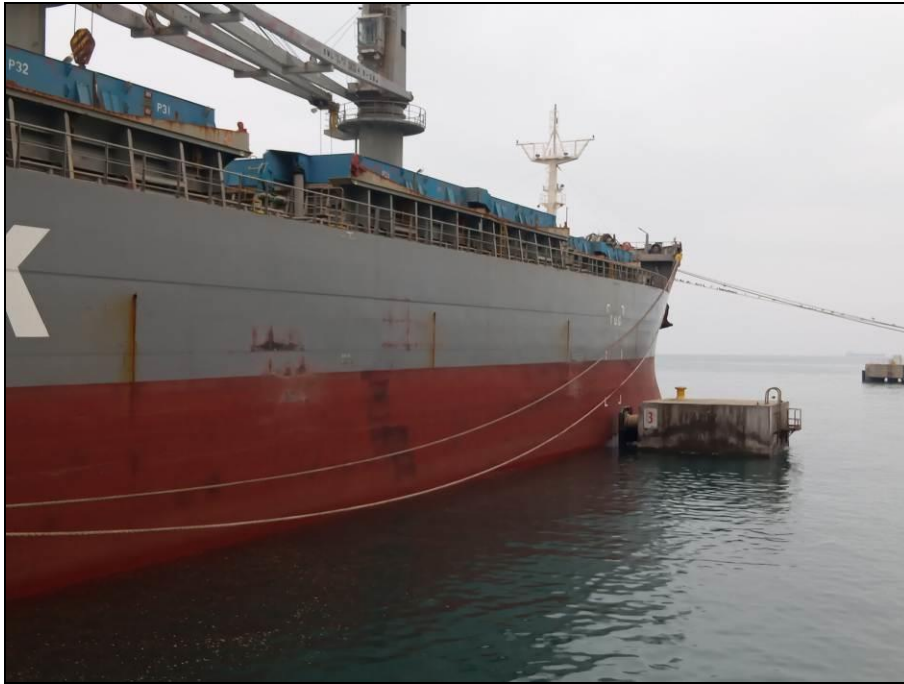
3. Another view.

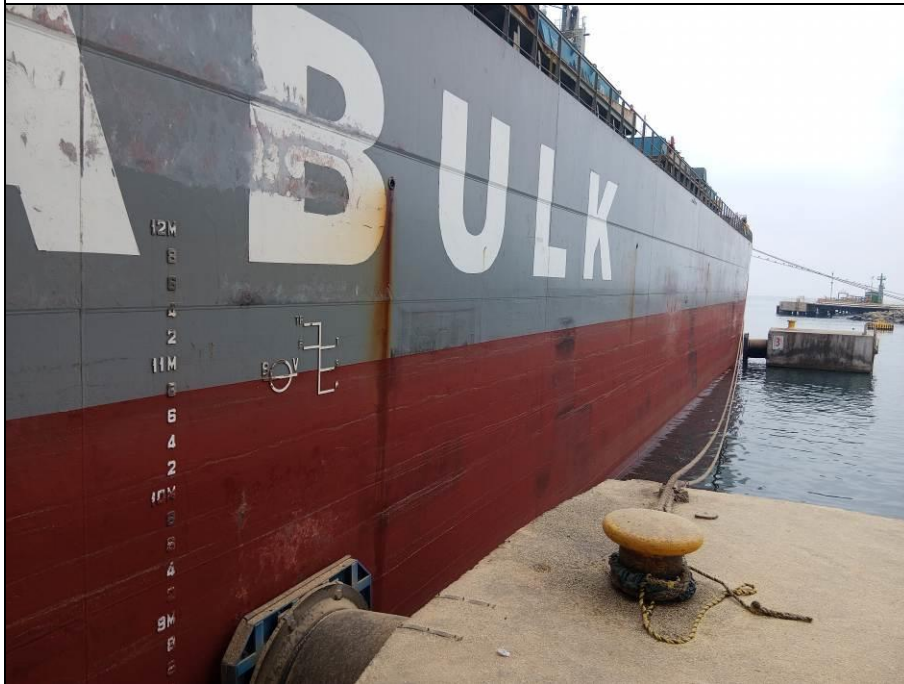
4. Midship to fwd view.

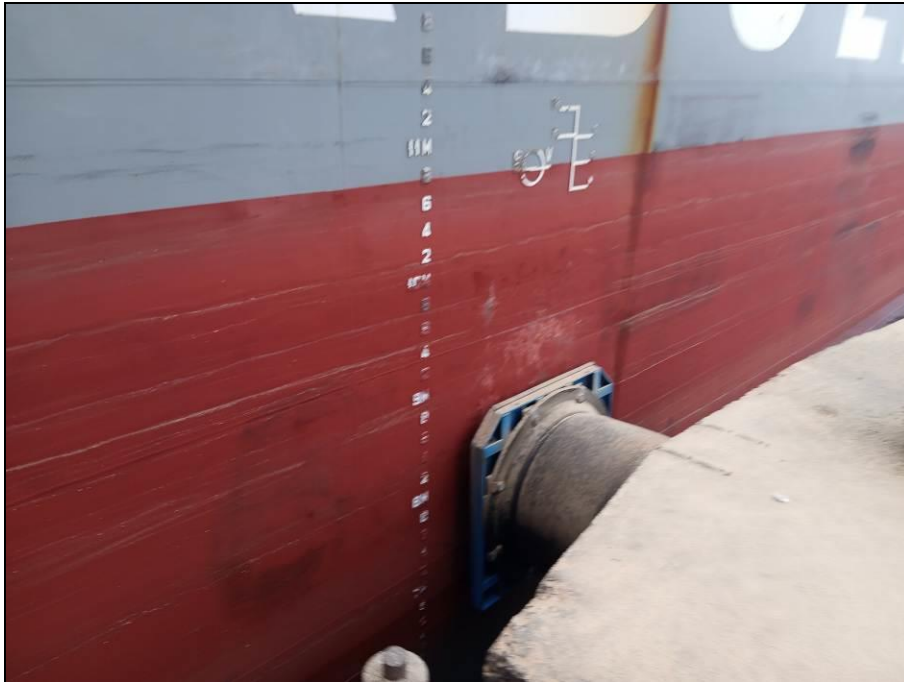
5. Hull, Mid. section; paint scratched and rusty.

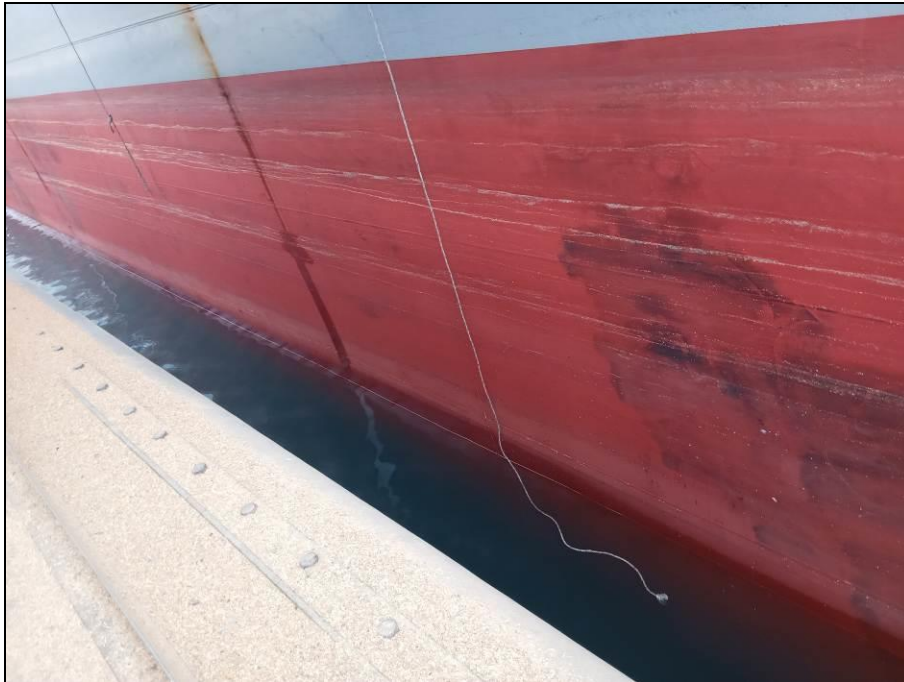
7. Hull with paint scratched.

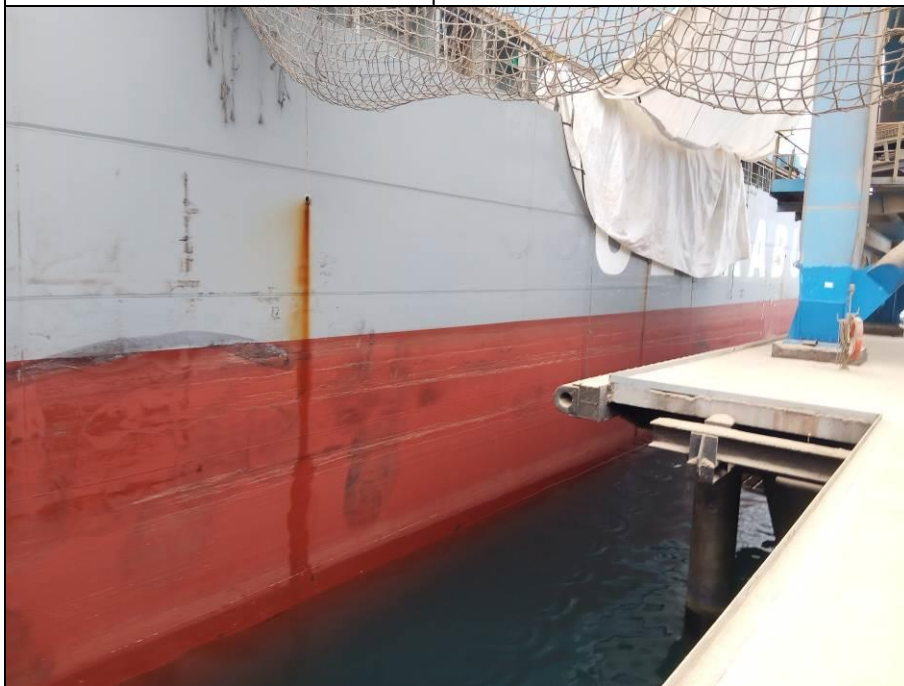
8. Hull with paint scratched and rusty.

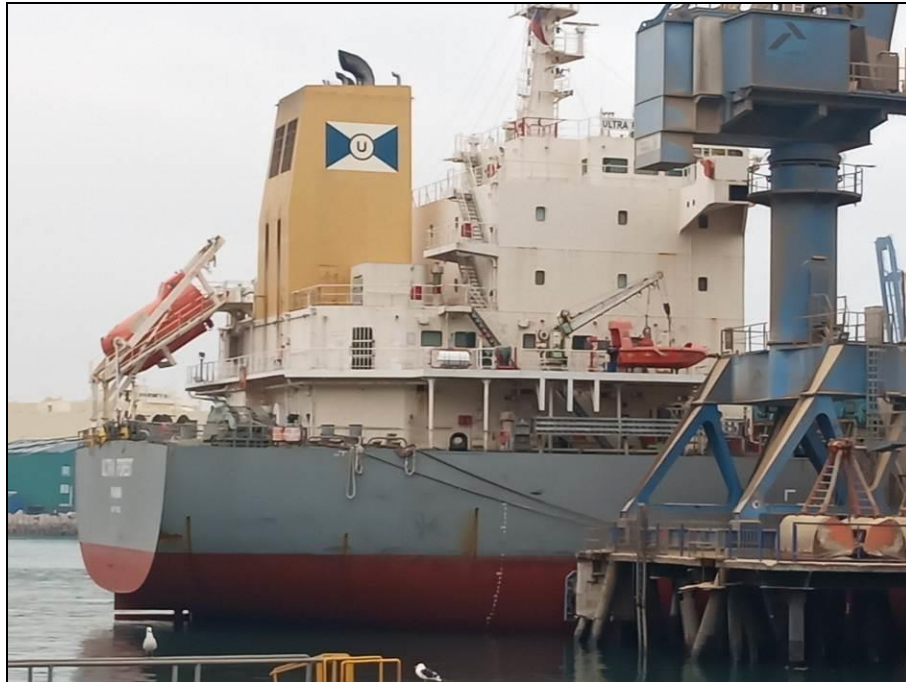
9. Hull aft section, general view.

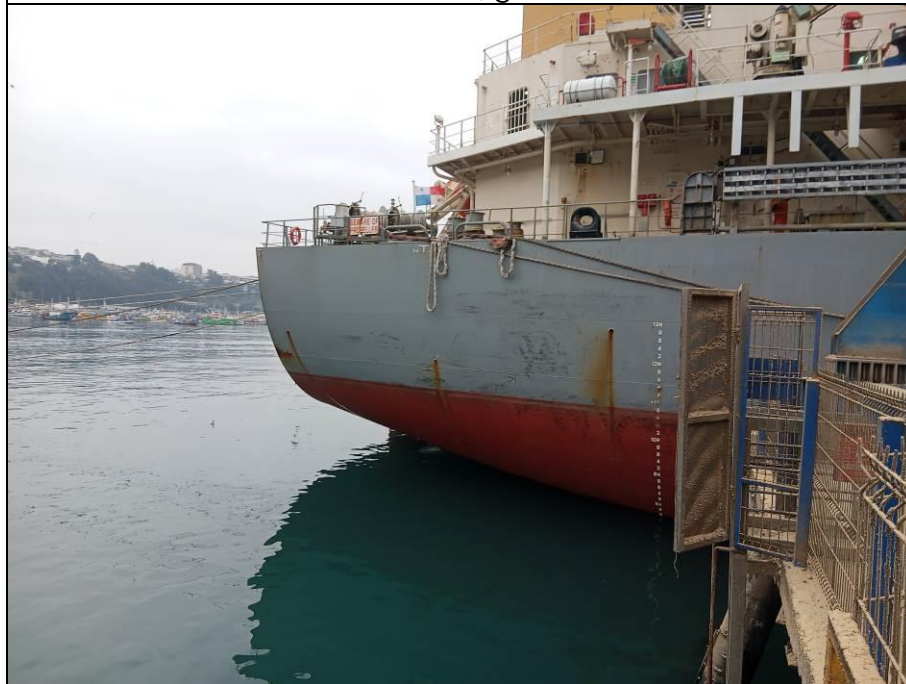
10. Hull with paint scratched & stained.

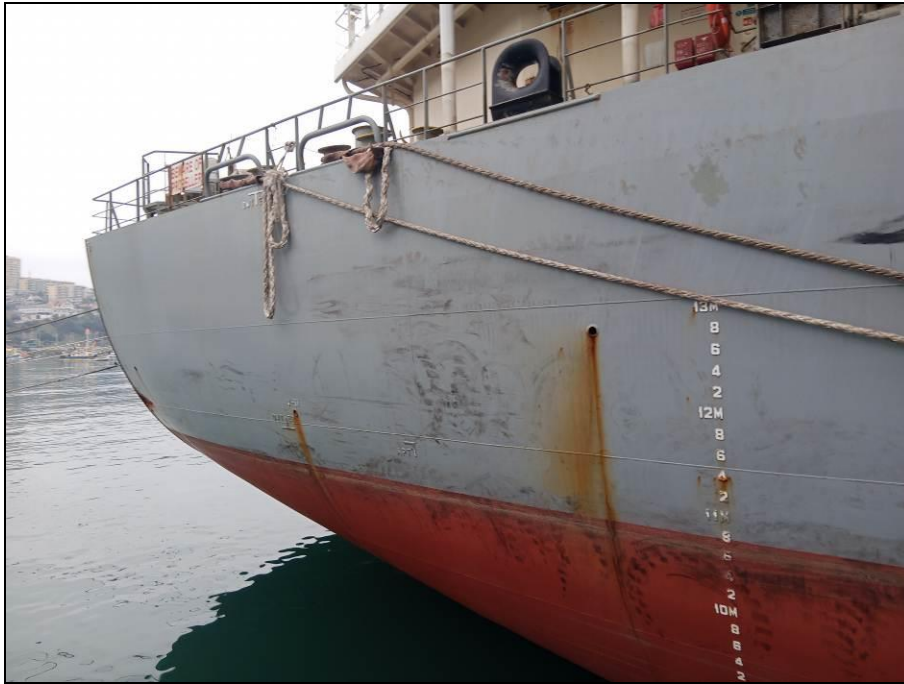
11. Another view.

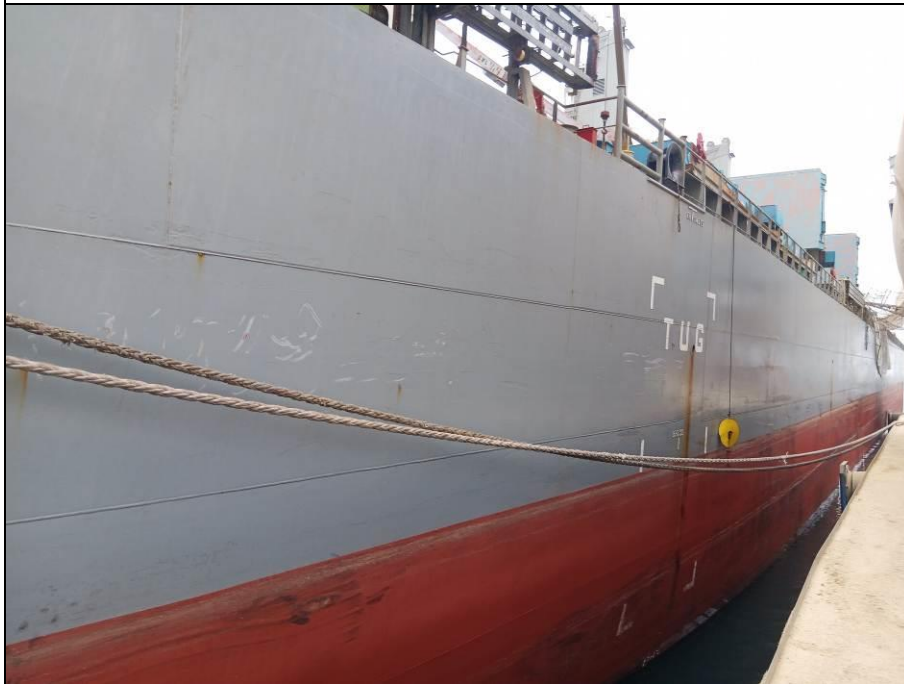
12. Aft to fwd view.

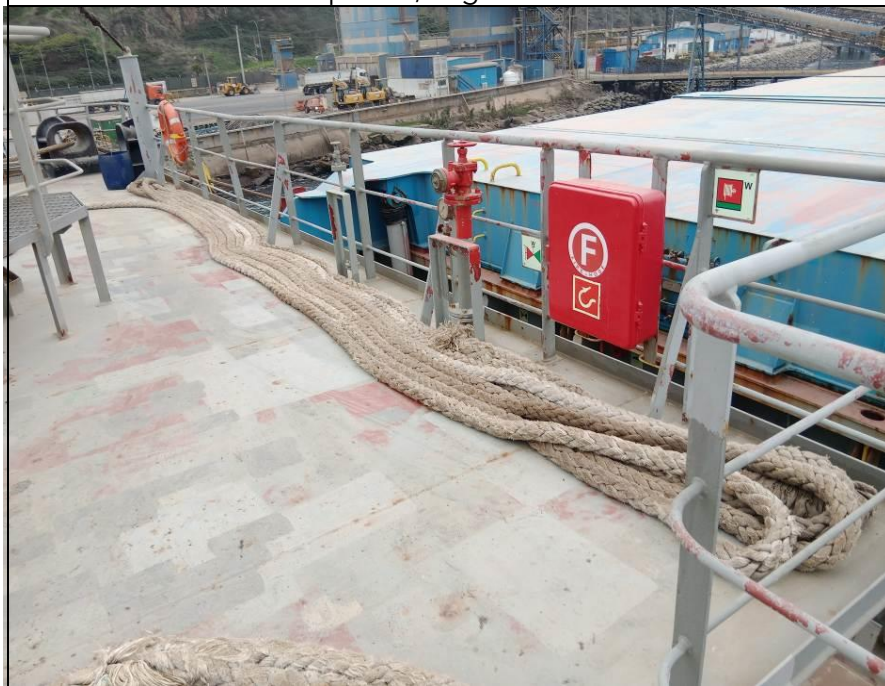
Nr. 2: Mooring lines Fwd wear and tear (See photo Nr. 20)

20. Forward mooring lines stained and worn out.

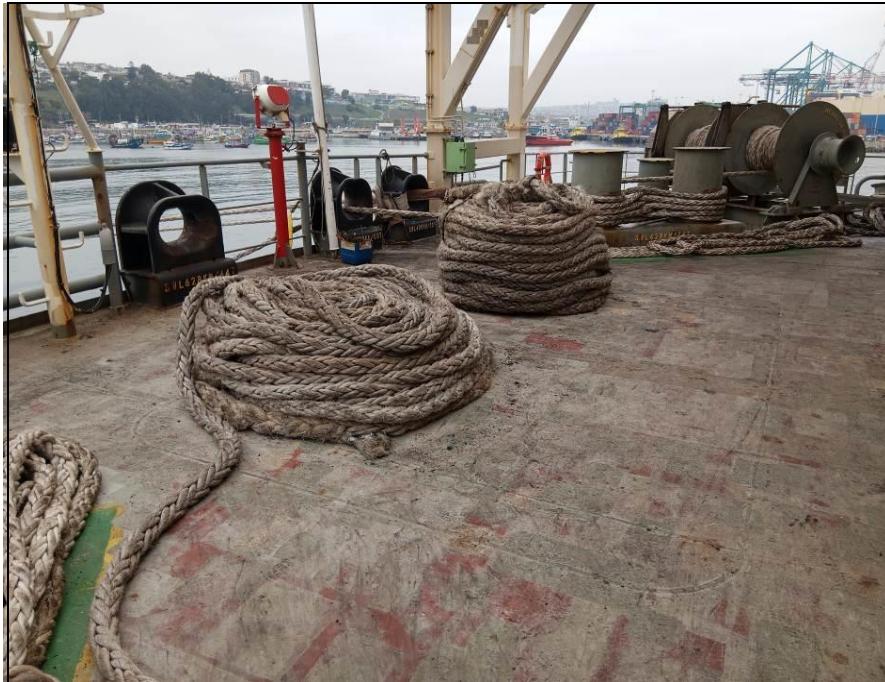
Nr. 3: Mooring lines Aft wear and tear (See photo Nr. 25)

25. Aft mooring lines stained and worn out.

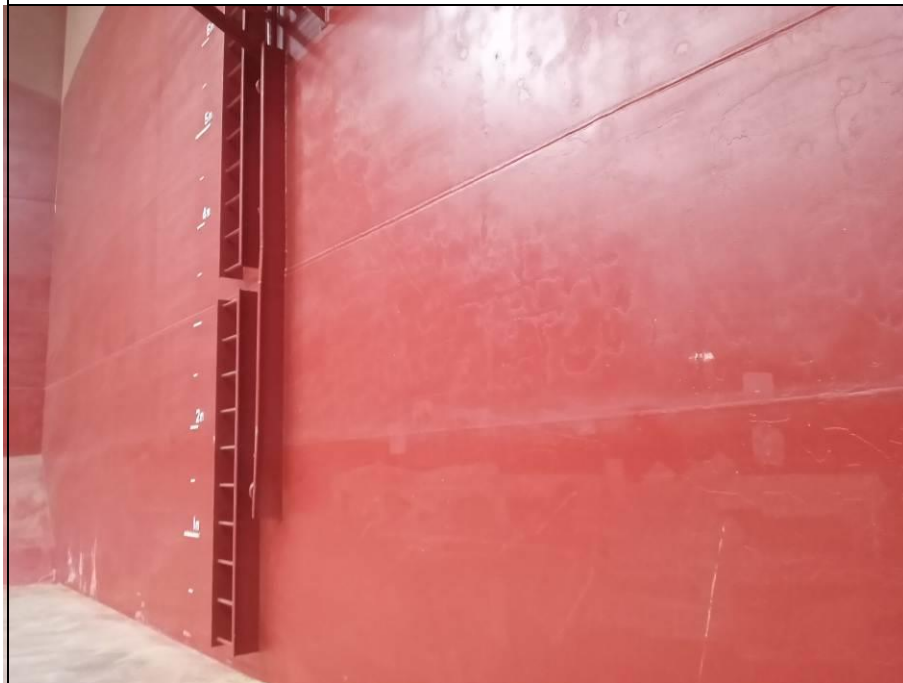
No. 4: Forward bulkhead with paint scratched and rust (See photo No. 28)

28. Fwd bulkhead with paint scratched.

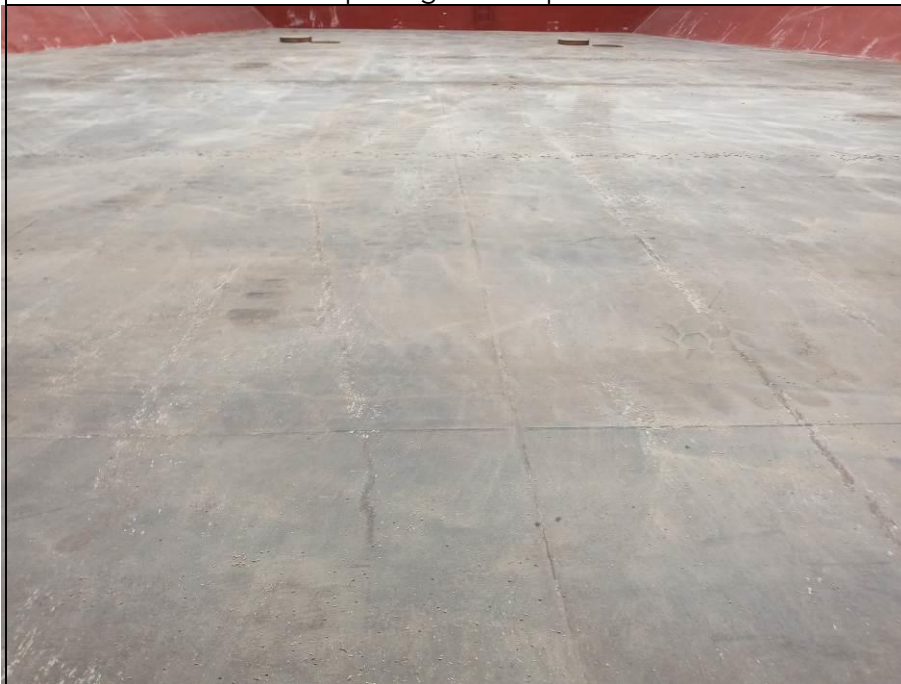
No. 8: Tan top plating with dust (See photos No. 32)

32. Tank top plating with rust.

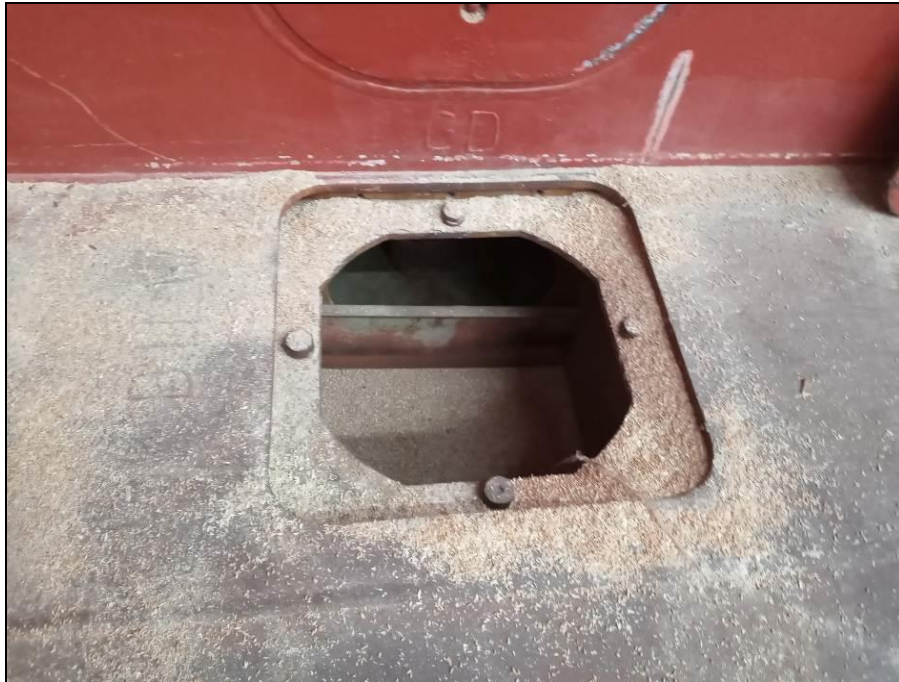
33. Bilge with dust of cargo discharged.

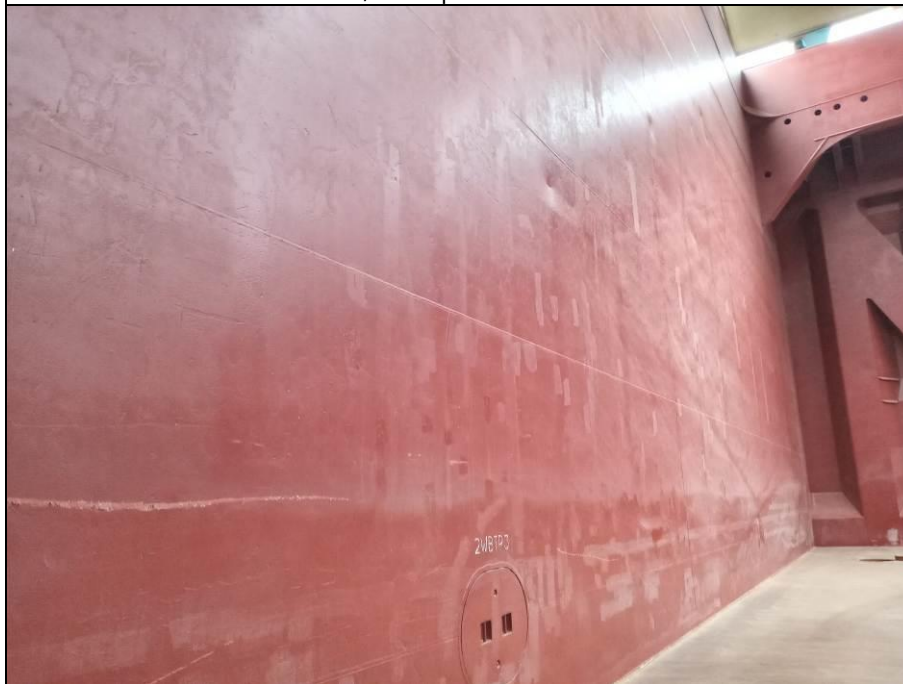
No. 11: Side/shell plating Ps with paint scratched and dust (See photo No. 40)

40. Side/shell plating Ps, with paint scratched and dust.

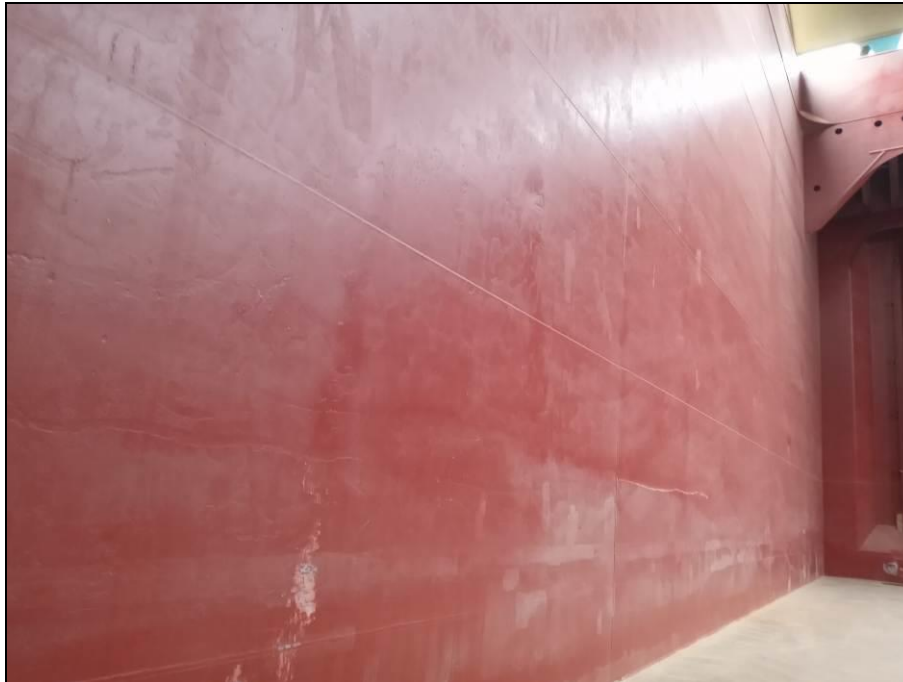
No. 12: Side/shell plating Ss with paint scratched and dust (See photo No. 41)

41. Side/shell plating Ss, with paint scratched and rust.

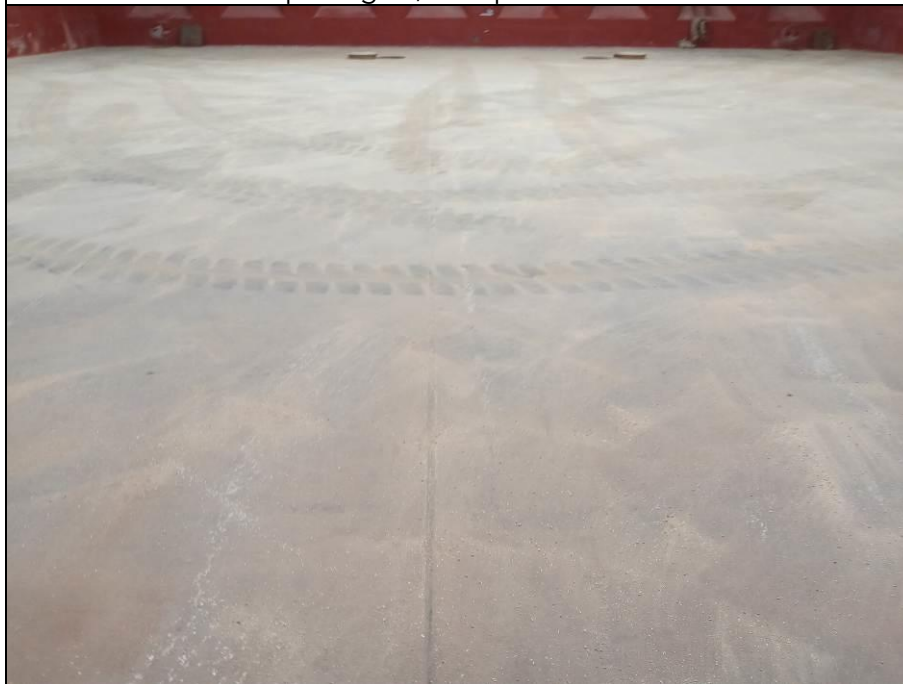
No. 13: Tan top plating with dust (See photos No. 42 & 43)

42. Tank top plating with dust.

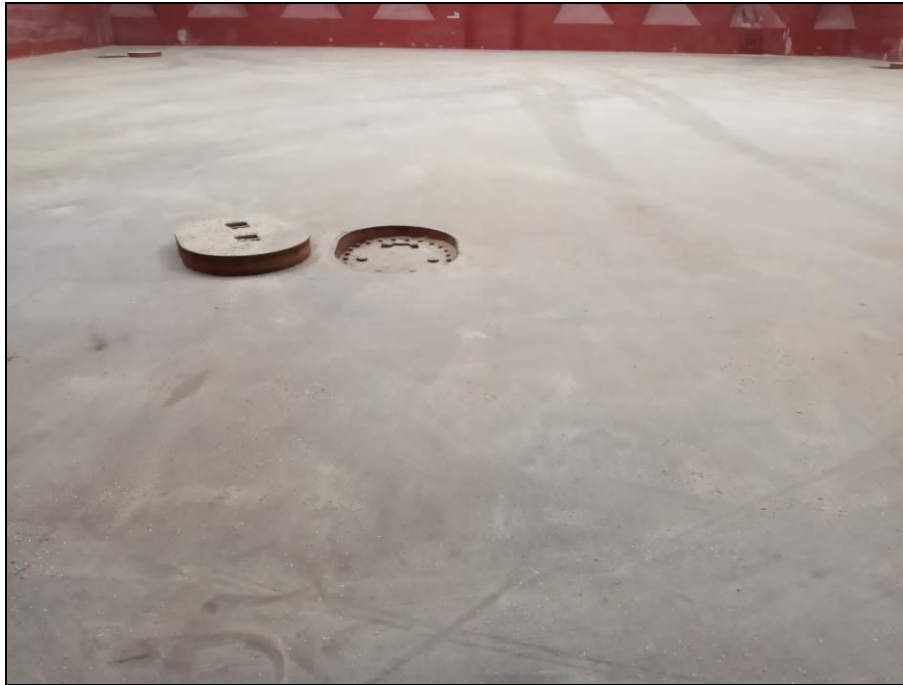
43. Another view.

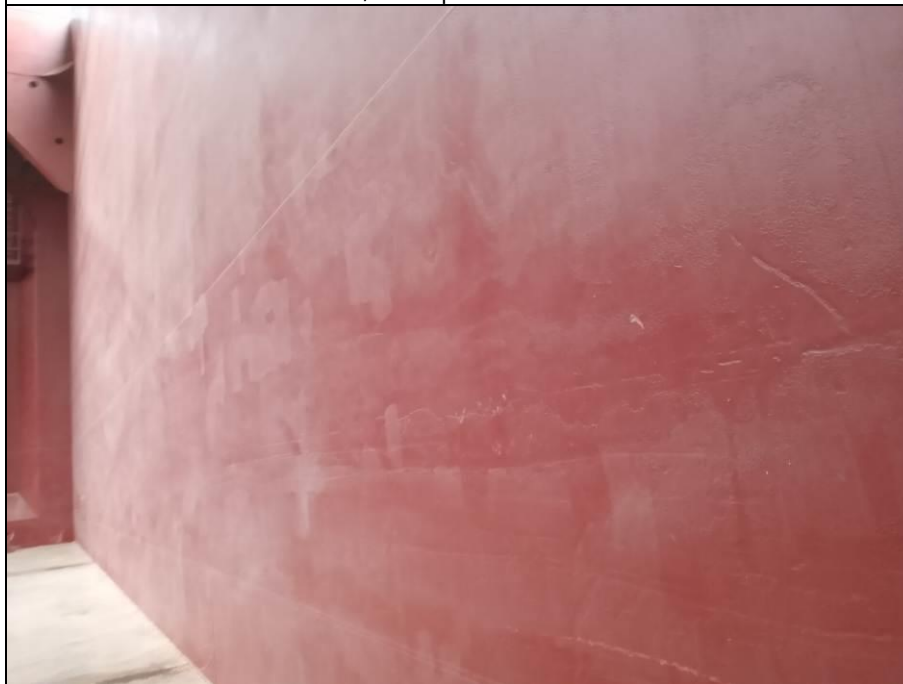
No. 16: Side/shell plating Ps with paint scratched and dust (See photo No. 50)

50. Side/shell plating Ps, with paint scratched and dust.

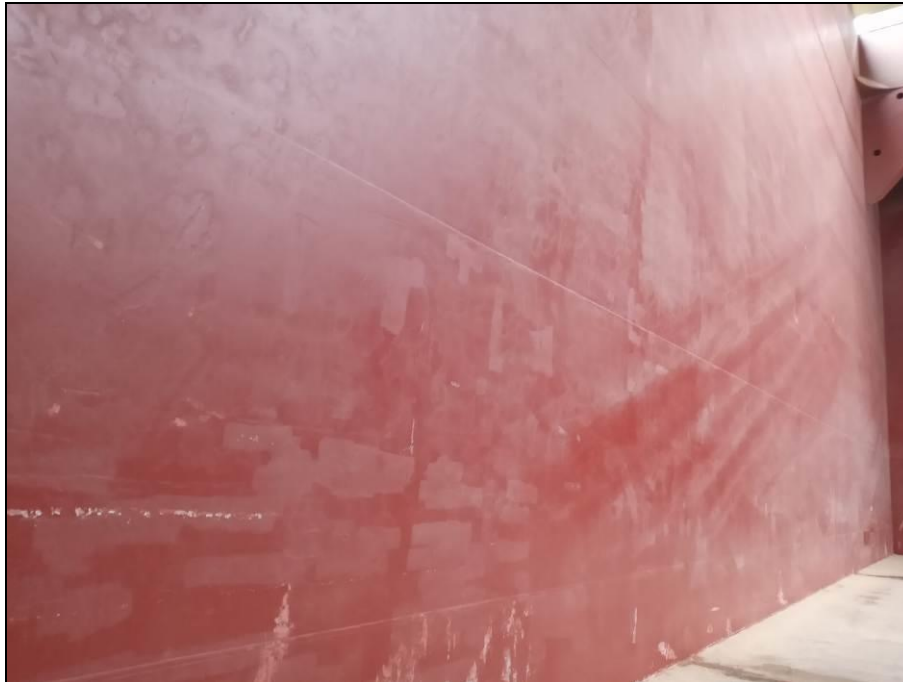
No. 17: Side/shell plating Ss with paint scratched and dust (See photo No. 51)

51. Side/shell plating Ss, with paint scratched and rust.

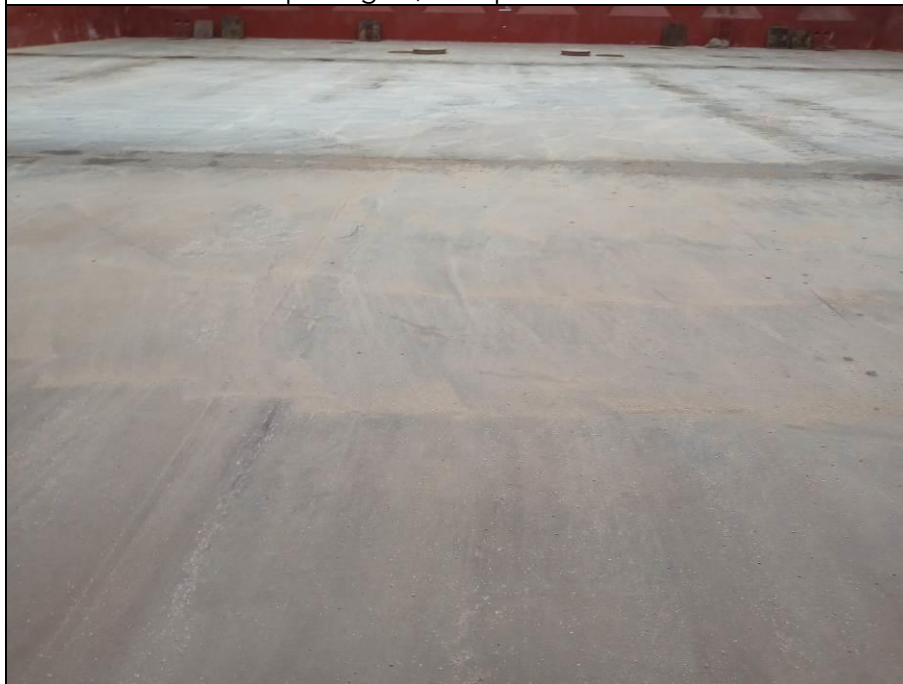
No. 18: Tan top plating with dust (See photos No. 52)

52. Tank top plating with dust.

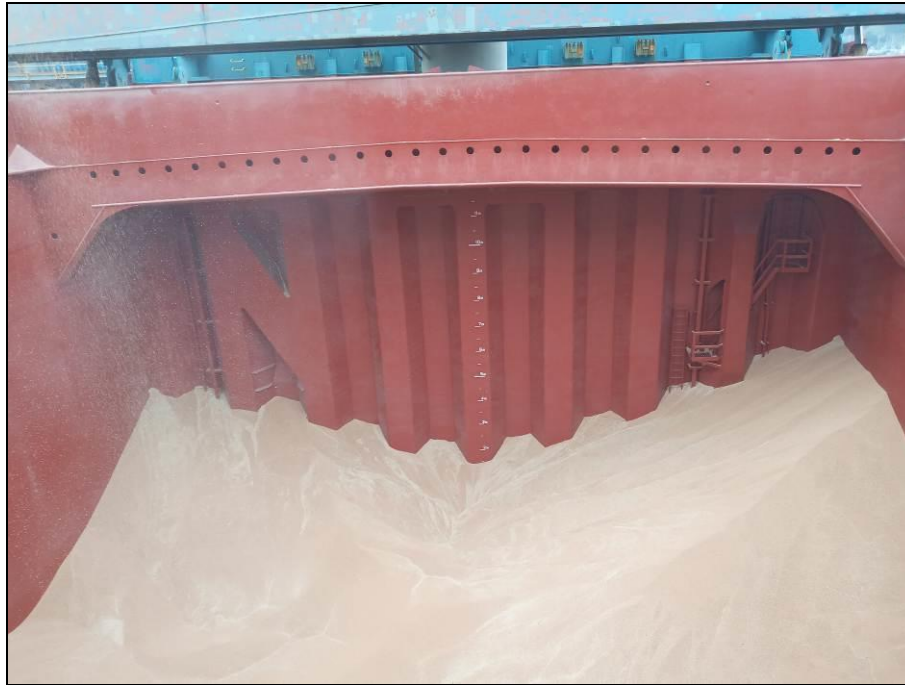
59. Aft bulkhead with paint scratched and rust.

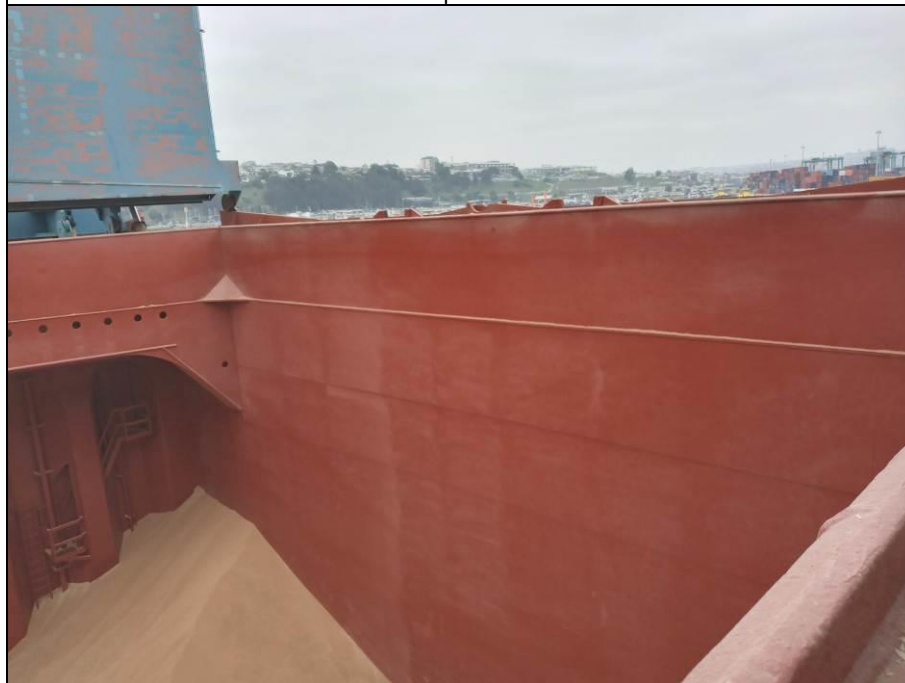
60. Side/shell plating Ps, with paint scratched and rust.

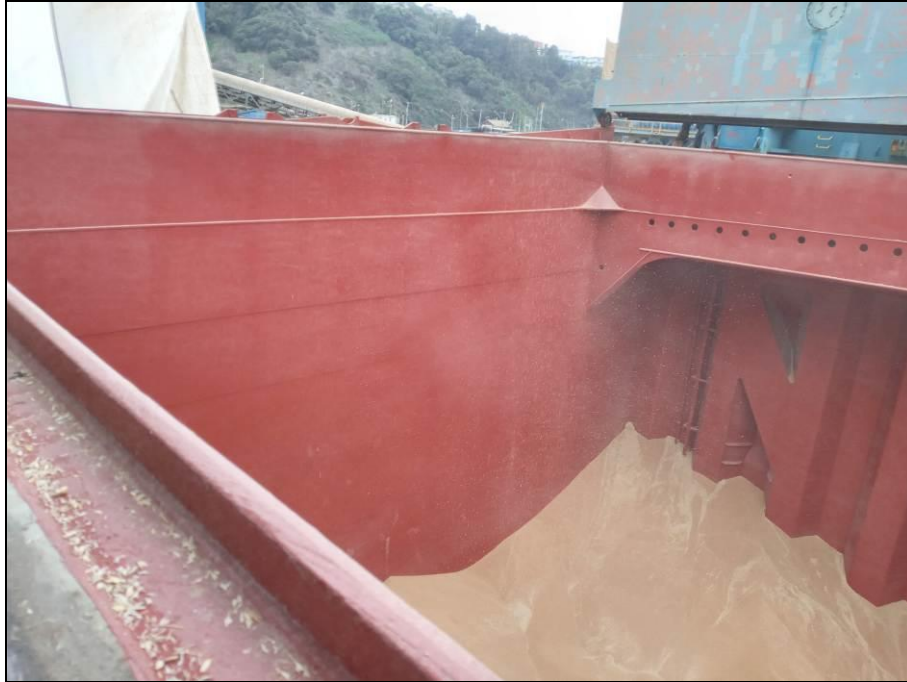
61. Side/shell plating Ss, with paint scratched and rust.

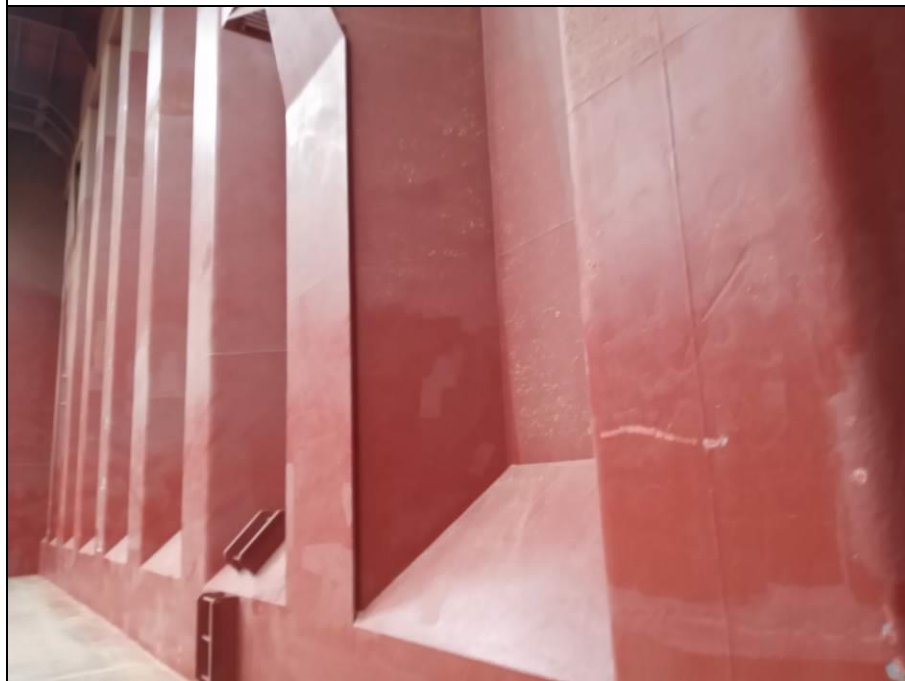
No. 20: Forward bulkhead with paint scratched and rust (See photo No. 68)

68. Fwd bulkhead with paint scratched.

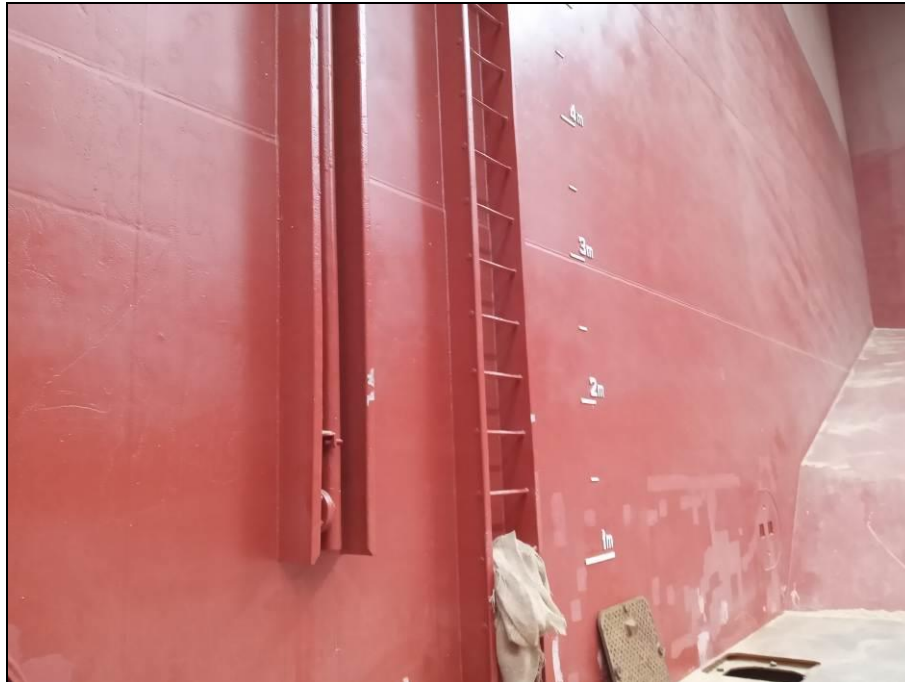
No. 21: After bulkhead with paint scratched and rust (See photo No. 69)

69. Aft bulkhead with paint scratched.

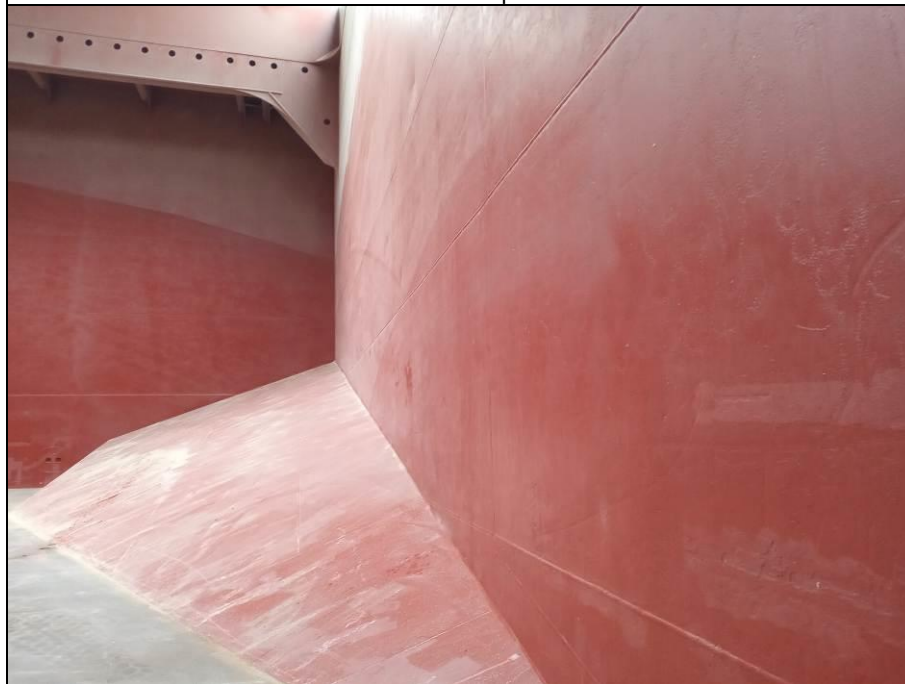
No. 22: Side/shell plating Ps with paint scratched and rust (See photo No. 70)

70. Side/shell plating Ps, with paint scratched and rust.

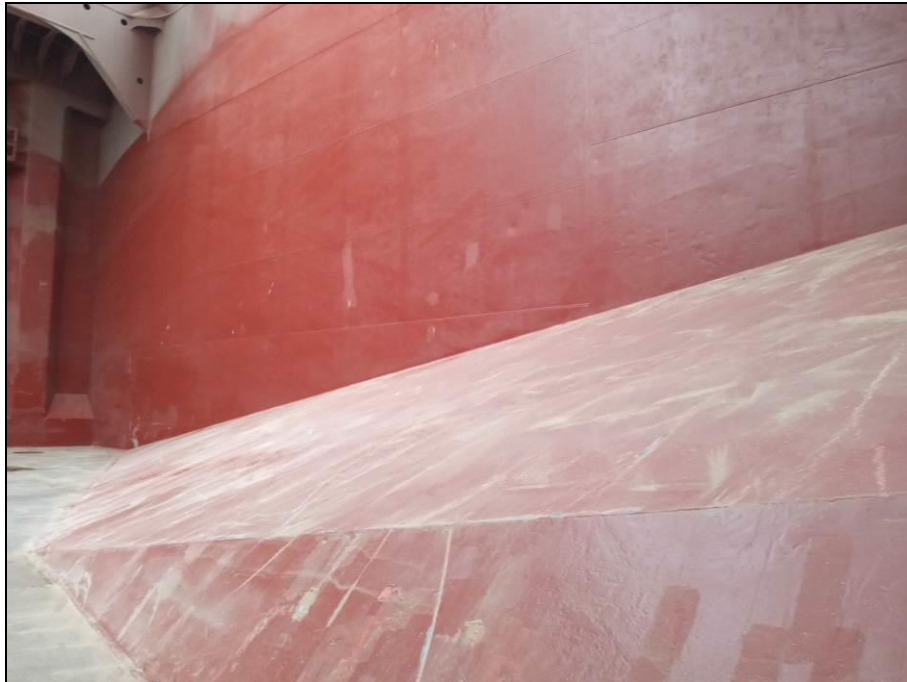
No. 23: Side/shell plating Ss with paint scratched and rust (See photo No. 71)

71. Side/shell plating Ss, with paint scratched and rust.

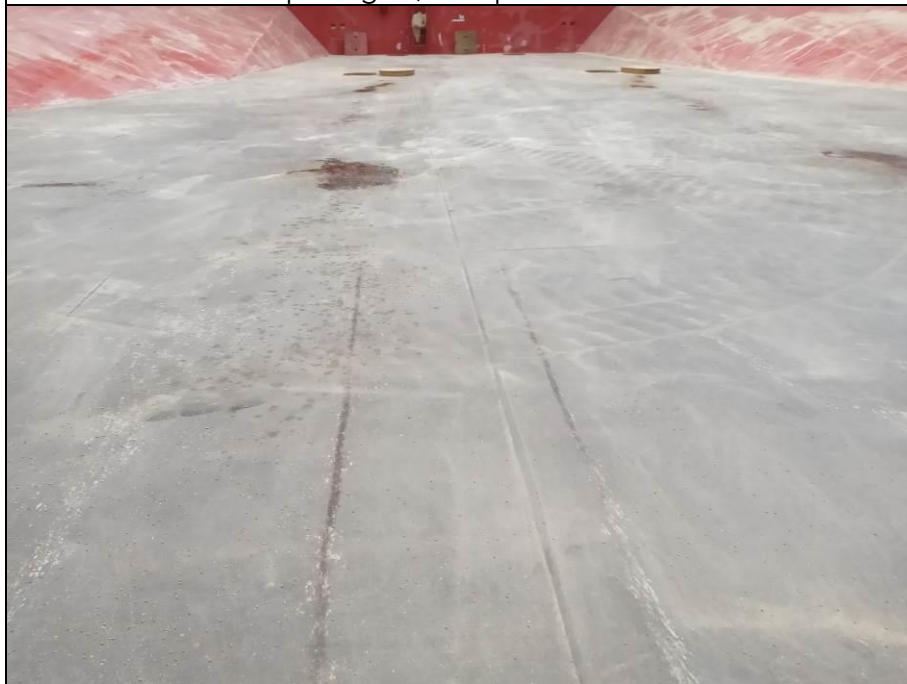
No. 24: Tan top plating with dust (See photos No. 72 & 73)

72. Tank top plating with dust.
