PRELIMINARY REPORT

TO	GUAYACAN TERMINAL
FROM	ALS INSPECTION CHILE SPA
PRELIMINARY ISSUE DATE	JANUARY 15, 2026
CLIENT REF	N/A
ALS REF	VAP-2601-0183
SCOPE OF SURVEY	INSPECTION OF 18 MOORING LINES.
VESSEL NAME	NORD AURUM
PLACE OF SURVEY	COQUIMBO BAY
DATE OF SURVEY	JANUARY 15, 2026
TIME OF SURVEY	FROM 08:25 HRS TO 15:30 HRS
Please find our preliminary report; this should be taken as an initial approach of the appointed inspection. Additional information, findings, photographs, and conclusions will be part of our final report.

1. SCOPE OF SURVEY

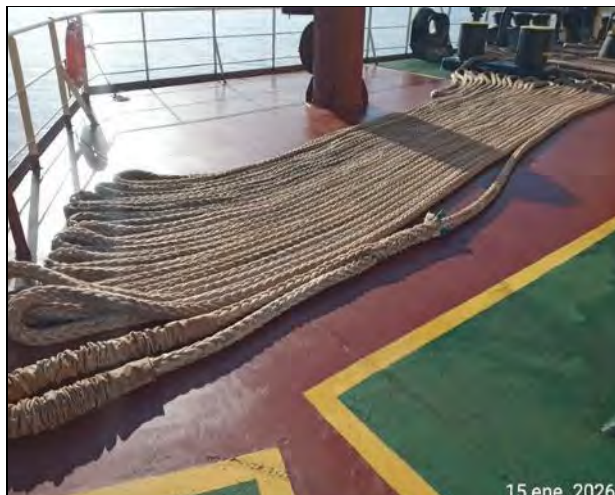
1. View of mooring lines conditions in vessel Aft.

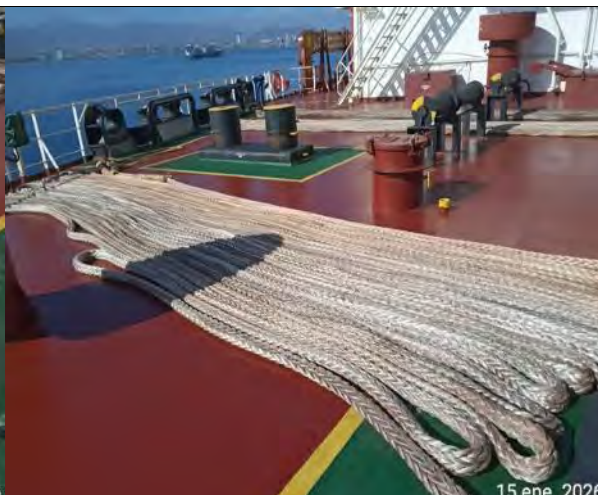
2. Another mooring lines arranged for its inspection.

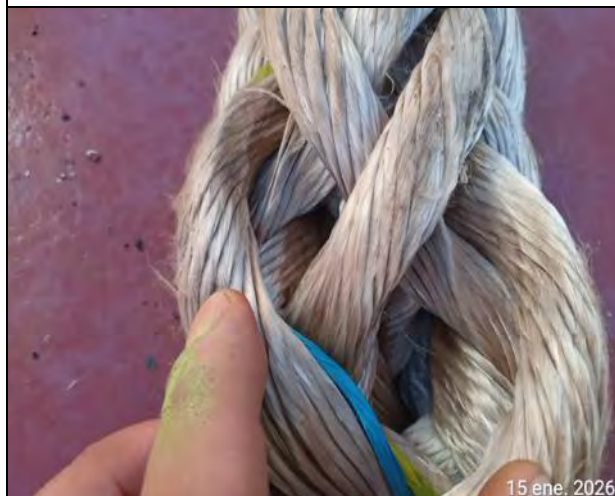
3. Internal condition of rope.

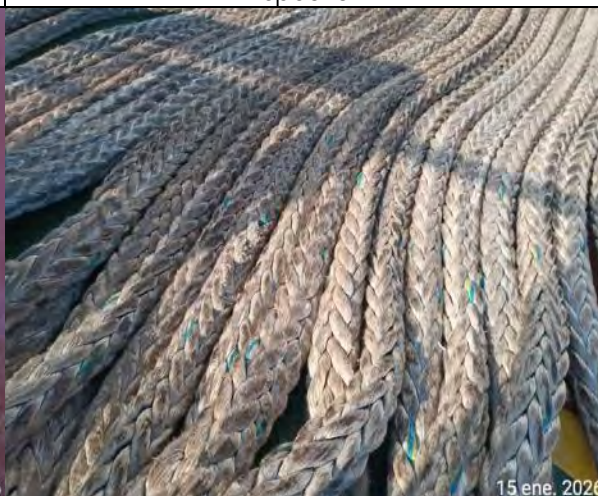
4. External condition of rope.

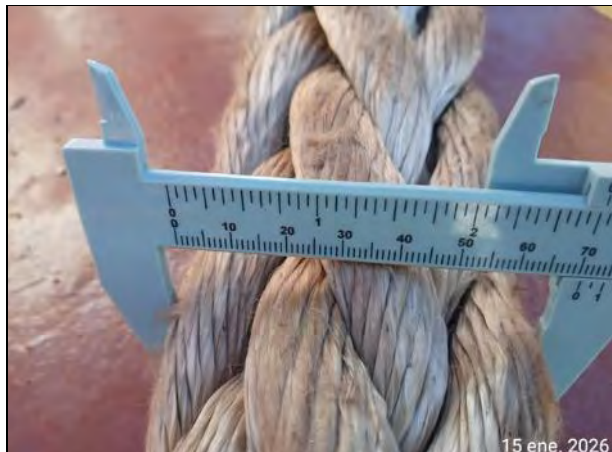
5. View of diameter measurement of the mooring lines.

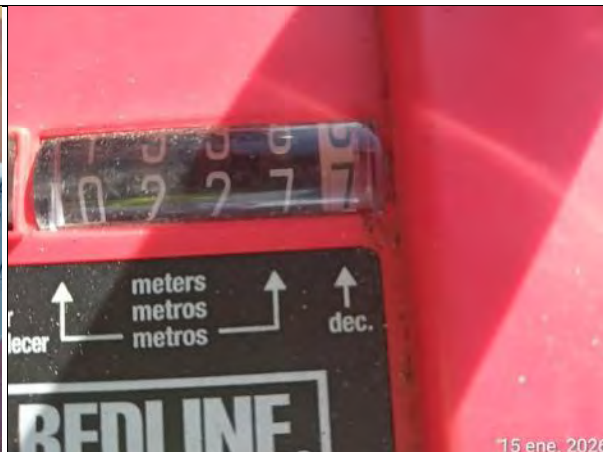
6. View of the mooring lines measurement.

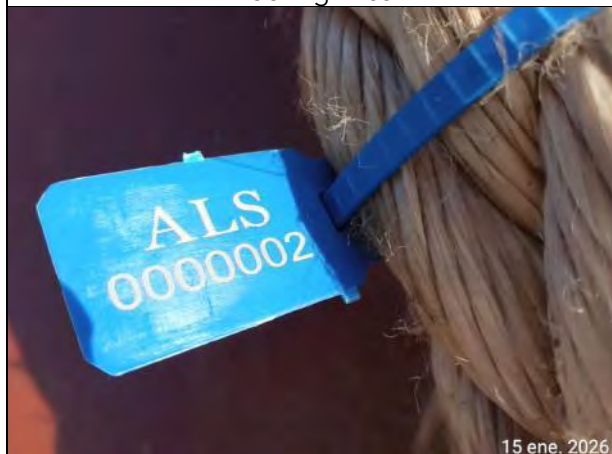
7. View of mooring line approved with ALS SEAL Nr. 0000002.

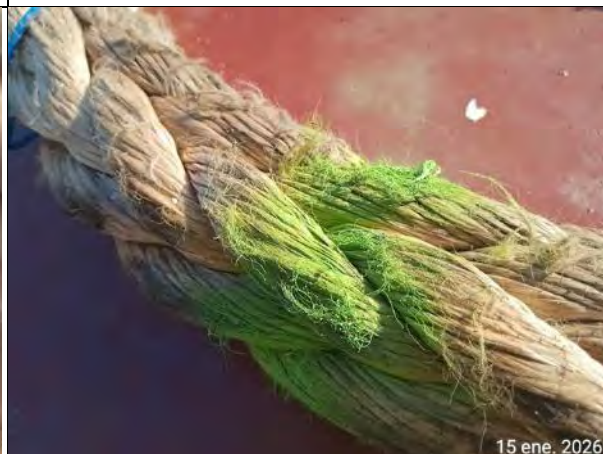
The inspected mooring lines were also properly marked with a color: green for accepted lines.

8. View of mooring line approved with green mark.
