FINAL REPORT

SURVEY	MOORING ROPES INSPECTION
TO	GUAYACAN TERMINAL
FROM	ALS INSPECTION CHILE SPA.
CLIENT REF	N/A
ALS REF	VAP-2604-1462
SCOPE OF THE SURVEY	INSPECTION OF 18 MOORING LINES.
VESSEL NAME	NISEKO QUEEN
OWNER	GREEN SPANKER SHIPPING S.A.
DISPONENT OWNER	KOWA MARINE SERVICE CO. LTD.
CHARTERERS	CLASSIC MARITIME INC.
PLACE OF SURVEY	COQUIMBO BAY
DATE OF SURVEY	APRIL 16 & 17, 2026
TIME OF SURVEY	FROM 20:30 HRS TO 01:00 HRS

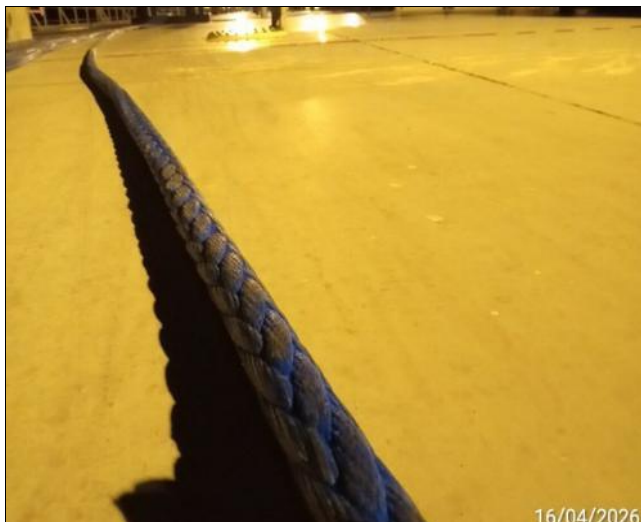
1. General view of the rope.

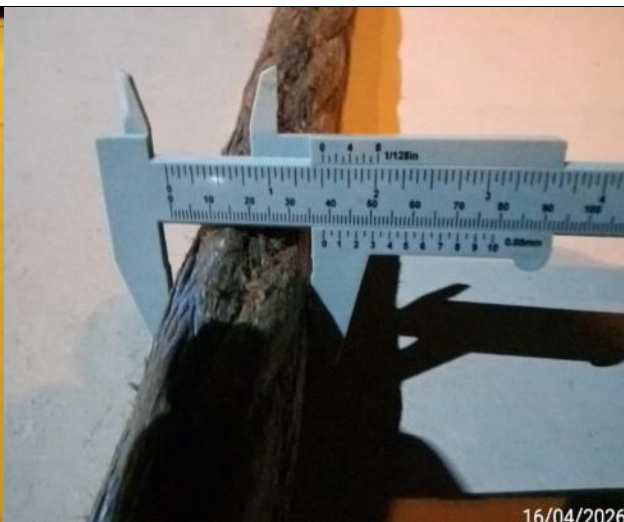
2. Diameter of the rope.

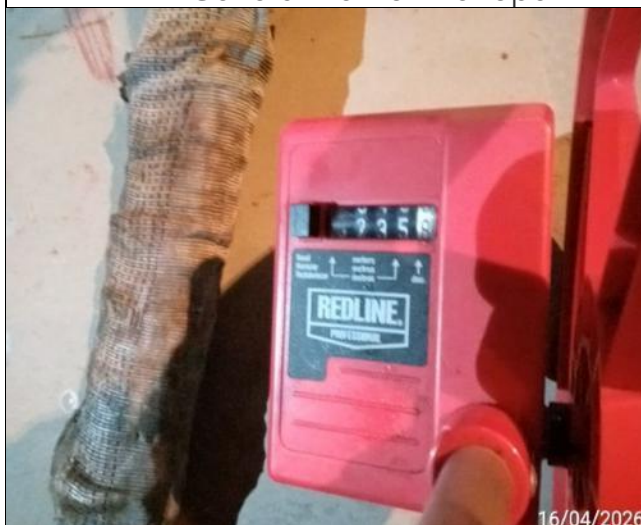
3. Measurement of the rope,
235.8 meters.

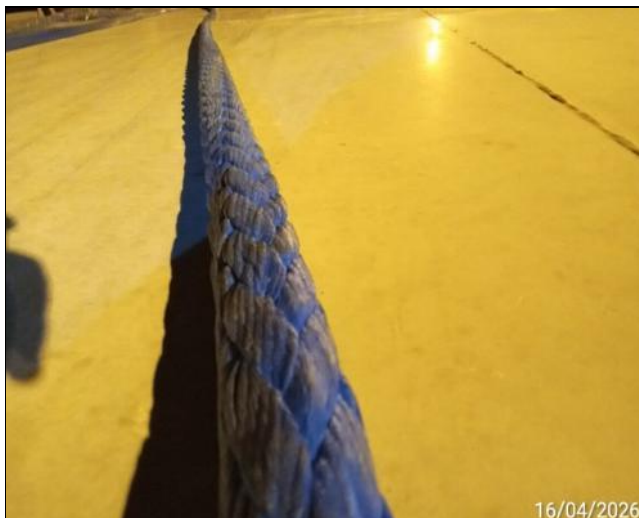
5. General view of the rope.

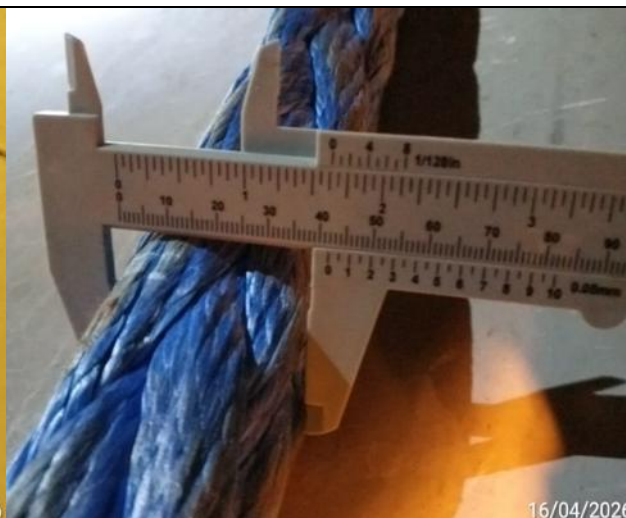
6. Diameter of the rope.

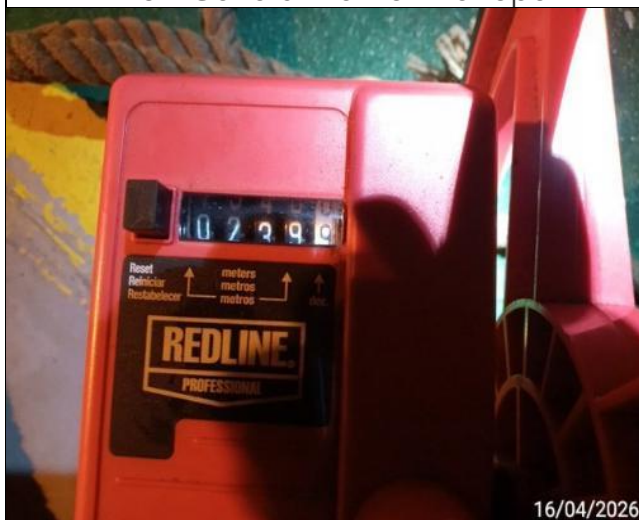
7. Measurement of the rope,
239.9 meters.

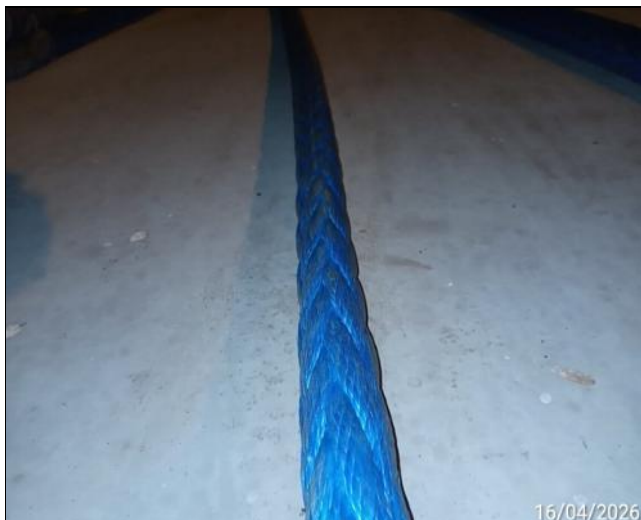
9. General view of the rope.

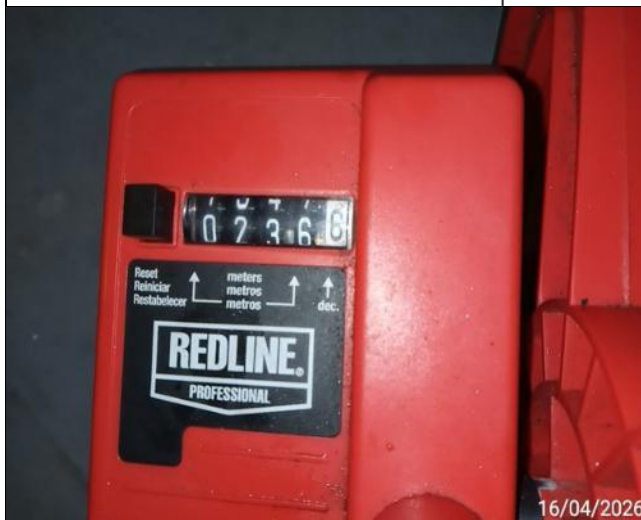
11. Measurement of the rope,
236.6 meters.

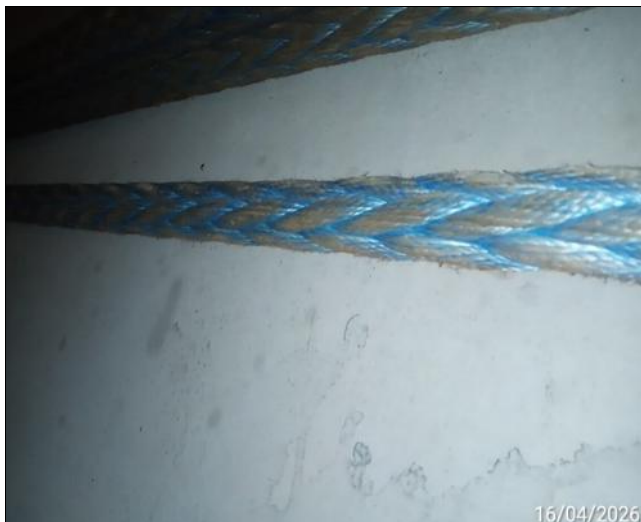
13. General view of the rope.

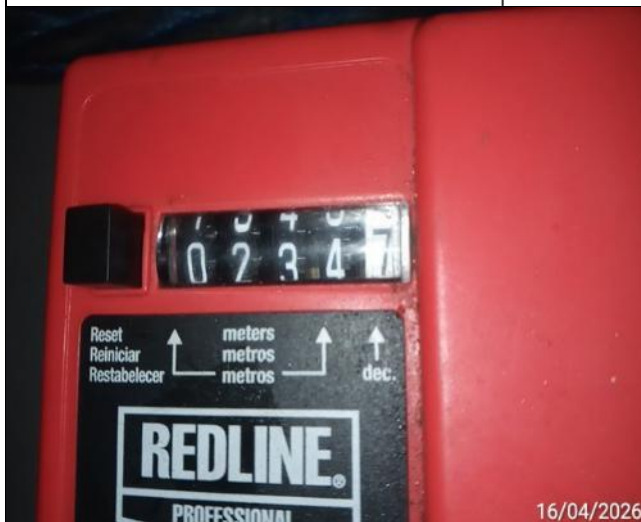
15. Measurement of the rope,
234.7 meters.

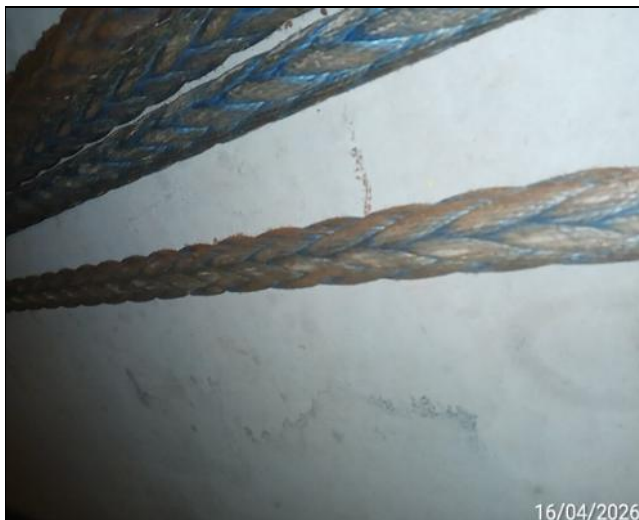
17. General view of the rope.

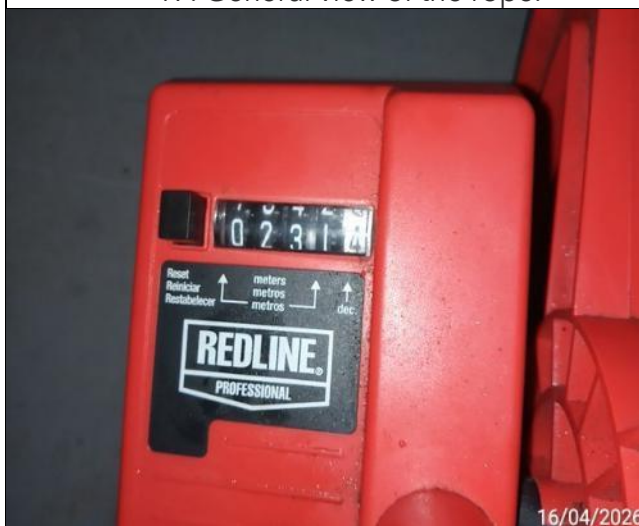
19. Measurement of the rope,
231.4 meters.

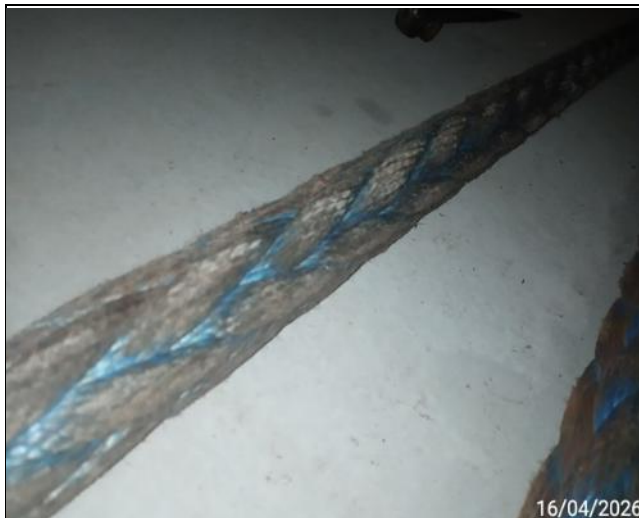
21. General view of the rope.

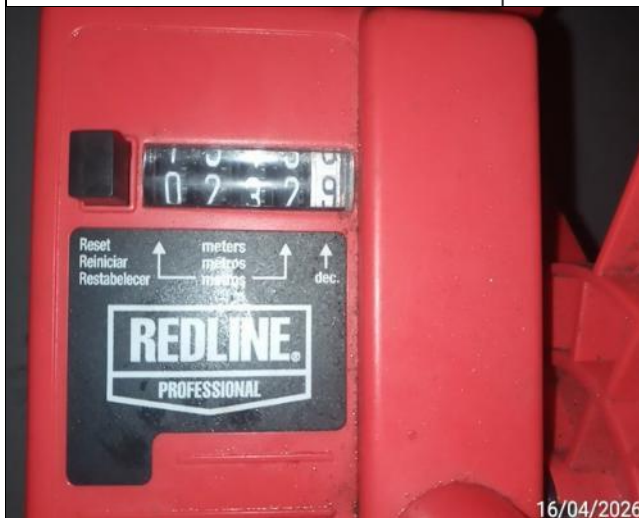
23. Measurement of the rope,
232.9 meters.

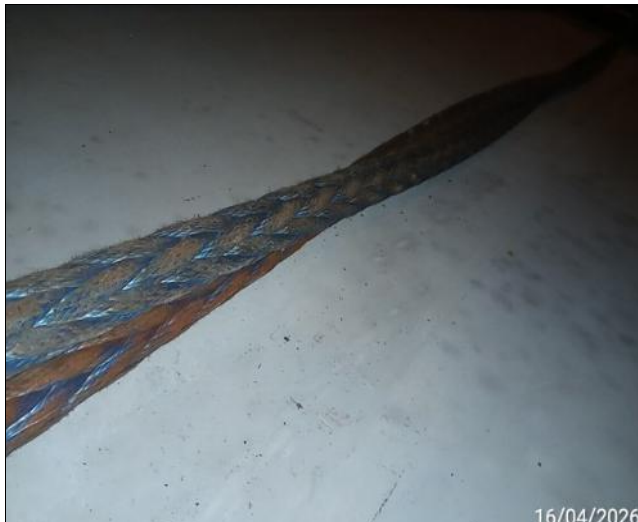
25. General view of the rope.

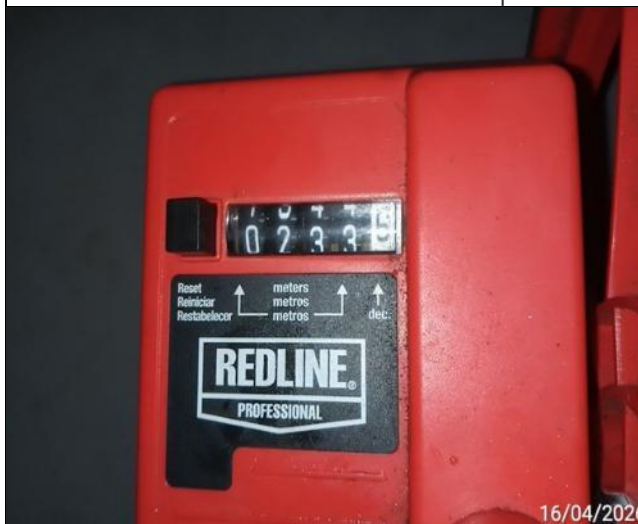
27. Measurement of the rope,
233.6 meters.

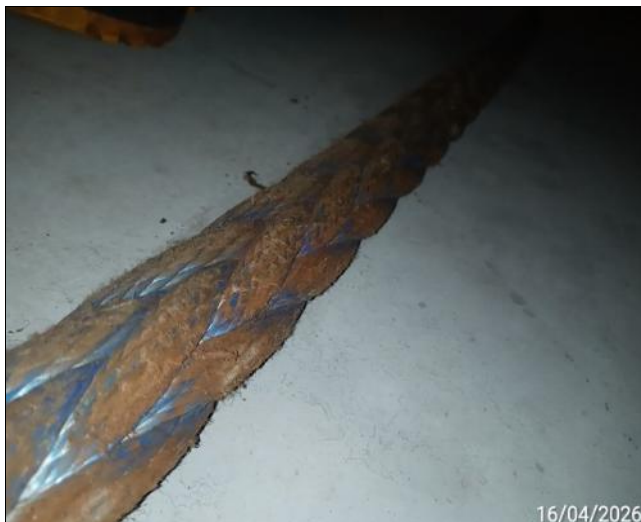
29. General view of the rope.
