PRELIMINARY REPORT

TO	GUAYACAN TERMINAL
FROM	ALS INSPECTION CHILE SPA
PRELIMINARY ISSUE DATE	APRIL 17, 2026
CLIENT REF	N/A
ALS REF	VAP-2604-1462
SCOPE OF SURVEY	INSPECTION OF 18 MOORING LINES.
VESSEL NAME	NISEKO QUEEN
PLACE OF SURVEY	COQUIMBO BAY
DATE OF SURVEY	APRIL 16 & 17, 2026
TIME OF SURVEY	FROM 20:30 HRS TO 01:00 HRS
Please find our preliminary report; this should be taken as an initial approach of the appointed inspection. Additional information, findings, photographs, and conclusions will be part of our final report.

1. SCOPE OF SURVEY

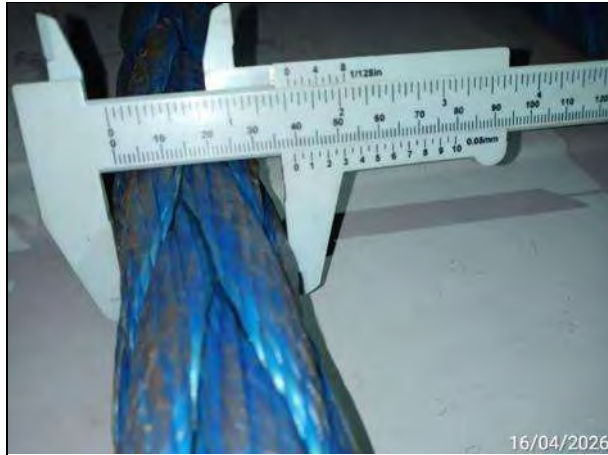
5. View of diameter measurement of the mooring lines.

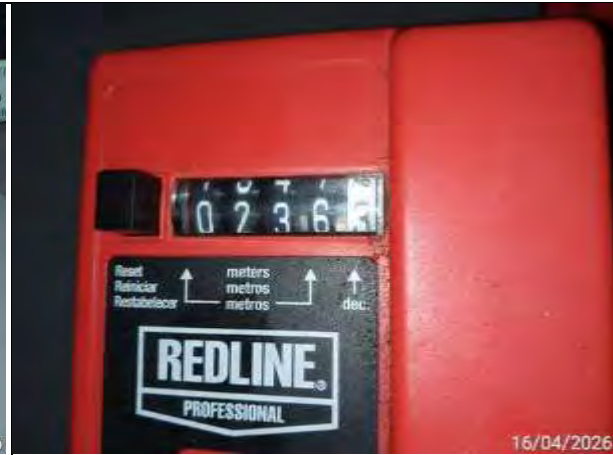
6. View of the mooring lines measurement.

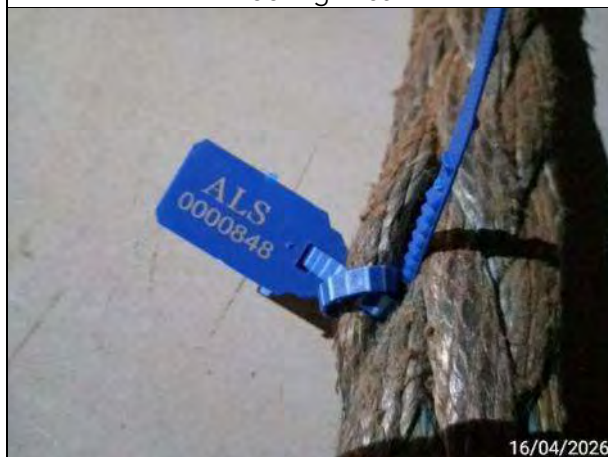
7. View of mooring line approved with ALS SEAL Nr. 0000848.

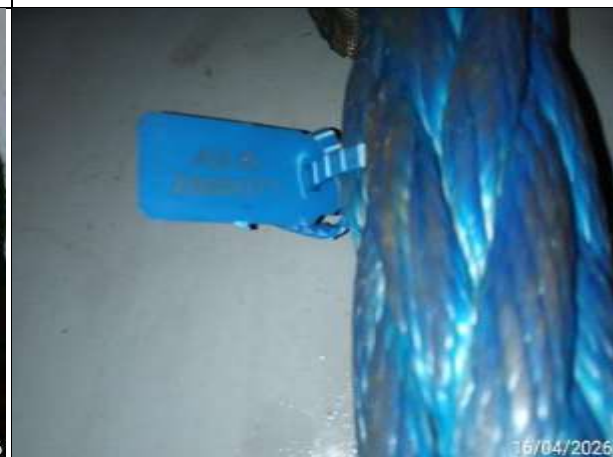
8. View of mooring line approved with ALS SEAL Nr. 2985071.
