FINAL REPORT

SURVEY	MOORING ROPES INSPECTION
TO	GUAYACAN TERMINAL
FROM	ALS INSPECTION CHILE SPA.
CLIENT REF	N/A
ALS REF	VAP-2605-1839
SCOPE OF SURVEY	INSPECTION OF 18 MOORING LINES.
VESSEL NAME	PIGI
OWNER	OLYMPIAN CORAL MARINE LTD.
DISPONENT OWNER	EAST 33 MARITIME LTD.
CHARTERERS	CLASSIC MARITIME INC.
PLACE OF SURVEY	COQUIMBO BAY
DATE OF SURVEY	MAY 19, 2026
TIME OF SURVEY	FROM 02:00 HRS TO 05:20 HRS

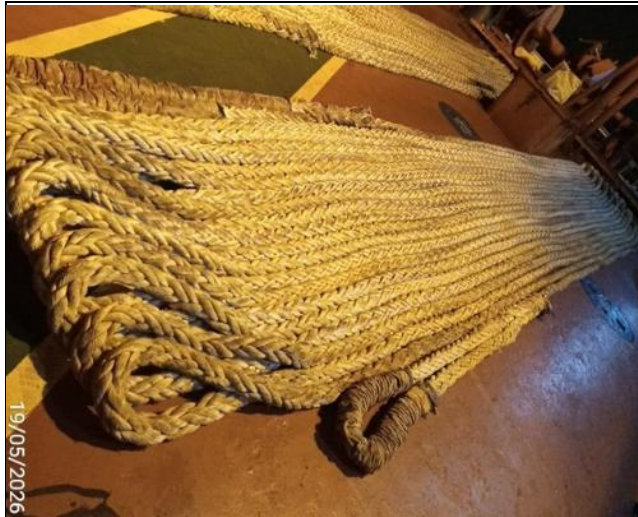
1. General view of the rope.

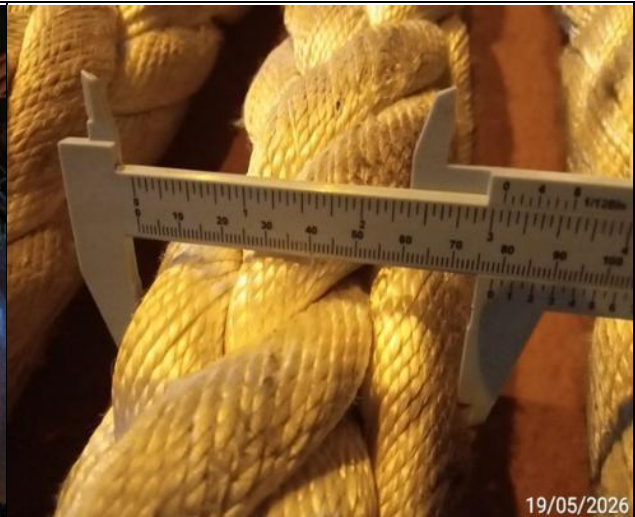
2. Diameter of the rope.

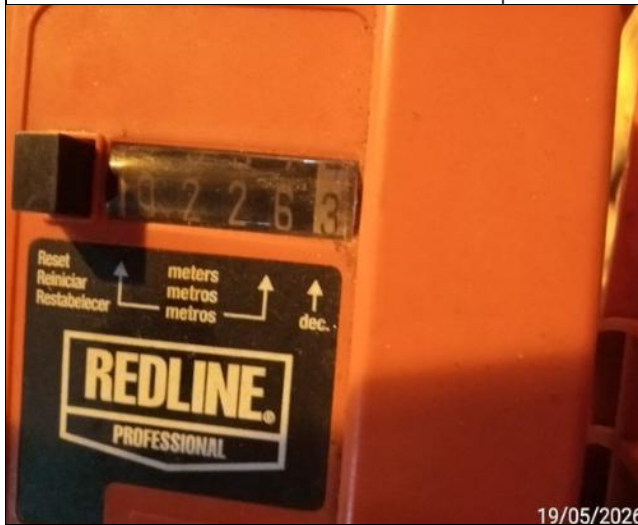
3. Measurement of the rope,
226.3 meters.

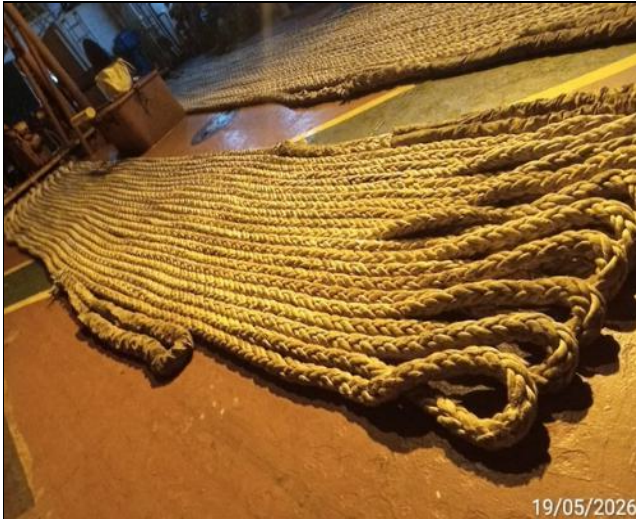
5. General view of the rope.

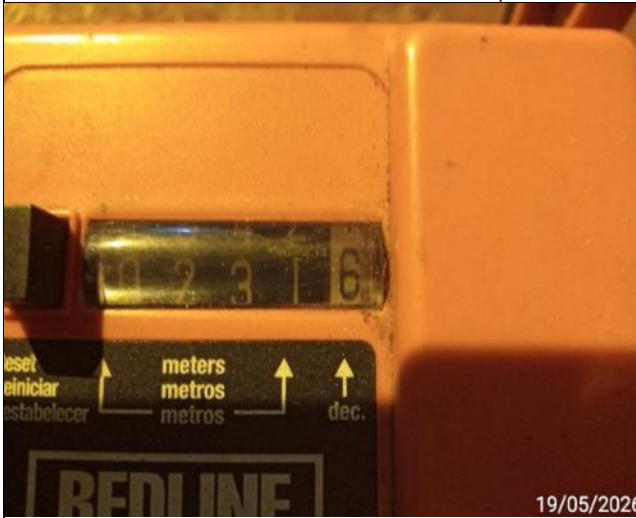
7. Measurement of the rope,
231.6 meters.

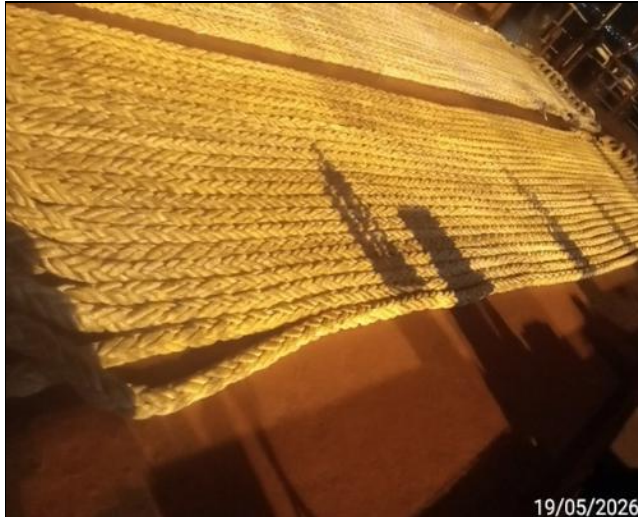
9. General view of the rope.

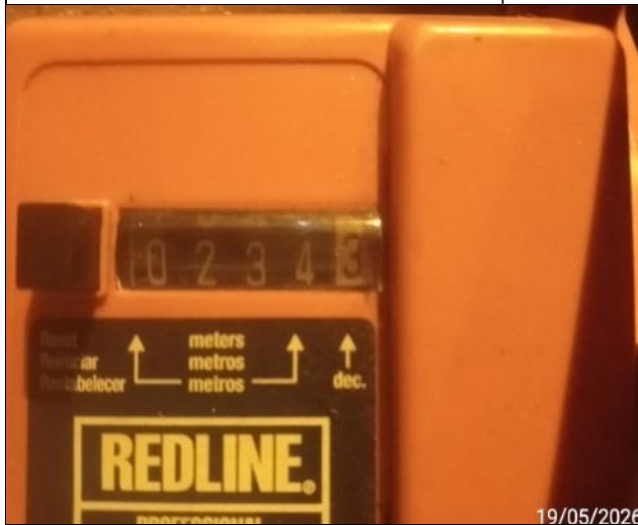
11. Measurement of the rope,
234.3 meters.

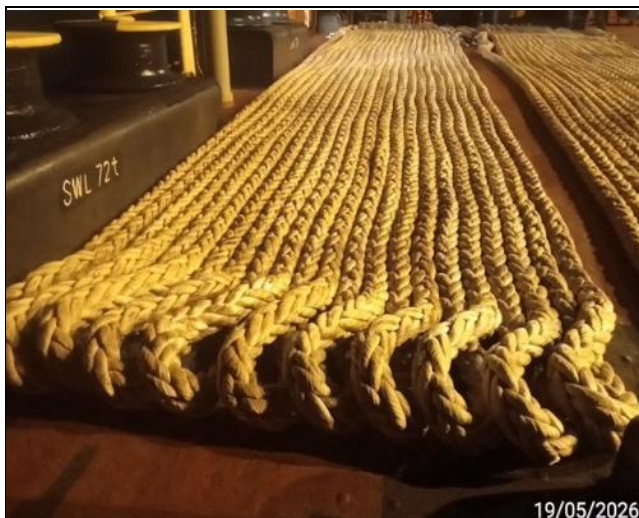
13. General view of the rope.

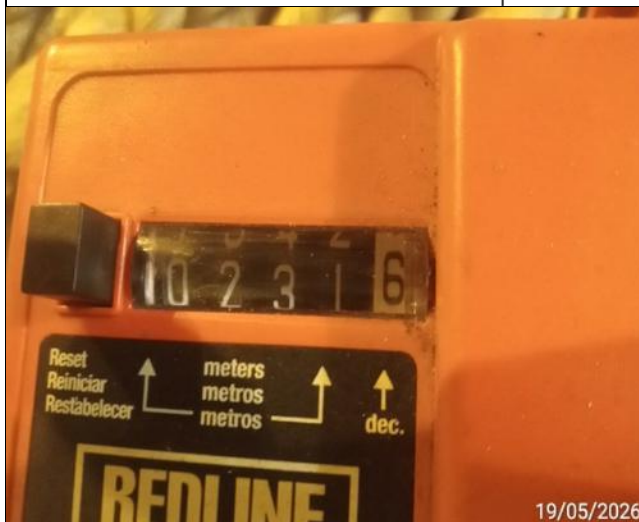
15. Measurement of the rope,
231.6 meters.

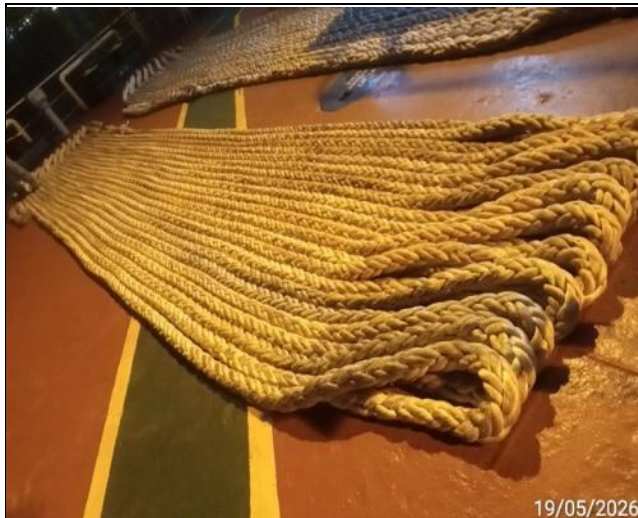
17. General view of the rope.

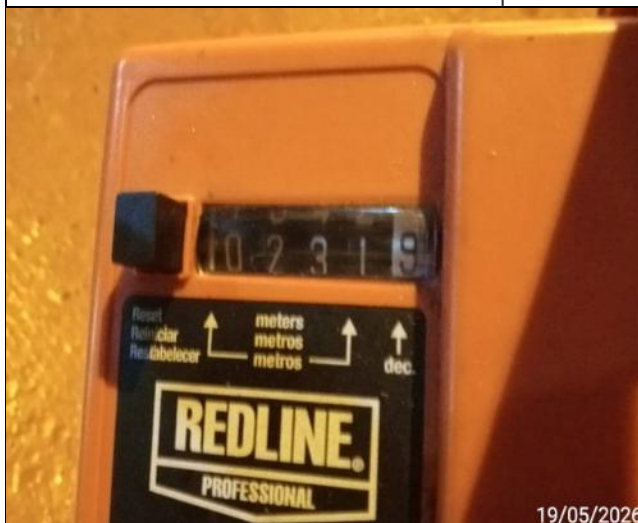
19. Measurement of the rope,
231.9 meters.

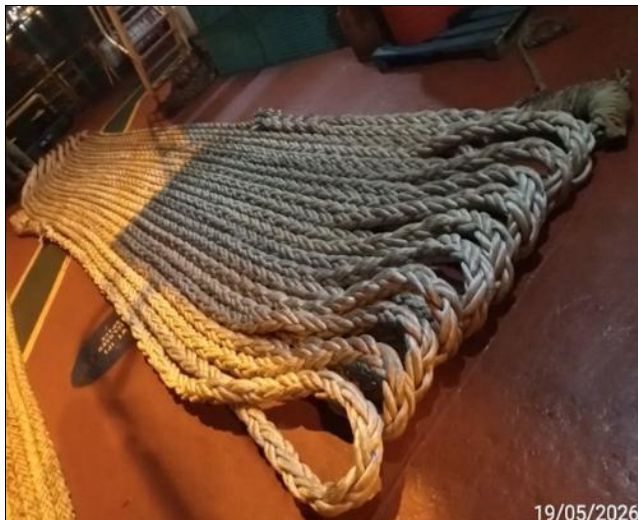
21. General view of the rope.

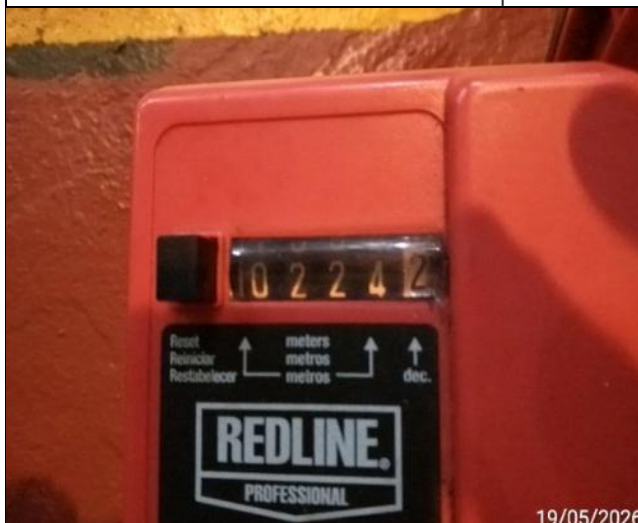
23. Measurement of the rope,
224.2 meters.

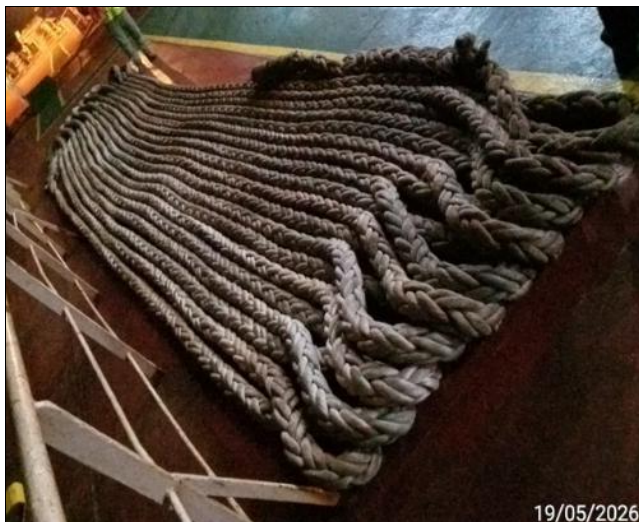
25. General view of the rope.

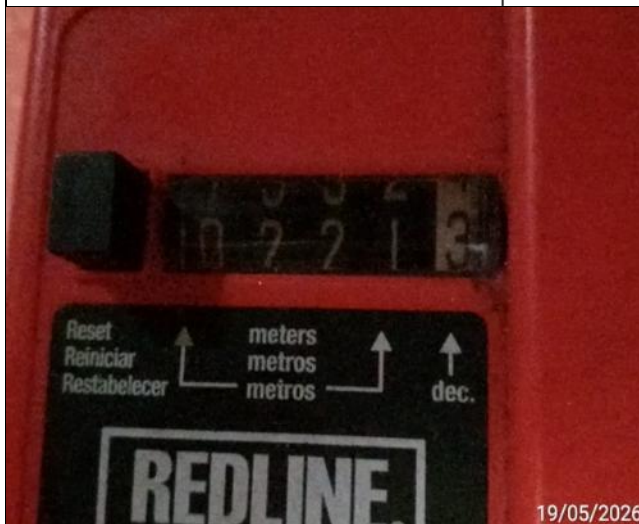
27. Measurement of the rope,
221.3 meters.

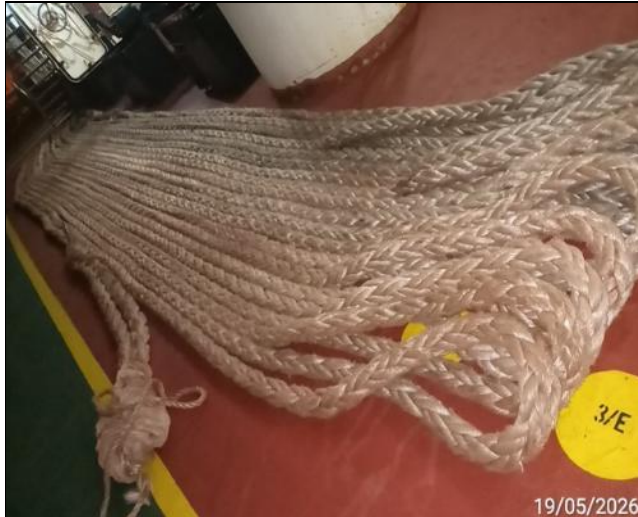
DAMAGE ITEM	GOOD	FAIR	POOR
Ext. Abrasion (max 25%)	<input type="checkbox"/>	<input checked="" type="checkbox"/>	Over 25% <input type="checkbox"/>
Int. Abrasion	<input checked="" type="checkbox"/>	<input type="checkbox"/>	<input type="checkbox"/>
Cut strands	<input checked="" type="checkbox"/>	<input type="checkbox"/>	<input type="checkbox"/>
Burn/ heated parts / fusion	<input checked="" type="checkbox"/>	<input type="checkbox"/>	<input type="checkbox"/>
Sun degradation /discoloration	<input checked="" type="checkbox"/>	<input type="checkbox"/>	<input type="checkbox"/>
Fiber broken	<input checked="" type="checkbox"/>	<input type="checkbox"/>	<input type="checkbox"/>
Black stains / dirty	<input type="checkbox"/>	<input checked="" type="checkbox"/>	<input type="checkbox"/>
Inconsistent diameter	<input checked="" type="checkbox"/>	<input type="checkbox"/>	<input type="checkbox"/>
Inconsistent flexibility	<input checked="" type="checkbox"/>	<input type="checkbox"/>	<input type="checkbox"/>

29. General view of the rope.

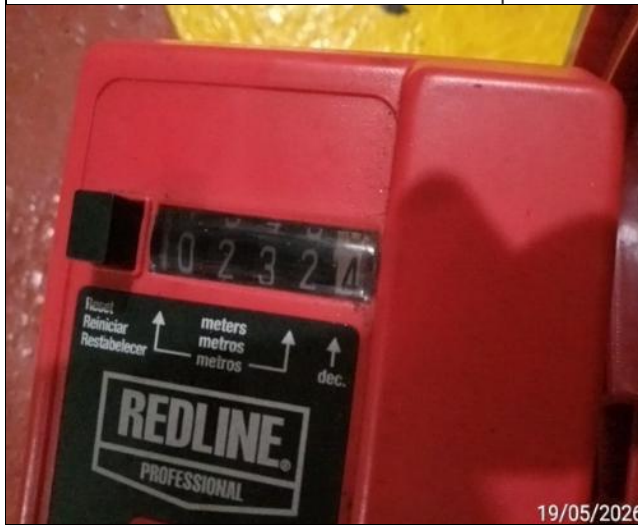
31. Measurement of the rope,
232.4 meters.

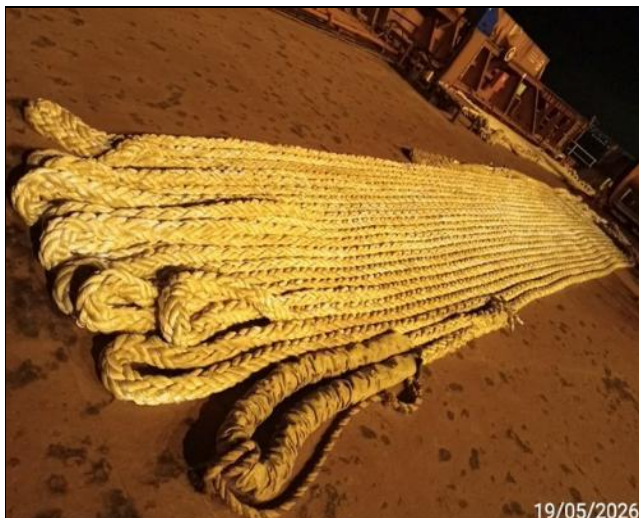
DAMAGE ITEM	GOOD	FAIR	POOR
Ext. Abrasion (max 25%)	<input type="checkbox"/>	<input checked="" type="checkbox"/>	Over 25% <input type="checkbox"/>
Int. Abrasion	<input checked="" type="checkbox"/>	<input type="checkbox"/>	<input type="checkbox"/>
Cut strands	<input checked="" type="checkbox"/>	<input type="checkbox"/>	<input type="checkbox"/>
Burn/ heated parts / fusion	<input checked="" type="checkbox"/>	<input type="checkbox"/>	<input type="checkbox"/>
Sun degradation /discoloration	<input checked="" type="checkbox"/>	<input type="checkbox"/>	<input type="checkbox"/>
Fiber broken	<input checked="" type="checkbox"/>	<input type="checkbox"/>	<input type="checkbox"/>
Black stains / dirty	<input type="checkbox"/>	<input checked="" type="checkbox"/>	<input type="checkbox"/>
Inconsistent diameter	<input checked="" type="checkbox"/>	<input type="checkbox"/>	<input type="checkbox"/>
Inconsistent flexibility	<input checked="" type="checkbox"/>	<input type="checkbox"/>	<input type="checkbox"/>

33. General view of the rope.

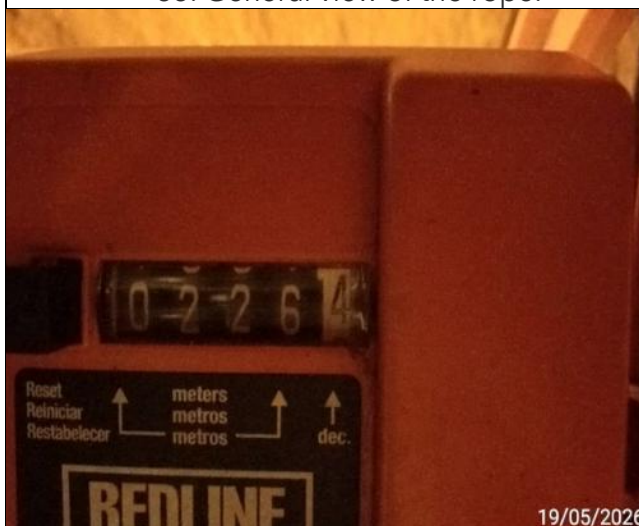
35. Measurement of the rope,
226.4 meters.

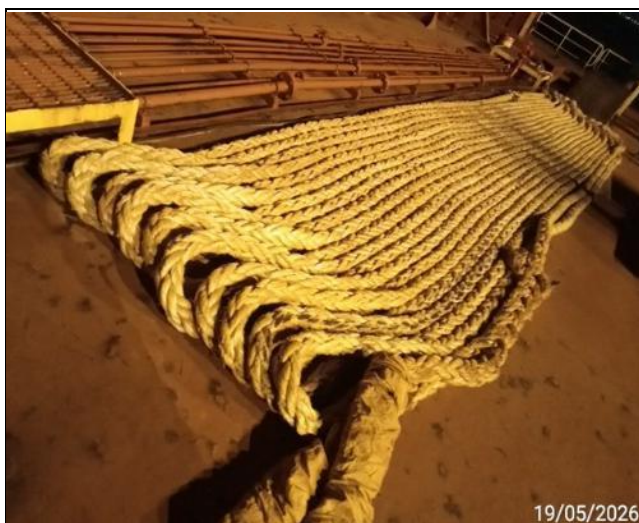
DAMAGE ITEM	GOOD	FAIR	POOR
Ext. Abrasion (max 25%)	<input type="checkbox"/>	<input checked="" type="checkbox"/>	Over 25% <input type="checkbox"/>
Int. Abrasion	<input checked="" type="checkbox"/>	<input type="checkbox"/>	<input type="checkbox"/>
Cut strands	<input checked="" type="checkbox"/>	<input type="checkbox"/>	<input type="checkbox"/>
Burn/ heated parts / fusion	<input checked="" type="checkbox"/>	<input type="checkbox"/>	<input type="checkbox"/>
Sun degradation /discoloration	<input checked="" type="checkbox"/>	<input type="checkbox"/>	<input type="checkbox"/>
Fiber broken	<input checked="" type="checkbox"/>	<input type="checkbox"/>	<input type="checkbox"/>
Black stains / dirty	<input type="checkbox"/>	<input checked="" type="checkbox"/>	<input type="checkbox"/>
Inconsistent diameter	<input checked="" type="checkbox"/>	<input type="checkbox"/>	<input type="checkbox"/>
Inconsistent flexibility	<input checked="" type="checkbox"/>	<input type="checkbox"/>	<input type="checkbox"/>

37. General view of the rope.

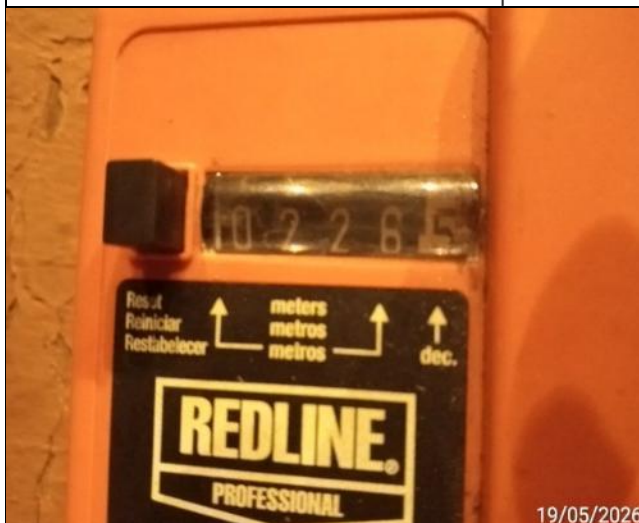
39. Measurement of the rope,
226.5 meters.

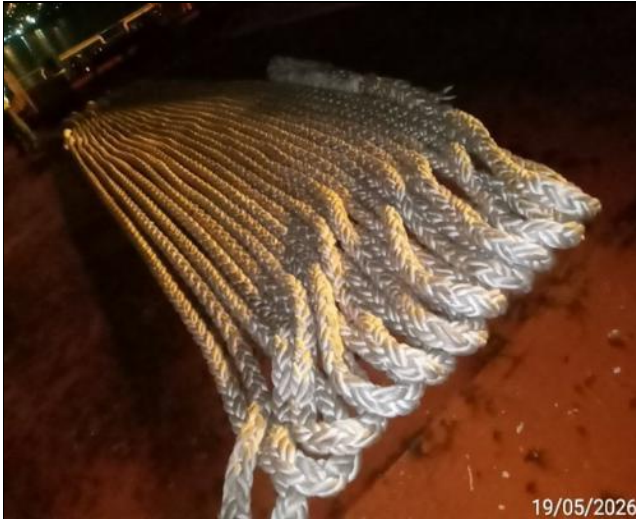
41. General view of the rope.

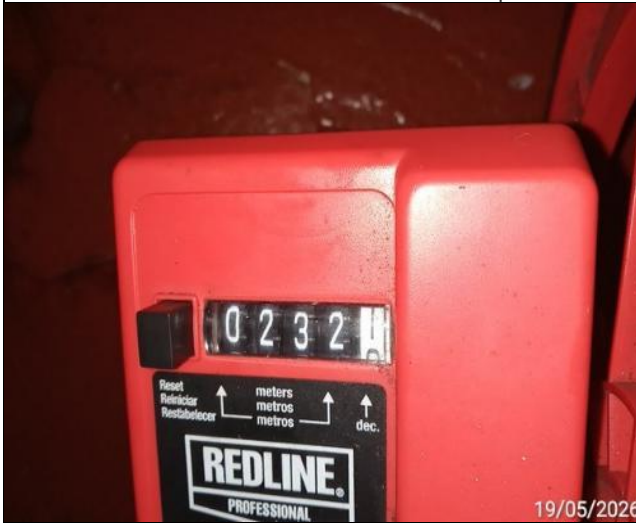
43. Measurement of the rope,
232.1 meters.

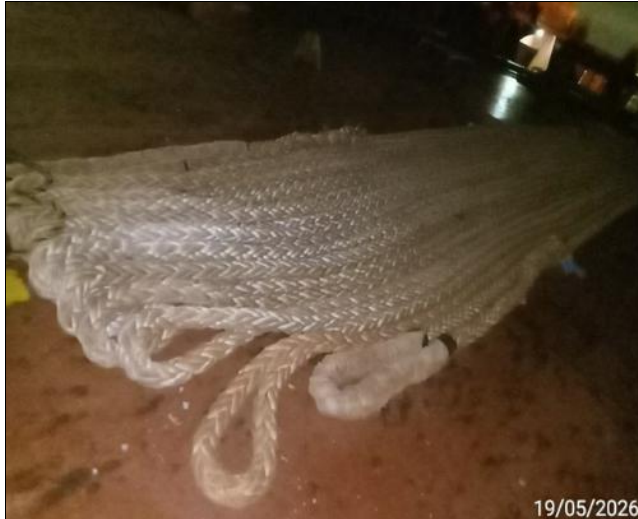
45. General view of the rope.

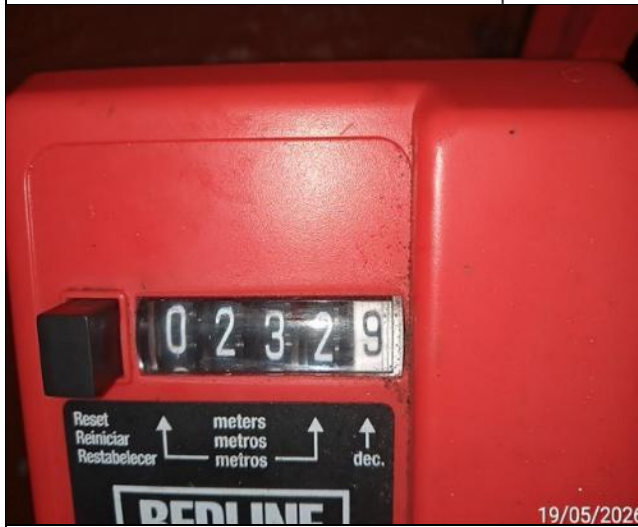
47. Measurement of the rope,
232.9 meters.

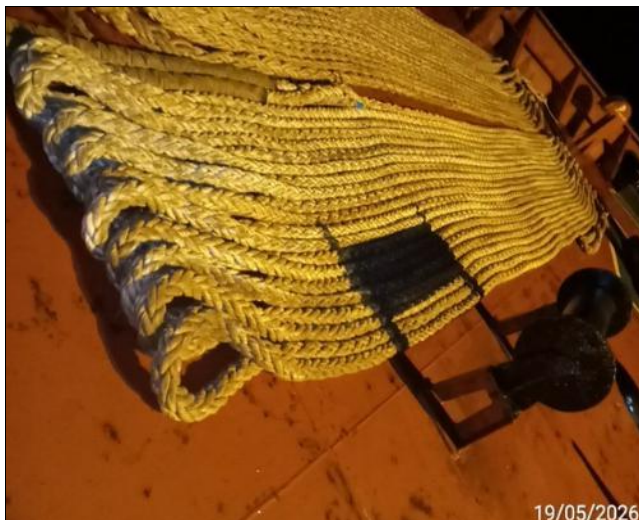
49. General view of the rope.

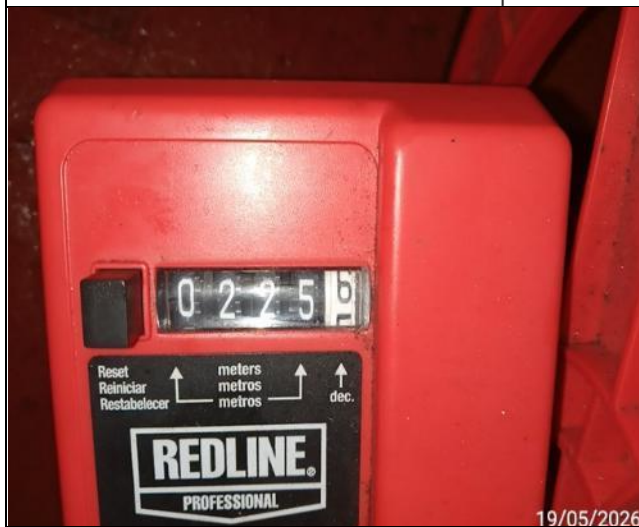
51. Measurement of the rope,
225.6 meters.

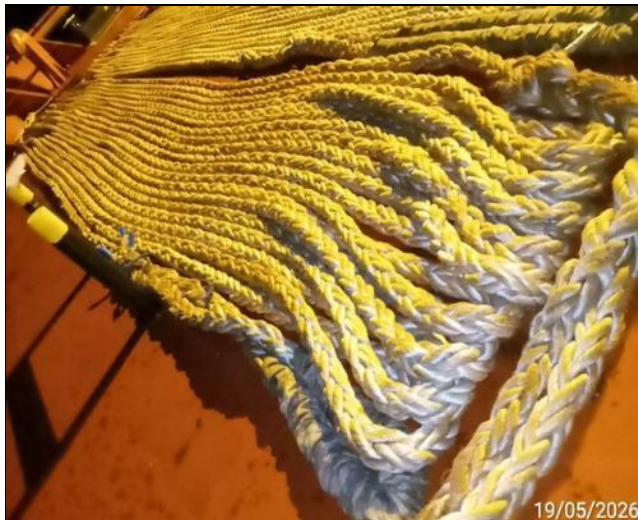
DAMAGE ITEM	GOOD	FAIR	POOR
Ext. Abrasion (max 25%)	<input type="checkbox"/>	<input checked="" type="checkbox"/>	Over 25% <input type="checkbox"/>
Int. Abrasion	<input checked="" type="checkbox"/>	<input type="checkbox"/>	<input type="checkbox"/>
Cut strands	<input checked="" type="checkbox"/>	<input type="checkbox"/>	<input type="checkbox"/>
Burn/ heated parts / fusion	<input checked="" type="checkbox"/>	<input type="checkbox"/>	<input type="checkbox"/>
Sun degradation /discoloration	<input checked="" type="checkbox"/>	<input type="checkbox"/>	<input type="checkbox"/>
Fiber broken	<input checked="" type="checkbox"/>	<input type="checkbox"/>	<input type="checkbox"/>
Black stains / dirty	<input type="checkbox"/>	<input checked="" type="checkbox"/>	<input type="checkbox"/>
Inconsistent diameter	<input checked="" type="checkbox"/>	<input type="checkbox"/>	<input type="checkbox"/>
Inconsistent flexibility	<input checked="" type="checkbox"/>	<input type="checkbox"/>	<input type="checkbox"/>

53. General view of the rope.

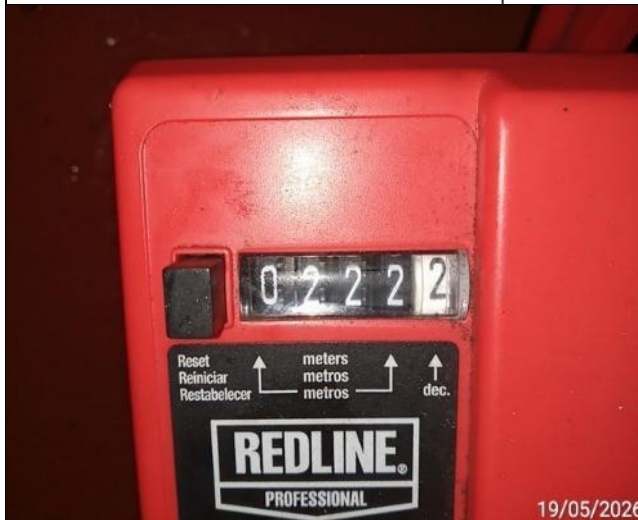
55. Measurement of the rope,
222.2 meters.

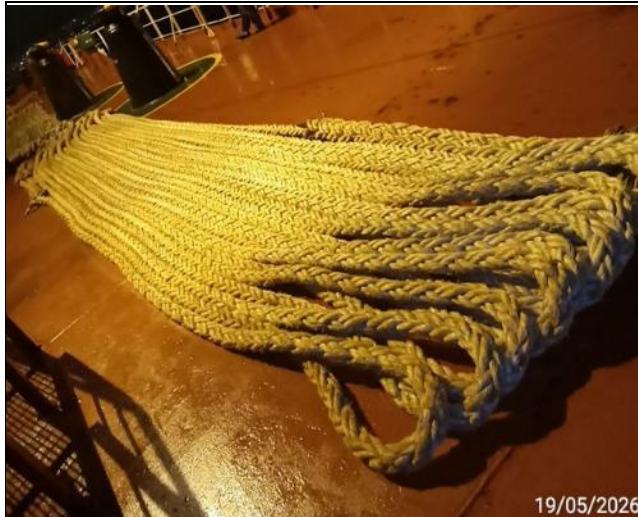
DAMAGE ITEM	GOOD	FAIR	POOR
Ext. Abrasion (max 25%)	<input type="checkbox"/>	<input checked="" type="checkbox"/>	Over 25% <input type="checkbox"/>
Int. Abrasion	<input checked="" type="checkbox"/>	<input type="checkbox"/>	<input type="checkbox"/>
Cut strands	<input checked="" type="checkbox"/>	<input type="checkbox"/>	<input type="checkbox"/>
Burn/ heated parts / fusion	<input checked="" type="checkbox"/>	<input type="checkbox"/>	<input type="checkbox"/>
Sun degradation /discoloration	<input checked="" type="checkbox"/>	<input type="checkbox"/>	<input type="checkbox"/>
Fiber broken	<input checked="" type="checkbox"/>	<input type="checkbox"/>	<input type="checkbox"/>
Black stains / dirty	<input type="checkbox"/>	<input checked="" type="checkbox"/>	<input type="checkbox"/>
Inconsistent diameter	<input checked="" type="checkbox"/>	<input type="checkbox"/>	<input type="checkbox"/>
Inconsistent flexibility	<input checked="" type="checkbox"/>	<input type="checkbox"/>	<input type="checkbox"/>

57. General view of the rope.

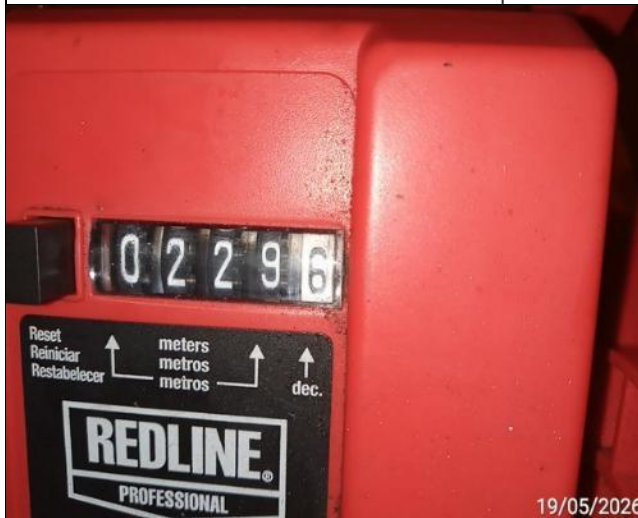
59. Measurement of the rope,
229.6 meters.

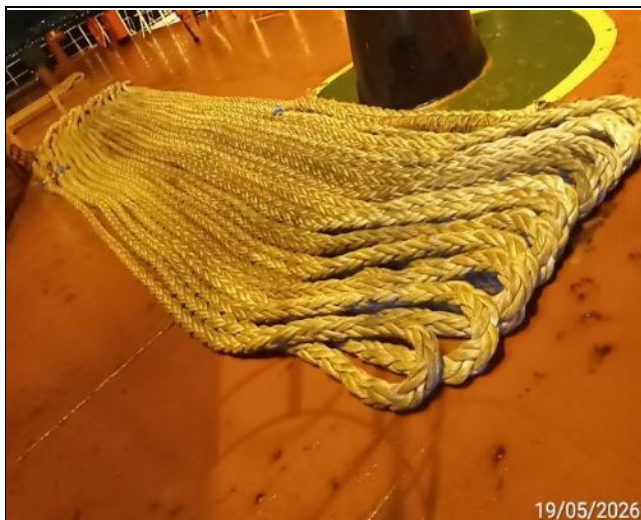
61. General view of the rope.

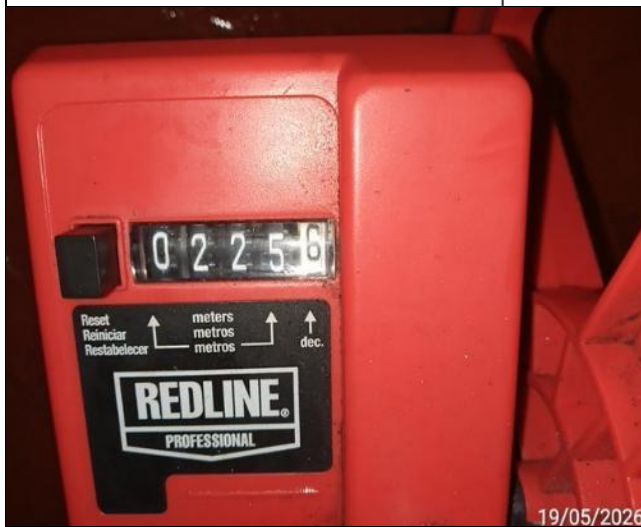
63. Measurement of the rope,
225.6 meters.

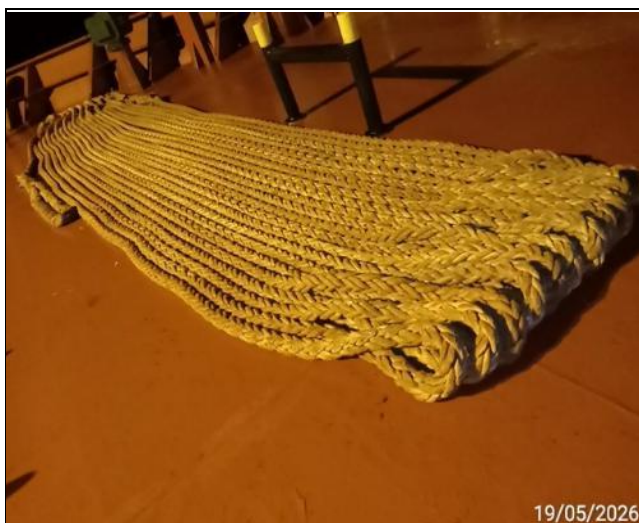
65. General view of the rope.

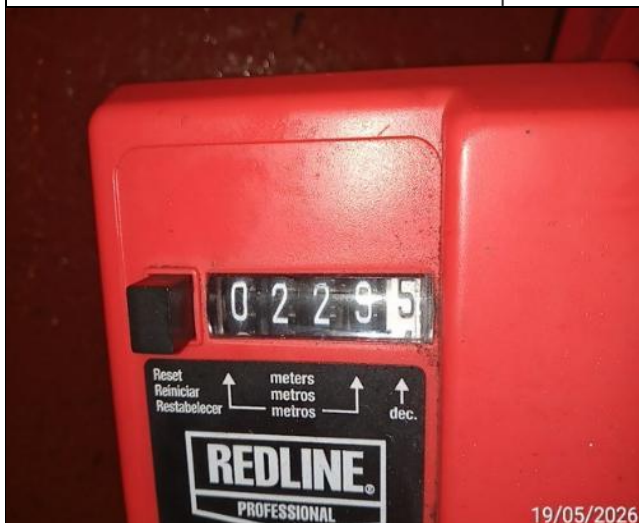
67. Measurement of the rope,
229.5 meters.

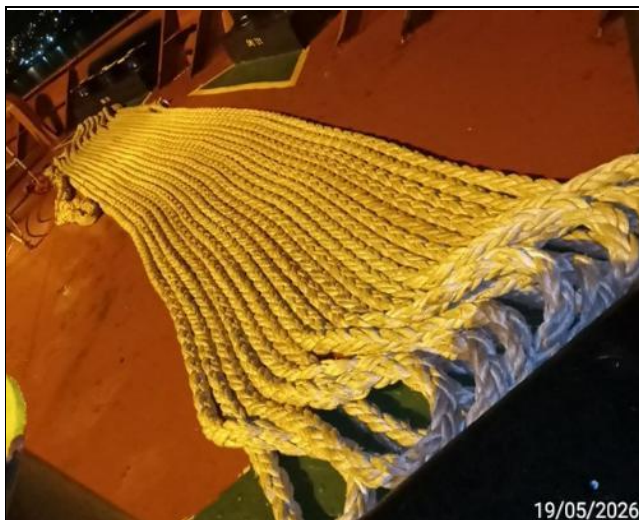
69. General view of the rope.

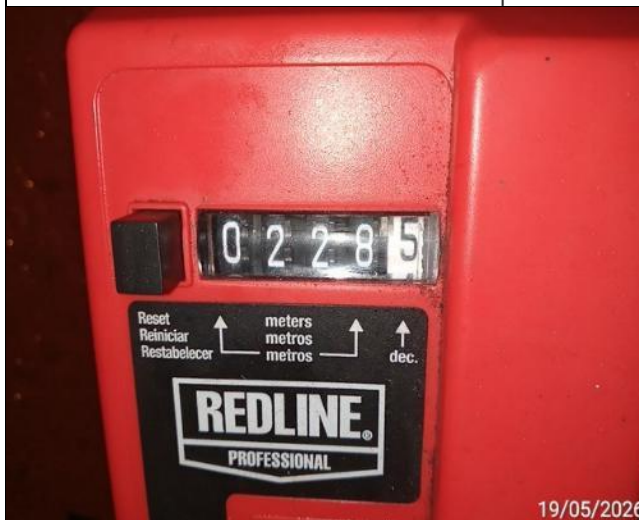
71. Measurement of the rope,
228.5 meters.
