CPA-2602-0598.,

Inspection Report

GENERAL INFORMATION	
Client	: Ocean Partners UK Ltd
Clients reference	: ZU5T586
ALS Reference	: CPA-2602-0598
Place of Inspection	: Contopsa inland terminals
Date of Attendance	: FEBRUARY 11 st , 2026
Material	: Secondaries Copper Concentrates B3 (perfilado de piso).
Surveyor	: ALS Inspection Chile SpA
Inspector	: Constanza Valladares

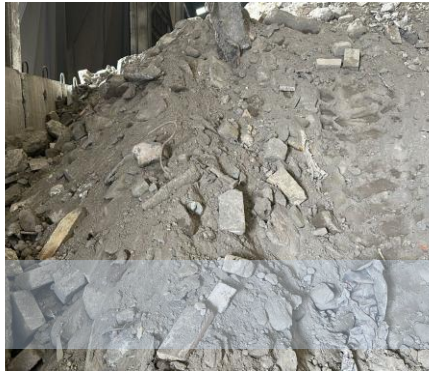
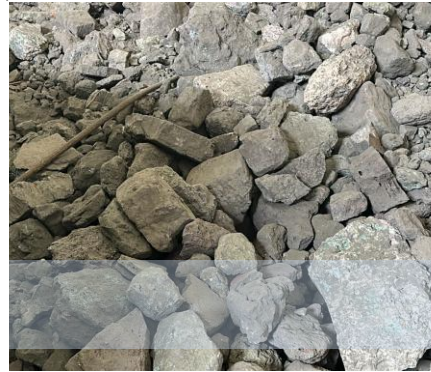
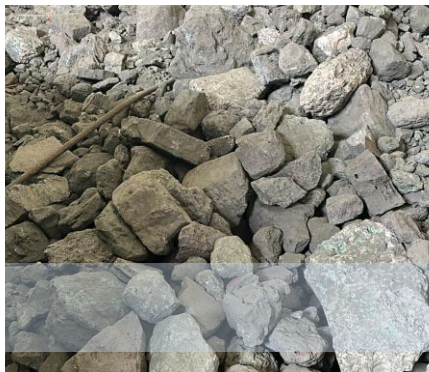
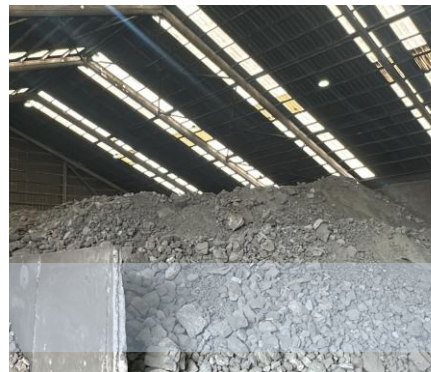
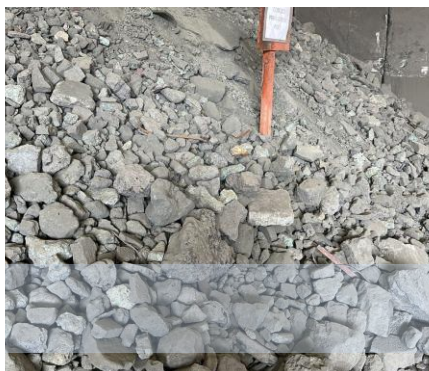
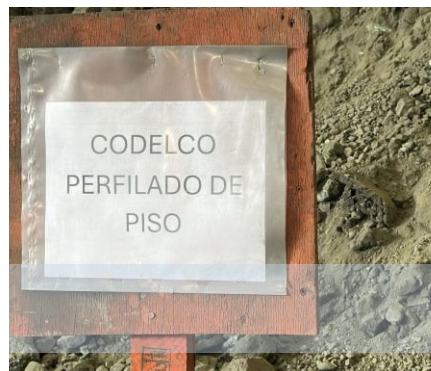
- The material consists of a collection of **rocks and mineral fragments of various sizes**, stored in what appears to be an industrial stockpile. The overall appearance suggests that it may be **metallic slag, crushed mineral, or raw rock**, based on its irregular shape and dusty surface.

- The predominant color is a **dull gray**, with some fragments showing **greenish or gray-green tones**, likely due to oxidation or specific mineral content. Several areas are covered with **light gray fine dust**, giving the material a matte, low-reflective appearance.

- The texture is **very rough and irregular**, typical of fractured rock or industrial by-products from smelting processes. Some pieces appear **porous**, while others are **dense and compact**. The surfaces are coated with **loose dust**, and many fragments show **broken or sharp edges**.

- **Estimated Particle Size Range**
 - **Large fragments:** Approximately **10 cm to 40 cm** ($\approx 4''$ to $16''$)
 - **Medium fragments:** Approximately **3 cm to 10 cm** ($\approx 1''$ to $4''$)

- **Fine fragments:** **Less than 1 cm** ($\approx < 0.4''$)

- The fragments show **irregular, angular shapes**, with sharp or fractured edges. They do not appear to be manufactured pieces, but rather **natural or residual material** resulting from breakage or industrial processing.
- Piles are located in a covered warehouse with concrete floor at Contopsa inland terminals, San Antonio-Chile
