INDEPENDENT SURVEY REPORT

Product: Frozen Tuna Whole Round Skipjack.

SURVEY REPORT No. 287-2026-AIP

Aivepet Inspecciones Peru SAC, in according to the instructions received from **ALS Inspection SpA**, on behalf **JAIS Srl company**, have carried out an arrival condition inspection, of 26,280.00 kgs of Whole Frozen Tuna in bulk condition, stuffed inside container N°HLXU 8778905. This product was produced on Albacora Caribe (factory ship-Coast of Ivory) and shipped on the following Vessels: AS CYPRIA V.2602N (2026/01/20), CLAUDIA /V 605N (2026/02/09) and CMA CGM ANTOINE V.6208S (2026/03/03); arriving to Callao Port on March 28th, 2026. This cargo was claimed by temperature loss.

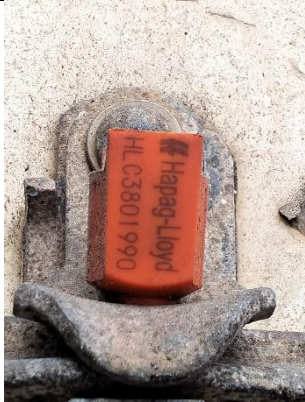
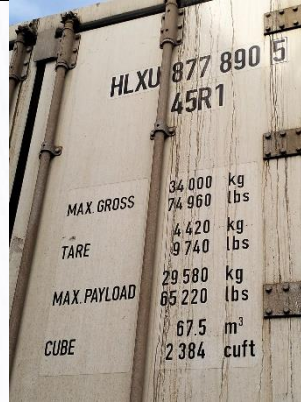
Container HLXU 877890-5 /Happag-Lloyd Line's Seal / Arriving to Seafrost Canned Factory

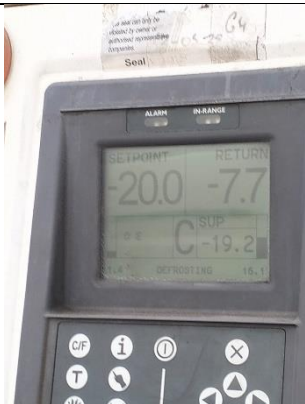
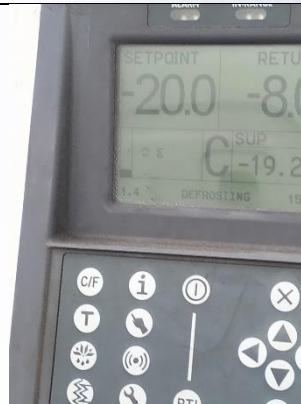
- In good order:	Yes.
- Any sign of manipulation:	No.
Exterior condition of container:	
- Holes/scratches, etc.:	No.
- Working condition of the reefer unit:	The reefer unit was connected, and the supply temperature was close to temperature range, but the return temperature was far from the frozen temperature requested for this product.

Bases on observations of the reefer unit operations, the air exits cold (-19,2°C) but returns very hot (-7,7°C), which demonstrates that the airflow does not have the force or the thermal mass to cool the load. According to the mark that was found handwriting on the front panel of the reefer unit, the unit presented short gas; with little gas, the evaporator only cools the area near the supply sensor but runs out of refrigerant to cool the rest of the coil. Therefore, the air circulating through the container is at an average temperature, that is unacceptable for keeping frozen the cargo at -20°C.

Frozen Unit : Set point - 20.0 °C, Supply Tempertature -19.2°C, Return Temperature -7.7 °C

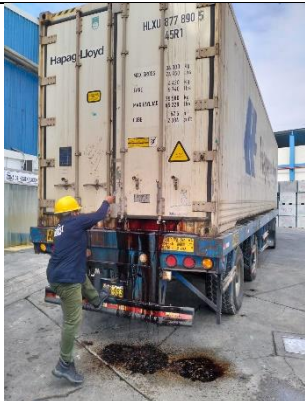
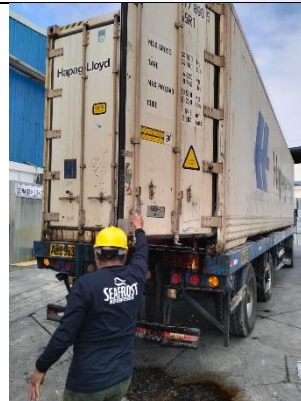
- External marks:	Short gas 50% (Was observed handwriting on the control panel of the reefer unit).
Interior condition of container:	
- Clean, watermarks, holes:	The container floor was flooded with water mix with blood of the thawing of the fish.

Opening the container - View of a liquid mixture of water and blood from the thawed product was observed.

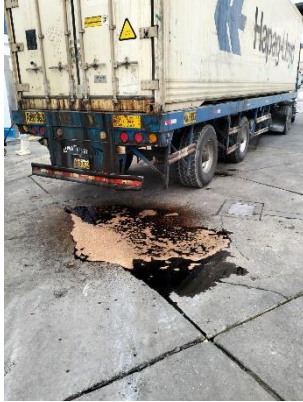
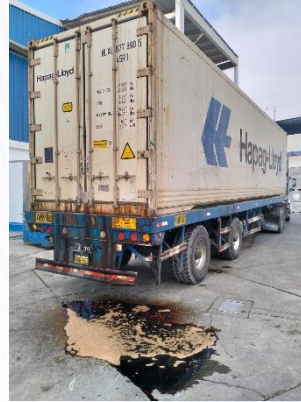
- Drains:	Open, but covered with the decomposing product.
- Smell:	Smell of decomposition and rancidity.

This survey was concluded since according Seafrost Company Plant Manager, the product was declared unsuitable as raw material for the canning process and requested to close the unit, due to the presence of abundant liquid that was spilling from inside the container, creating a source of contamination in that area.

Liquid mixture of water and blood was observed draining from the bottom of the reefer and a larger volume of this liquid was drained from the container was opening.

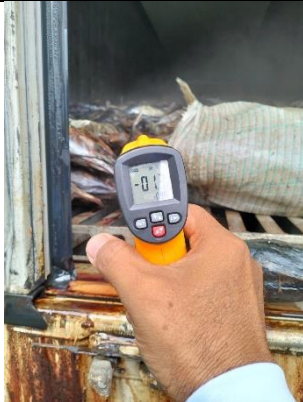
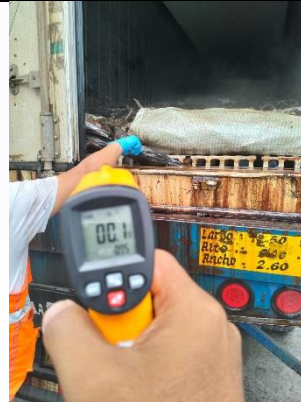
Temperature Control : - 1.3 °C, 0.01 °C (defrosted producto)

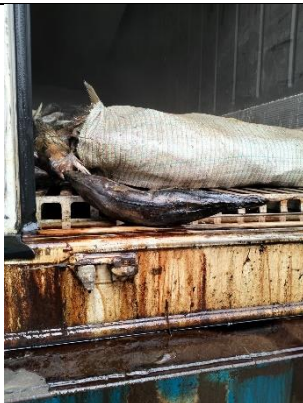
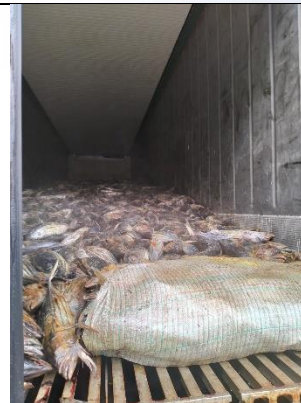
**View of the cargo into the container
View of a liquid mixture of water and blood from the thawed product was observed**

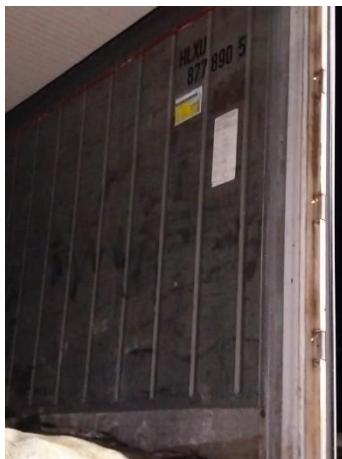
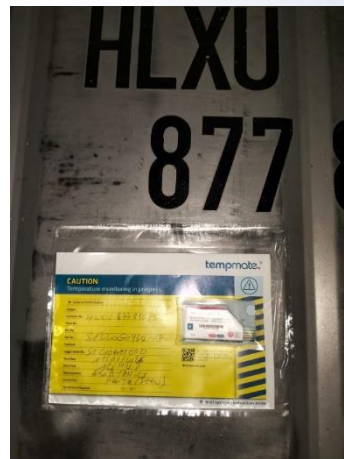
We also weren't provided with the shipper's thermograph "Tempmate N° S122060934-08", so we can't comment from the temperature behavior during the transit time, since the cargo were loaded into the reefer unit N° HLXU 877890-5 on January 11th, 2026, until May 19th, 2026, when it was open at Seafrost's premises at Paita, Perú.

Tempmate -1 temperature control device No. S12206050934-08

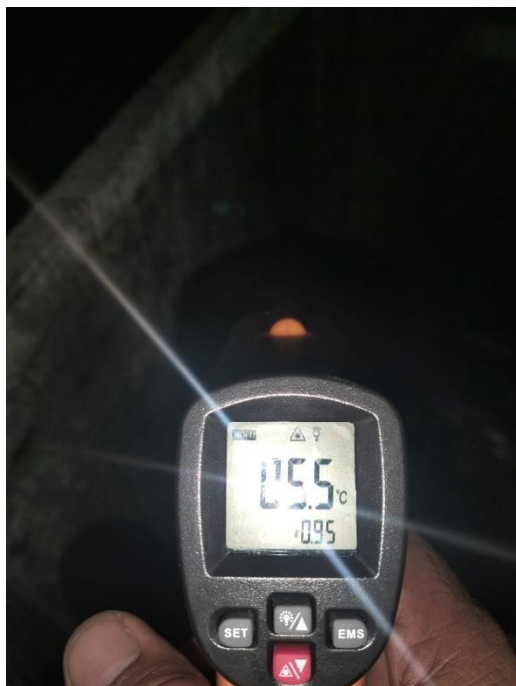
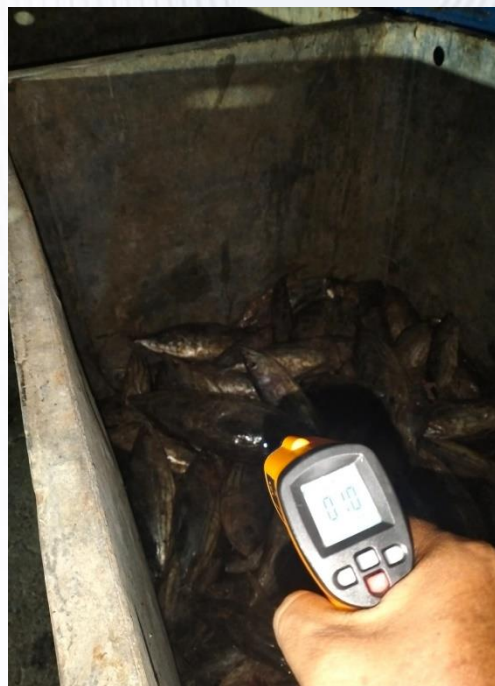
- The first unload process took place on May 19th, from 19:30 hrs. until 00:30 hrs., and the second part took place on May 20th from 07:30 hrs. to 08:35 hrs. (LT).
- The container contains whole Tuna on bulk condition.
- The container arrived from the Seafrost canning premises with the seal N°0018766-Seafrost S.A.C.
- The reefer unit`s refrigeration equipment was off.
- Upon opening the containers doors and beginning the unloading process of the product, it was observed that the unit contained temperature register of the brand “Tempmate 51” N°S122060934-08, Model S1C10A01000, which was attached with tape to the inner panel of the container.
- The load was observed to be in a defrosting condition.
- During the unloading process, the cargo temperature was checked, and it were found with temperatures of 5,5 °C, 3,9 °C, 8,4 °C, 15,8 °C, 12,2 °C and 5,7 °C.

Control Temperature (5.5°C, 1.0°C)

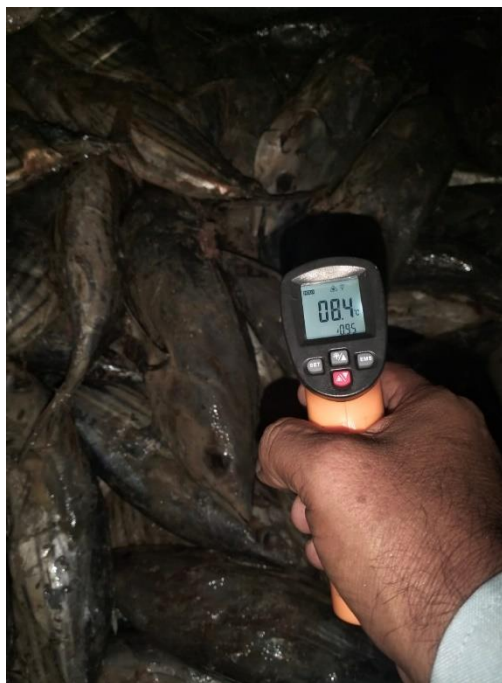
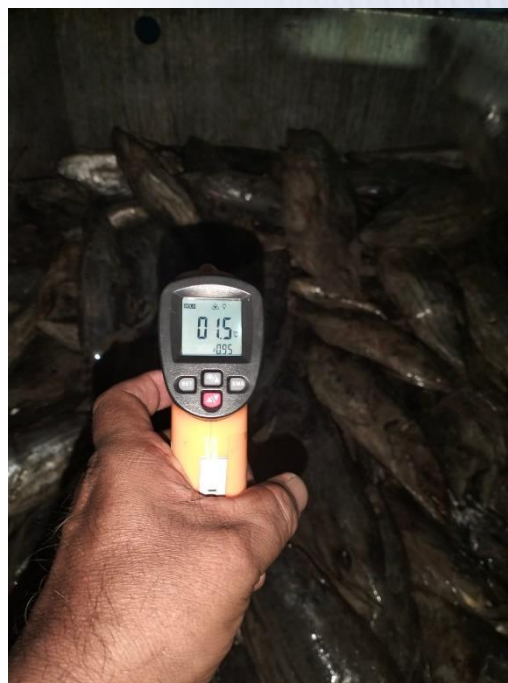
Control Temperature (8.4 °C, 1.5 °C)
