M/V “MSC EDNA”

10th – February– 2026

PORT OF BILBAO

SUBJECT	ACTION AS MARINE SURVEYOR
VESSEL	M/V "MSC EDNA"
PORT	BILBAO
PIER	CSP Iberian Bilbao Terminal
DATE	10th February 2026
OPERATION	Preloading, Loading and Lashing, survey.
PORT OF DESTINATION	CORONEL (Chile)
GOOD	Two airport walkways

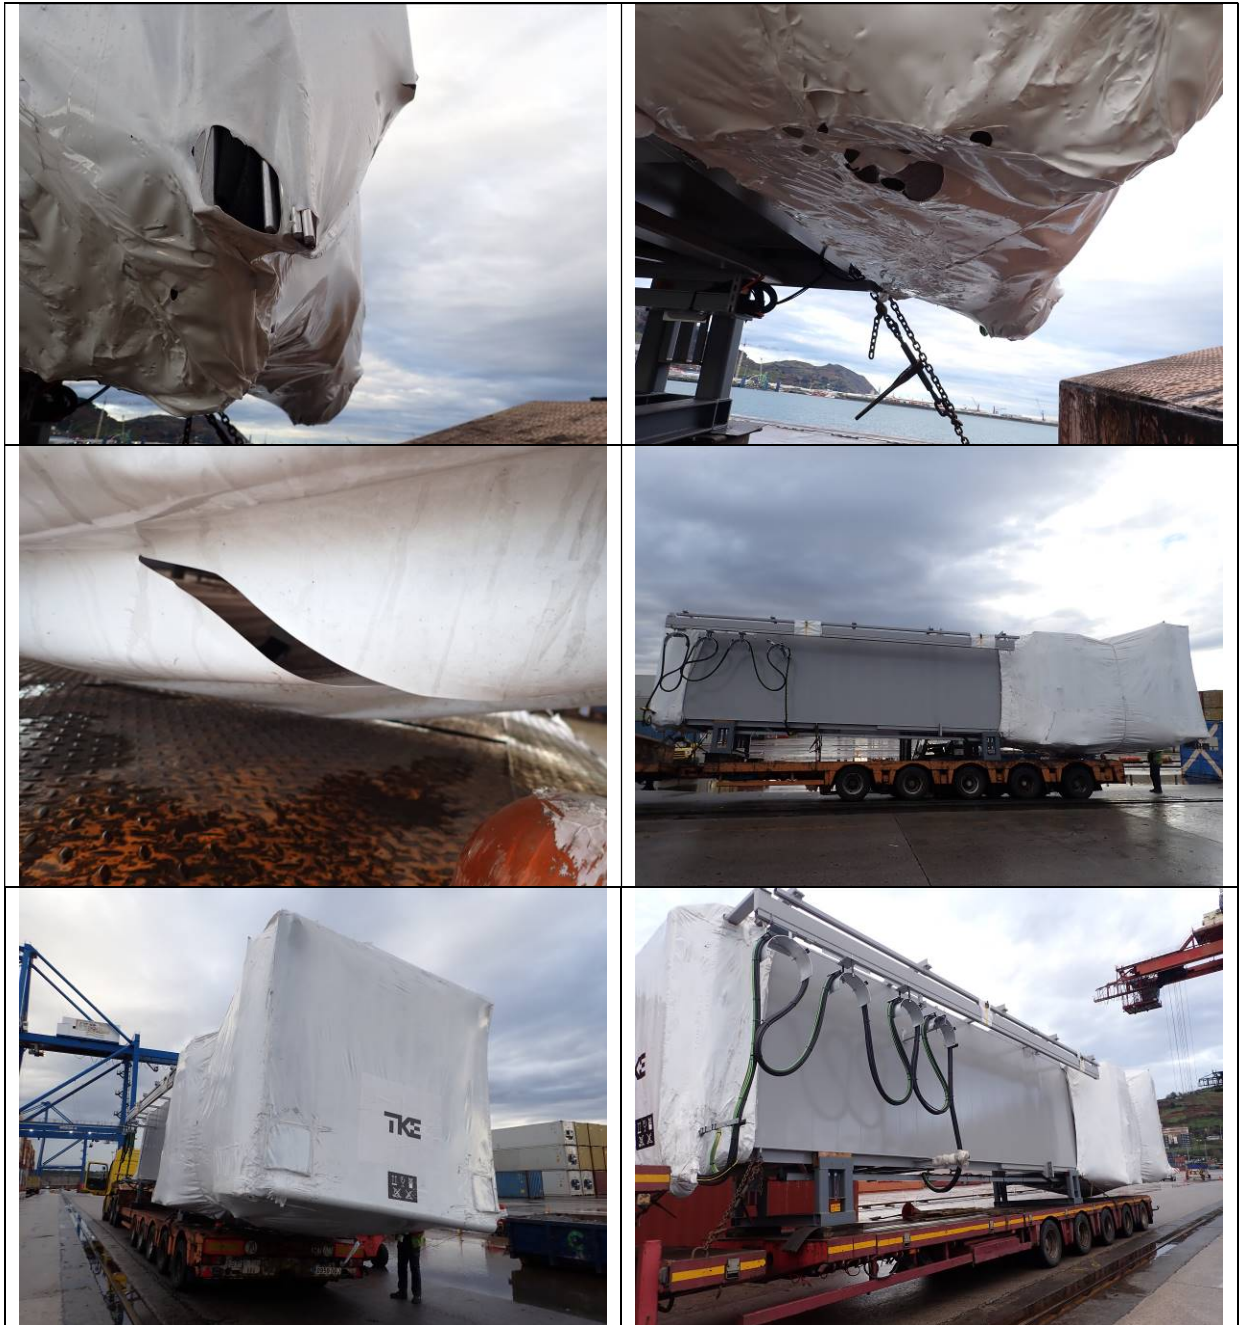
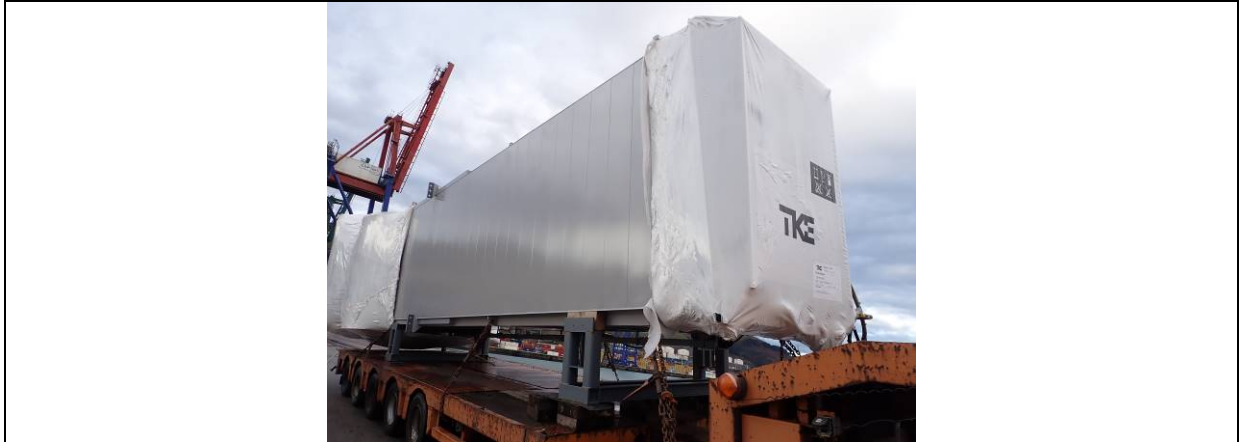
- 1. Project No 1015-01:** shrink-wrapped plastic with small tears at the tunnel end, and cut on the lower part of bridgehead end (to remove water inside).

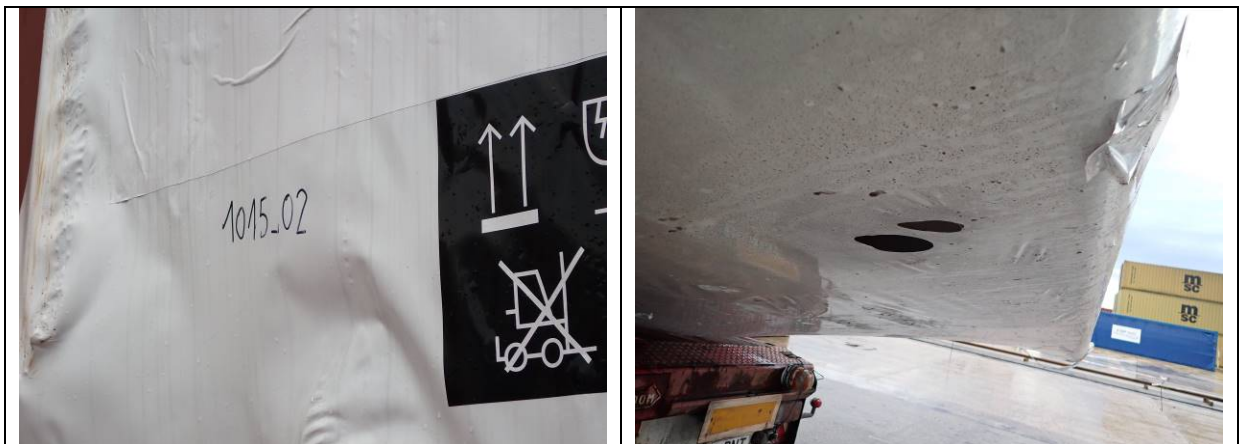
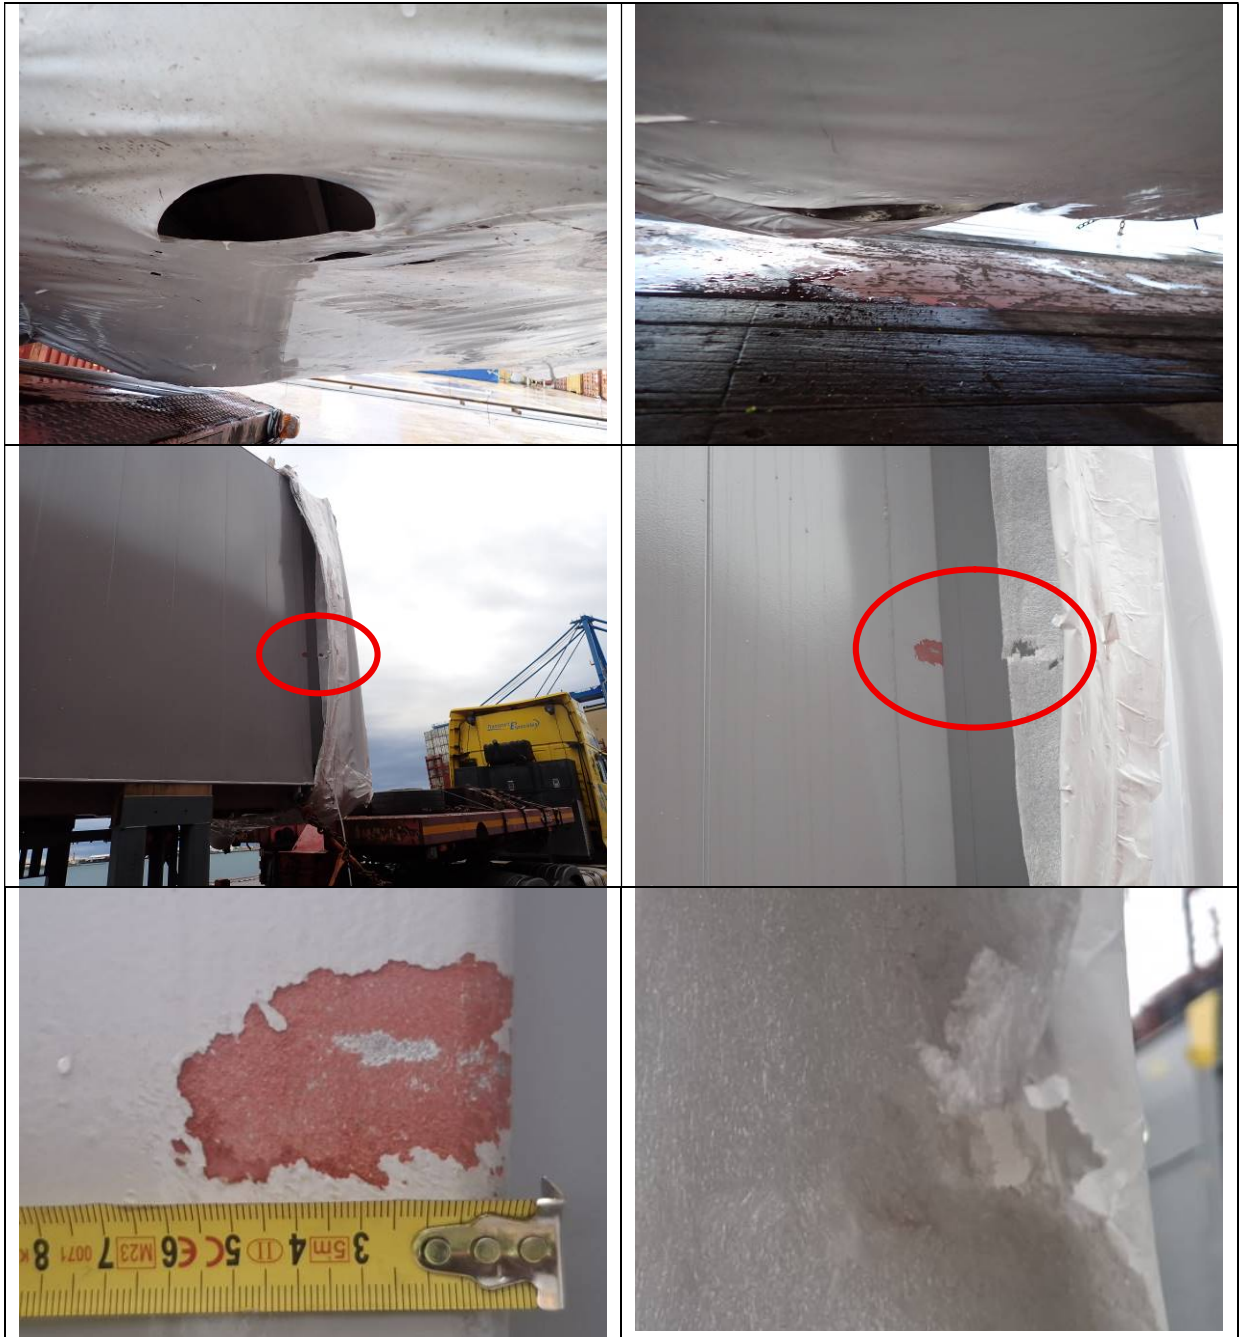
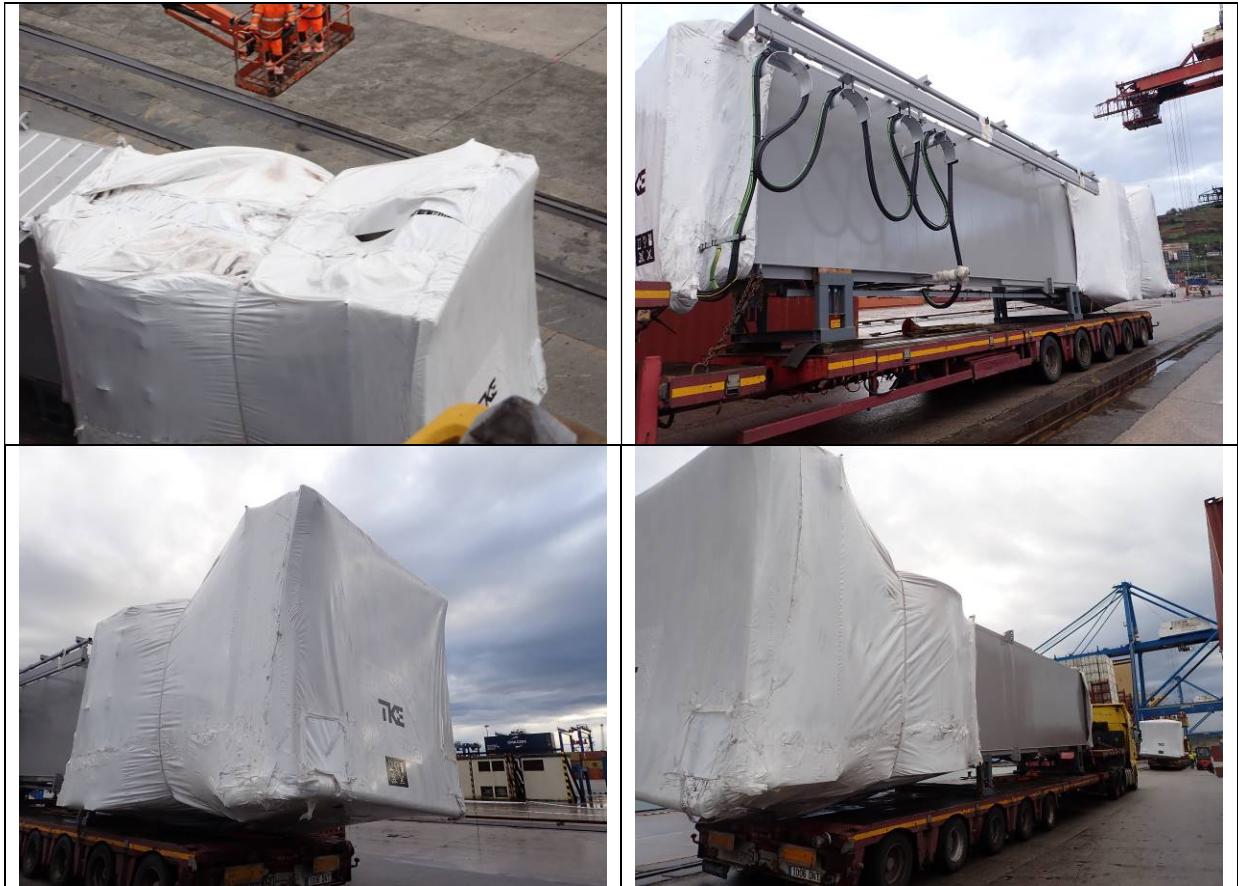
- 2. Project No 1015-02:** Without info label (only project No. written), shrink-wrapped plastic with small tears, and cut on the lower part of bridgehead end (to remove water inside), and an area with the paint removed on the tunnel end, and plastic unstick. This damage was rechecked as soon as the cargo was loaded and I have access, and on the same area, the foam and the shrink-wrapped are damage too, which indicates that it occurred during road transport. Also, during the loading operations, it was noted that on the top of the bridgehead, the shrink-wrapped was loose

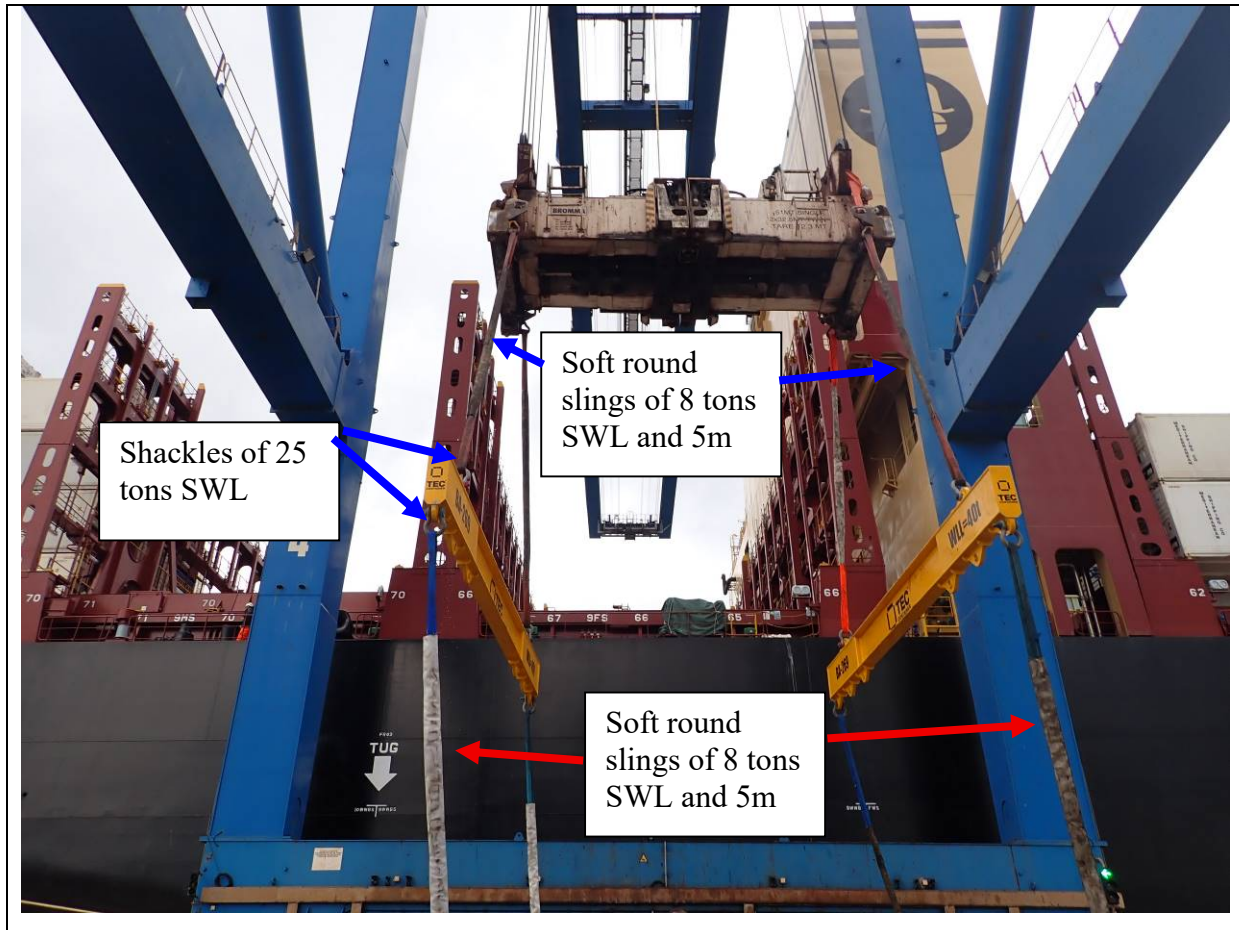
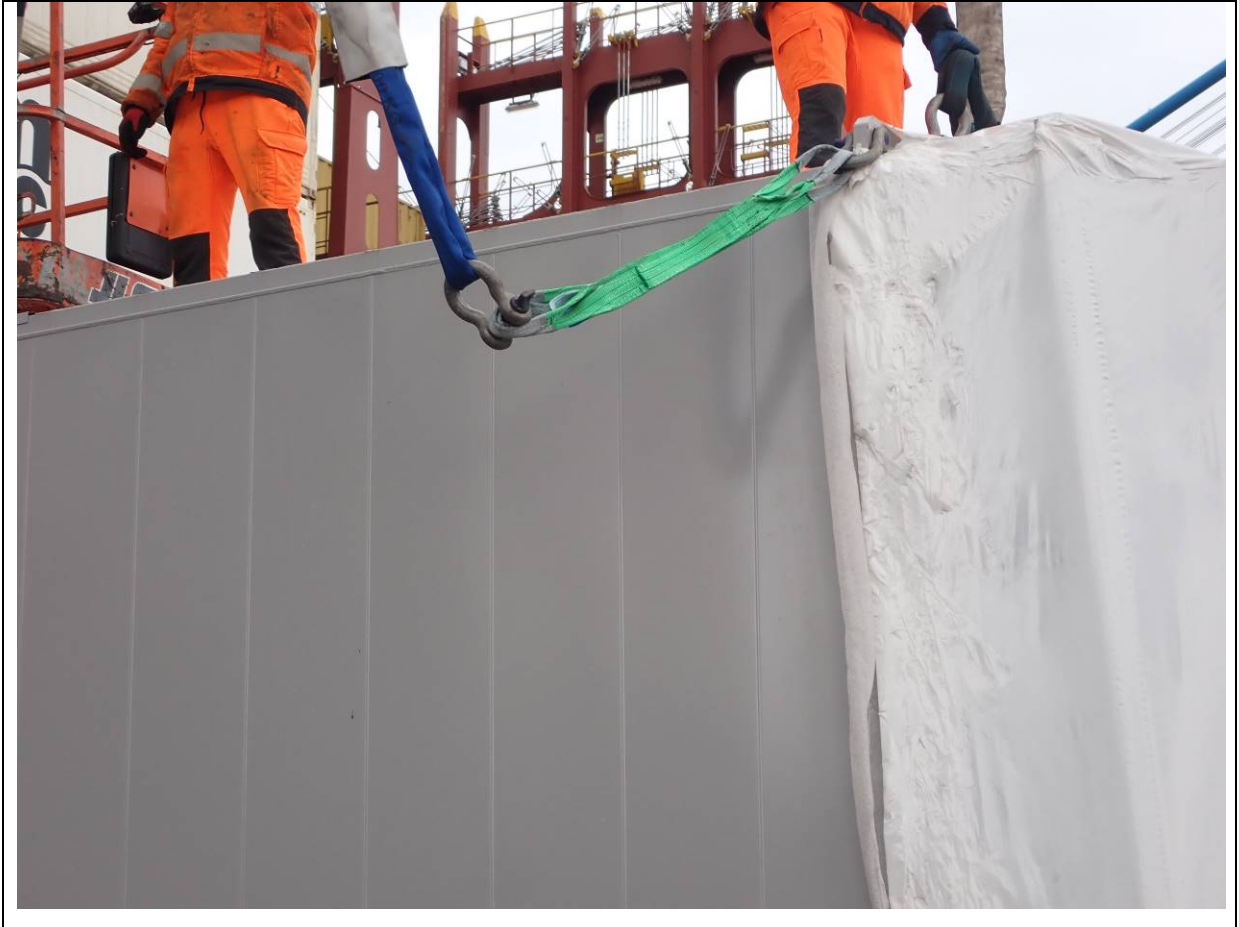
- Gantry Shore crane, PACECO with a container spreader with lifting capacity of 65 tons.
- With the container spreader closed to load 20', the following rigging was connected:
 - On each corner (SWL 15tons), a soft round sling of 8tons SWL and 5m. Each 2 slings, connected with a shackle of 25 tons SWL to a beam spreader of 40m and 6m. From these 2 beam spreaders, connected by shackles of 25 tons SWL, 4 soft round slings of 8 tons and 5m. From

these 4 soft round slings, on the bridgehead, two shackles 12 tons SWL, and on the tunnel end, in order to lift on horizontal way, it was lengthened by means of 2 shackles of 12 tons SWL and 2 flat slings of 2 tons and 1.5m in double, and connected to the lifting points by means of shackles 12 tons SWL.

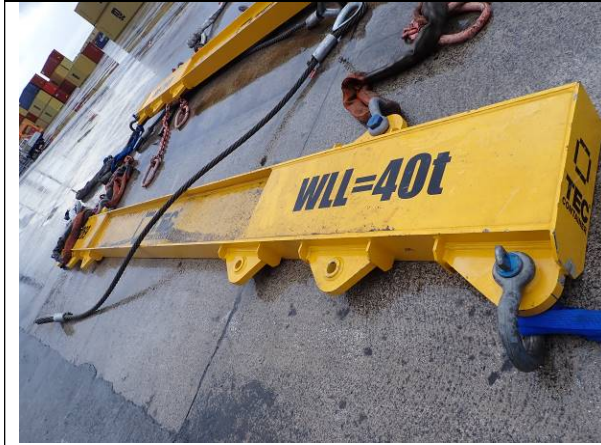
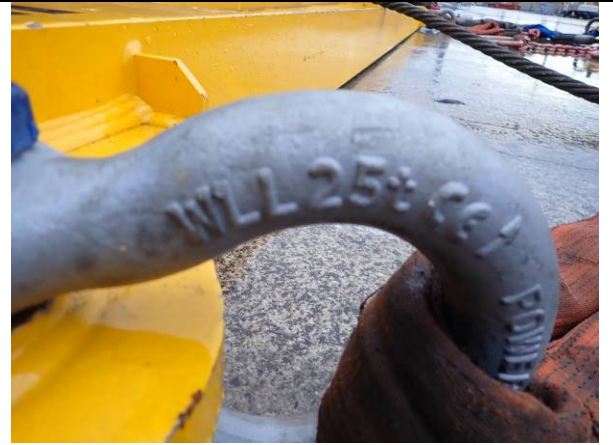
Rigging elements

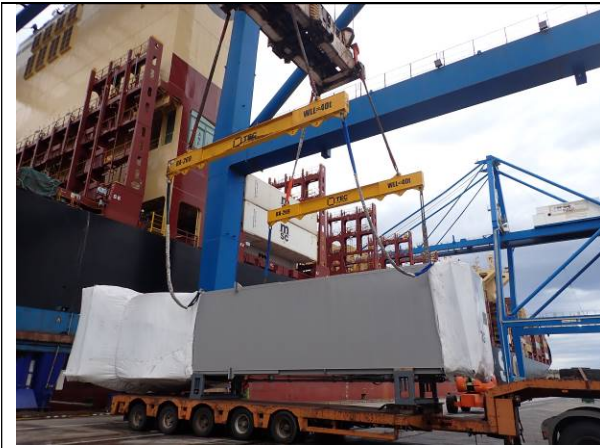
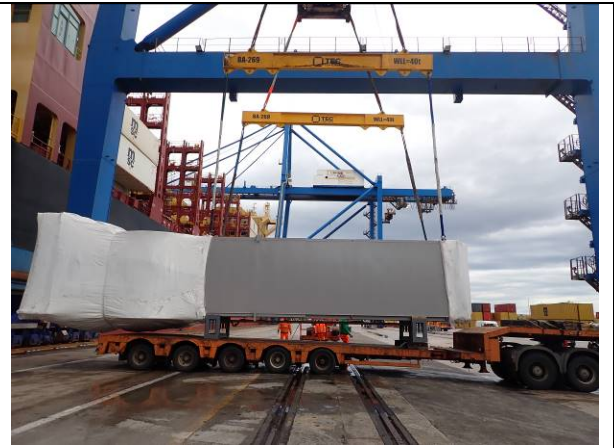
At 11:10hrs, first piece hooked and the crane hook up to tight, and is observed that, as we had expected, the tunnel end lift before the bridgehead.

First lifting in which was observed that the lifting will be not horizontally

The rigging was modified, lengthening the slings that hook on the tunnel end with a shackle 12tons and a flat sling 2tons and 1.5m in double.

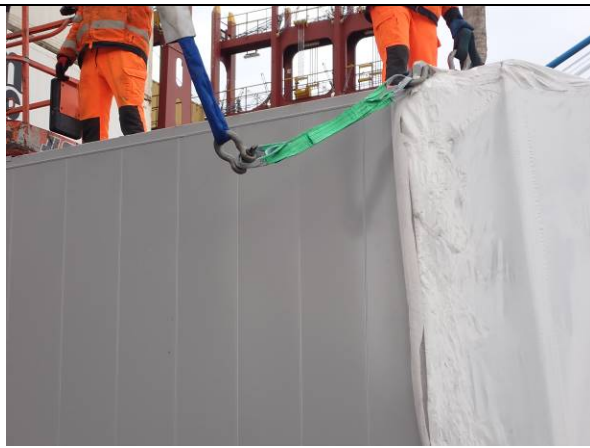
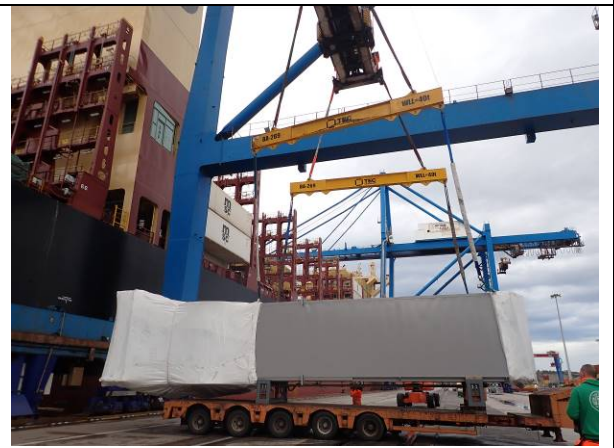
Lifting with rigging modified and correct

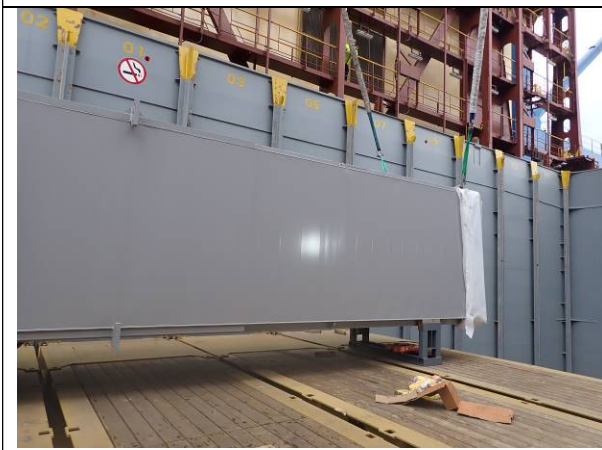
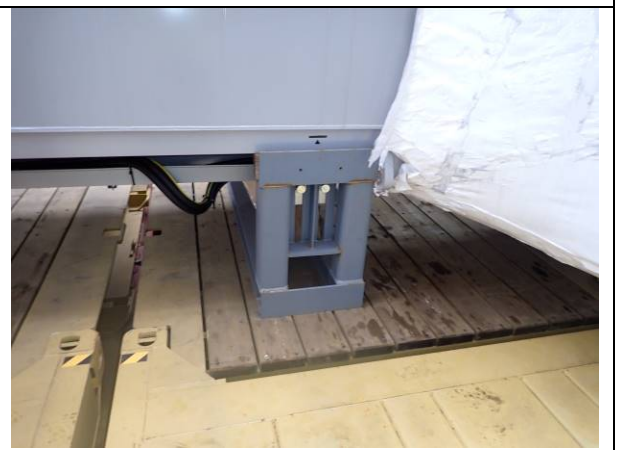
Cargo stowed on transversal way in the bay 66 on a bed of 6 x 40' Flat Racks, placed on the rows 05, 03, 01, 02, 04 and 06, on the tier 08

Stowed on board

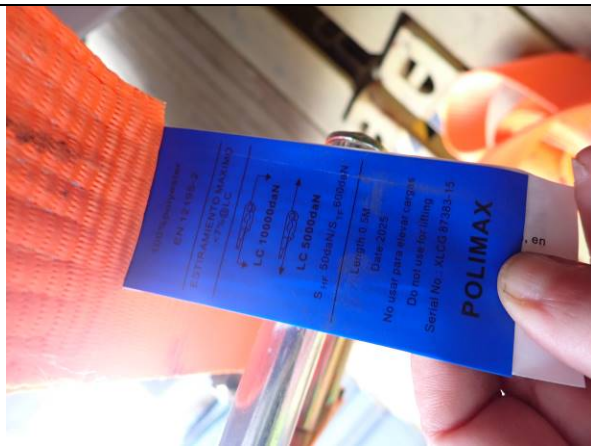
The lashing jobs were performed using webbing belts with ratchet of 2.5 tons in double (5tons SWL) and 5 tons SWL

Lashing belts used

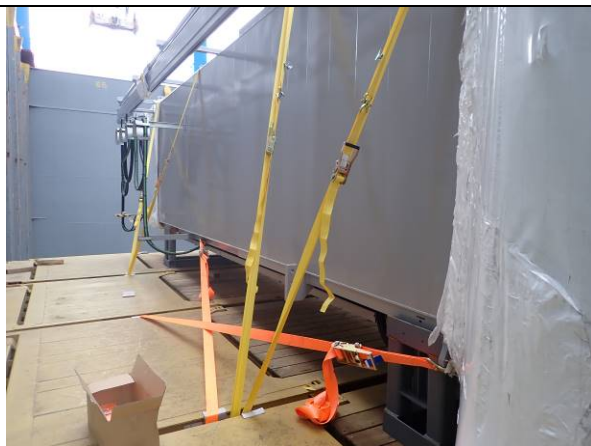
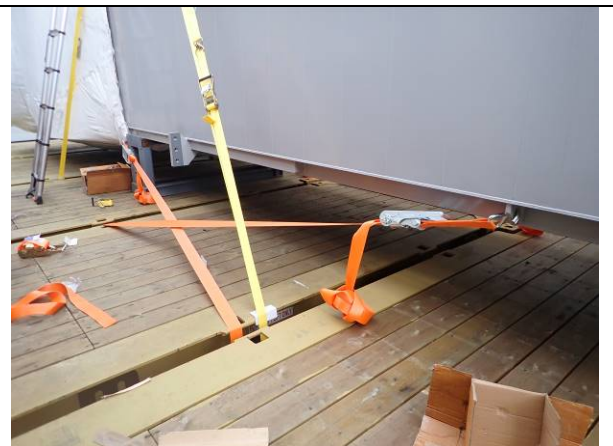
- Two belts of 5 tons crossed, working per rolling and pitching, per side and fasten on the lower lashing points,
- Four belts of 2.5 tons on double, working per rolling and pitching, per side and fasten on the lifting points and top lashing points.

Lashing per side
