MOTOR VESSEL "APEX" V. 54

SHIP'S GRABS AND CRANES, HATCH COVER, HATCH COAMING & HOLD INSPECTION

This is to certify that the undersigned representative of **ALS INSPECTION CHILE SpA** did, at the request of **Mr. Osvaldo Morales Cáceres**, from **EMPREMAR S.A.** attending on board motor vessel **"APEX"** with the Master consent, on November 03, 2025, as she was anchored at Caleta Patillos Terminal, Chile, to report upon Grabs & Hatch covers condition.

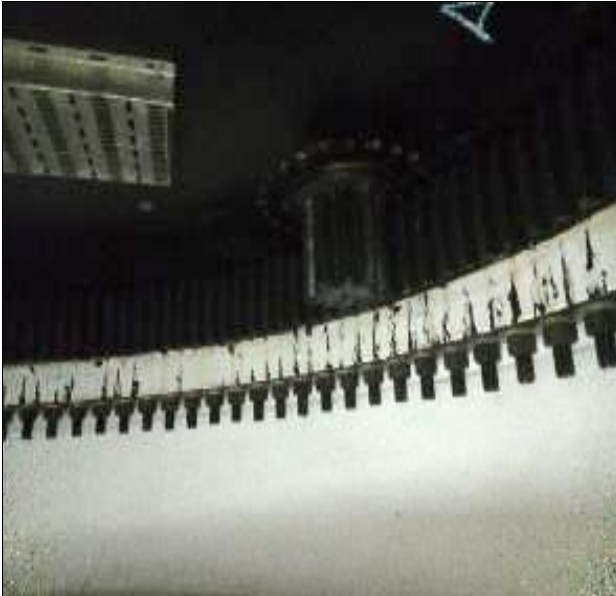
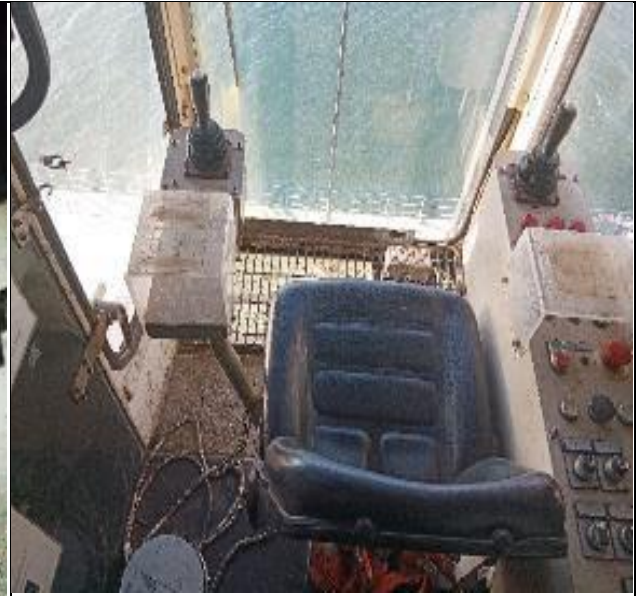
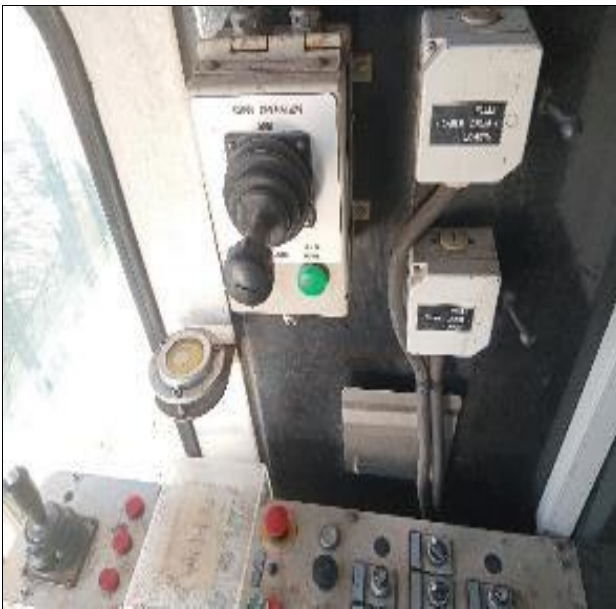
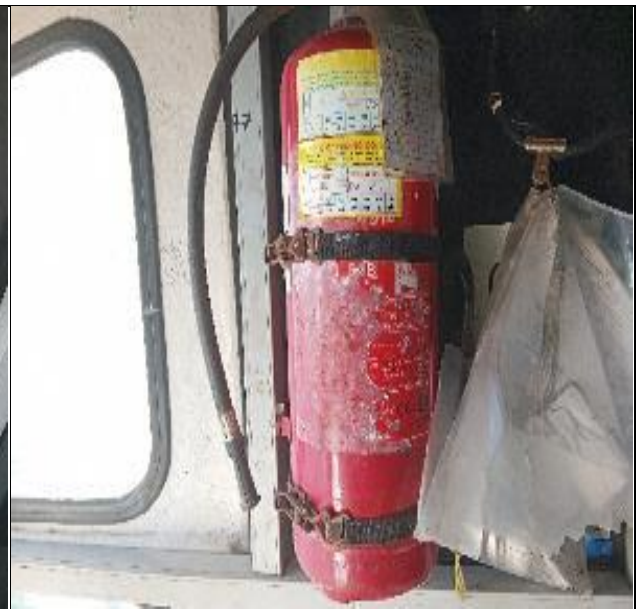
Nr. 1: The windshield wiper rubber was observed be in poor condition.

Nr. 2: Without ventilation and heating in the cabin.

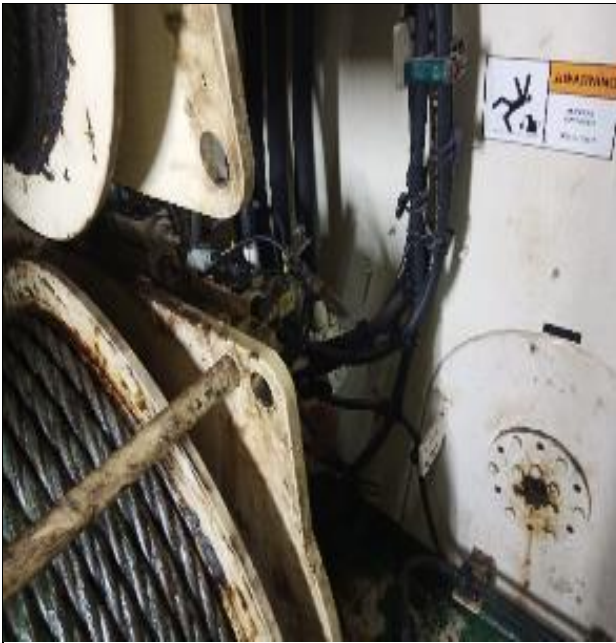
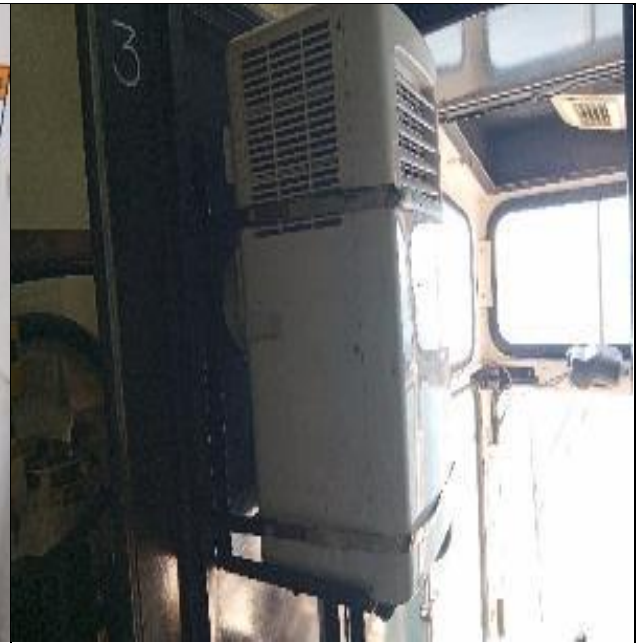
Nr. 1: The windshield wiper rubber was observed be in poor condition.

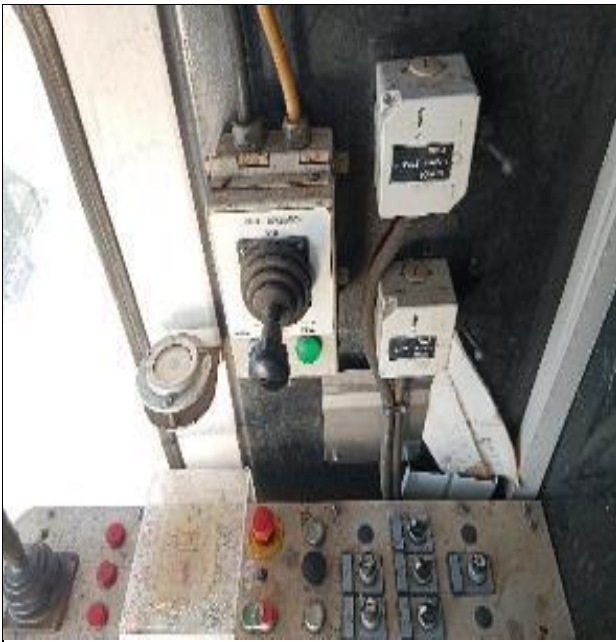
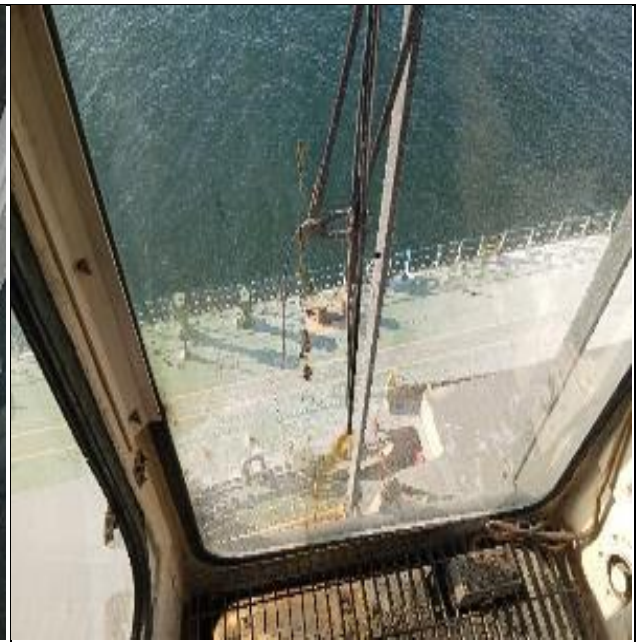
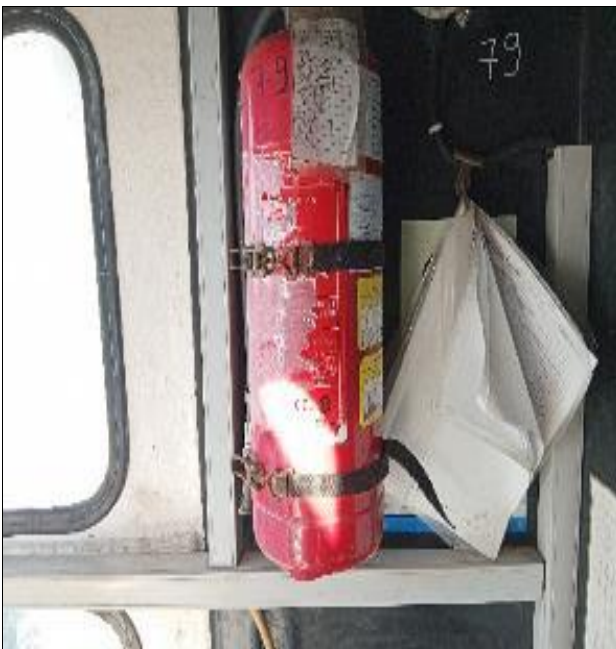
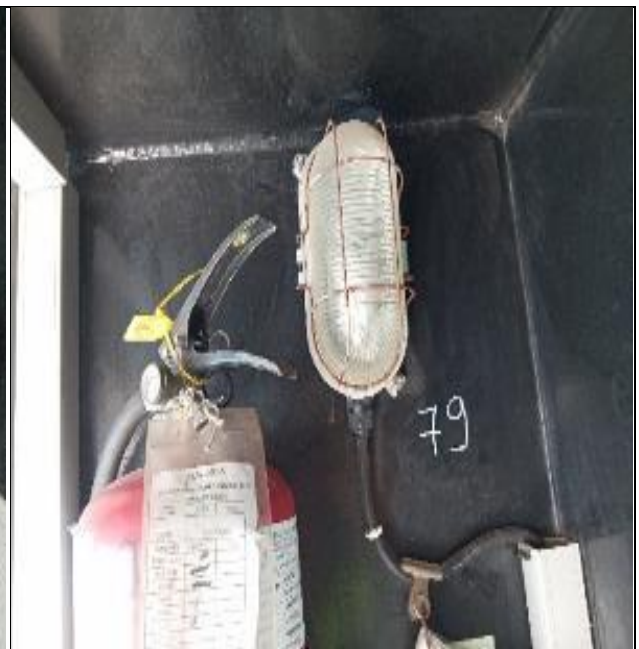
Nr. 1: The windshield wiper rubber was observed be in poor condition.

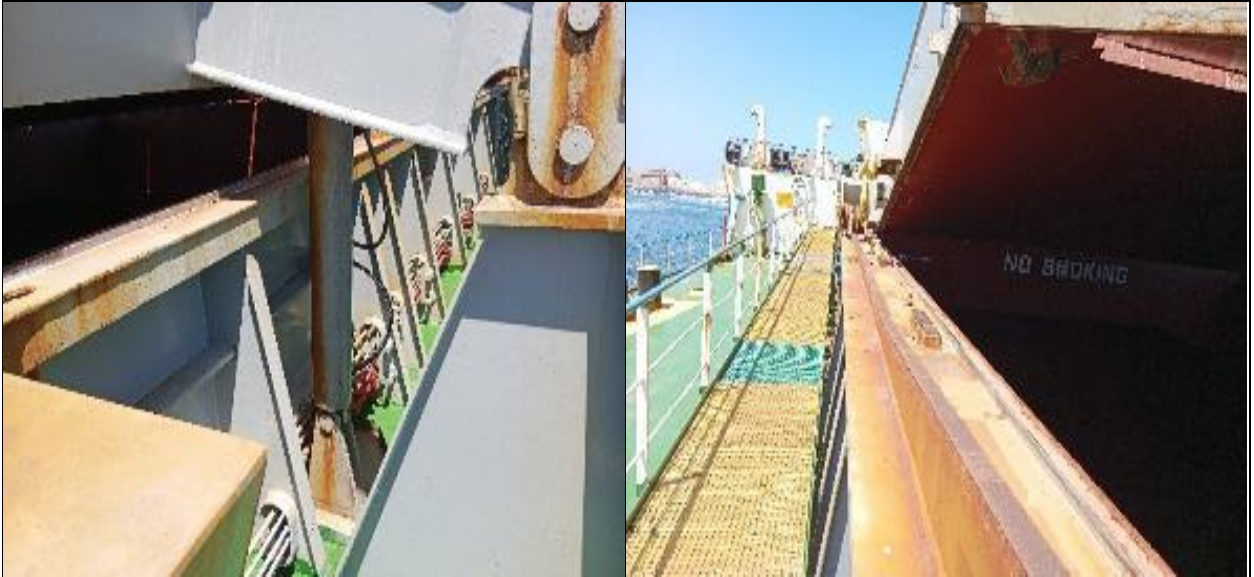
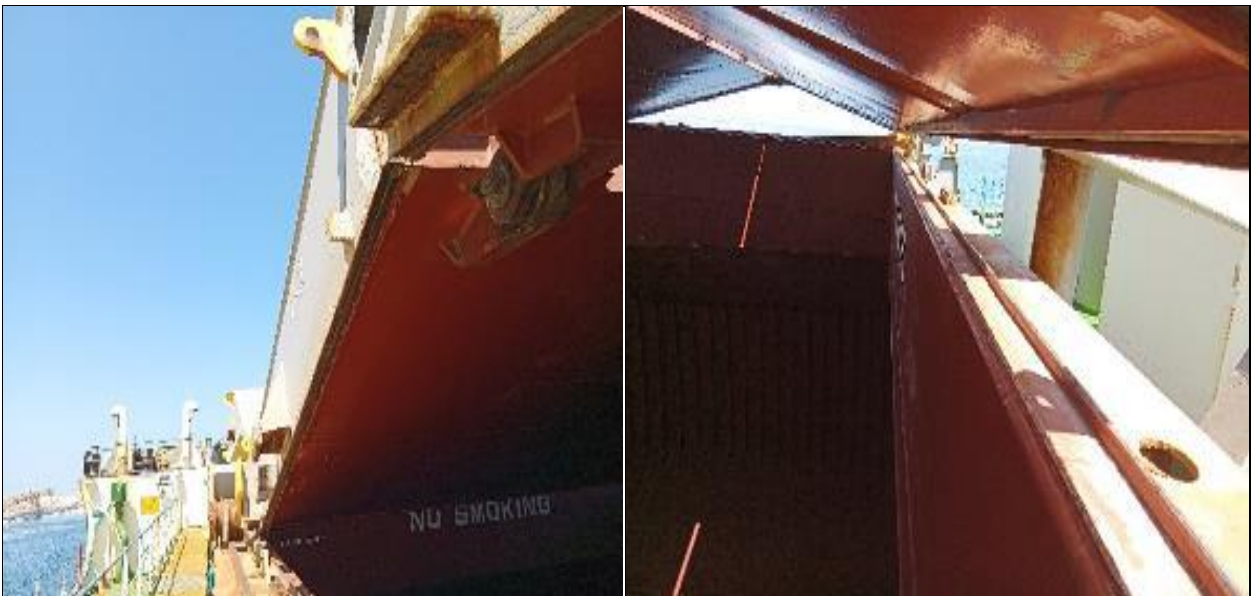
Hold Nr.1

All cargo holds, closing system were inspected, drain hole, compression bar, rubber gasket, hydraulic system, action cleats and non-return valve, all of them were found in good conditions.

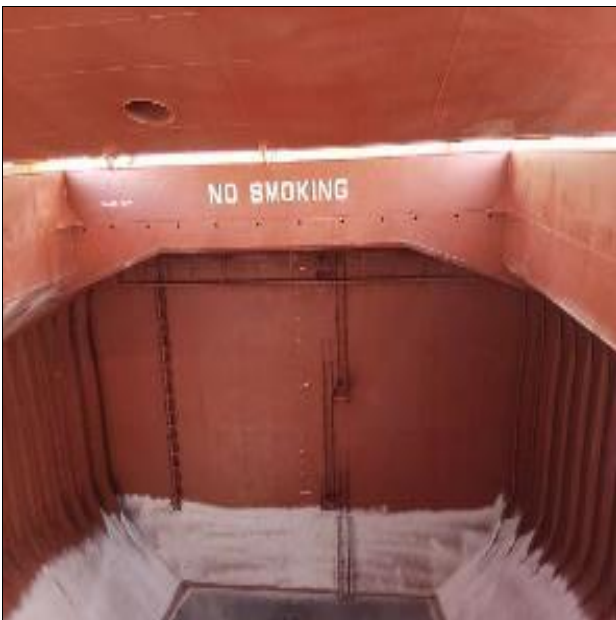
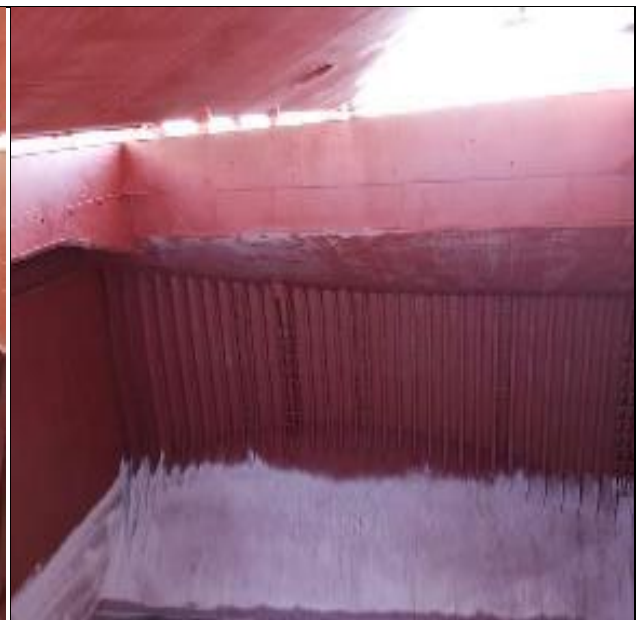
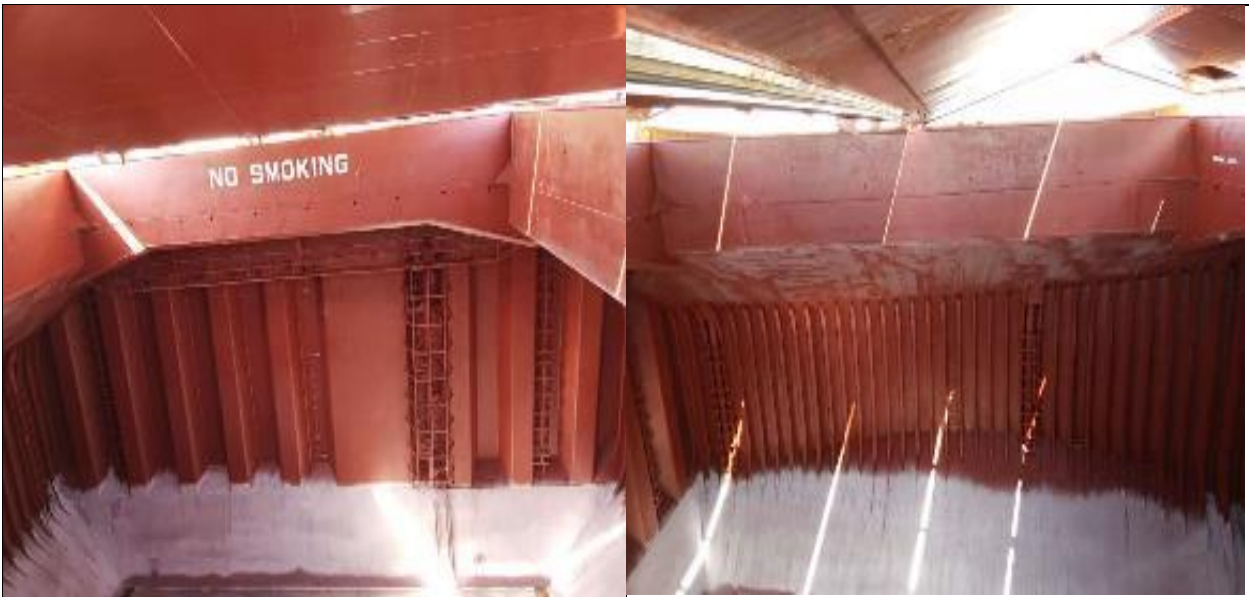
VI. HATCH COAMING INSPECTION HOLD Nr. 1:

The four sides of hatch coaming for each cargo holds were inspected to verify the level of wear in the edges.

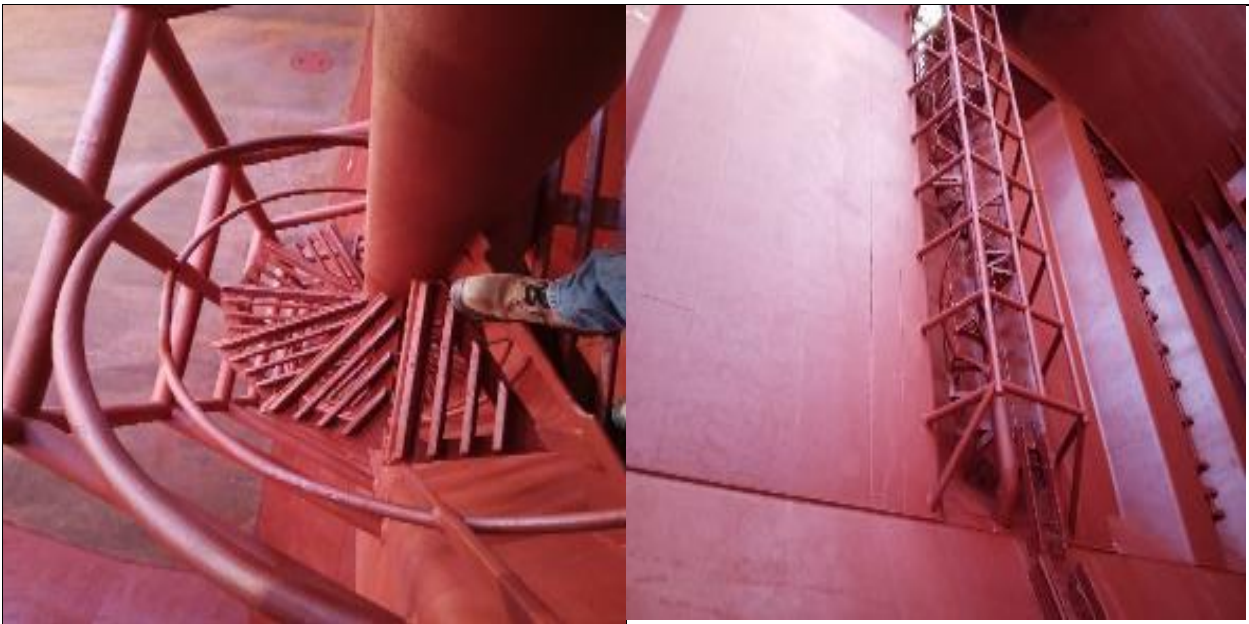
VII. INSPECTION OF LADDERS ACCESS TO HOLD Nr. 1

The ladders to access of cargo holds were inspected to verify the condition.

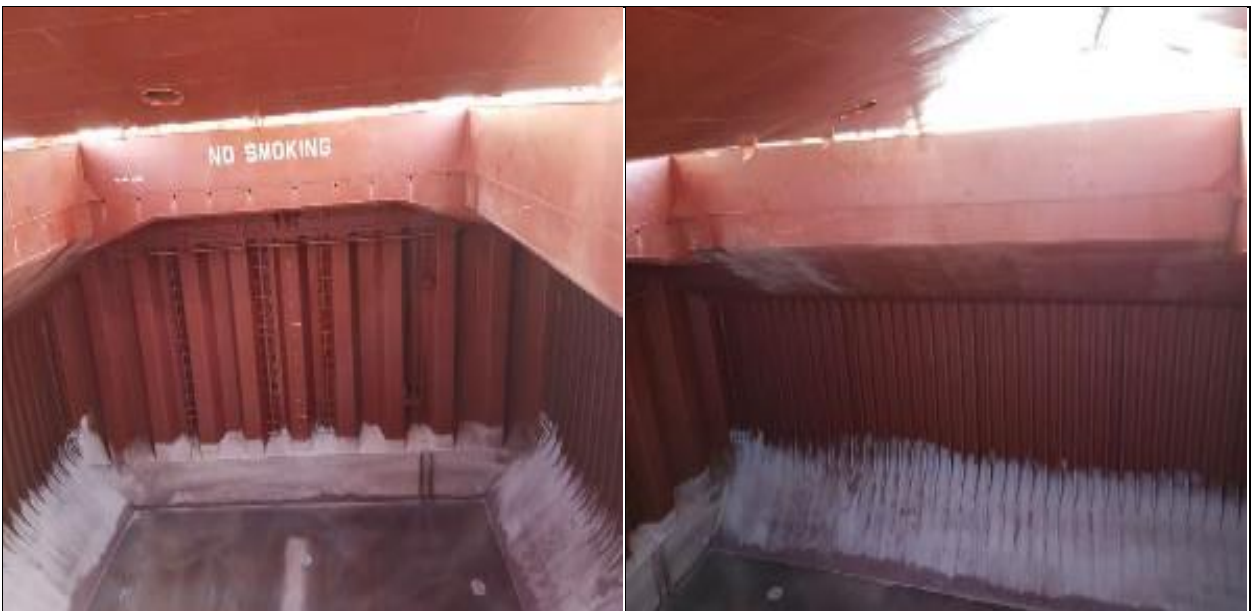
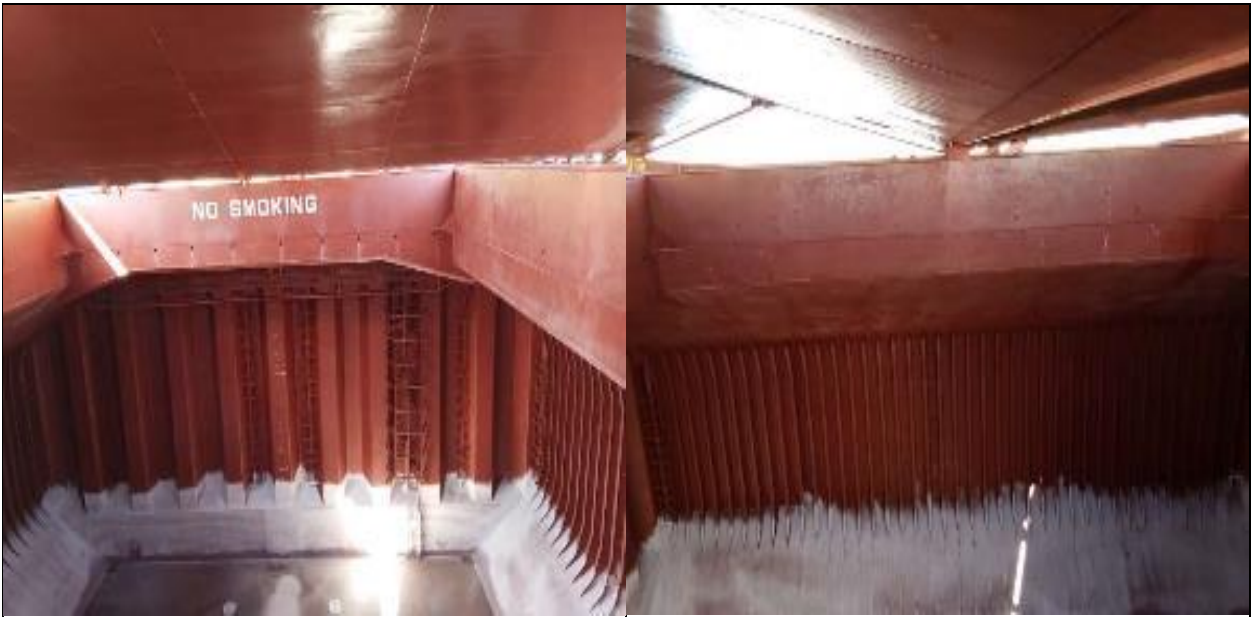
I. HATCH COAMING INSPECTION Nr. 2

The four sides of hatch coaming for each cargo holds were inspected to verify the level of wear in the edges.

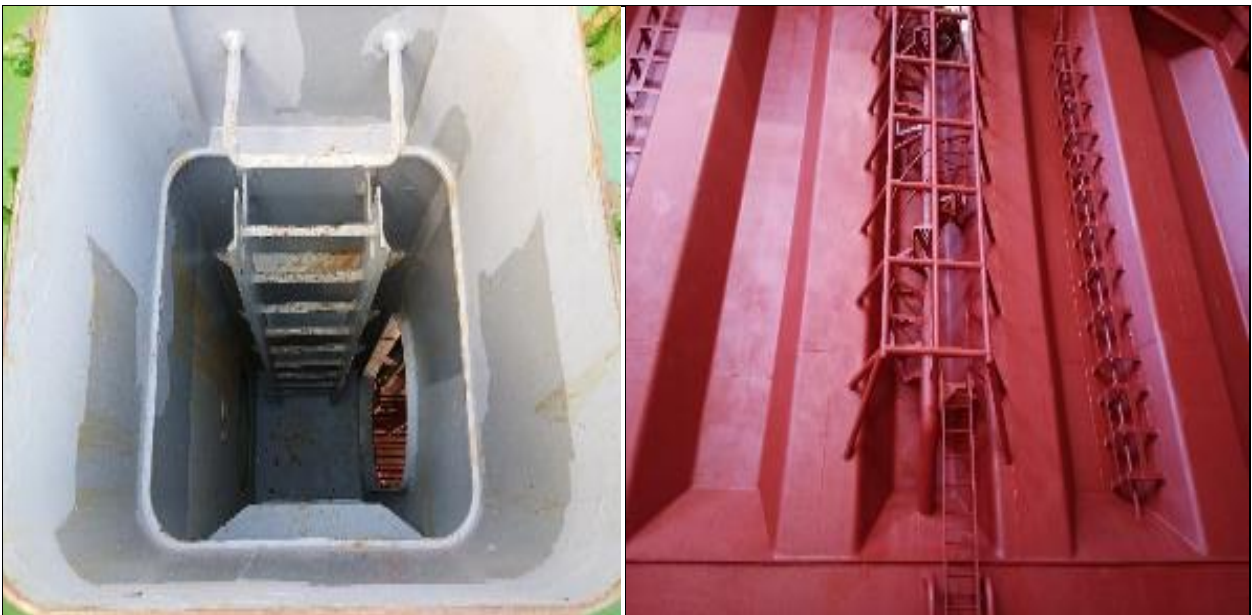
II. INSPECTION OF LADDERS ACCESS TO HOLD Nr. 2

The ladders to access of cargo holds were inspected to verify the condition.

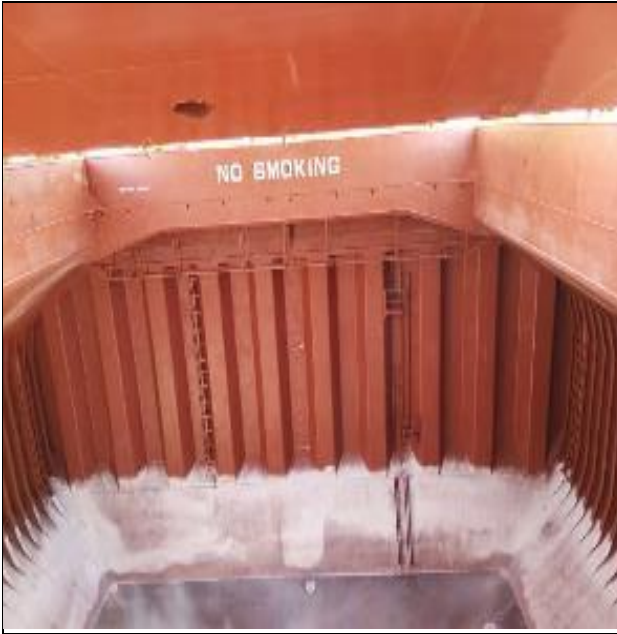
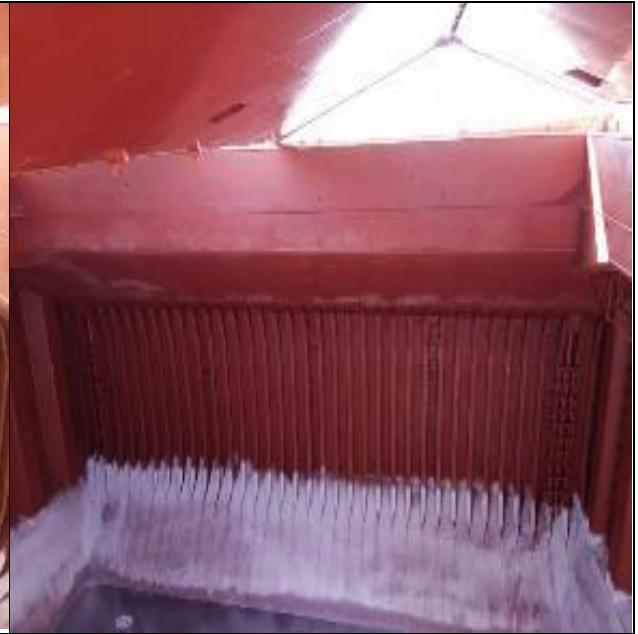
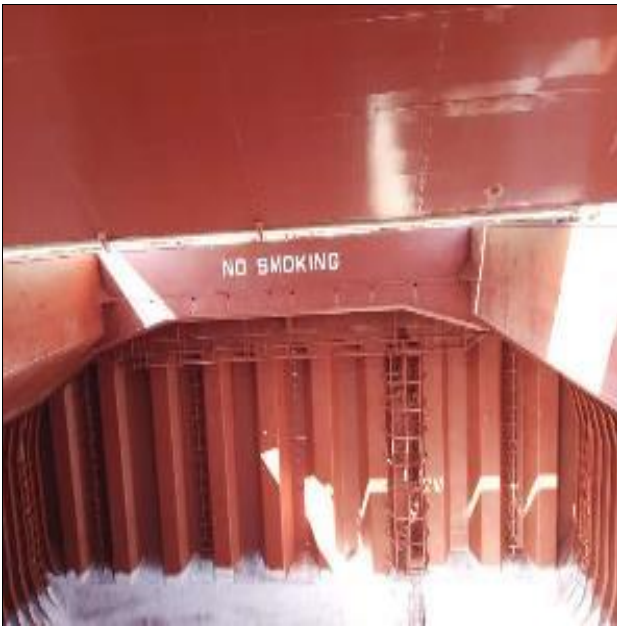
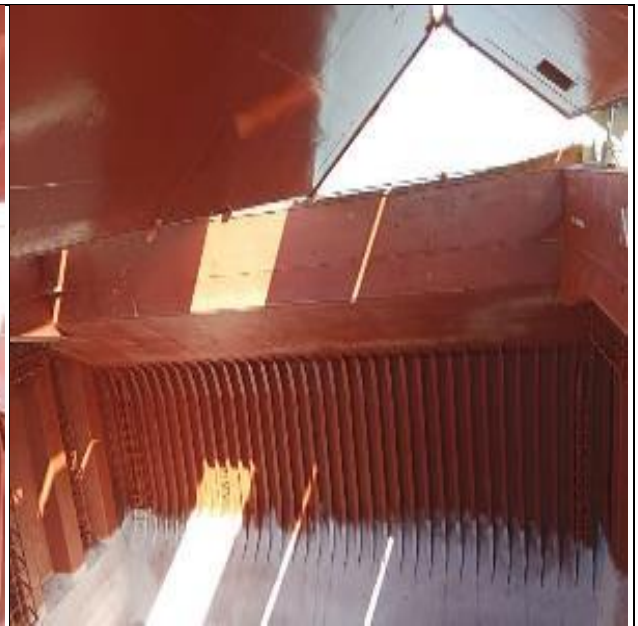
I. HATCH COAMING INSPECTION HOLD Nr. 3

The four sides of hatch coaming for each cargo holds were inspected to verify the level of wear in the edges.

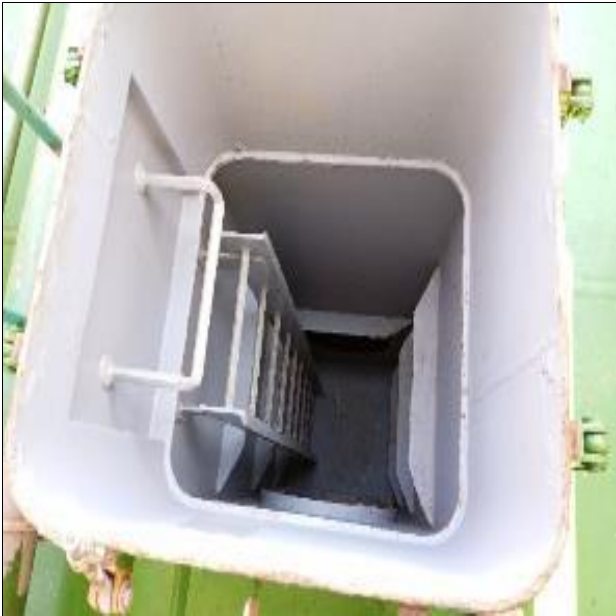
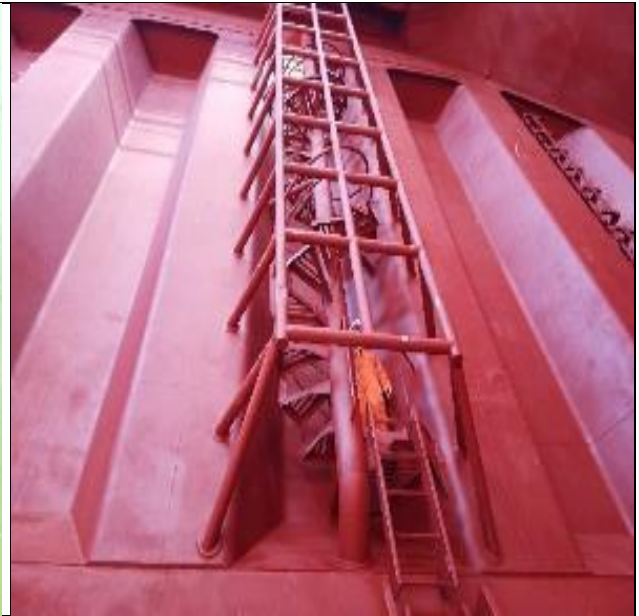
II. INSPECTION OF LADDERS ACCESS TO HOLD Nr. 3

The ladders to access of cargo holds were inspected to verify the condition.

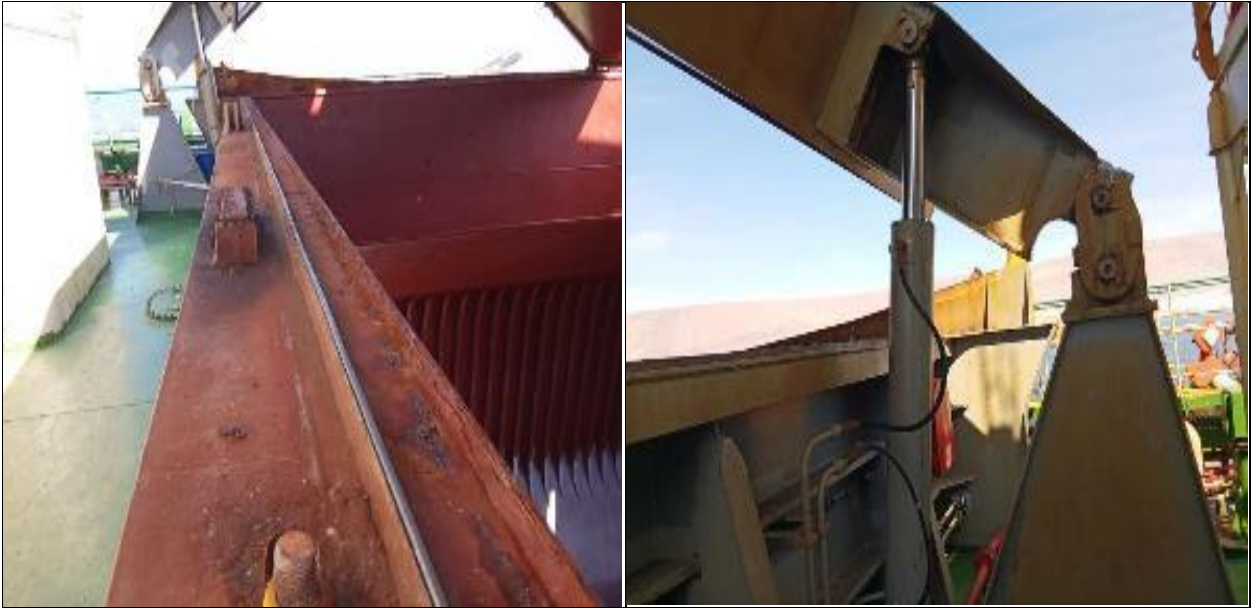
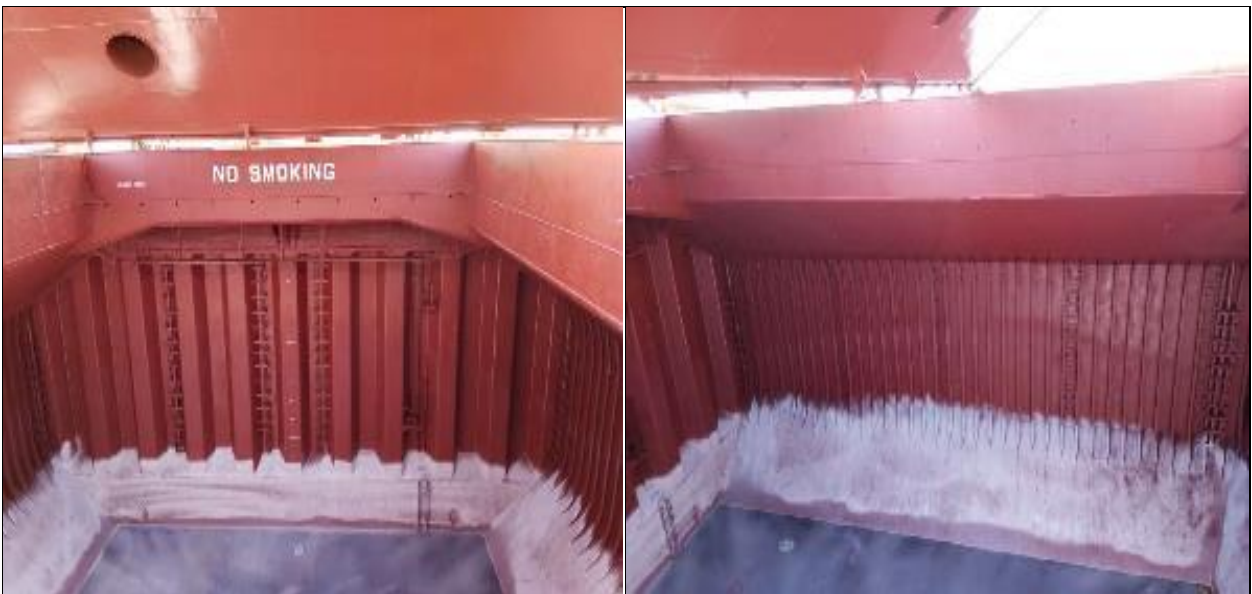
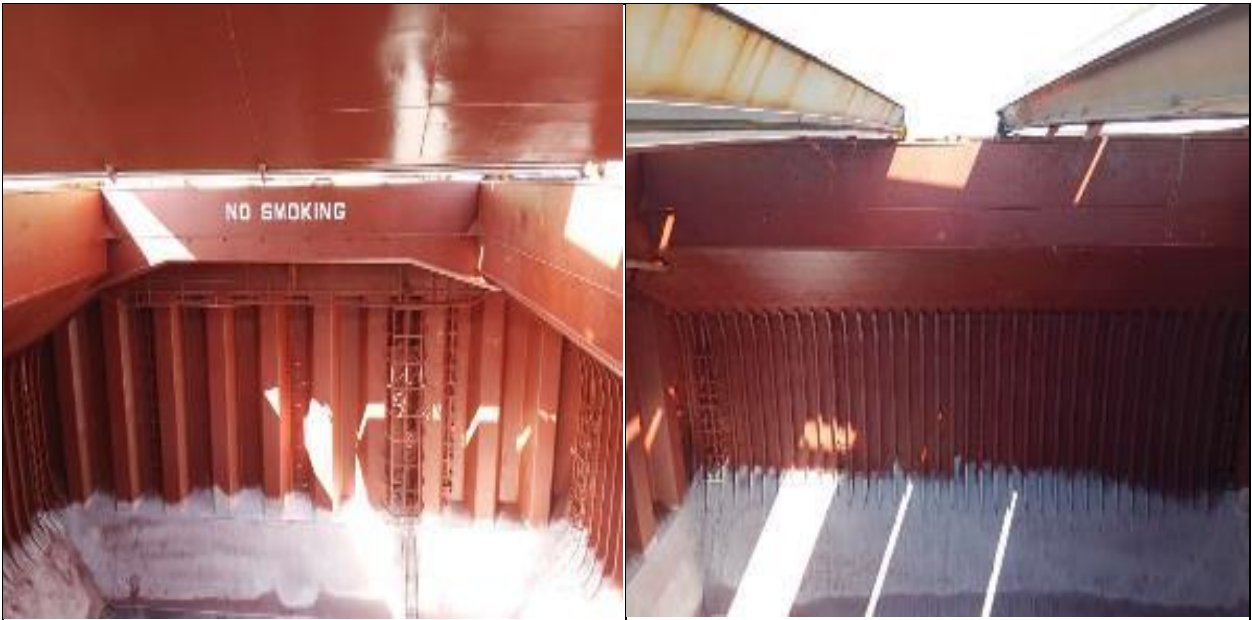
I. HATCH COAMING INSPECTION HOLD NR. 4

The four sides of hatch coaming for each cargo holds were inspected to verify the level of wear in the edges.

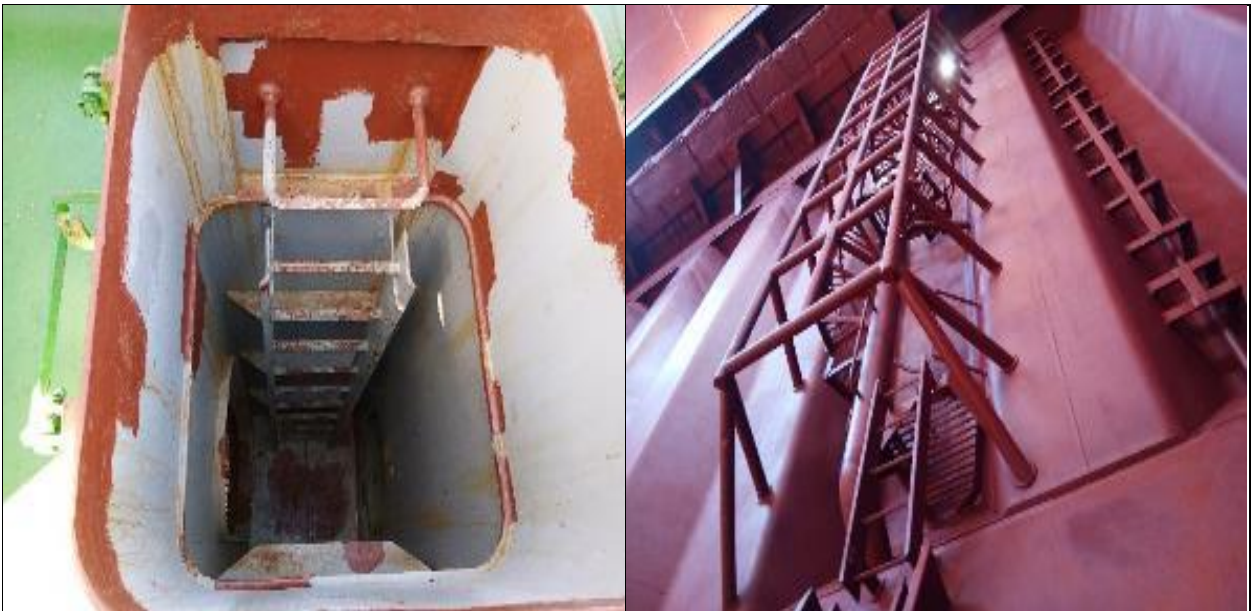
II. INSPECTION OF LADDERS ACCESS TO HOLD Nr. 4

The ladders to access of cargo holds were inspected to verify the condition.

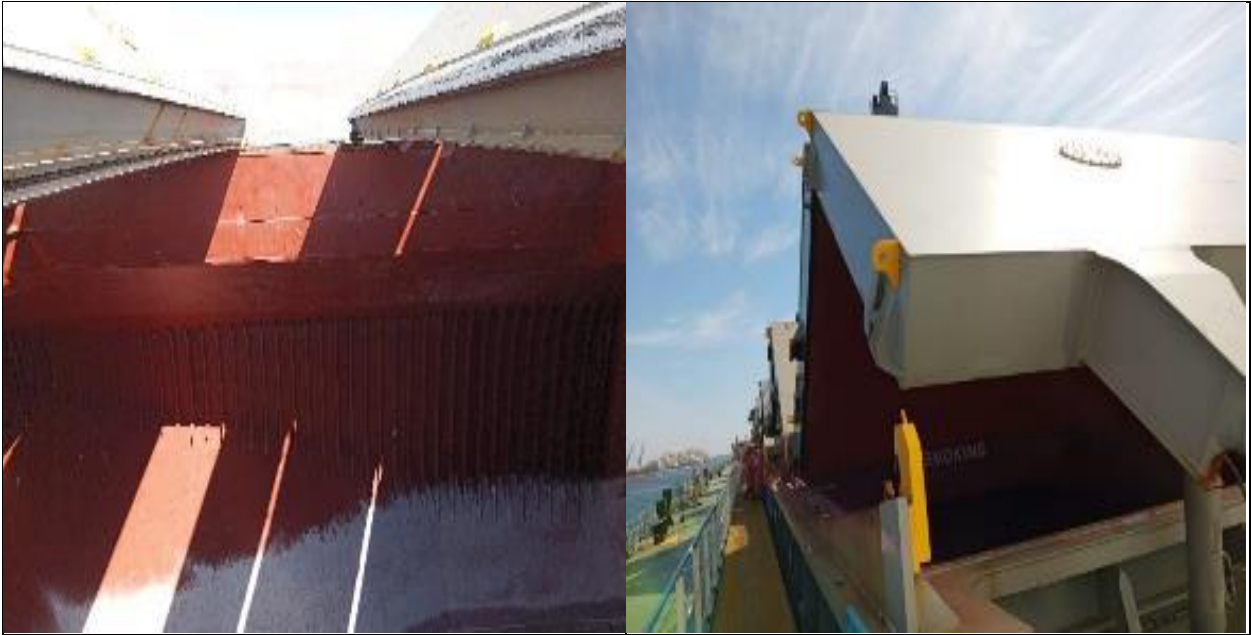
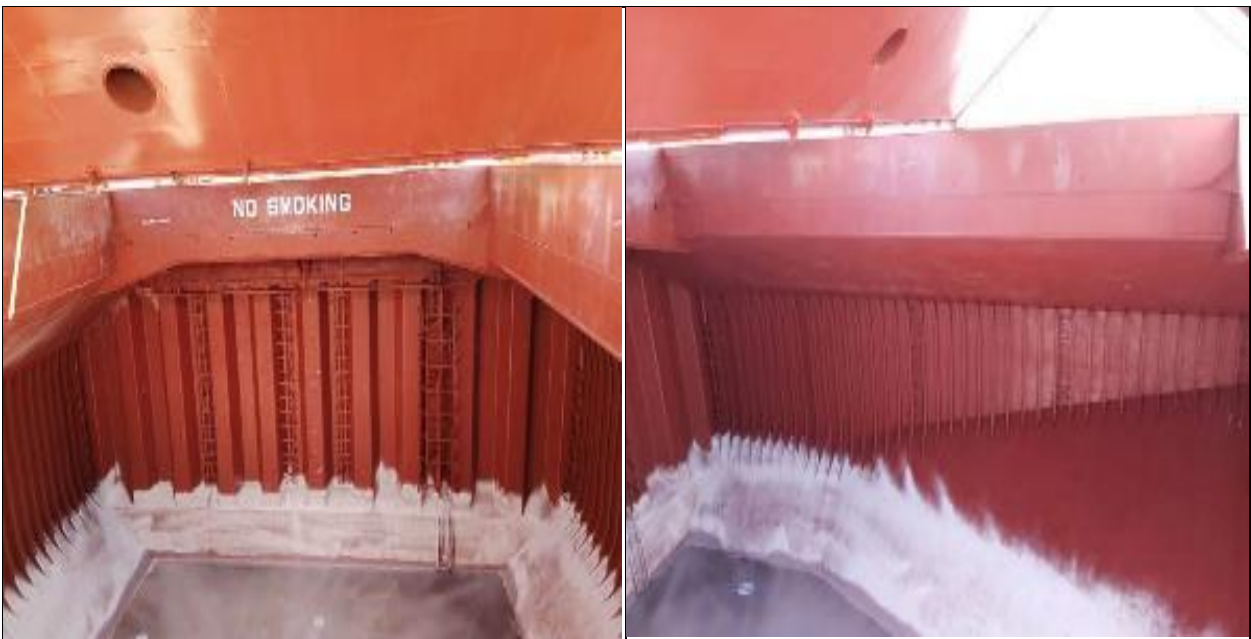
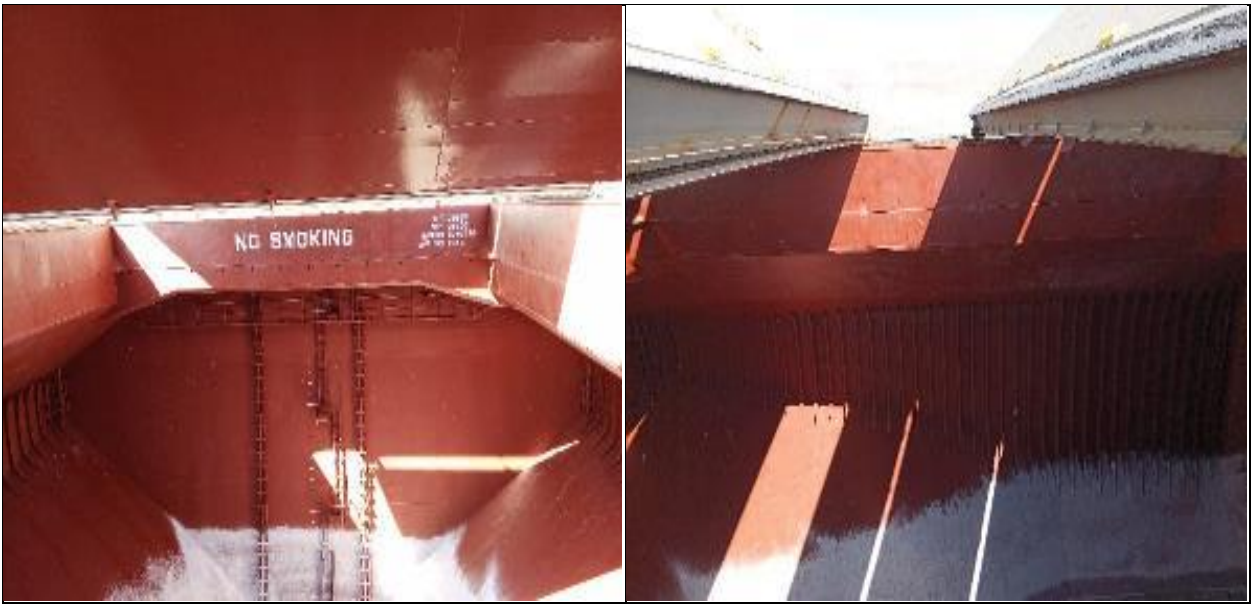
I. HATCH COAMING INSPECTION HOLD Nr. 5

The four sides of hatch coaming for each cargo holds were inspected to verify the level of wear in the edges.

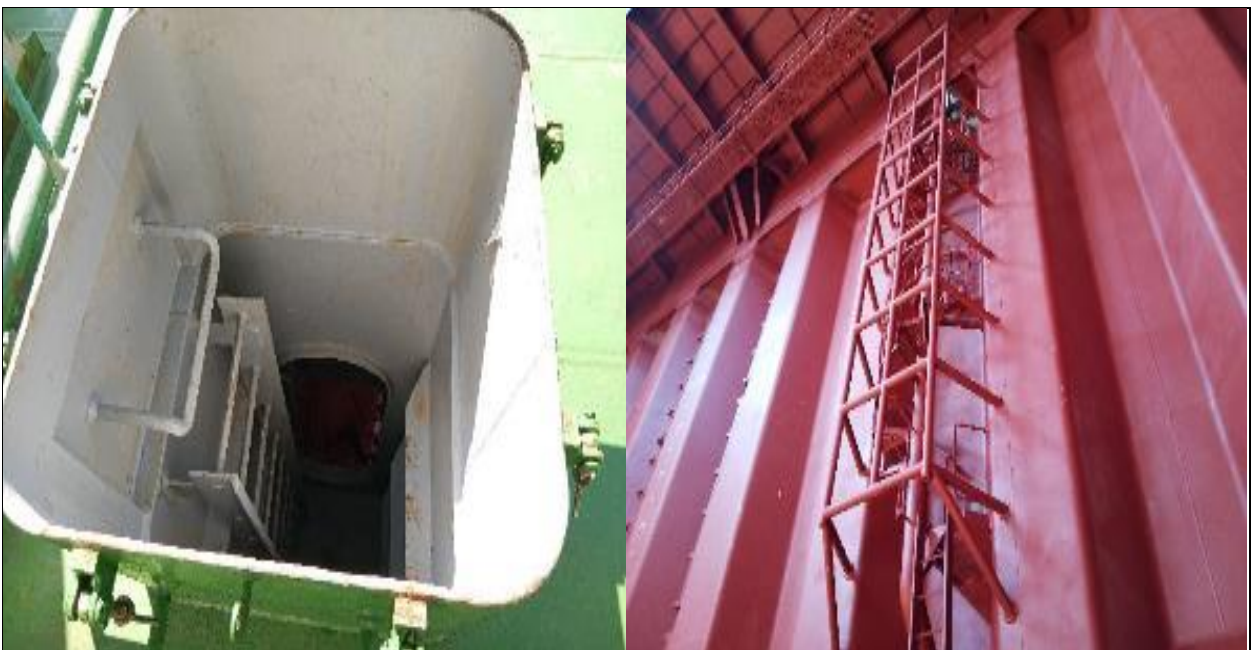
II. INSPECTION OF LADDERS ACCESS TO HOLD Nr. 5

The ladders to access of cargo holds were inspected to verify the condition.

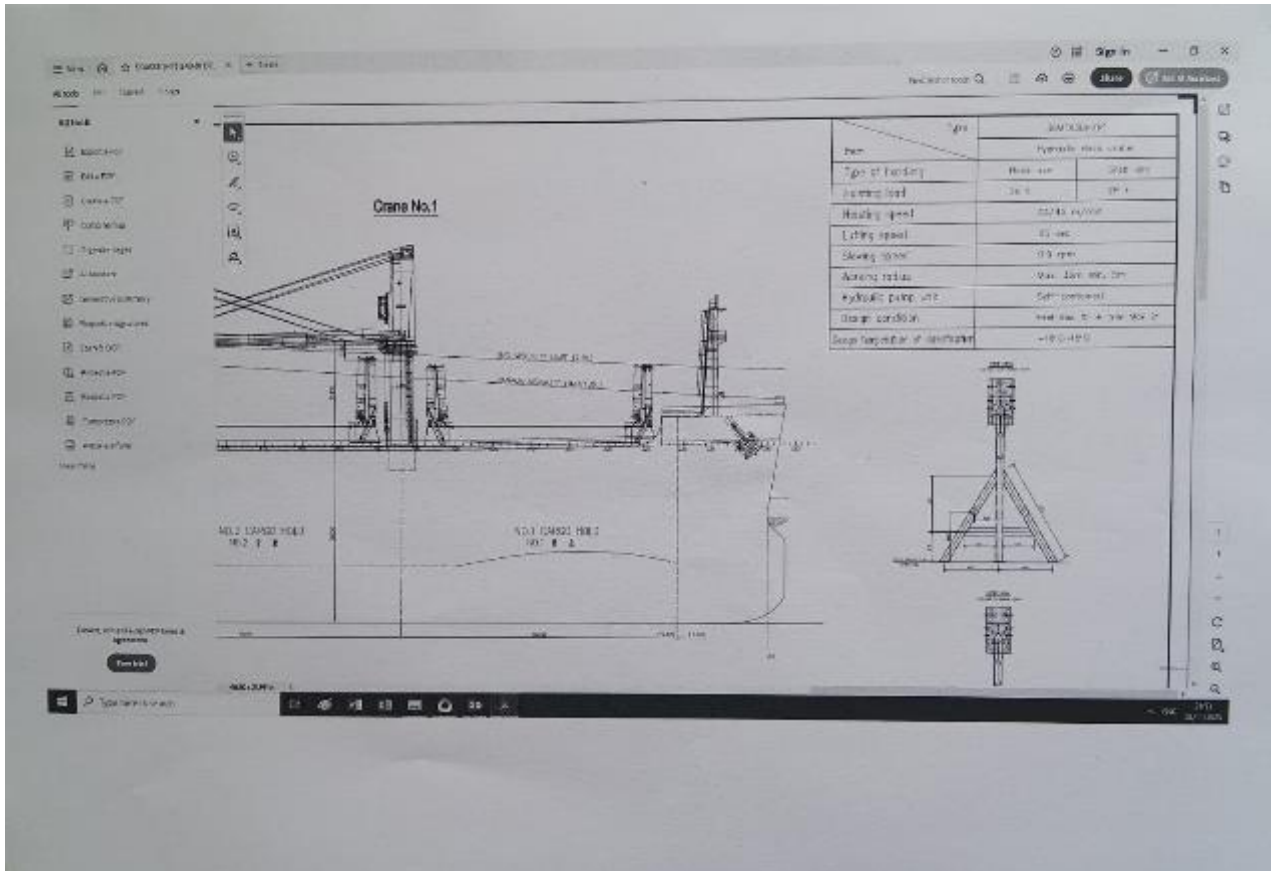
I. CRANE WORKING ZONE AND DISTANCE

We have access to drawing of cargo gear arrangement and could obtain the follow distances.
