MV "ASL SAKURA"

FULL OFF HIRE & BUNKER SURVEY

Report: SAI-2603-1081

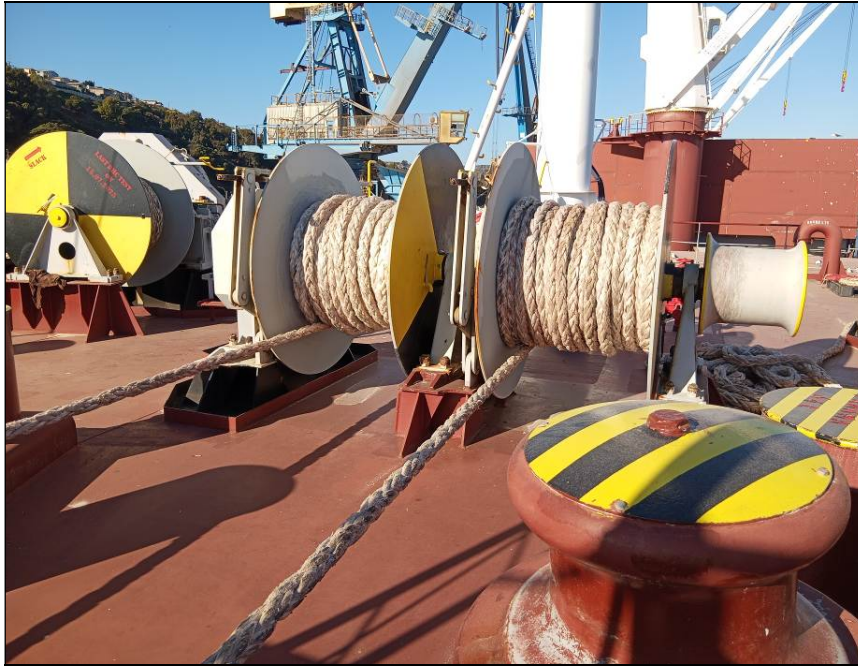
19. Center winch, in good conditions.

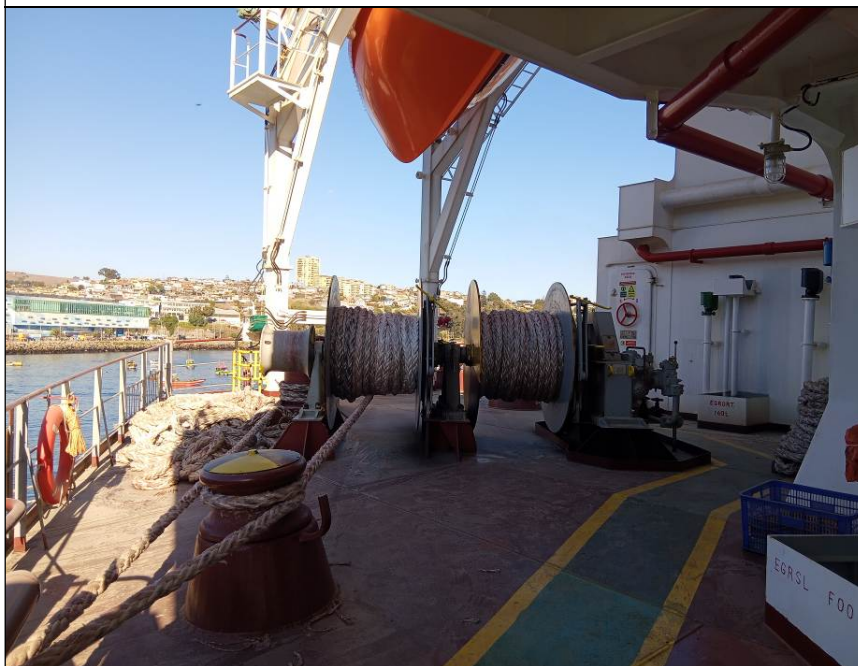
22. General view of Poop deck.

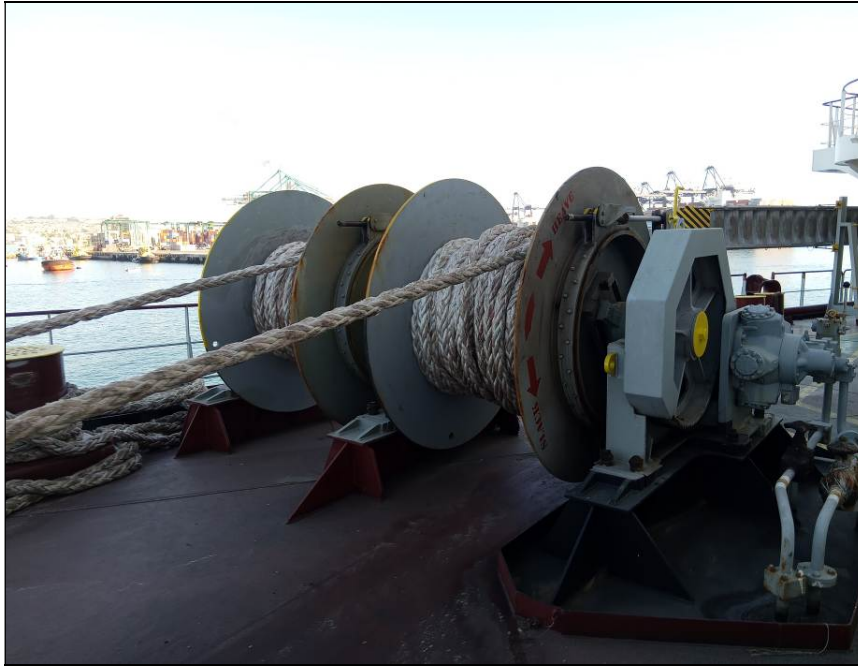
23. Winch Ps poop deck, in good conditions.

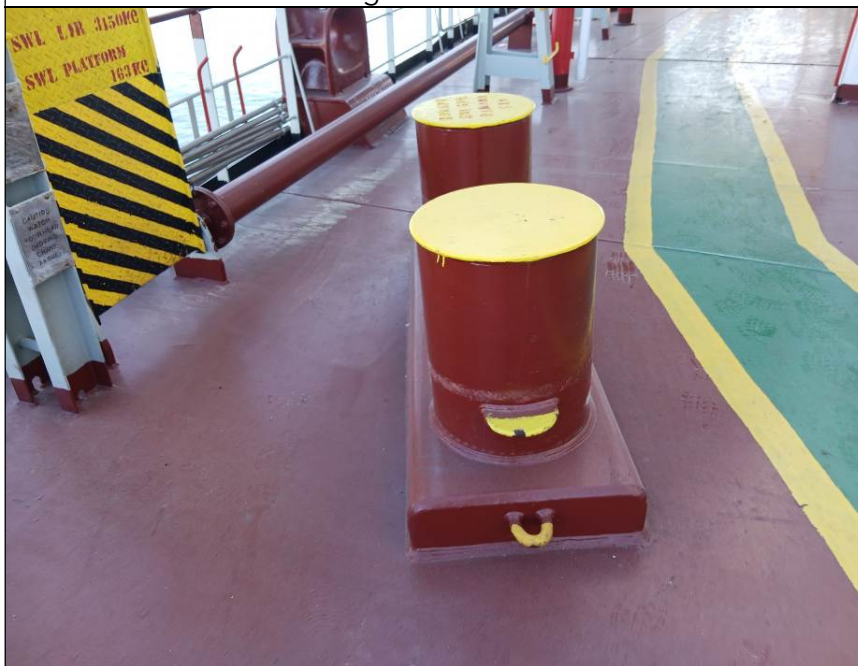
26. Bollards in good conditions.

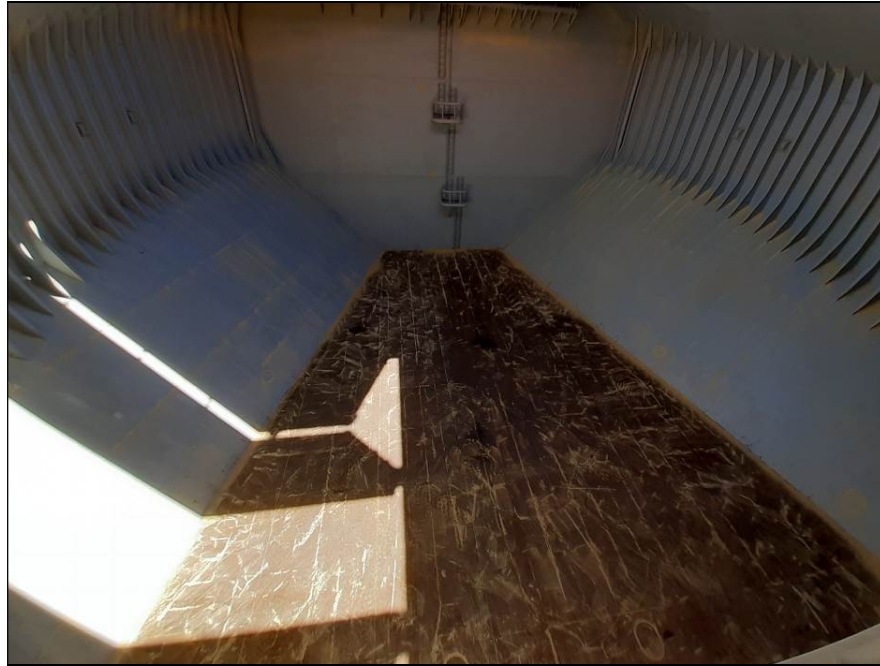
No. 8: Cargo hold with dust of cargo remaining (See photos No. 27 to 33)

27. General view of C/H N°1.

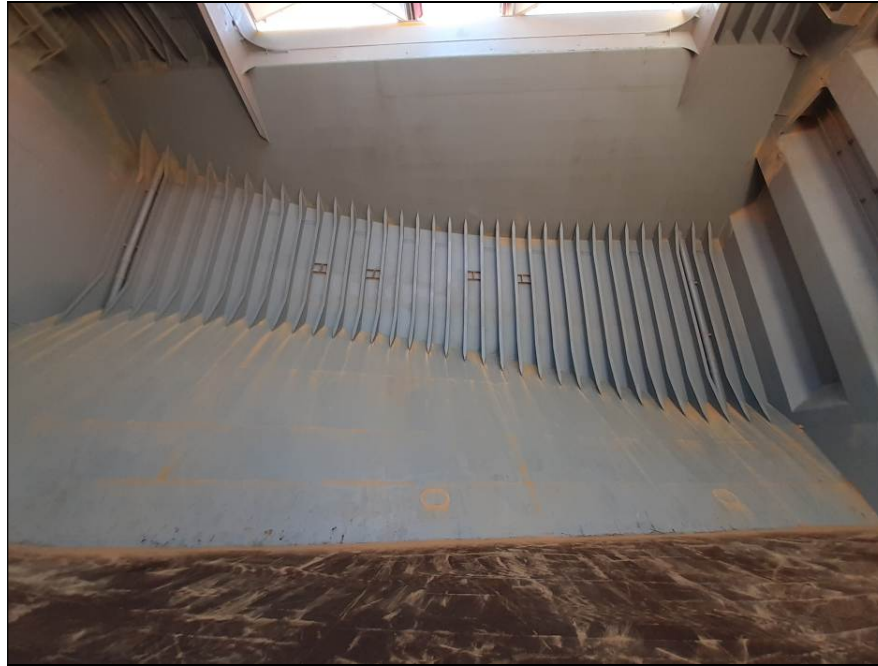
No. 7: Side/shell plating Ss with paint scratched and rust (See photo No. 31)

31. Side/shell plating Ss with paint scratched.

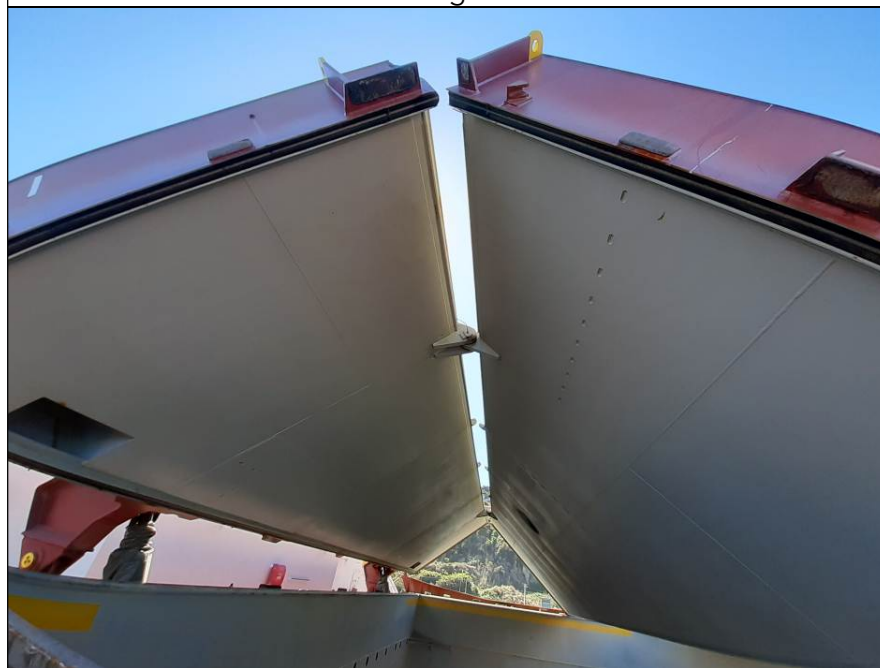
34. Hatchcover No.1, rubber gasket in good conditions.

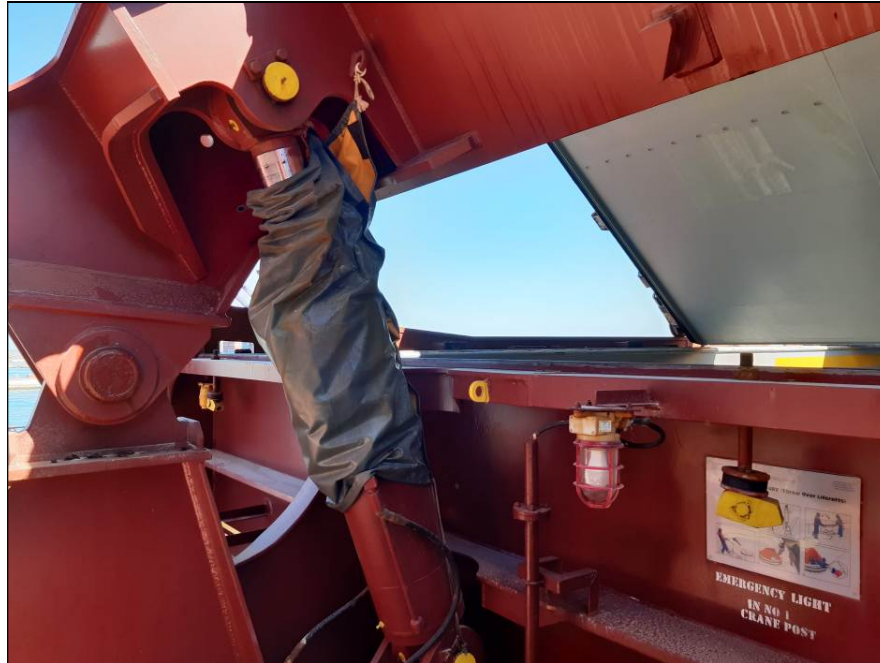
35. Hatchcover No. 1, hydraulic systems in good conditions

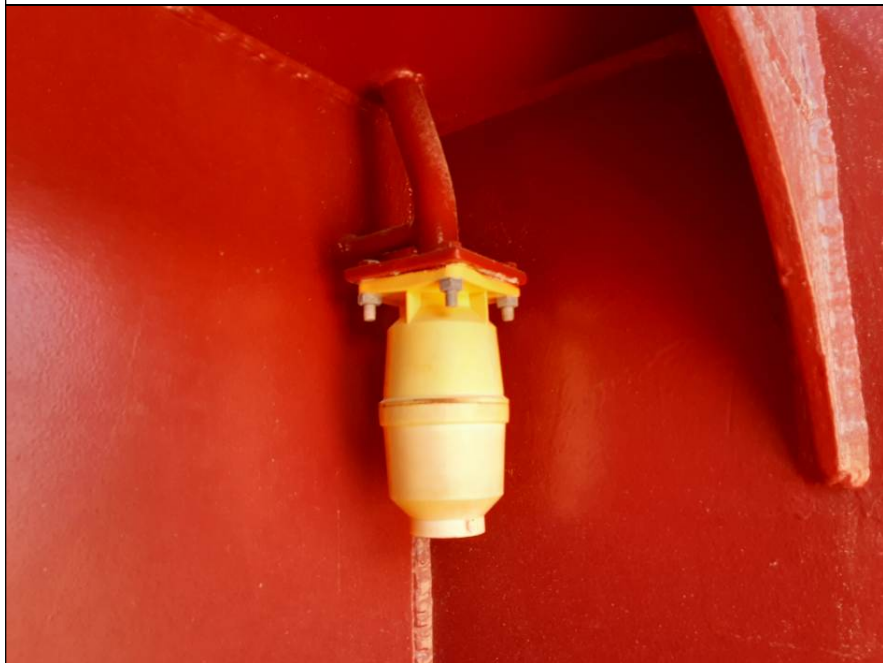
40. Hatchcover No. 2, non-return valves in good conditions.

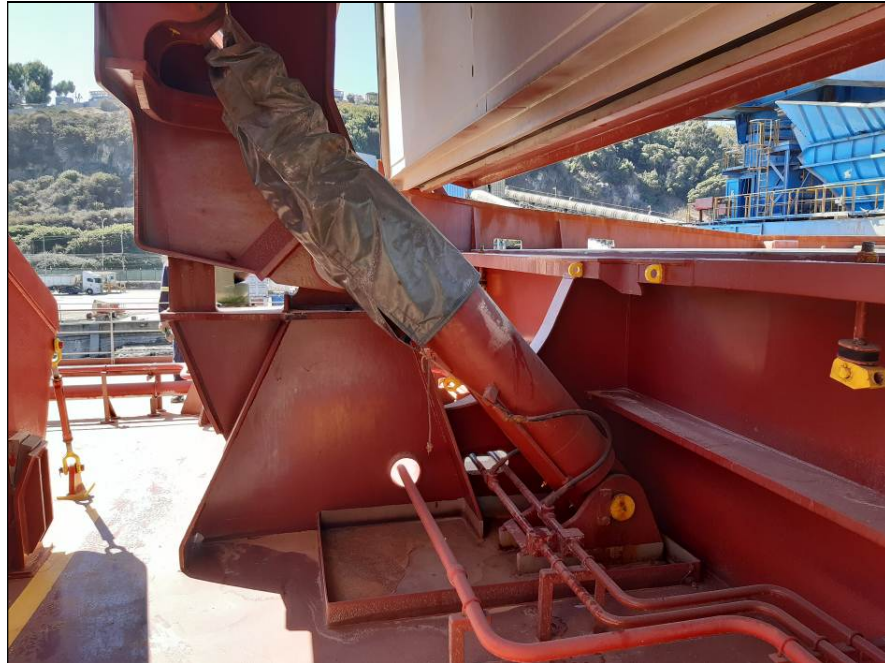
43. Hatchcover No. 2, hydraulic system in good conditions.

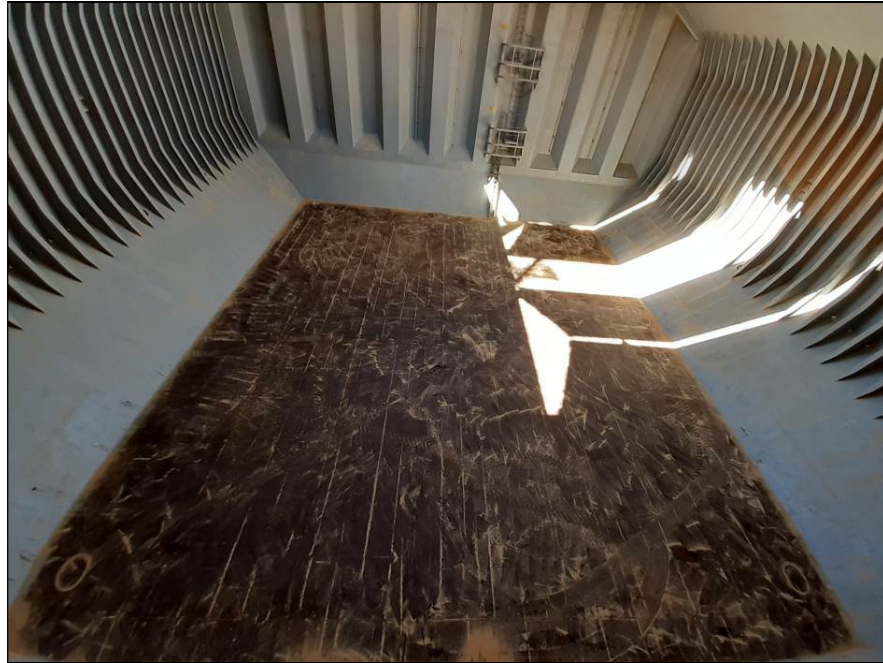
No. 14: Cargo hold with dust of cargo remaining (See photos No. 45 to 51)

45. General view of C/H N° 3.

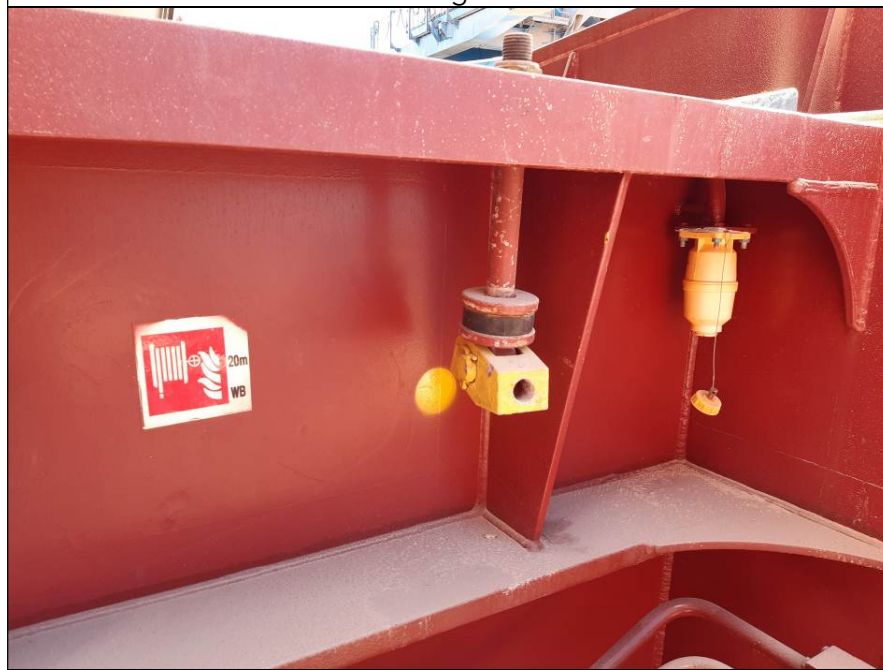
52. Hatchcover No. 3, non-return valves & acting cleats in good conditions.

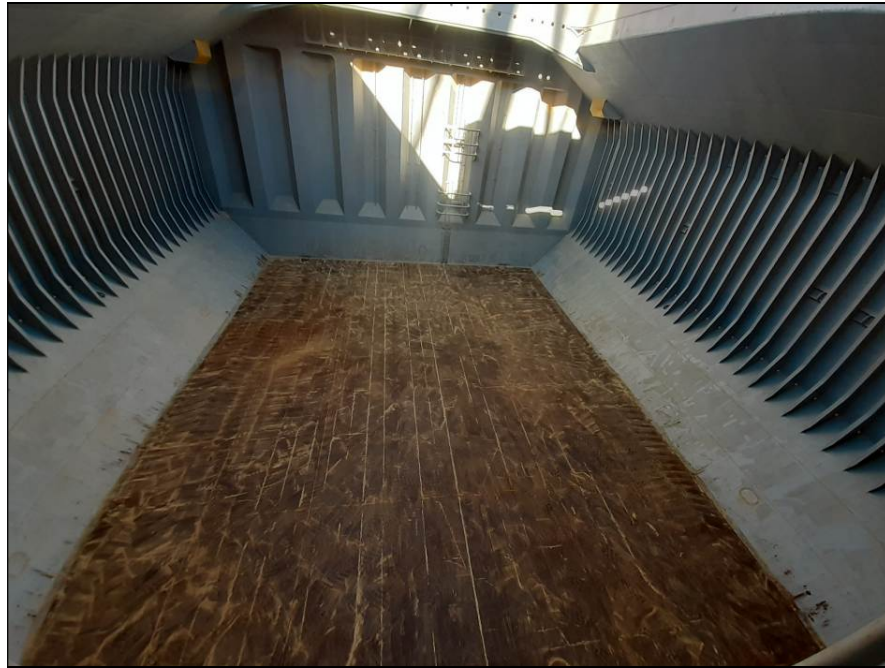
No. 19: Cargo hold with dust of cargo remaining (See photos No. 55 to 60)

55. General view of C/H N° 4.

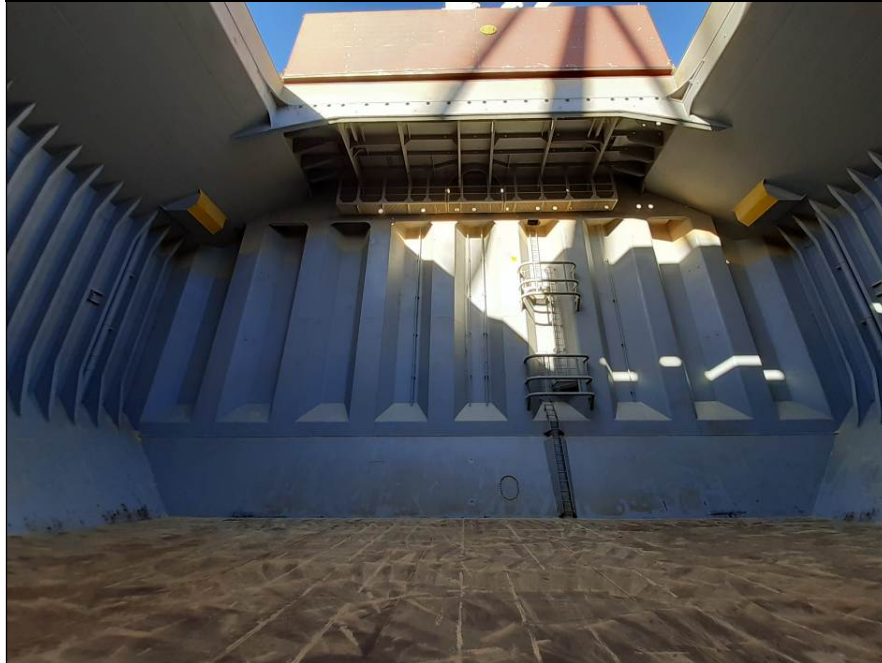
57. Aft bulkhead with paint scratched.

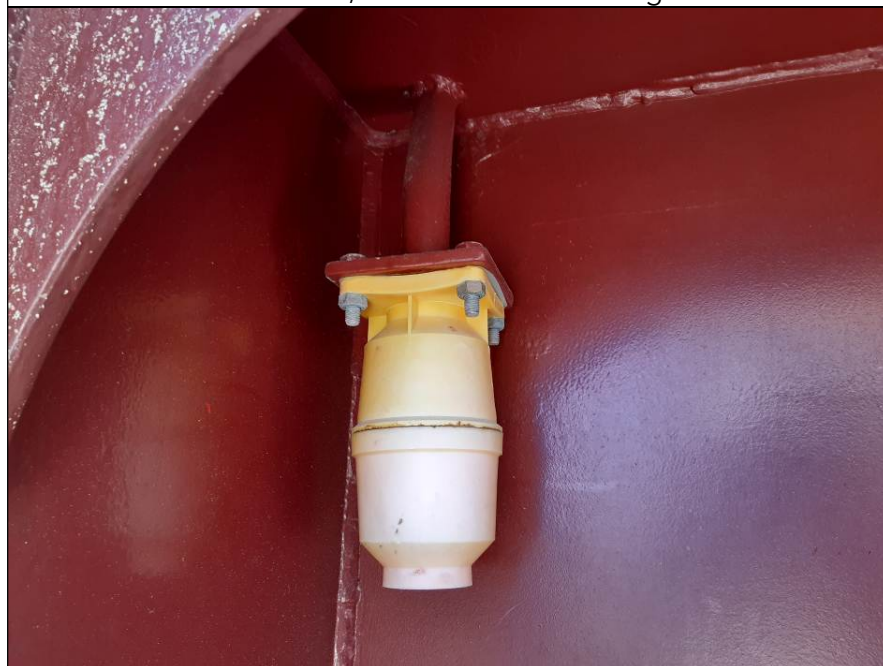
62. Hatchcover No. 4, non-return valves in good conditions.

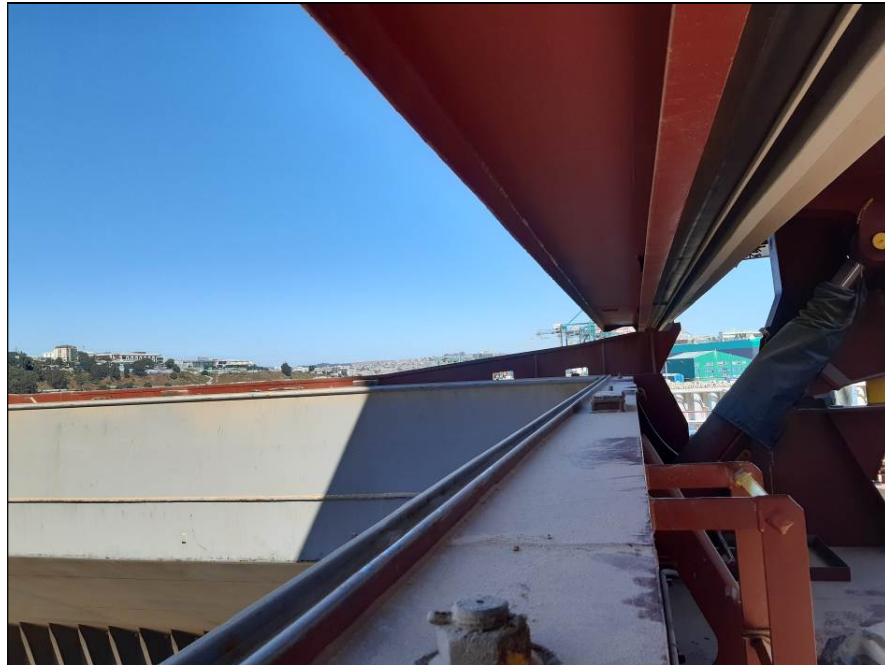
63. Hatchcover No. 4, rubber gasket in good conditions.

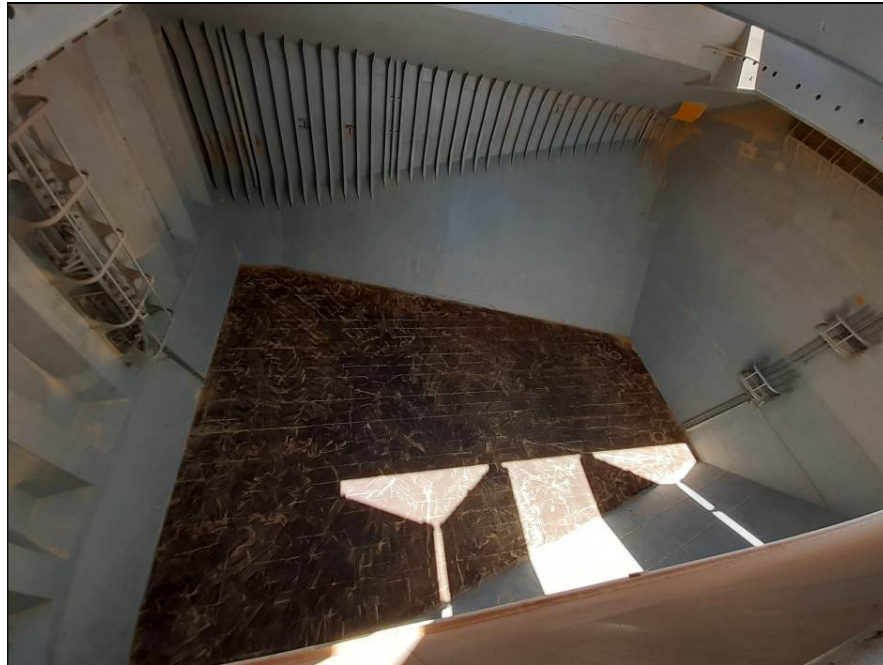
No. 20: Forward bulkhead with paint scratched and rust (See photo No. 65)

No. 24: Tank top plating rusty (See photos No. 65 to 70)

65. General view of C/H N° 5.

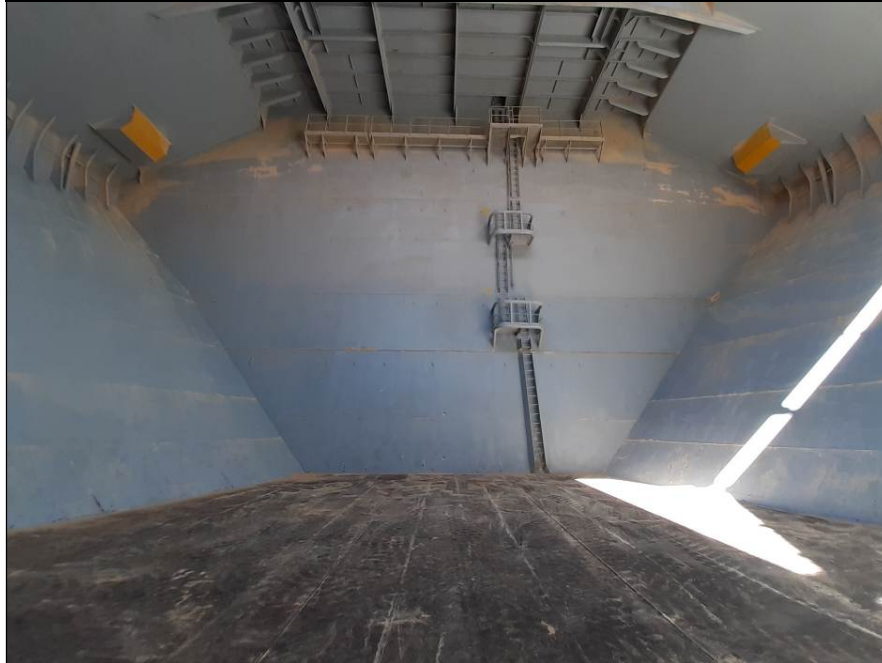
No. 22: Side/shell plating Ps with paint scratched and rust (See photo No. 67)

67. Aft bulkhead with paint scratched.
