Certificate No. B23615-3001-2026

Cargo Survey at Barranquilla (Palermo) – Colombia.

FINAL REPORT CARGO SURVEY

PHYSICAL INSPECTION OF THE EMPTYING OF TWO (02) CONTAINER X 40 TYPE OPEN TOP WITH EIGHTEEN (18) PIECES

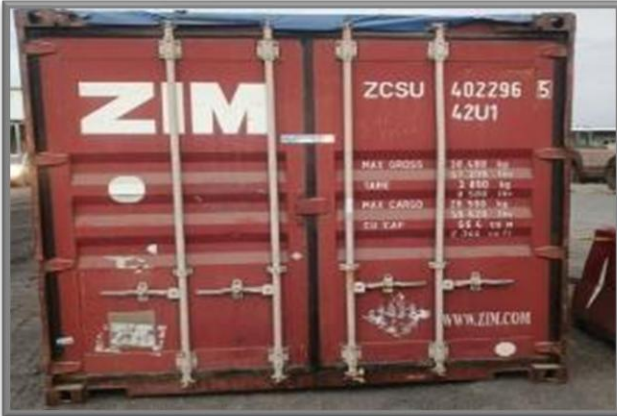
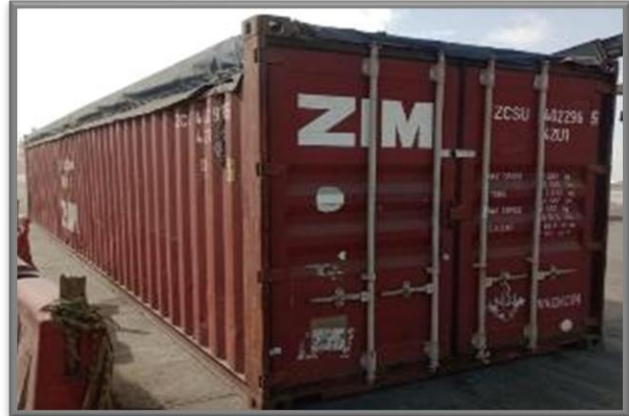
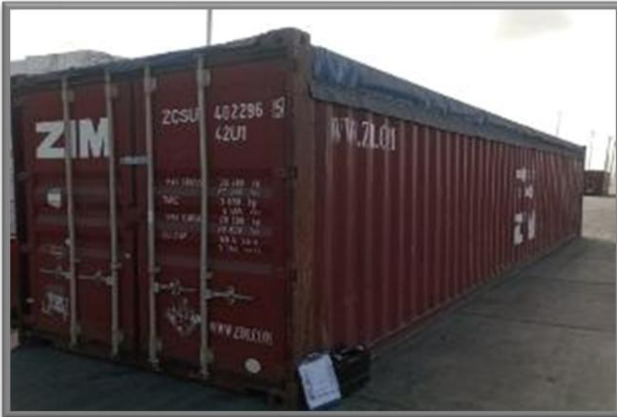
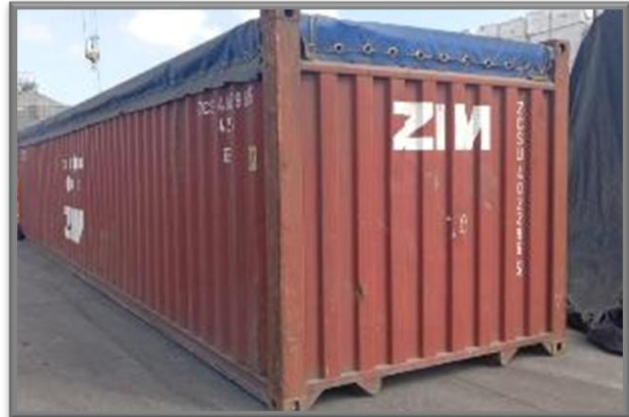
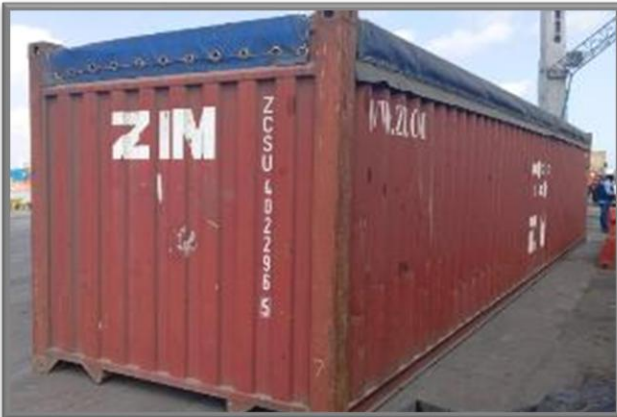
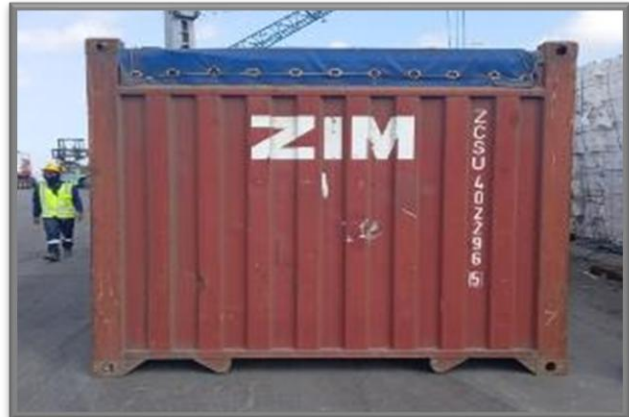
INSPECTION OF THE EXTERNAL PARTS OF THE CONTAINER

Item	Container Identification	Initial Container Seal	Initial condition and status of the external part of the container
1	<u>ZCSU 402296 - 5</u> <u>42U1</u>	<u>CAF7420</u> <u>L8725101</u> <u>CBL148857</u>	<ol style="list-style-type: none"> 1. Right and left side panels with oxidation, dented and scratches. 2. Rear, upper, and lower side rail with oxidation, dented and scratches. 3. Right and left doors with oxidation, dented and scratches. 4. Rear and front corner posts with oxidation, dented and scratches. 5. Door locking bars and closing hooks with oxidation, dented and scratches. 6. CSC plate and owner's emblem are visible in good condition. 7. Identification number and dimensional and type codes visible with oxidation. 8. Door Guide the bars bent.

- ❖ During the **external inspection** of the **two (02) containers**, dents, slight knocks, scratches, and general oxidation corresponding to the use of the containers were observed.

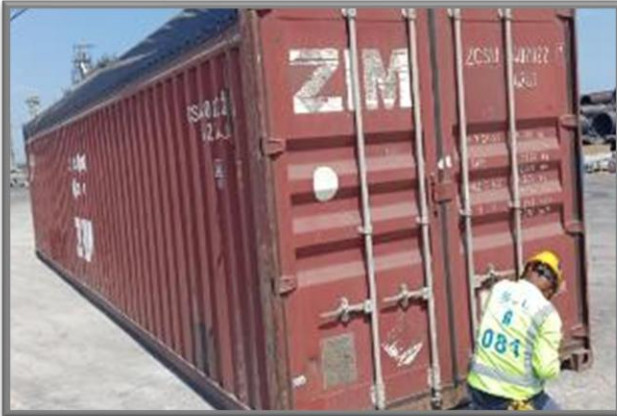
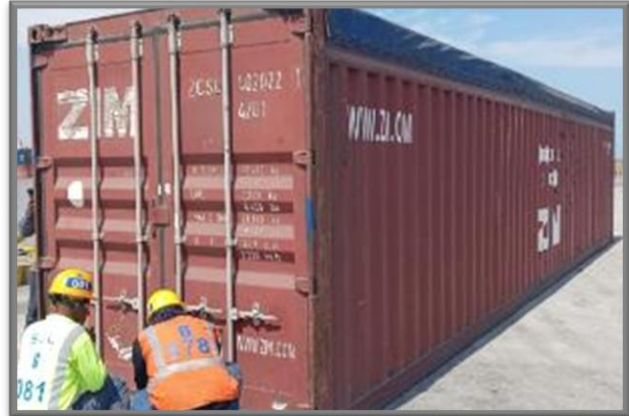
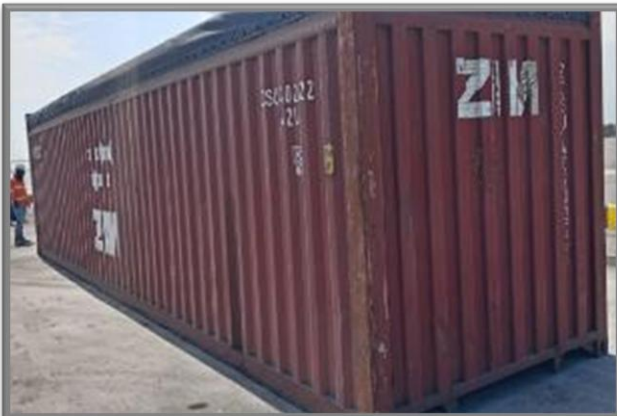
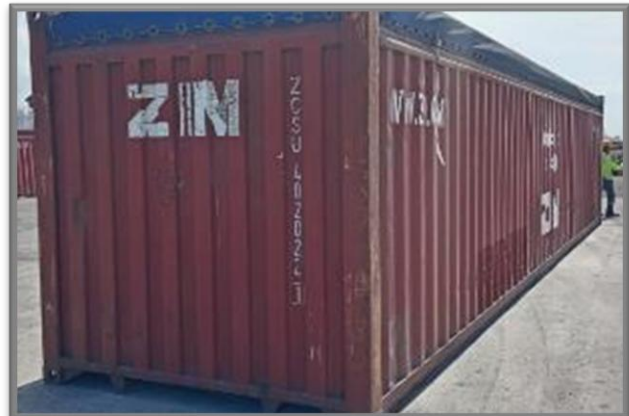
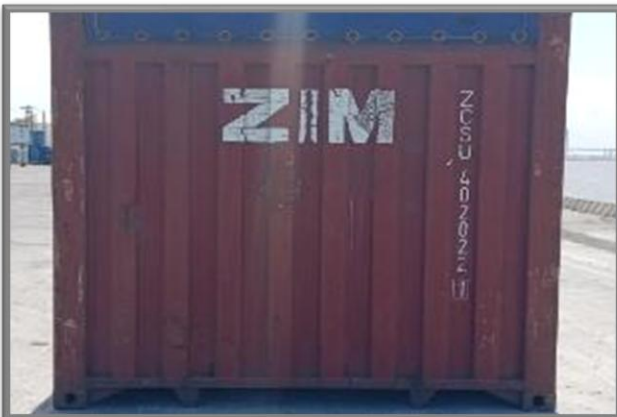
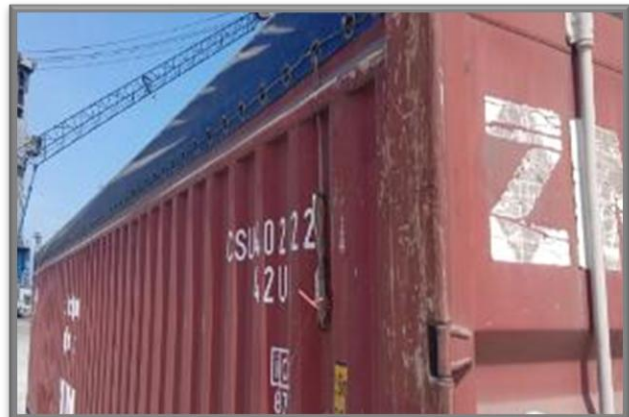
INSPECTION OF THE EXTERNAL PARTS OF THE CONTAINER

Item	Container Identification	Initial Container Seal	Initial condition and status of the external part of the container
2	<u>ZCSU 402022</u> <u>42U1</u>	<u>CAF7413</u> <u>0000099</u>	<ol style="list-style-type: none"> 1. Right and left side panels with oxidation, dented and scratches. 2. Rear, upper, and lower side rail with oxidation, dented and scratches. 3. Right and left doors with oxidation, dented and scratches. 4. Rear and front corner posts with oxidation, dented and scratches. 5. Door locking bars and closing hooks with oxidation, dented and scratches. 6. CSC plate and owner's emblem are visible in good condition. 7. Identification number and dimensional and type codes visible with oxidation. 8. Door Guide the bars bent.

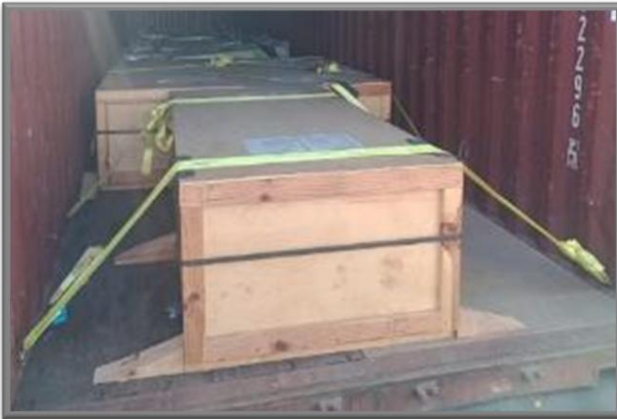
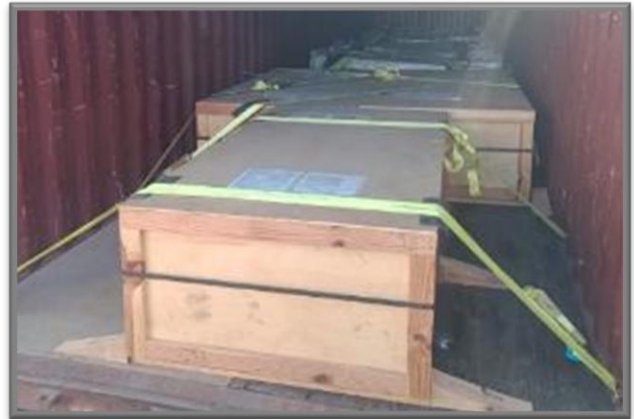
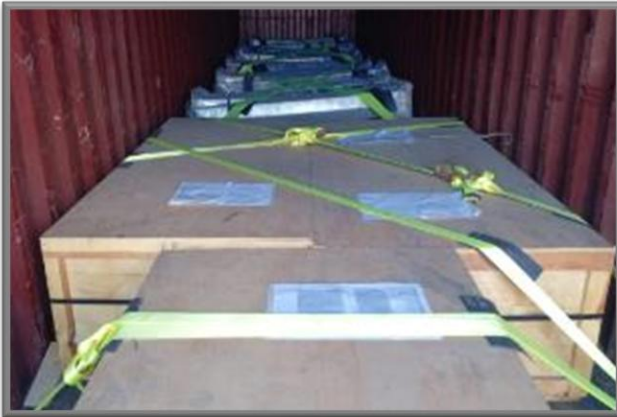
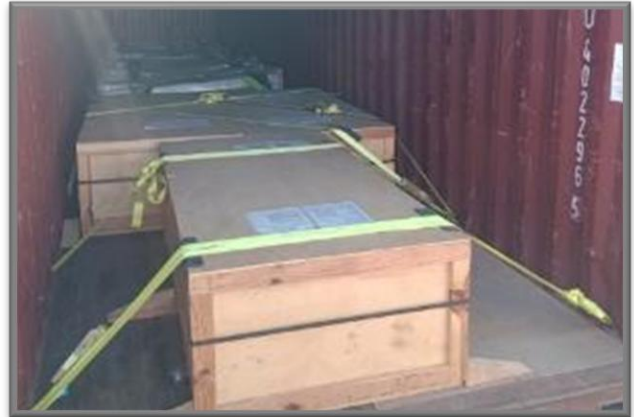
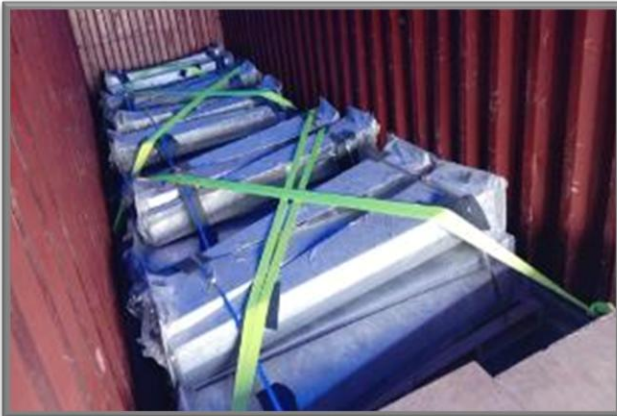
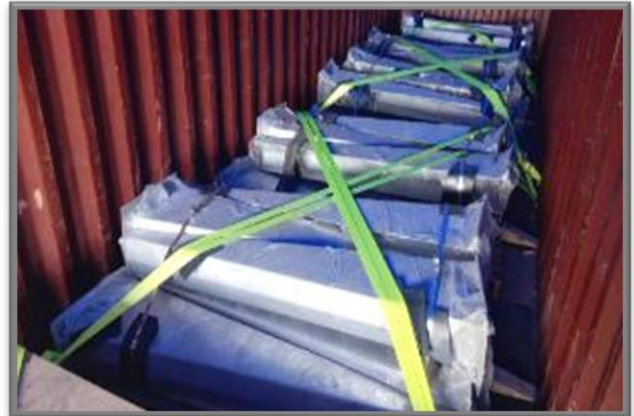
INSPECTION OF THE CARGO

- ❖ No slippage / No evidence of moisture.
- ❖ The cargo was properly stowed with wooden wedges.
- ❖ The cargo was securely lashed with synthetic slings and properly tensioned ratchets.
- ❖ No visible damage to the cargo was apparent.

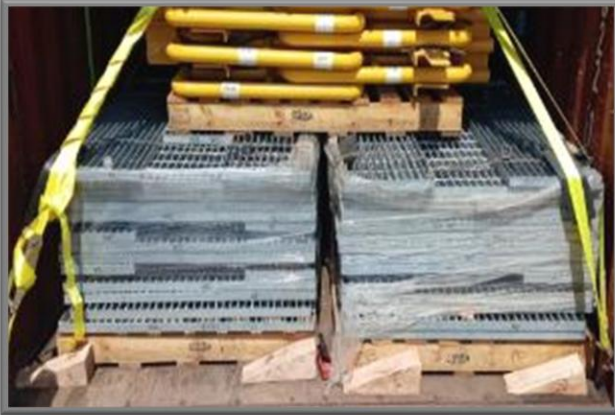
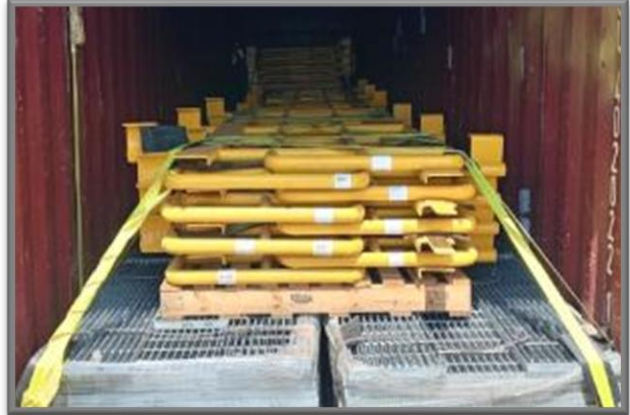
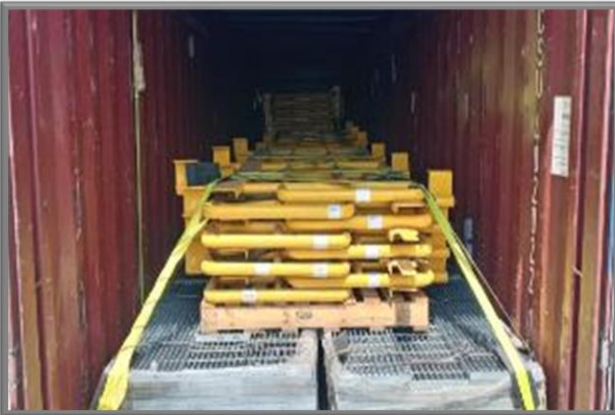
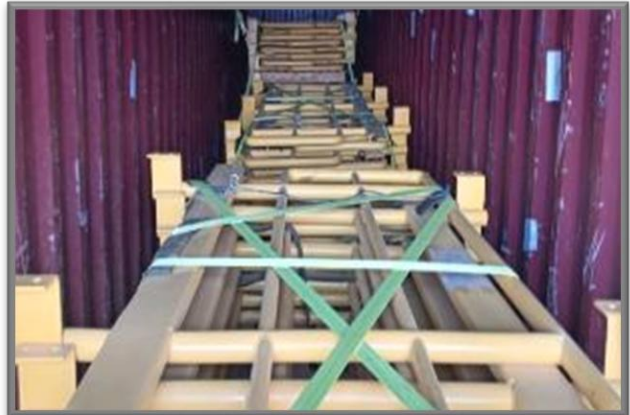
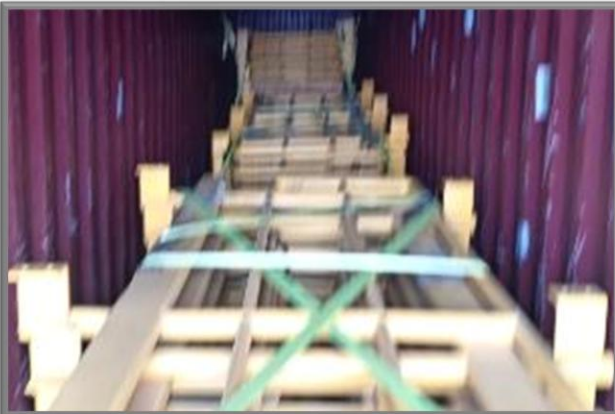
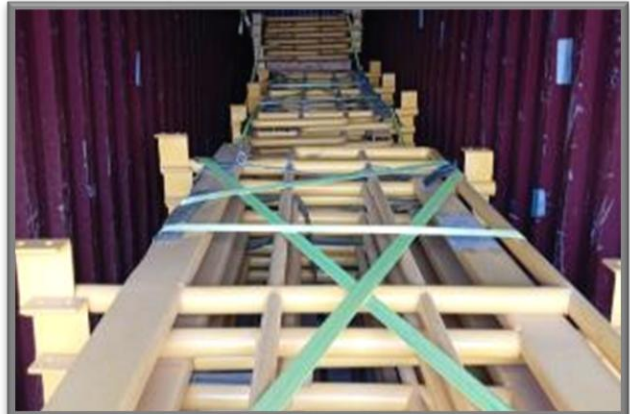
INSPECTION OF THE CARGO

- ❖ No slippage / No evidence of moisture.
- ❖ The cargo was properly stowed with wooden wedges.
- ❖ The cargo was securely lashed with synthetic slings and properly tensioned ratchets.
- ❖ No visible damage to the cargo was apparent.

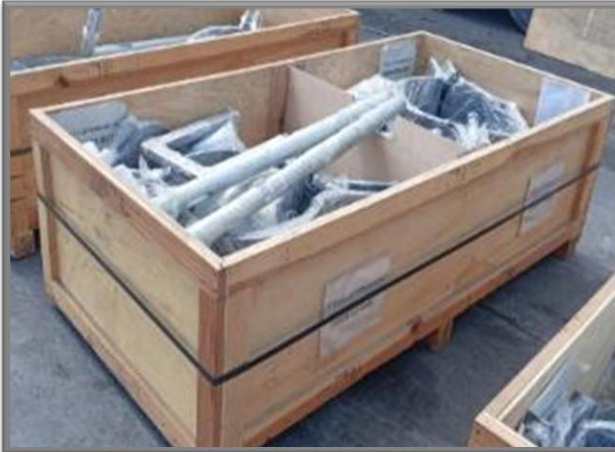
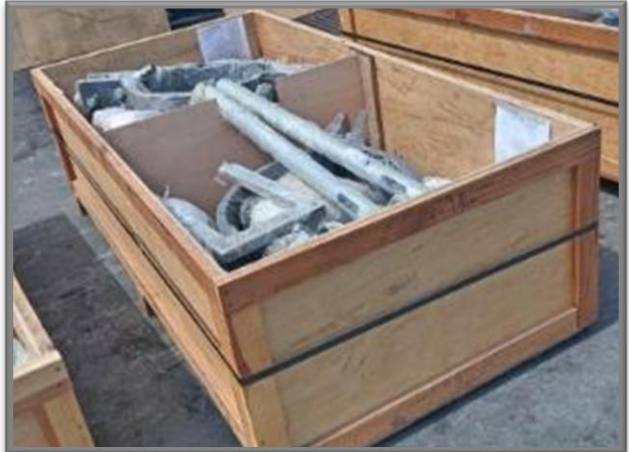
RE-SCAVENGER CLS L1 CELL 1

Item	Description	Gt Sap p/No. Of Tag No.	Length (Mts)	Heidt (Mts)	Width (Mts)	Quantity	Gross Weight (Kg)	Cause	Damage
1	Wooden Box	1320-Sep-00003	2,05	0,62	1,00	1	422,967	Origin	Ok
2	Wooden Box	0320-Sep-00001 0320-Sep-00002	2,05	0,62	1,00	1	820,934	Origin	Ok
3	Wooden Box	1320-Sep-00001 1320-Sep-00002	2,05	0,62	1,00	1	820,934	Origin	Ok
4	Radial Launder	1320-Sep-00003	1,8	0,68	1,35	1	282,000	Origin	Ok
5	Radial Launder	1320-Sep-00002	1,8	0,68	1,35	1	282,000	Origin	Pallet broken underneath
6	Radial Launder	1320-Sep-00001	1,8	0,68	1,35	1	282,000	Operation	Pallet broken underneath
7	Radial Launder	0320-Sep-00002	1,8	0,68	1,35	1	282,000	Origin	Pallet broken underneath
8	Radial Launder	0320-Sep-00001	1,8	0,68	1,35	1	282,000	Origin	Ok
Total,s						8	3051,868

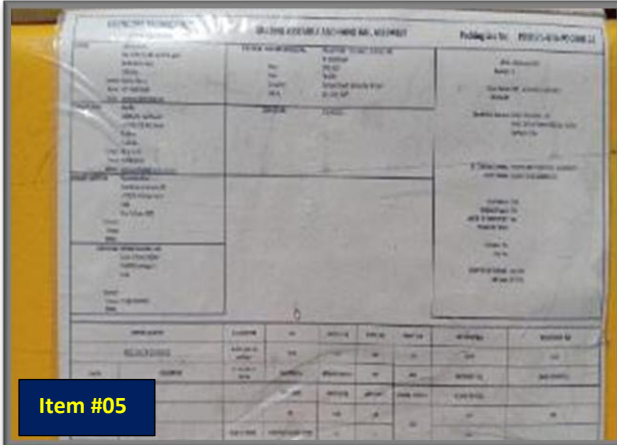
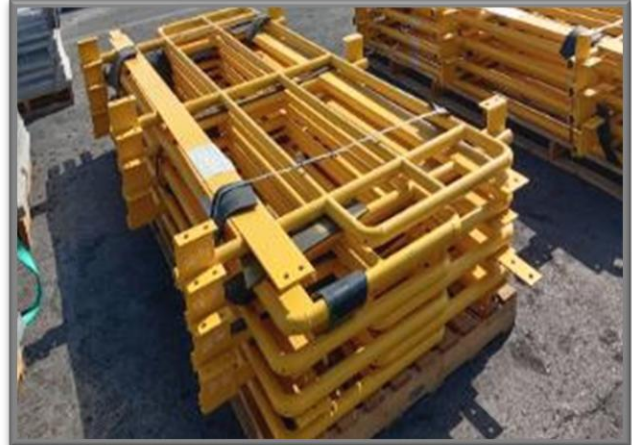
Item #05

Item	Description	Gt Sap p/No. Of Tag No.	Length (Mts)	Heidt (Mts)	Width (Mts)	Quantity	Gross Weight (Kg)	Cause	Damage
1	Hand Rail Assembly	0320-SEP-00001	3,5	0,64	1,68	1	700,000	Origin	Ok
2	Hand Rail Assembly	0320-SEP-00002	3,5	0,64	1,68	1	700,000	Origin	Ok
3	Hand Rail Assembly	320-SEP-00001	3,5	0,64	1,68	1	700,000	Origin	Ok
4	Hand Rail Assembly	320-SEP-00002	3,5	0,64	1,68	1	700,000	Origin	Ok
5	Hand Rail Assembly	320-SEP-00003	3,5	0,64	1,68	1	700,000	Origin	Ok
6	Grating Assembly	0320-SEP-00001	2,35	0,64	1,05	1	1630,000	Origin	Ok
7	Grating Assembly	0320-SEP-00002	2,35	0,64	1,05	1	1630,000	Origin	Ok
8	Grating Assembly	320-SEP-00001	2,35	0,64	1,05	1	1630,000	Origin	Ok
9	Grating Assembly	320-SEP-00001	2,35	0,64	1,05	1	1630,000	Origin	Ok
10	Grating Assembly	320-SEP-00001	2,35	0,64	1,05	1	1630,000	Origin	Ok
Total's						10	11650,000

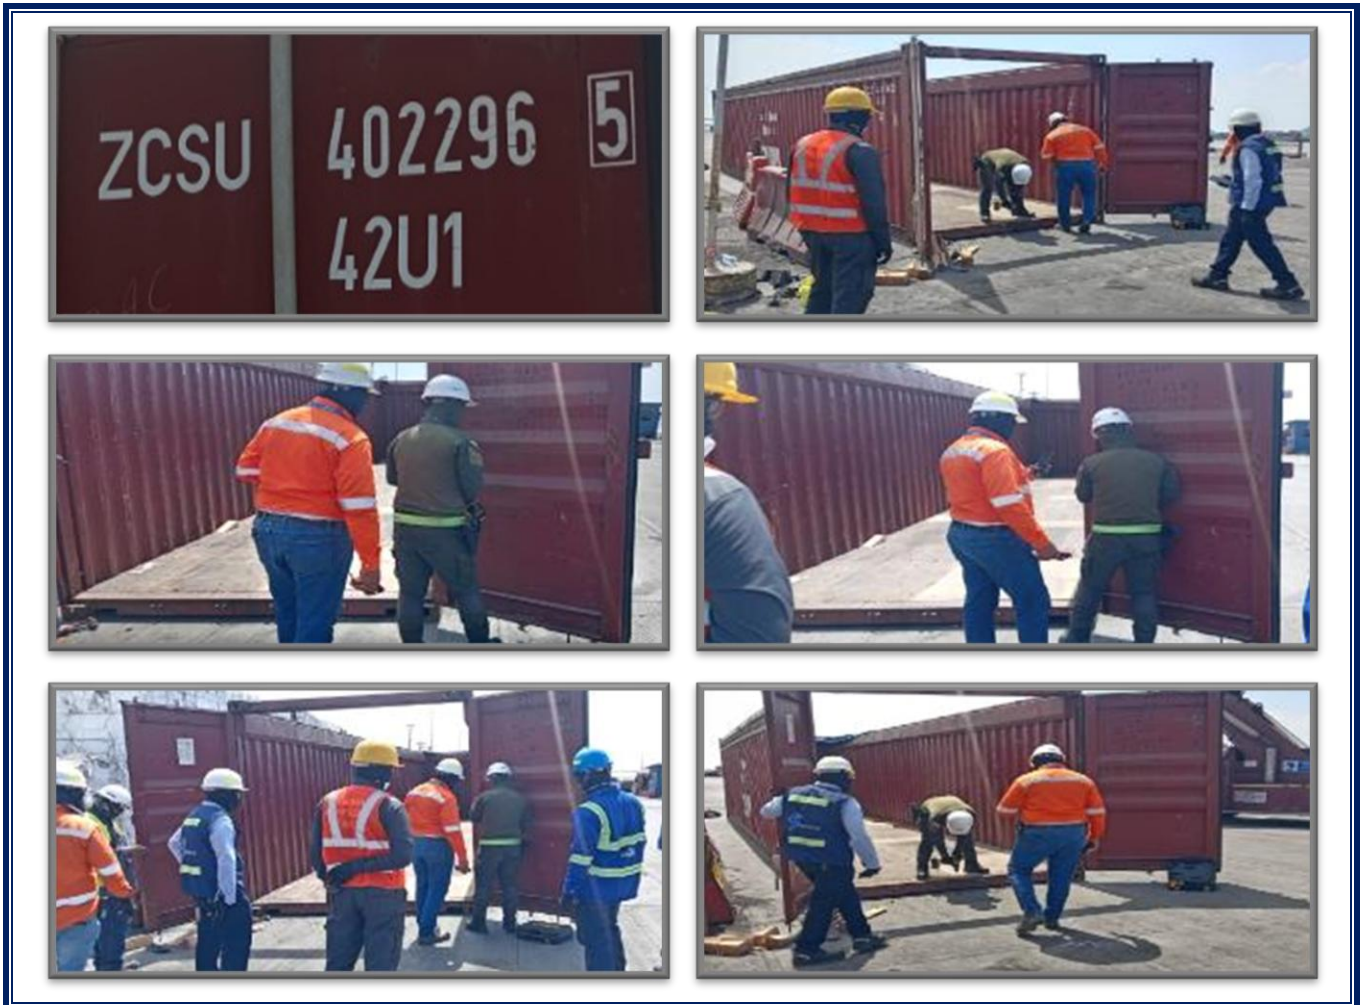
PERFORATIONS IN THE CONTAINER

- ❖ Drilling through the top and bottom rails.
- ❖ Drilling through the doors and roof.
- ❖ Drilling through the bars of both doors.

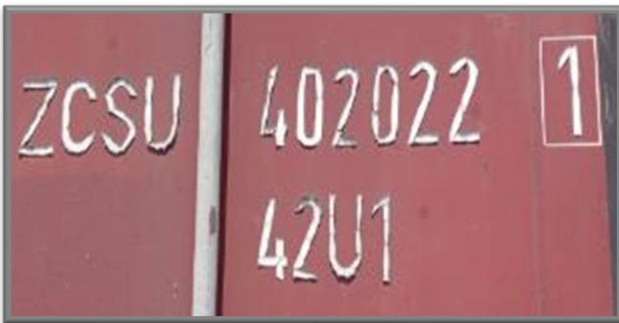
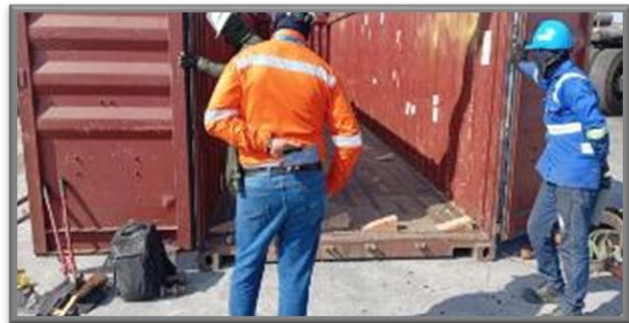
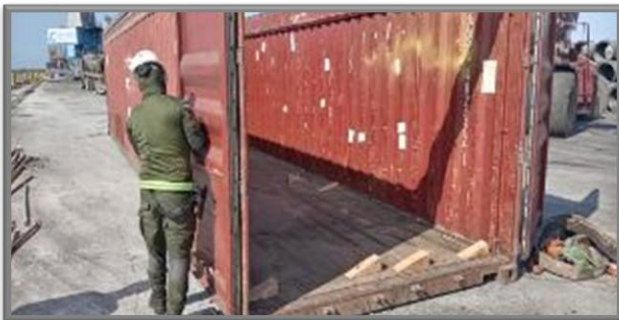
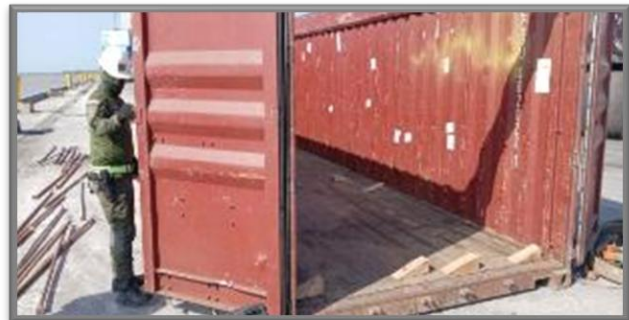
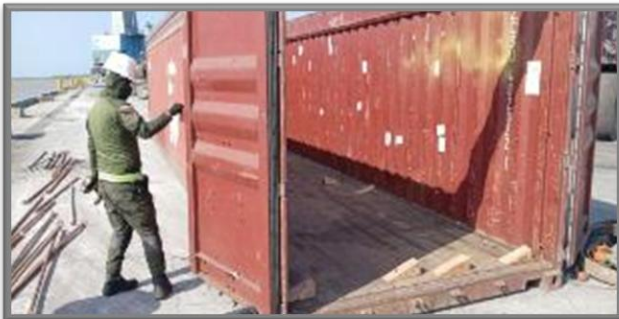
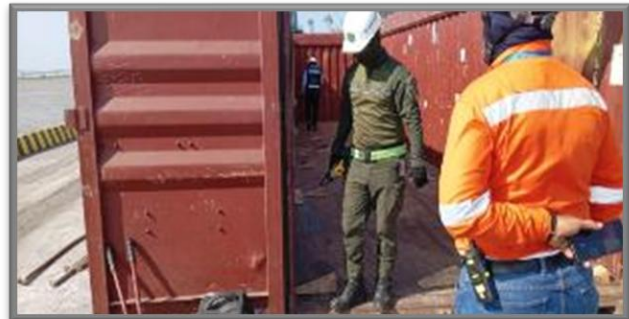
PERFORATIONS IN THE CONTAINER

- ❖ Drilling through the top and bottom rails.
- ❖ Drilling through the doors and roof.
- ❖ Drilling through the bars of both doors.

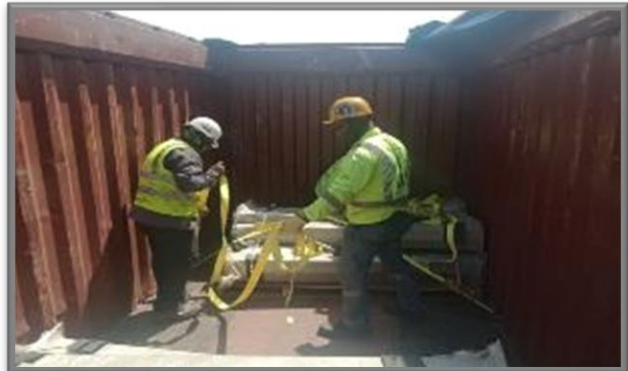
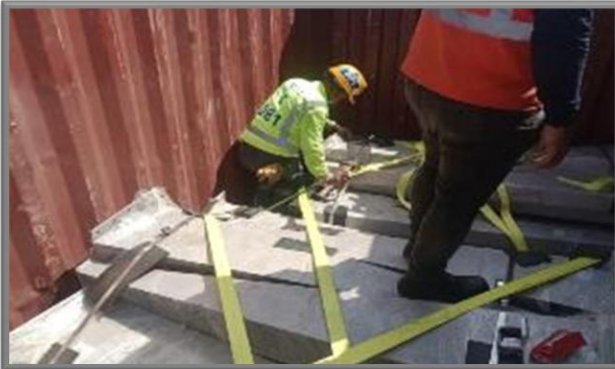
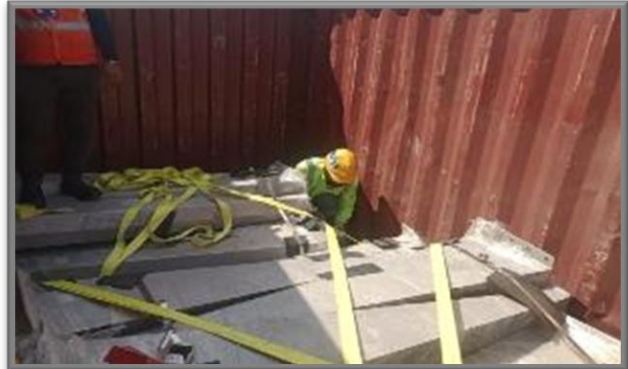
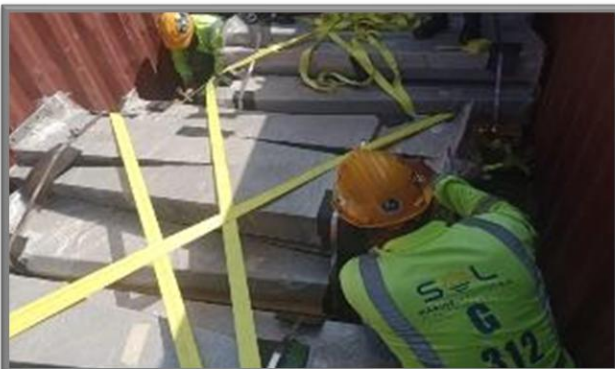
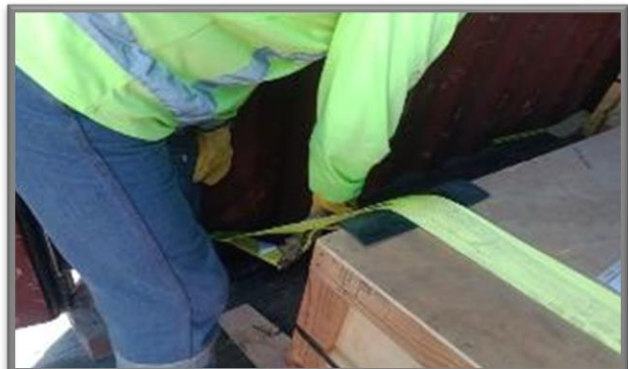
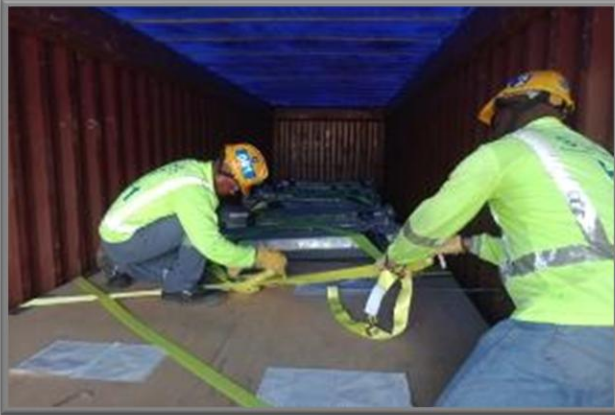
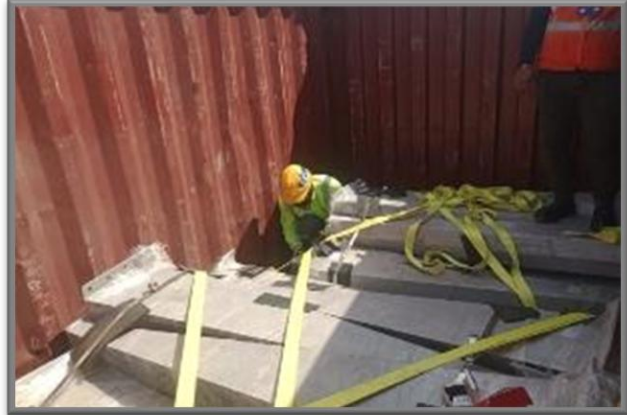
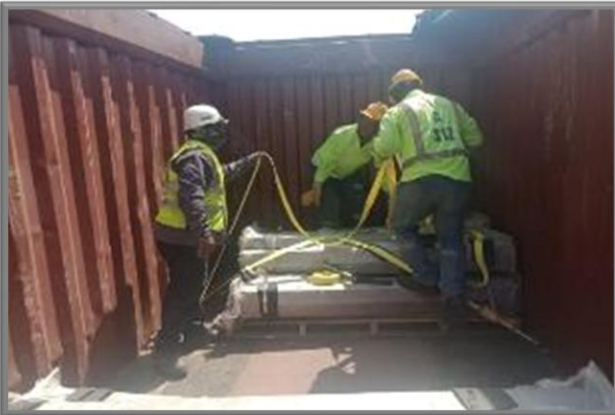
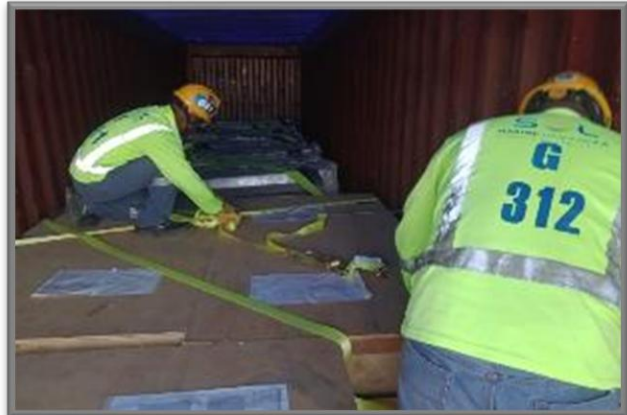
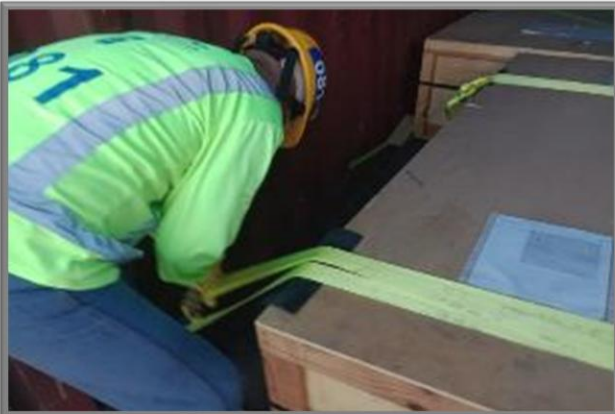
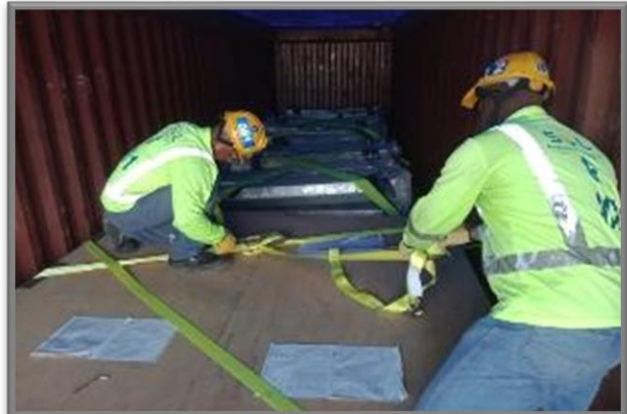
11.1 First Container / ZCSU 402296 - 5:

SECURING THE CARGO IN DEVELOPMENT

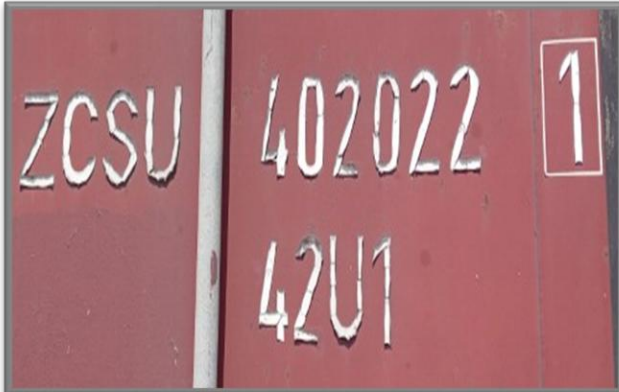
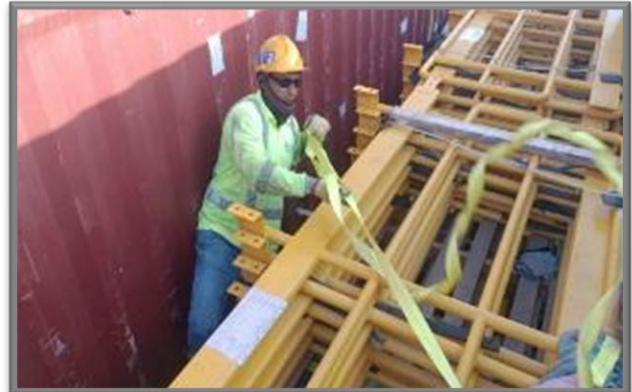
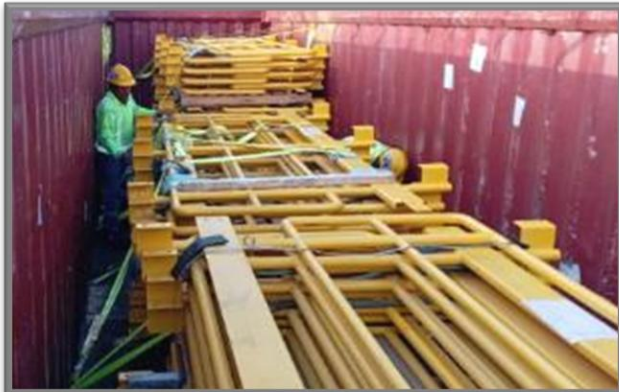
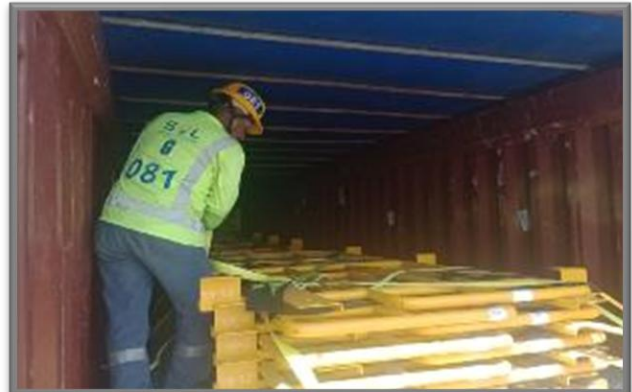
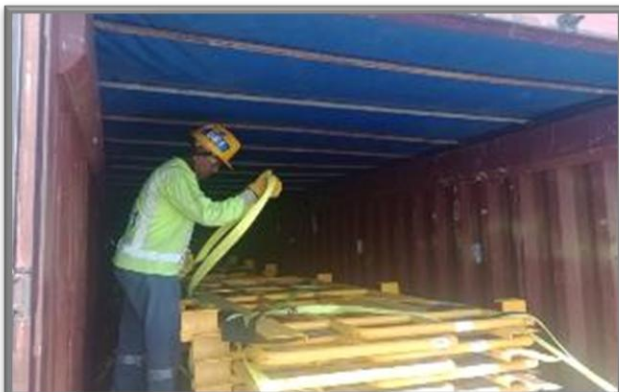
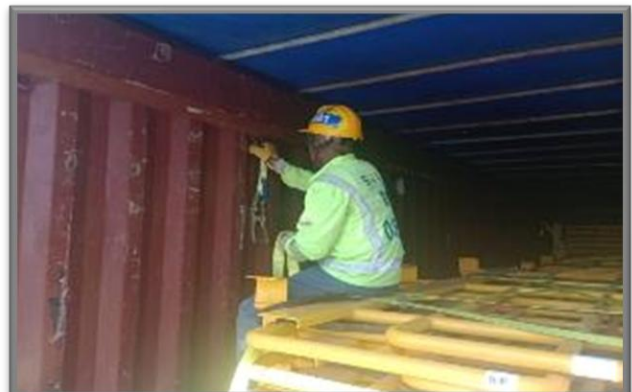
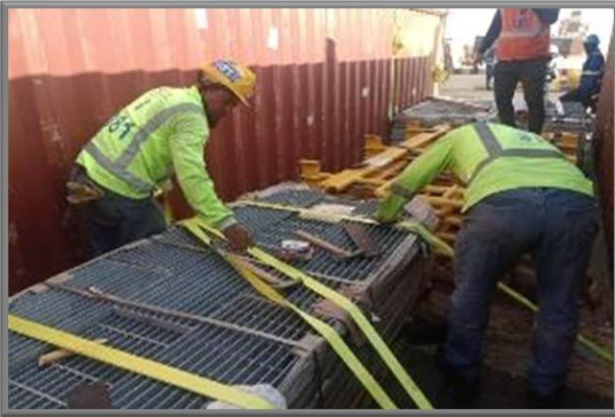
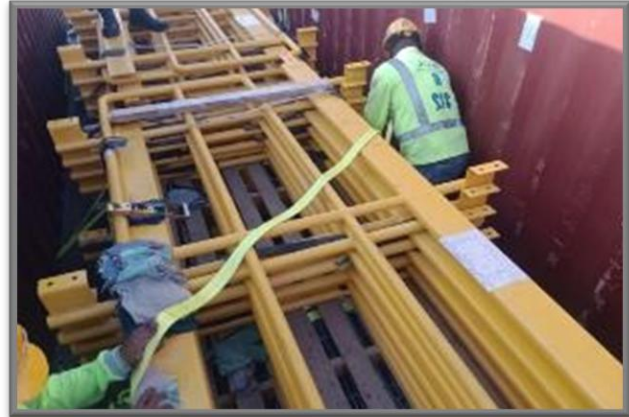
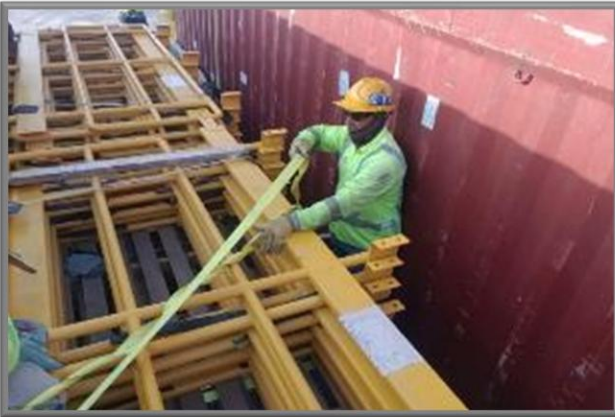
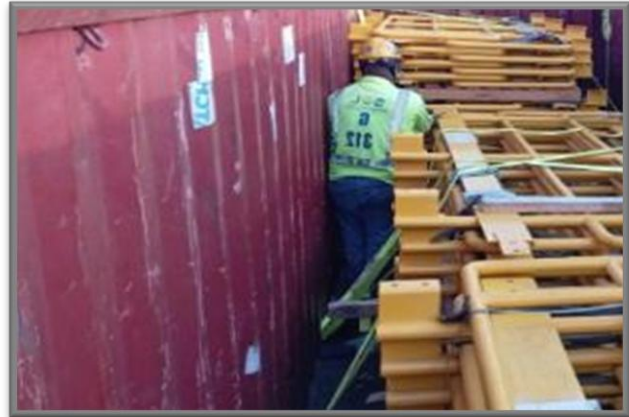
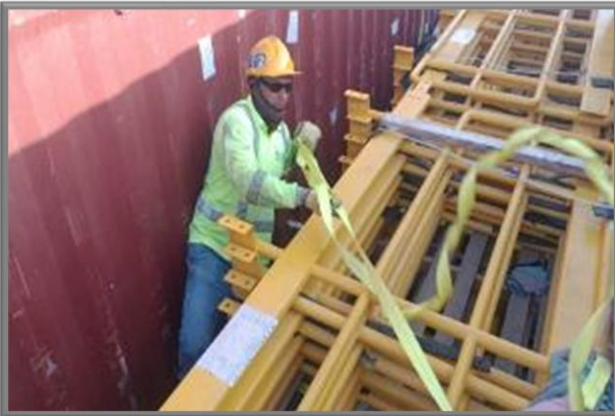
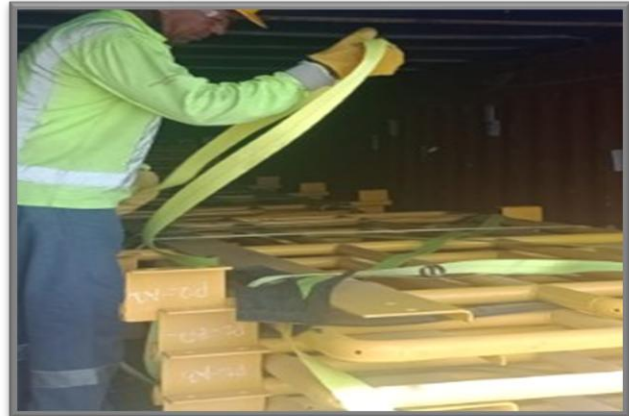
11.2 Second Container / ZCSU 402022 - 1:

SECURING THE CARGO IN DEVELOPMENT

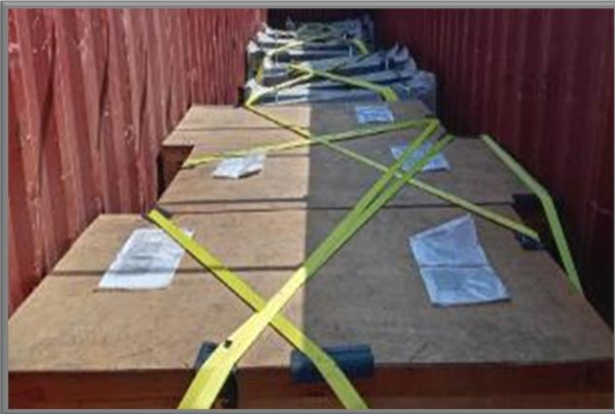
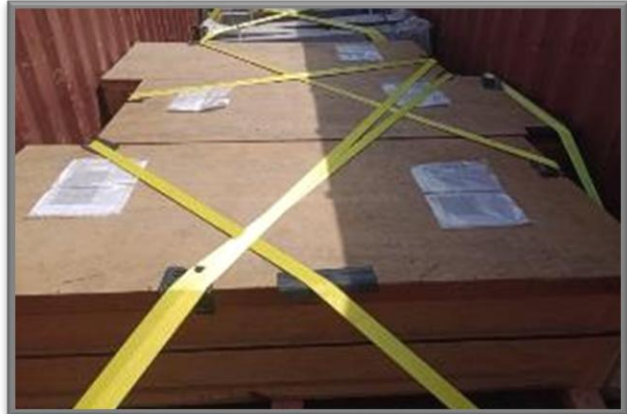
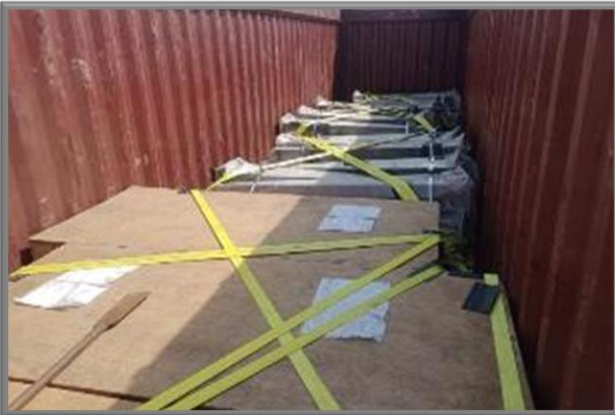
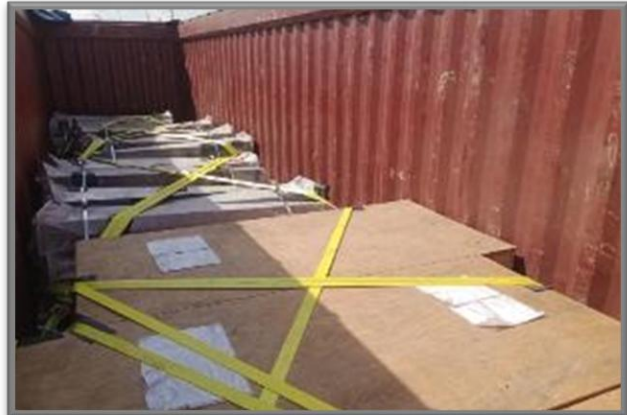
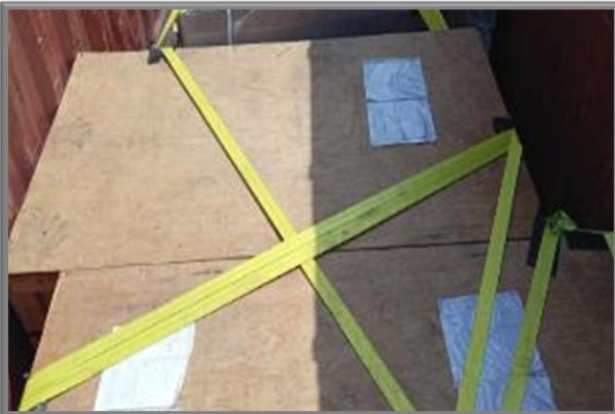
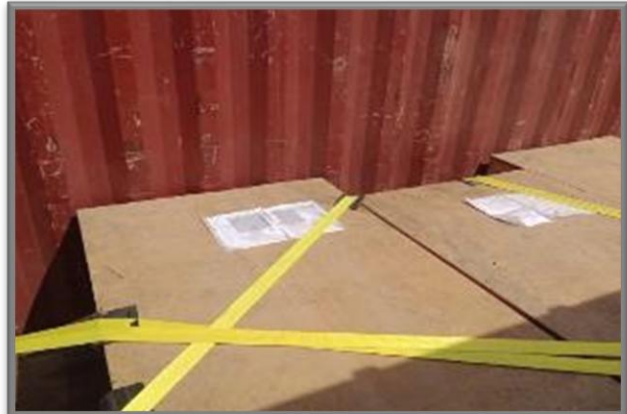
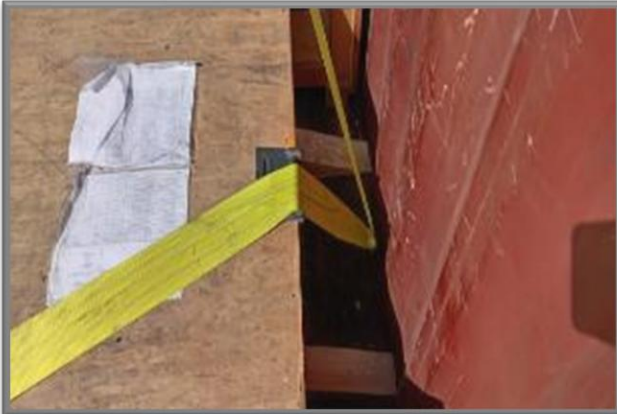
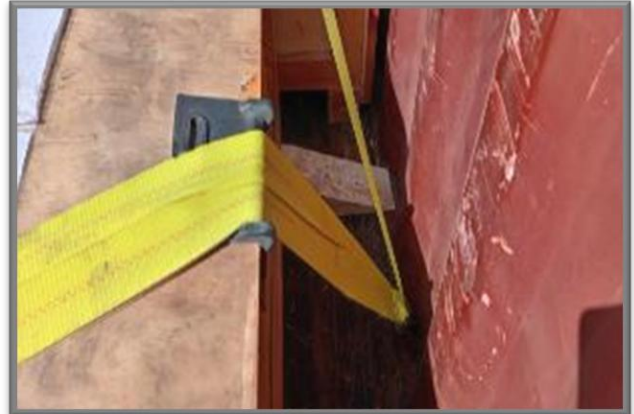
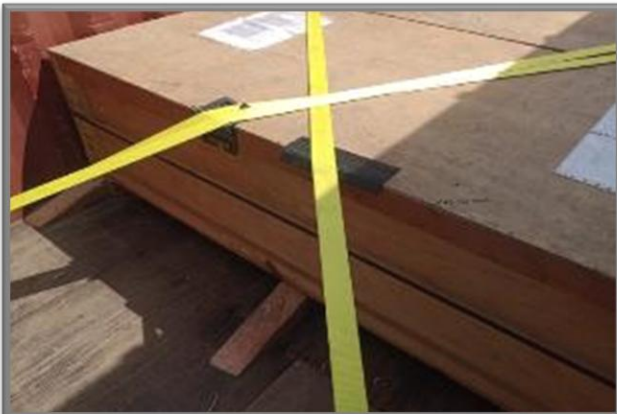
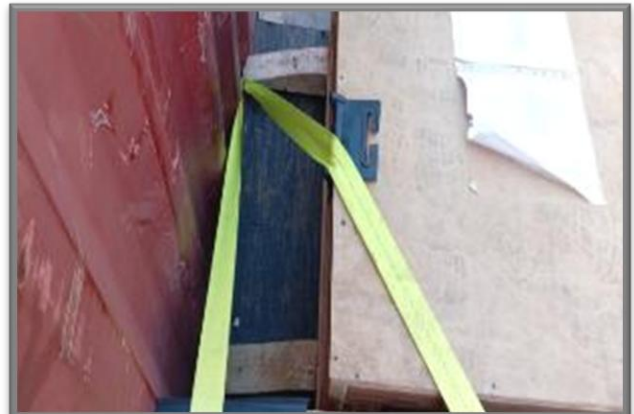
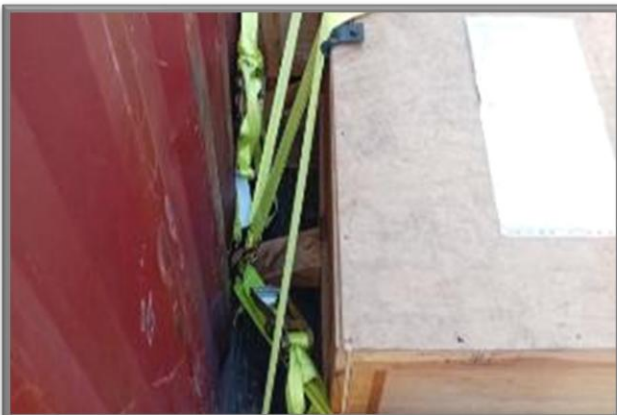
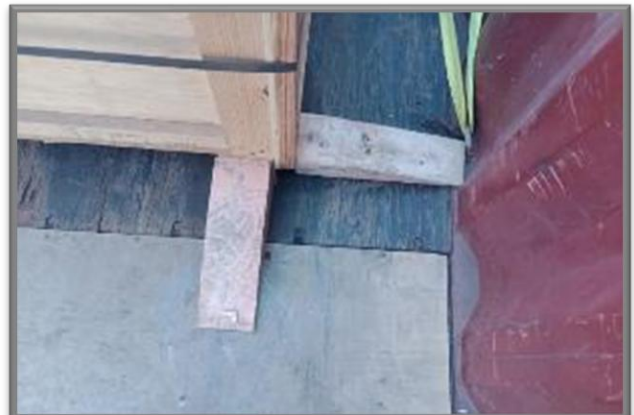
FINAL PRESENTATION OF LASHING

- ❖ No slippage / No evidence of moisture.
- ❖ Cargo properly stowed.
- ❖ Cargo secured with synthetic slings and ratchets.

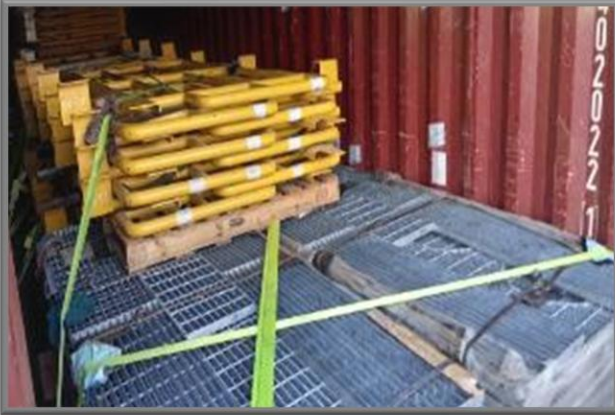
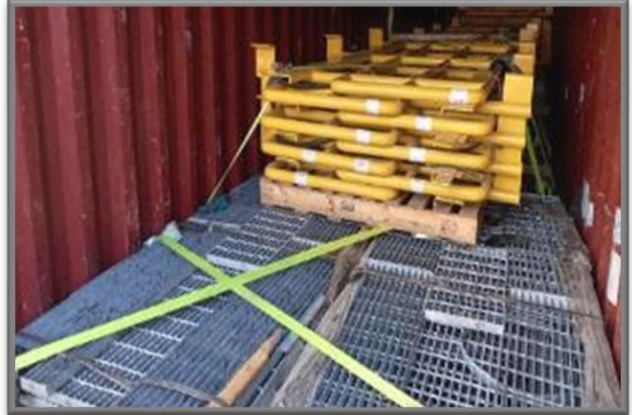
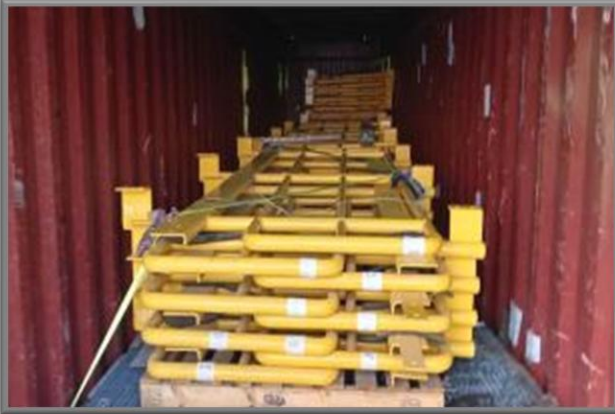
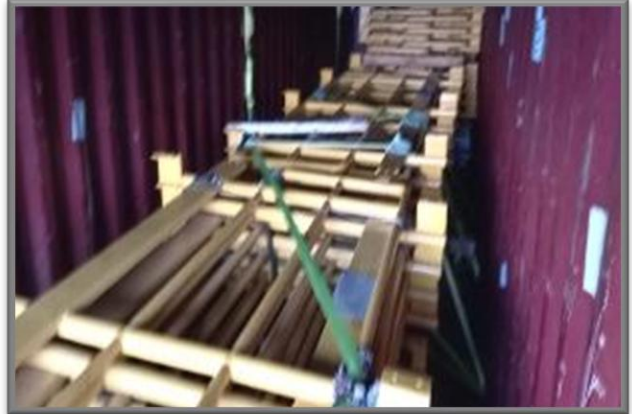
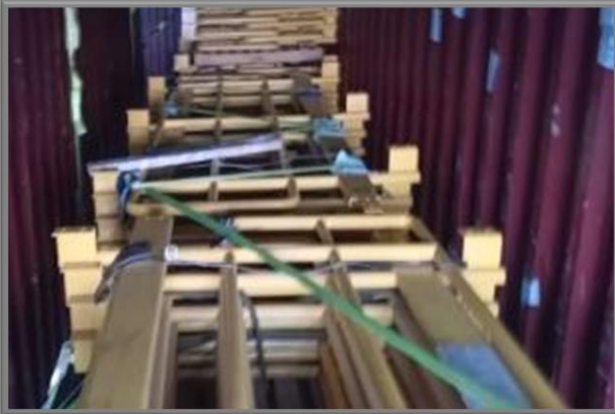
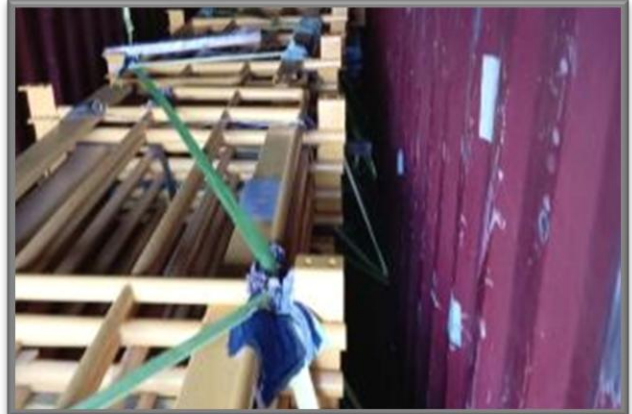
FINAL PRESENTATION OF LASHING

- ❖ No slippage / No evidence of moisture.
- ❖ Cargo properly stowed.
- ❖ Cargo secured with synthetic slings and ratchets.
