MV "ULTRA FOREST"

FULL ON HIRE & BUNKER SURVEY

This is to certify that the undersigned representative of ALS Inspection Chile did, at the request of **Messrs. DAMPSKIBSSELSKABET NORDEN A/S**, attend on board motor vessel "**ULTRA FOREST**" with Master consent on May 31, 2026, while she was at berthed at **pier Nr. 8, Panul Port**, San Antonio, Chile, in order to carry out an On Hire, general condition survey and bunker survey, as follows:

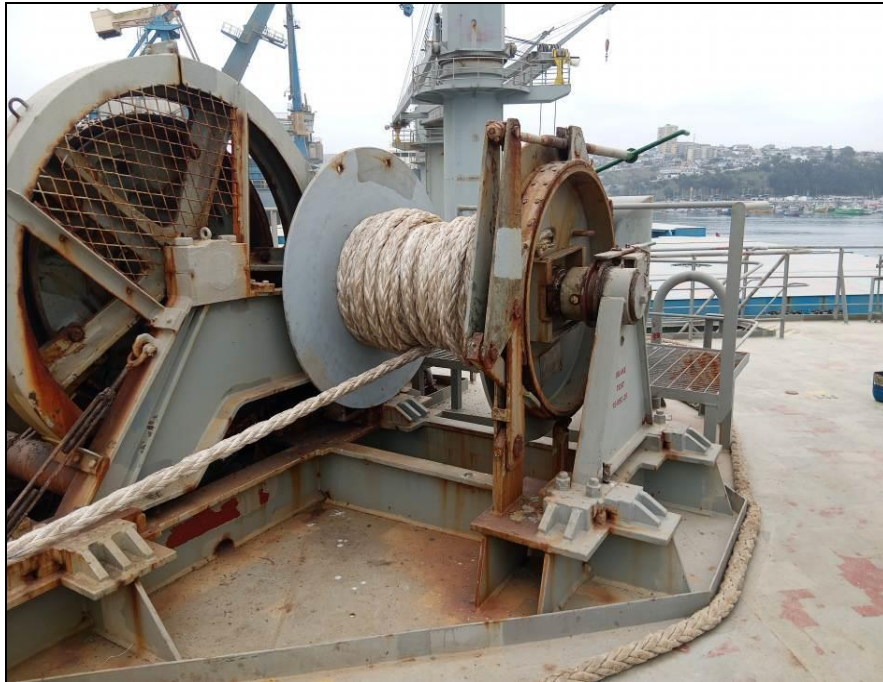
15. Winch Ss Fore deck, in good conditions.

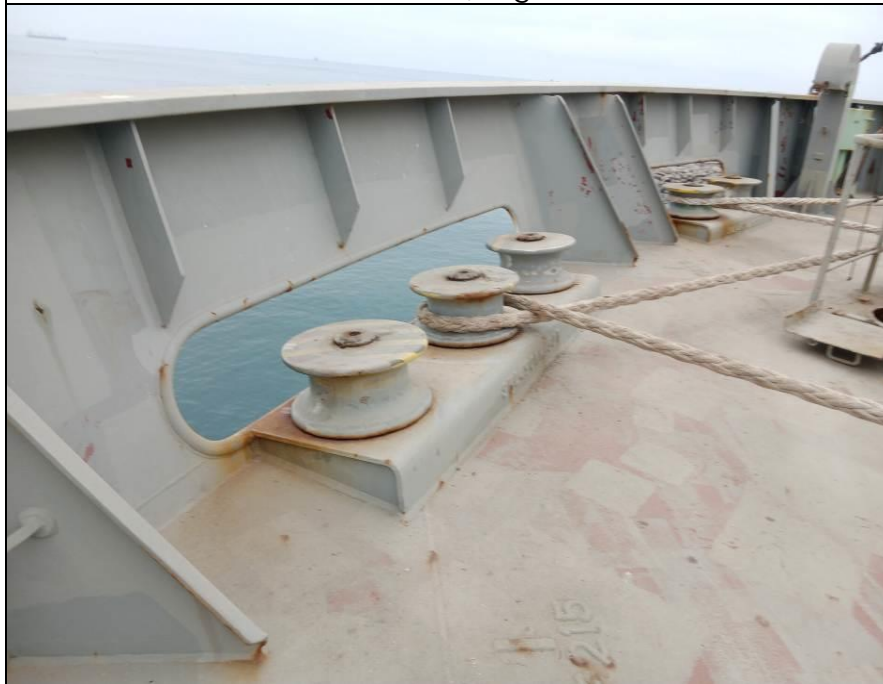
16. Roller guides in good conditions.

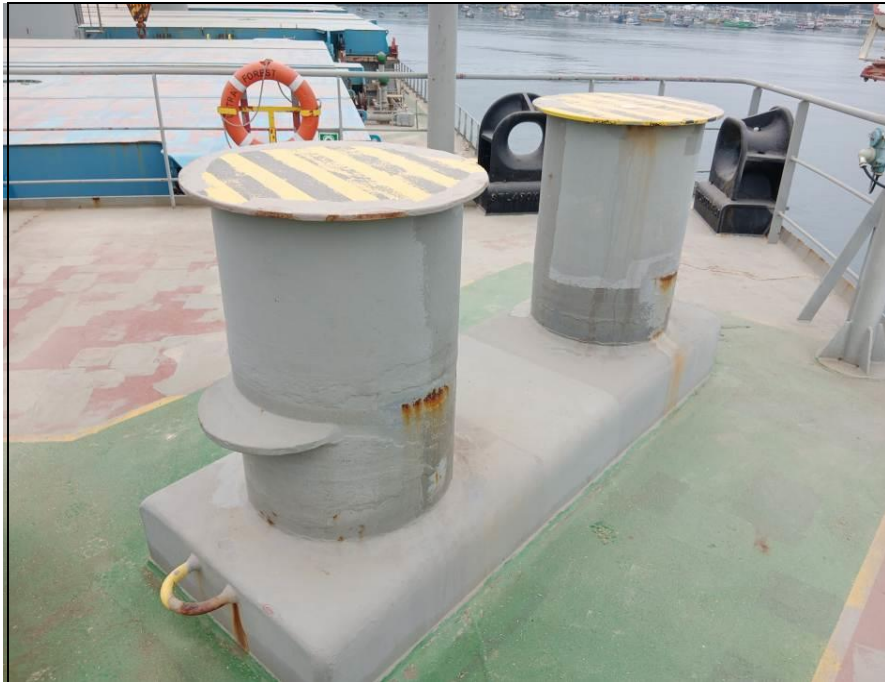
17. Bollards in good condition.

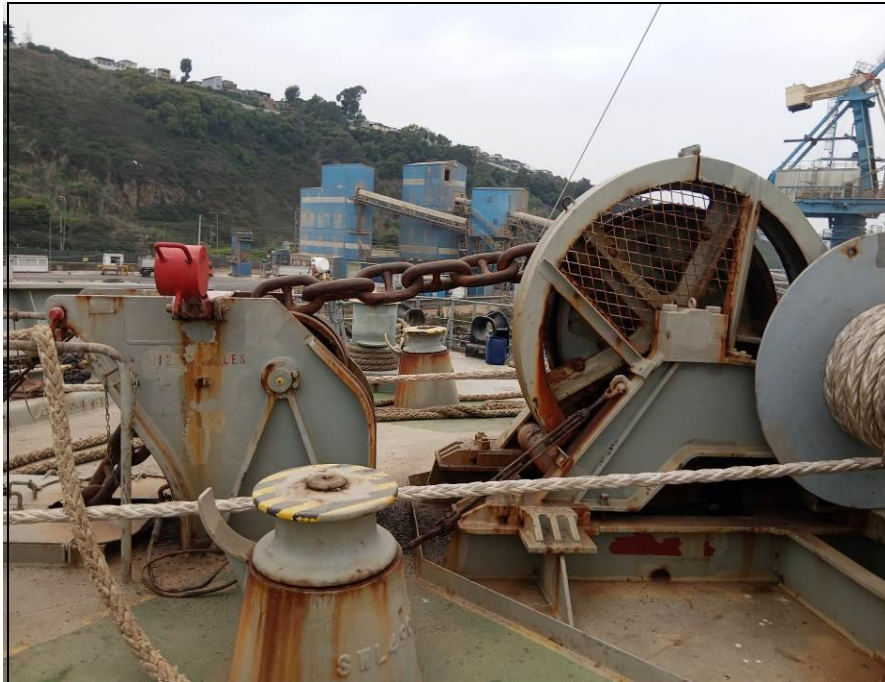
19. Ss capstans, in good conditions.

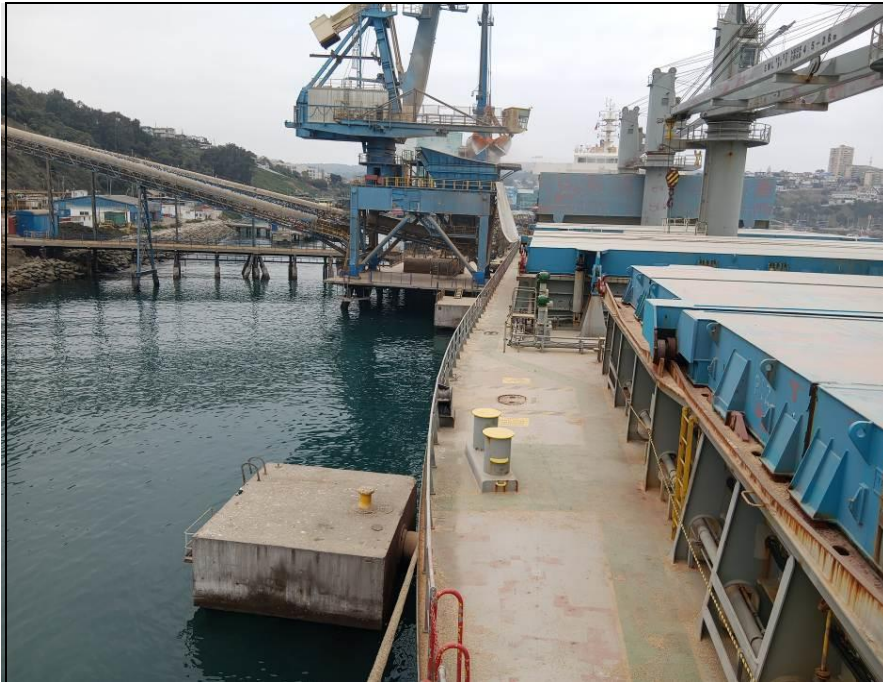
21. Starboard side main deck.

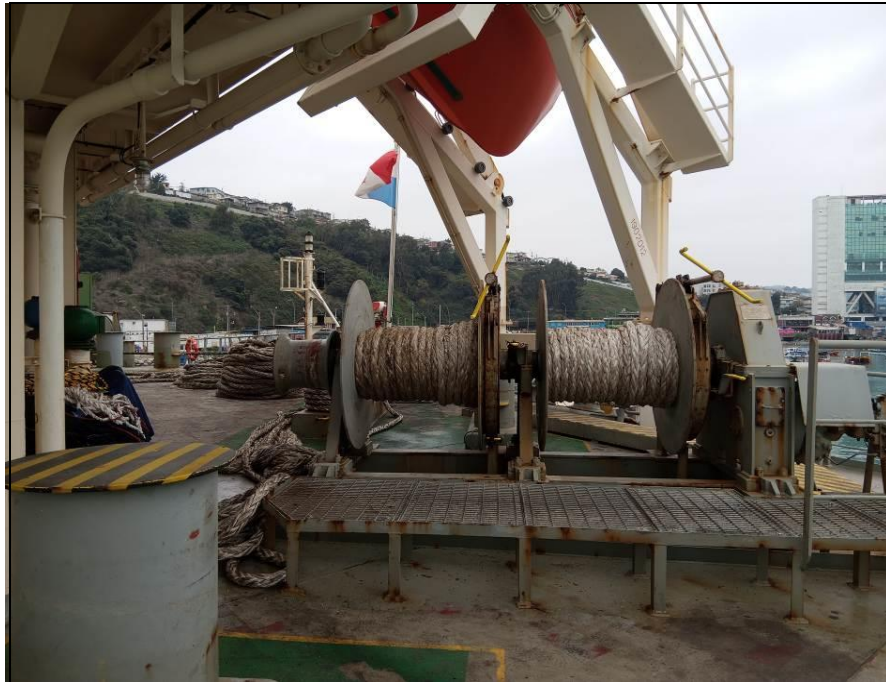
23. Winch Ps poop deck, in good conditions.

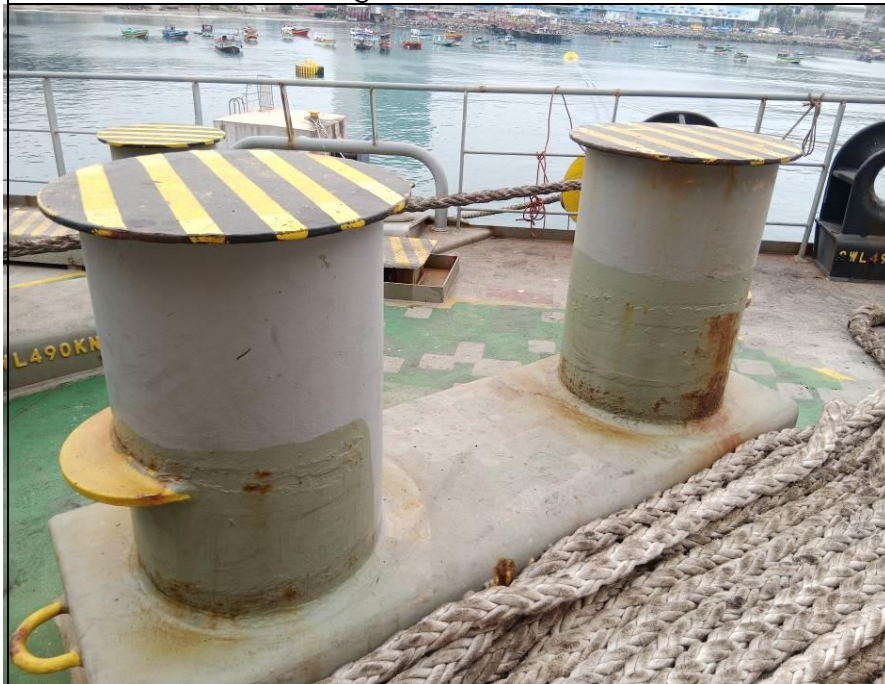
26. Bollards in good conditions.

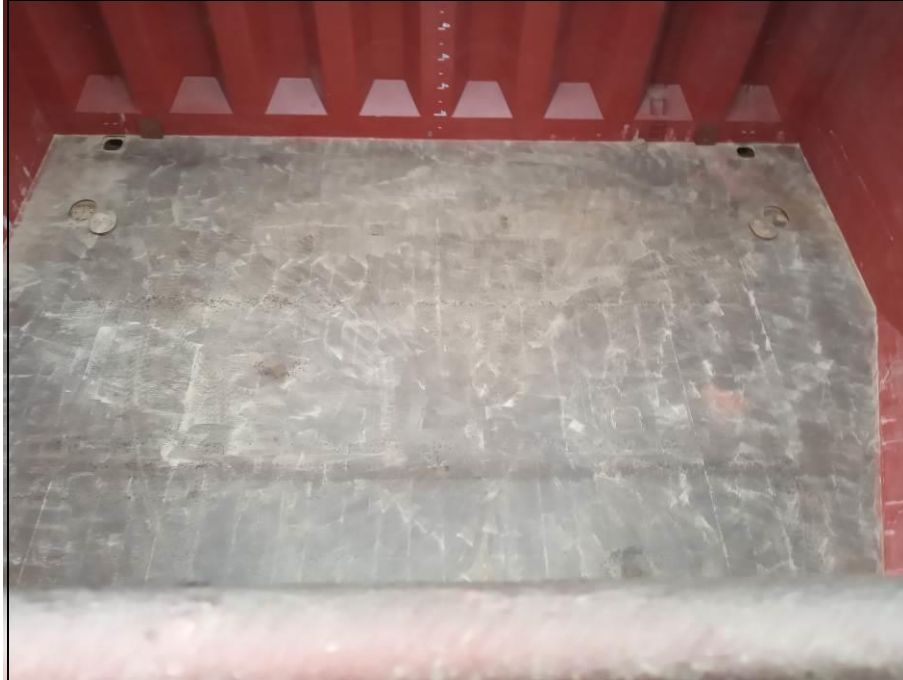
27. General view of C/H N°1.

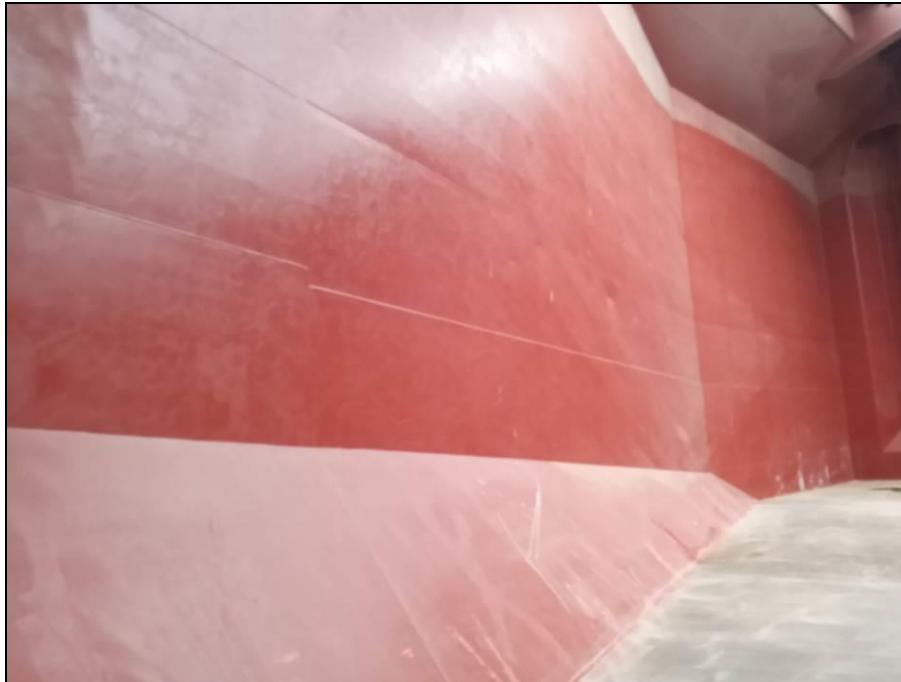
No. 7: Side/shell plating Ss with paint scratched and rust (See photo No. 31)

31. Side/shell plating Ss with paint scratched.

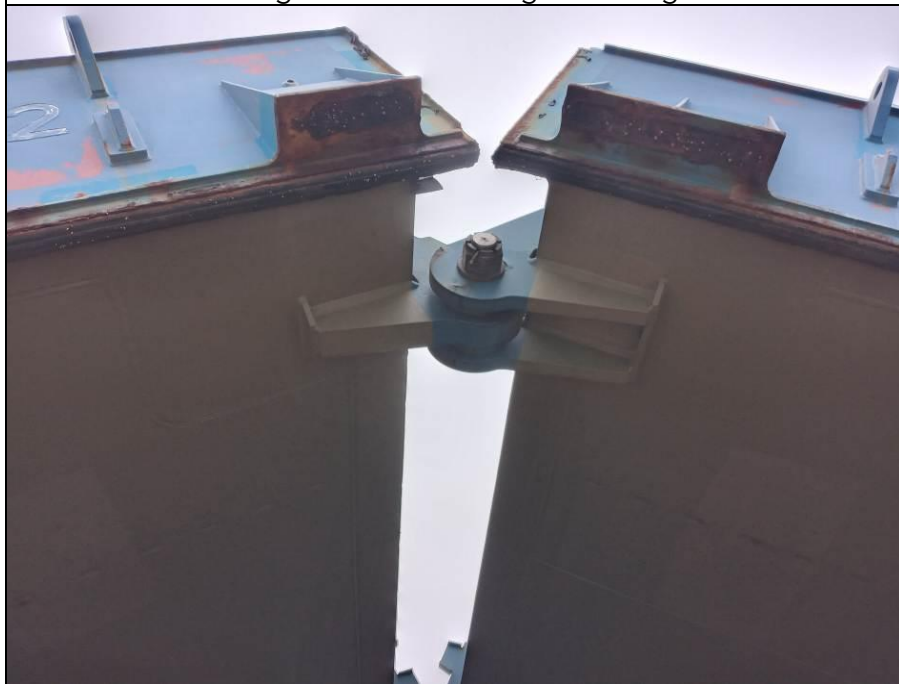
34. Hatchcover No.1, rubber gasket in good conditions.

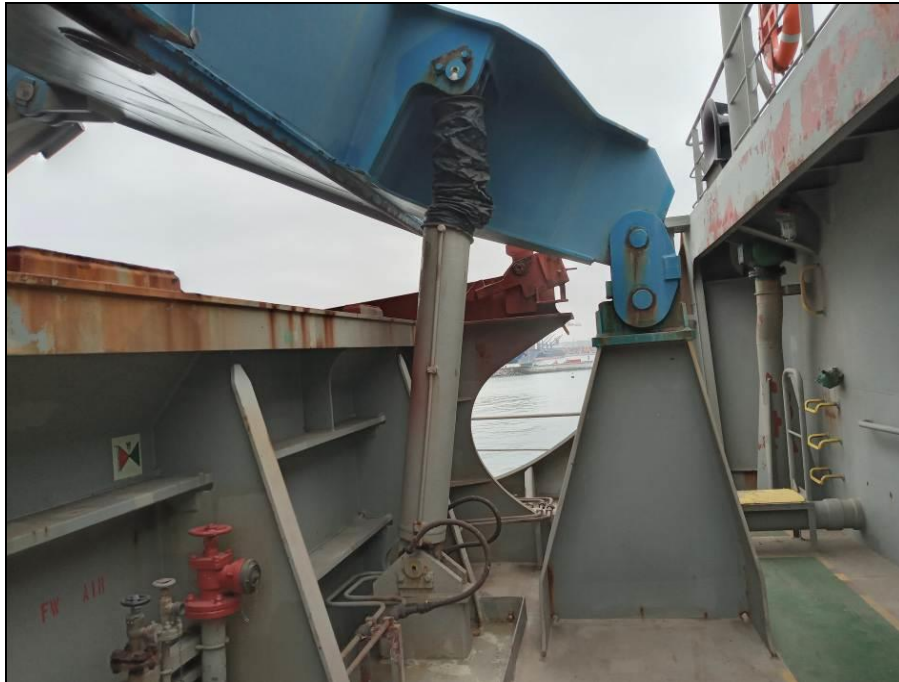
35. Hatchcover No. 1, hydraulic systems in good conditions

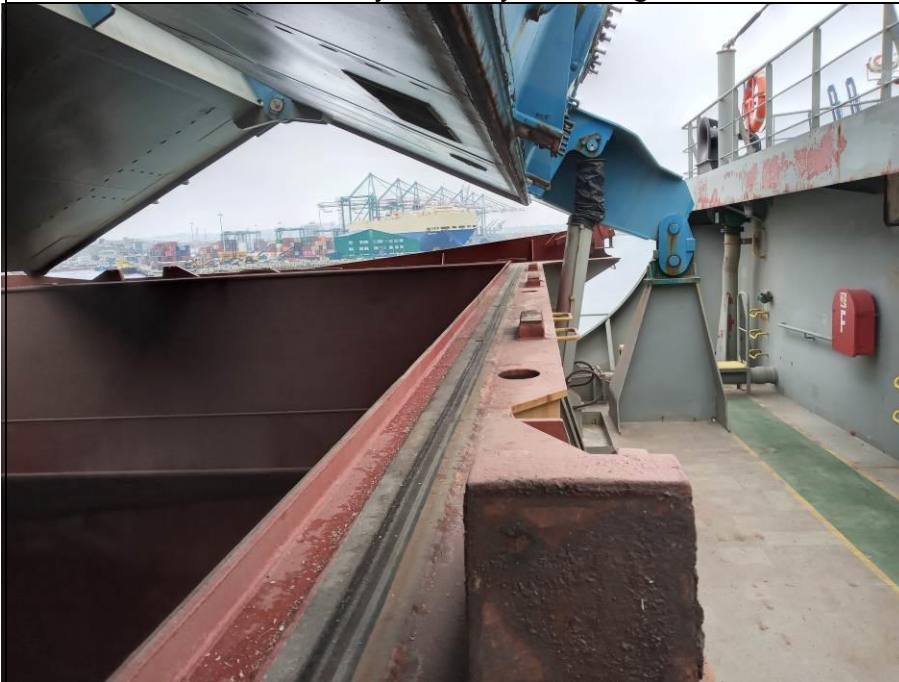
36. Hatchcover No. 1, compression bars in good conditions.

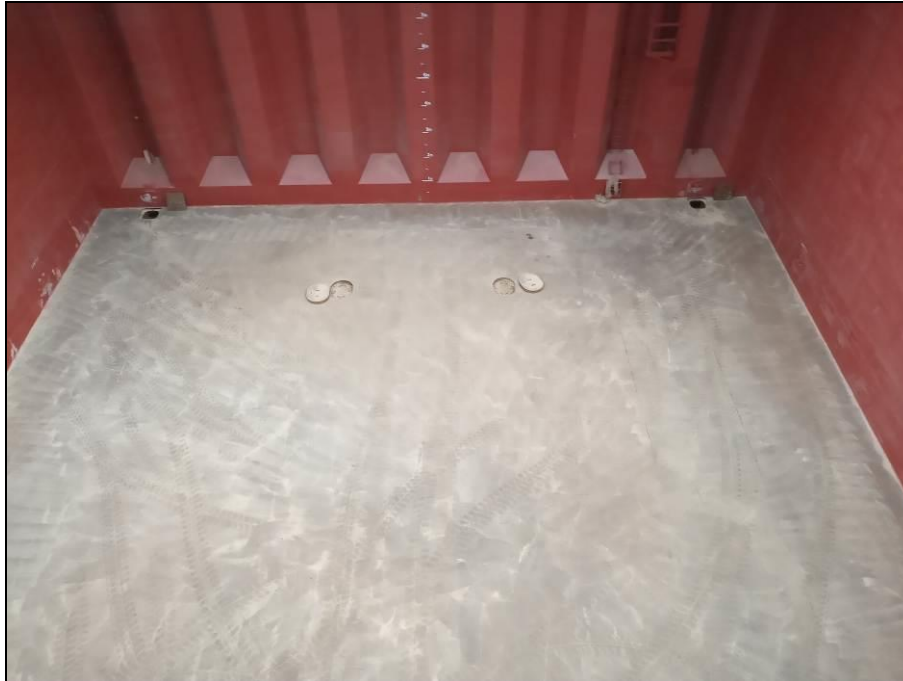
37. General view of C/H N° 2.

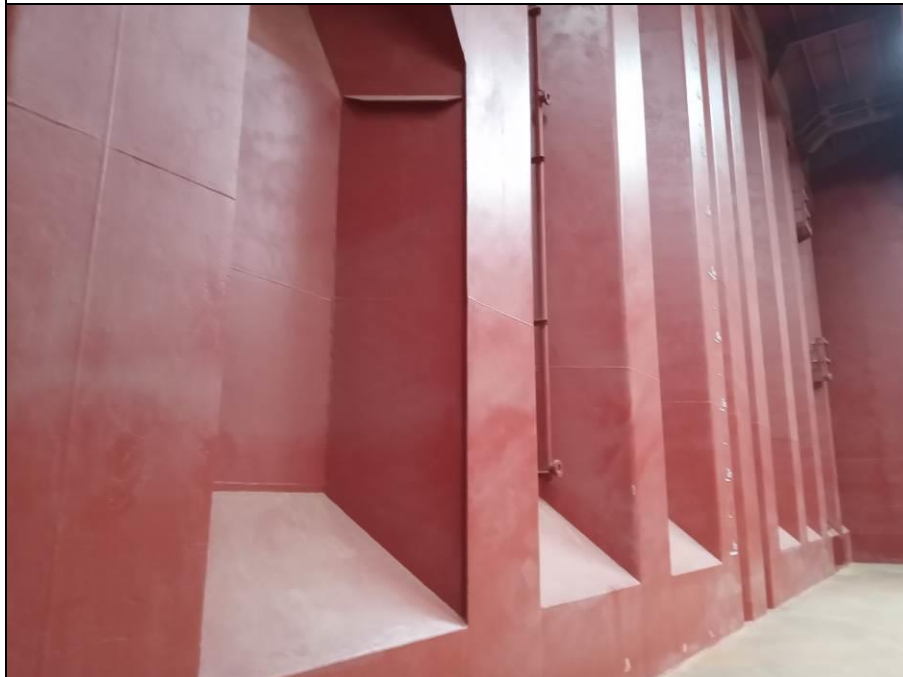
No. 9: Forward bulkhead with paint scratched and dust (See photo No. 38)

38. Fwd bulkhead, with paint scratched and dust.

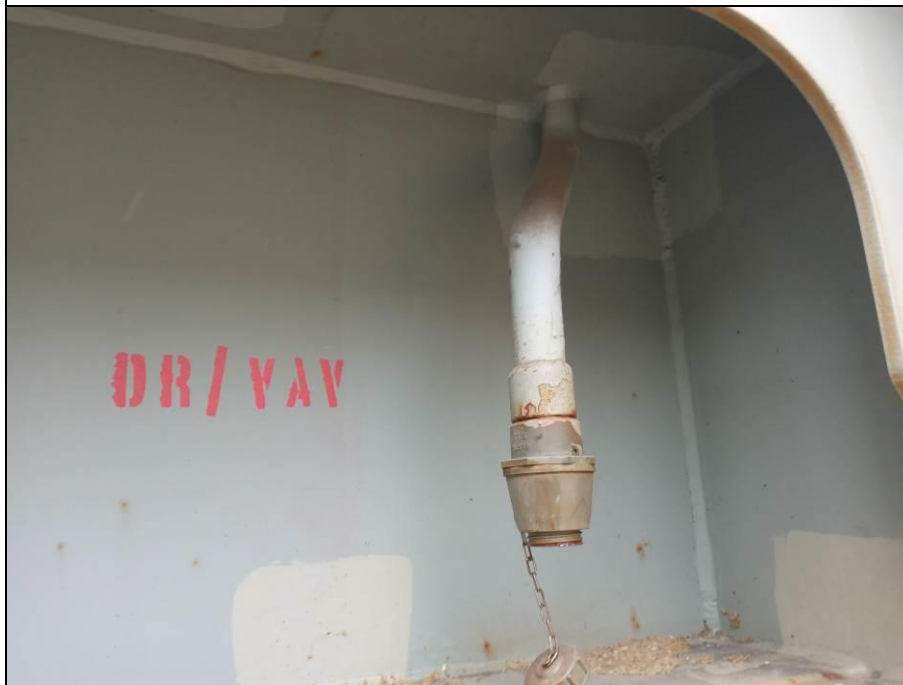
44. Hatchcover No. 2, non-return valves in good conditions.

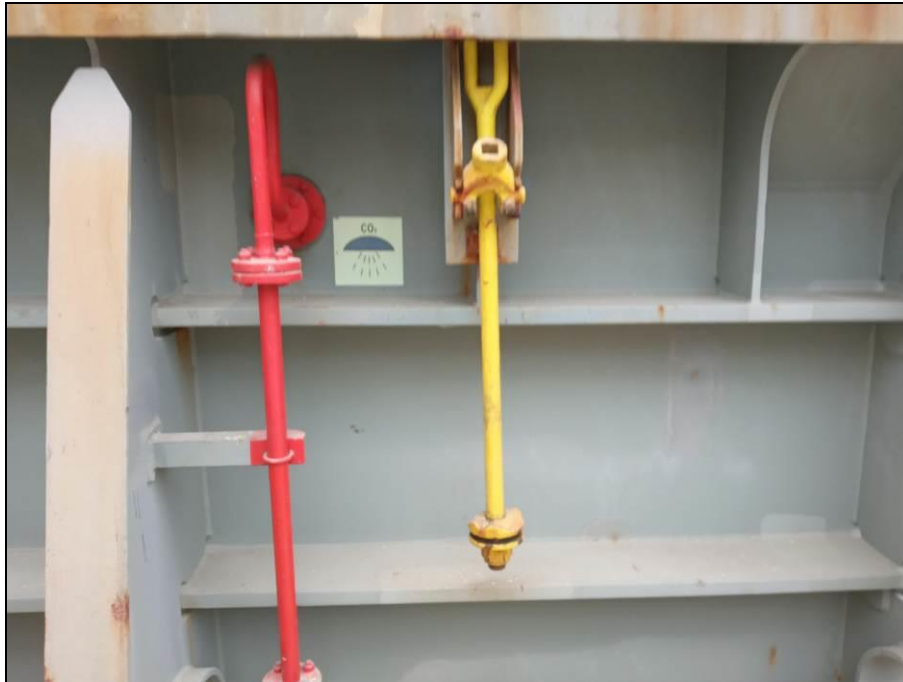
45. Hatchcover No. 2, active cleats in good conditions.

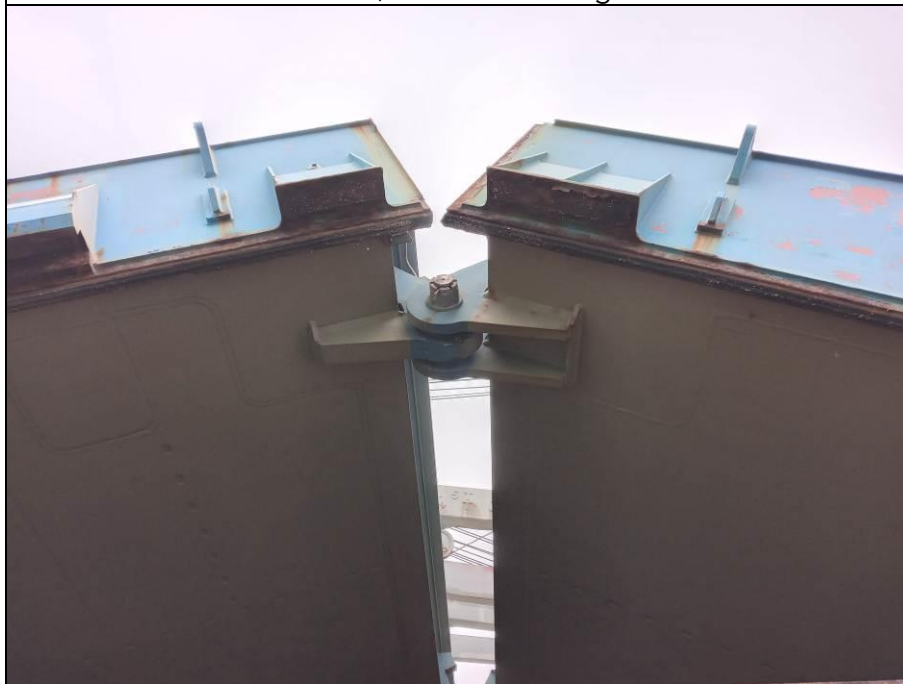
46. Hatchcover No. 2, rubber gasket in good condition.

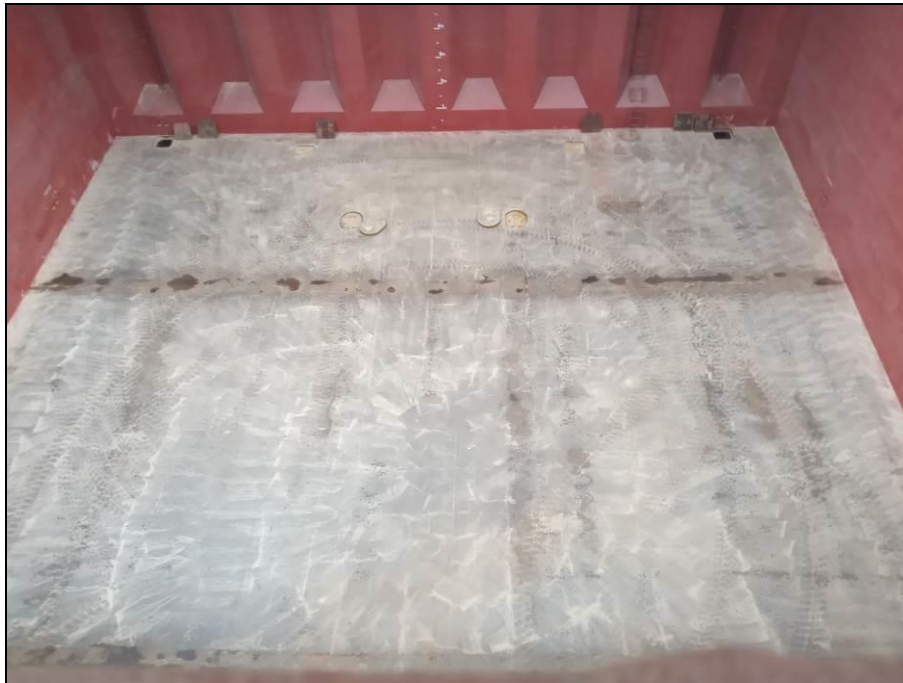
47. General view of C/H N° 3.

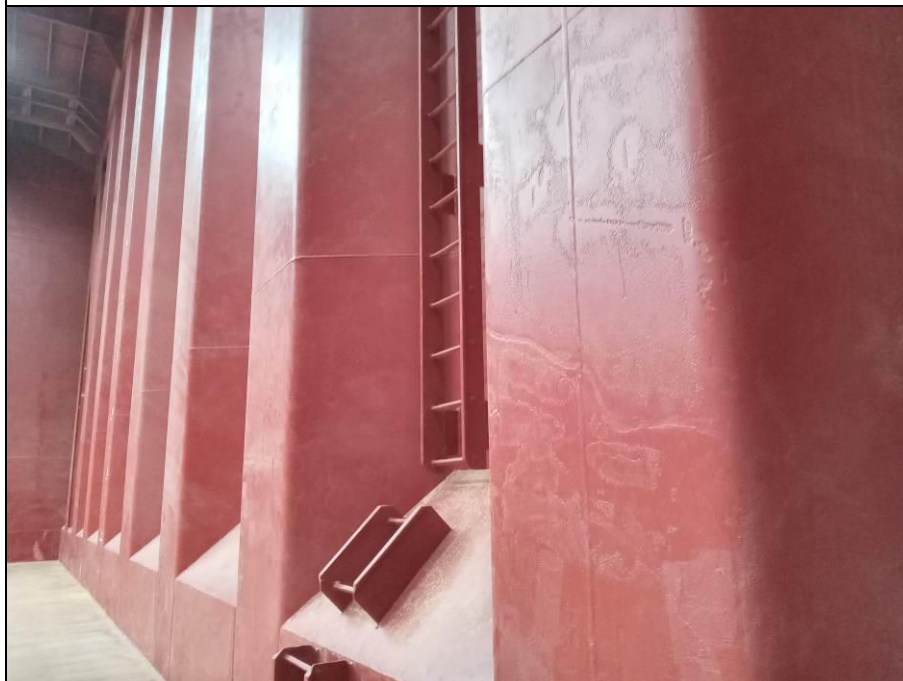
48. Fwd bulkhead, with paint scratched and dust.

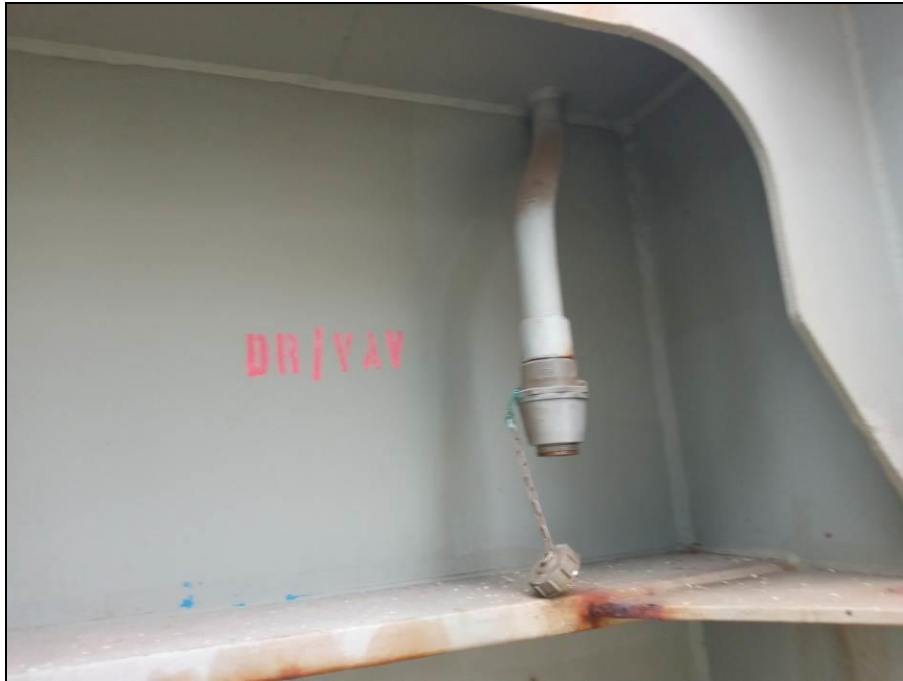
53. Hatchcover No. 3, non-return valves in good conditions.

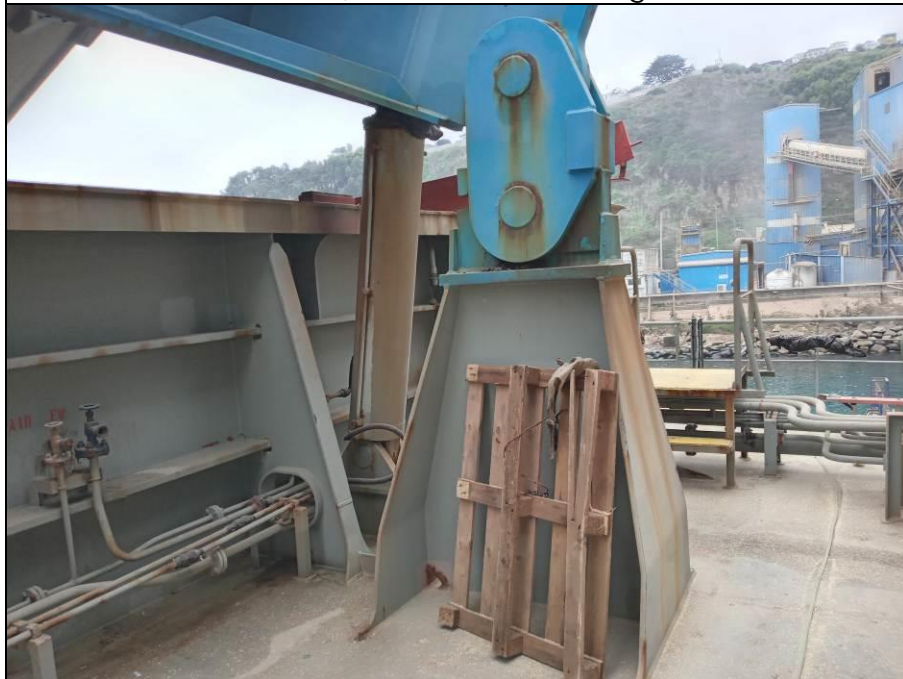
54. Hatchcover No. 3, hydraulic system in good conditions.

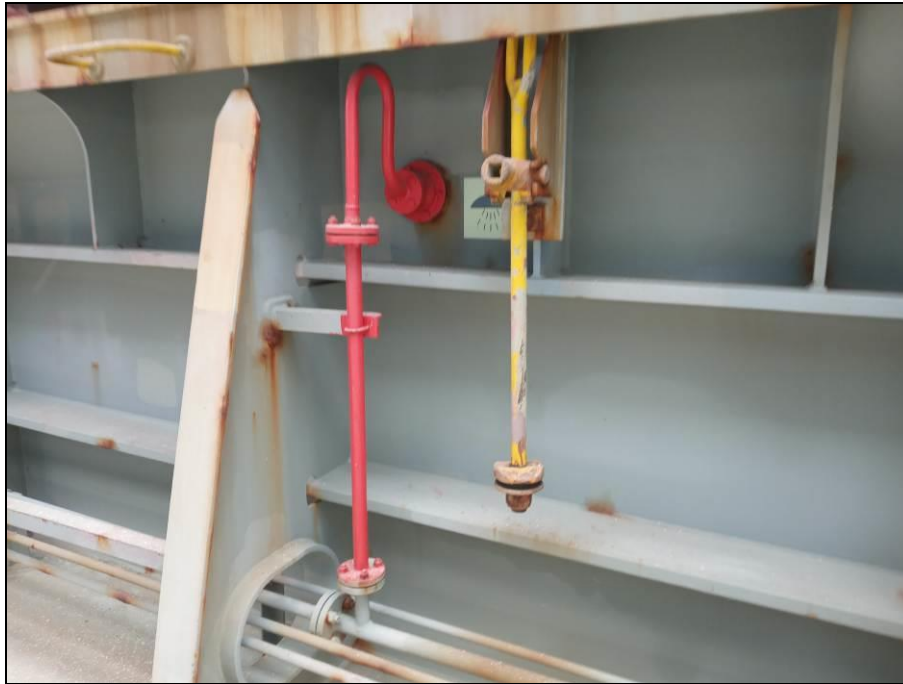
55. Hatchcover No. 3, active cleat in good conditions.

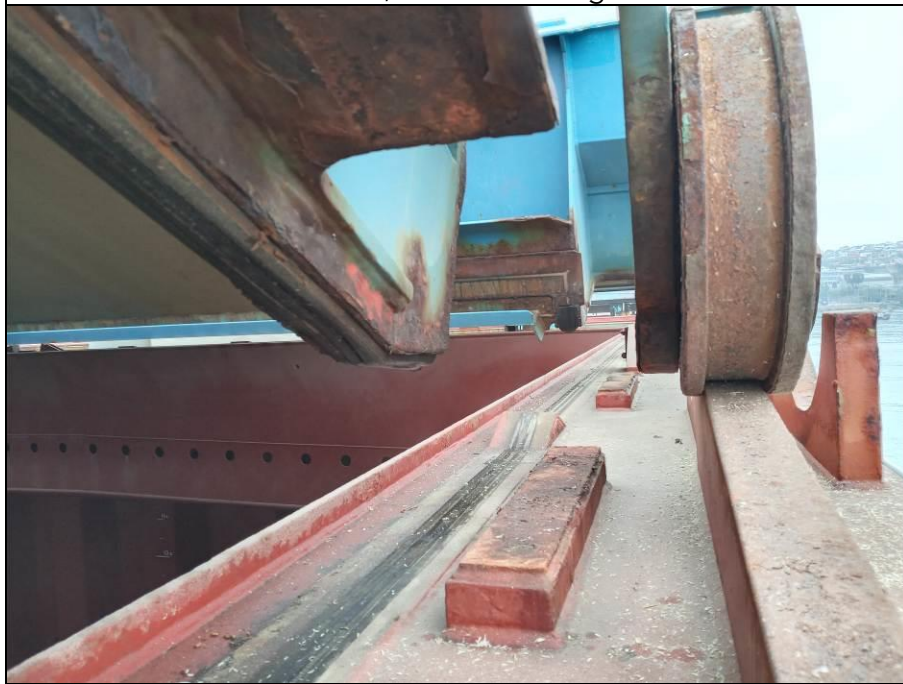
56. Hatchcover No. 3, compression bars in good conditions.

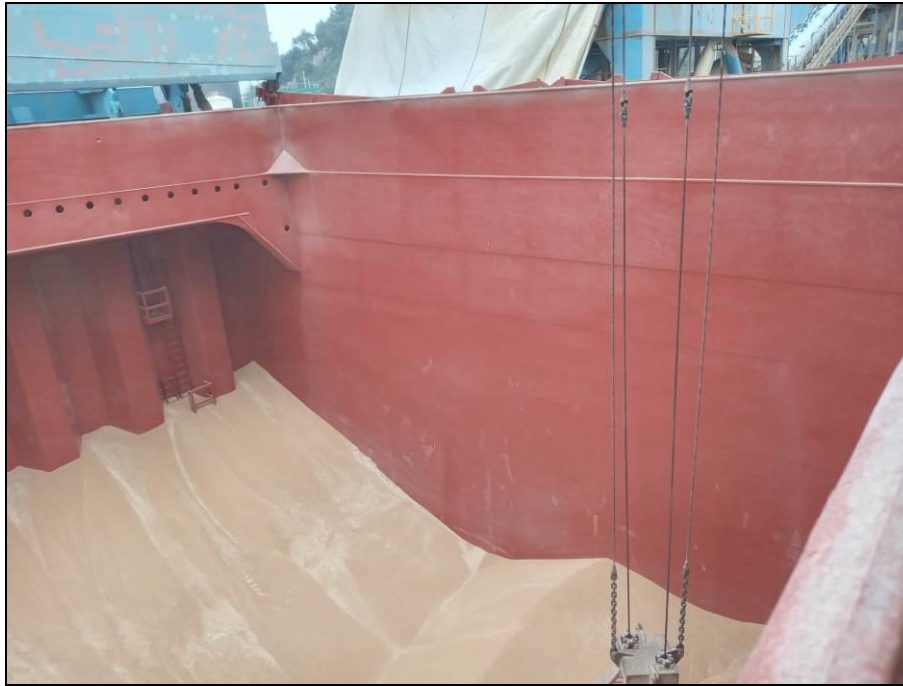
57. General view of C/H N° 4.

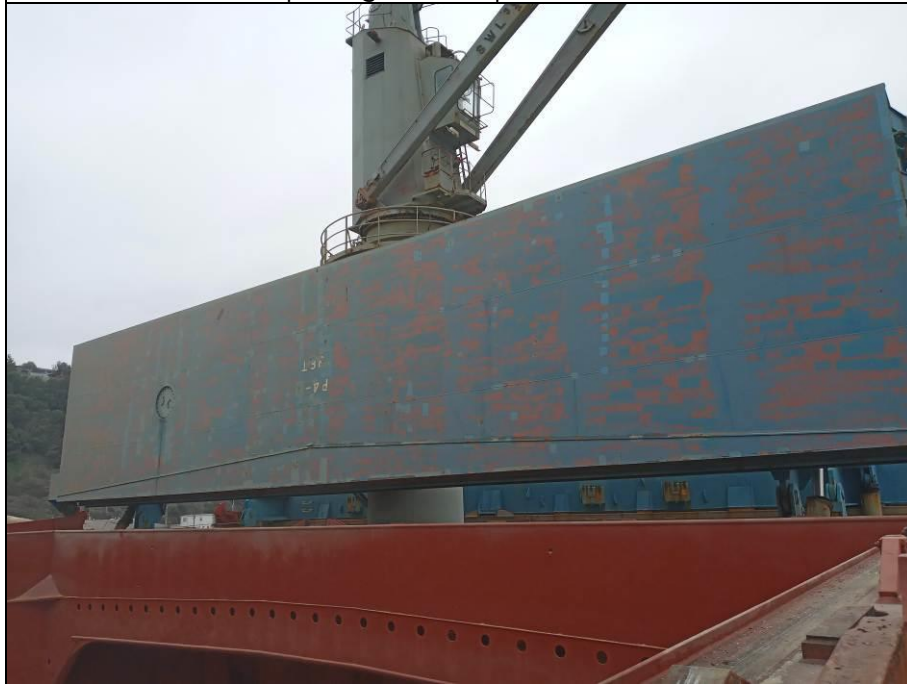
62. Hatch cover view.

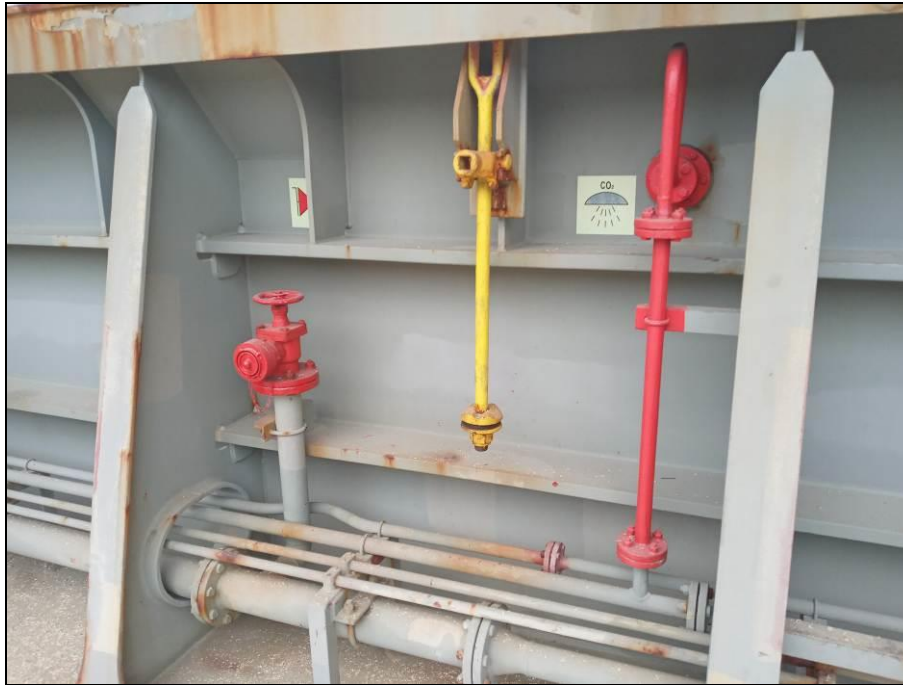
63. Hatchcover No. 4, active cleats valves in good conditions.

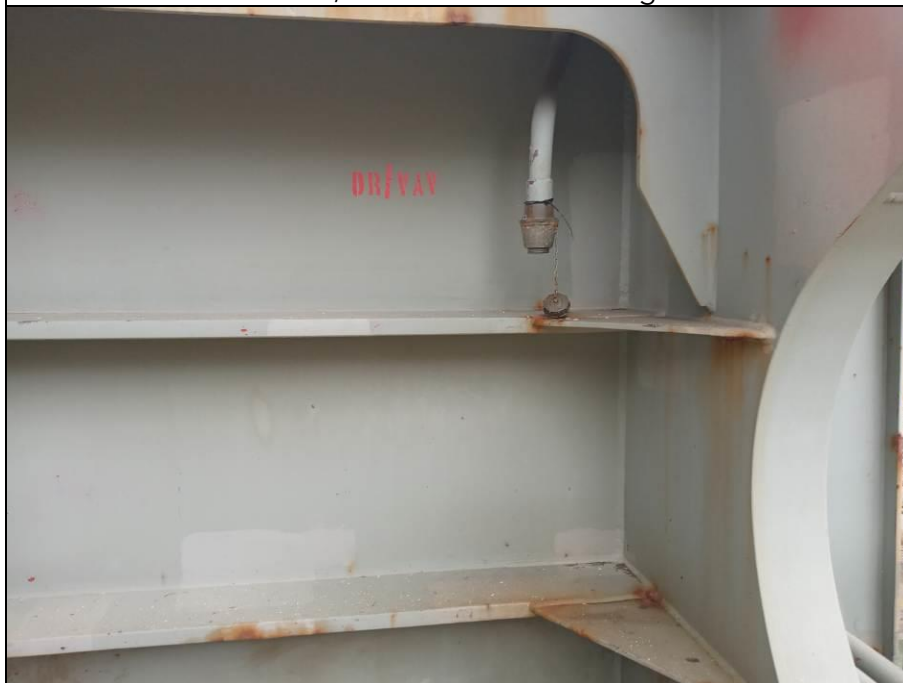
64. Hatchcover No. 4, non-return valves in good conditions.

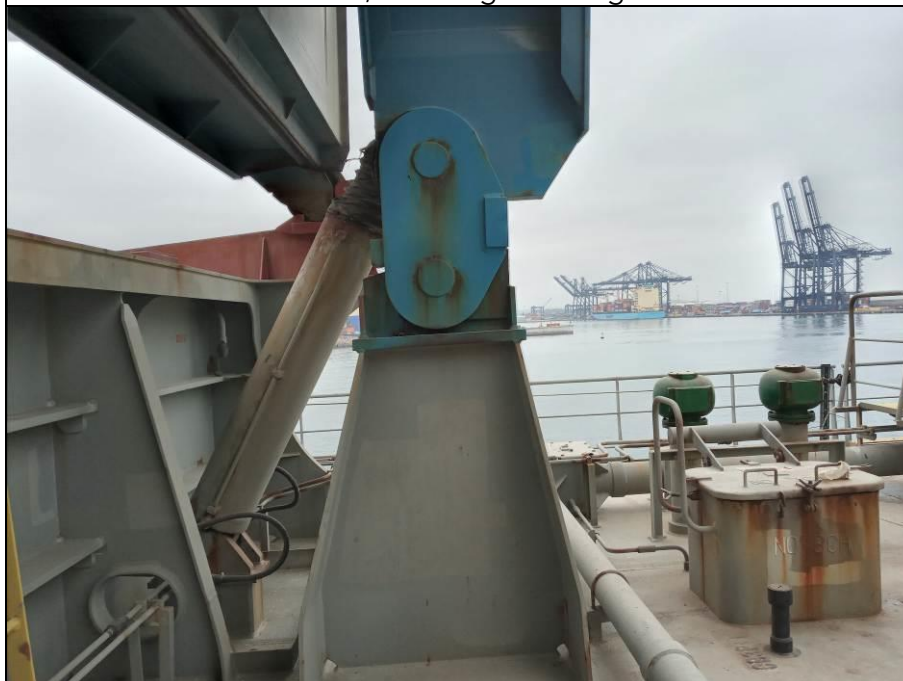
65. Hatchcover No. 4, rubber gasket in good conditions.

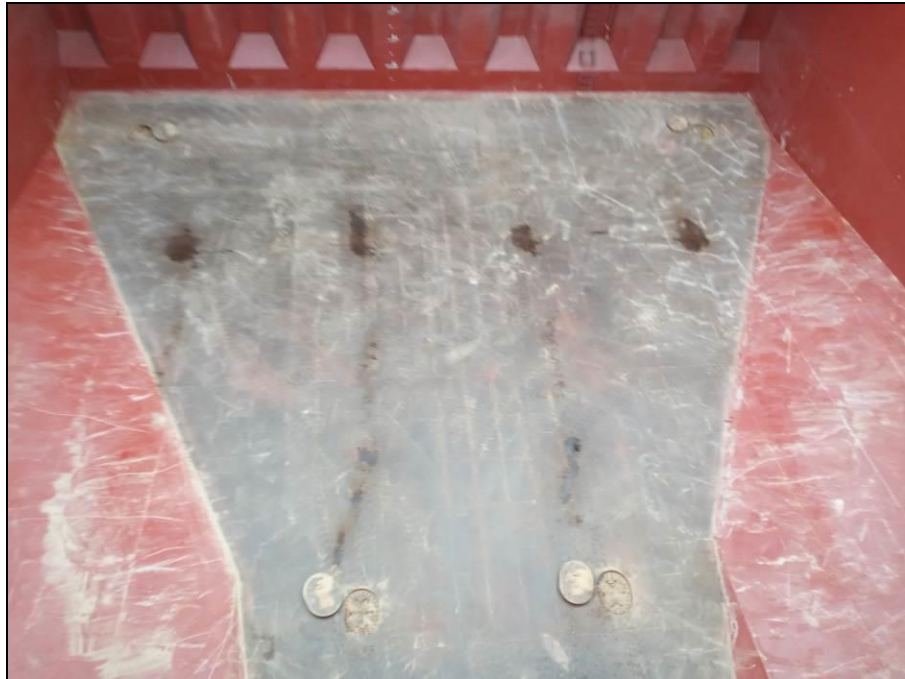
67. General view of C/H N° 5.

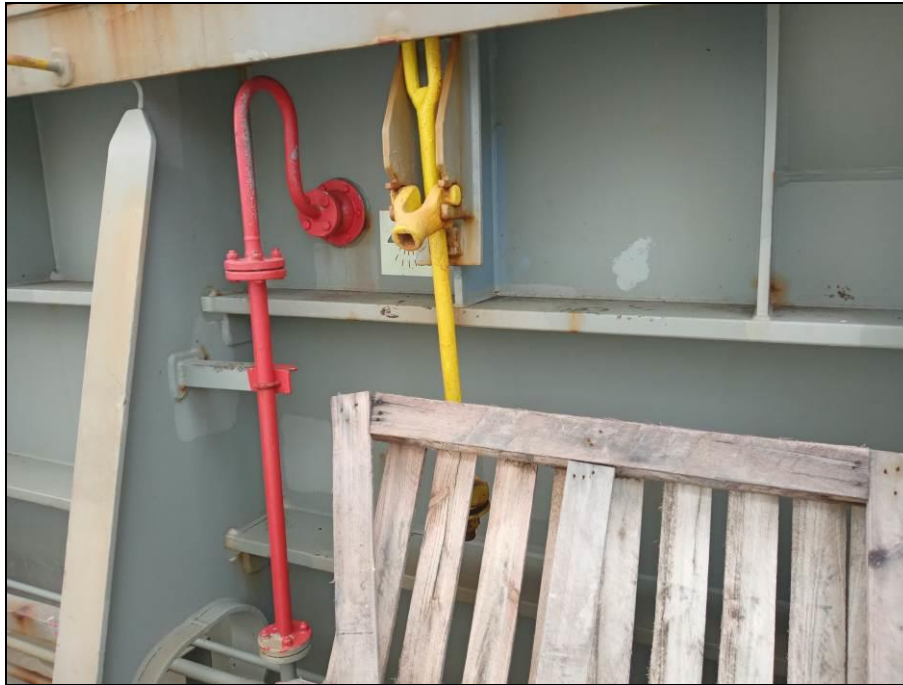
73. Hatchcover No. 5, active cleats in good conditions.

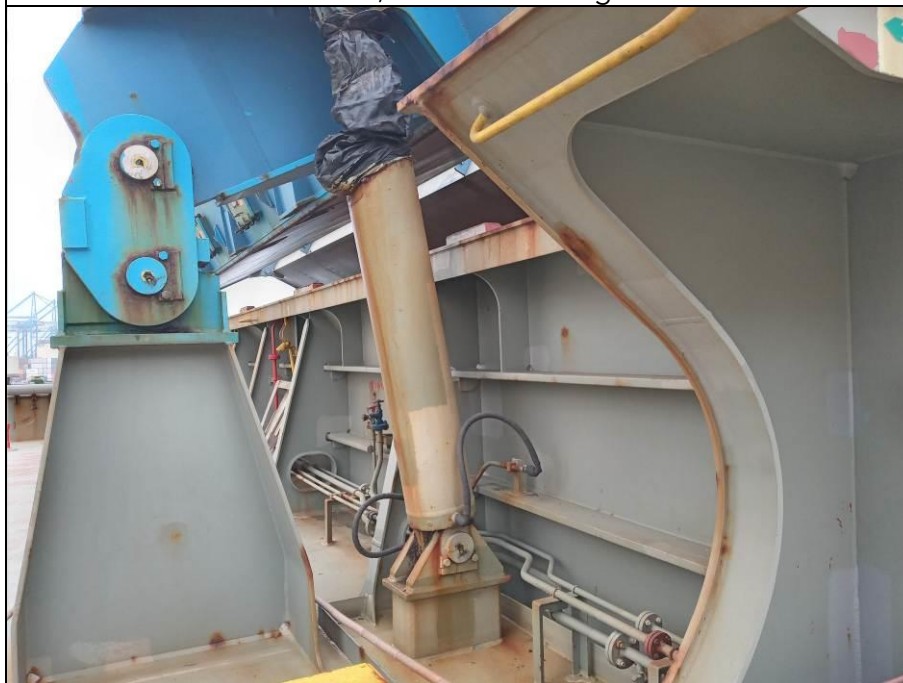
74. Hatchcover No. 5, hydraulic system in good conditions.

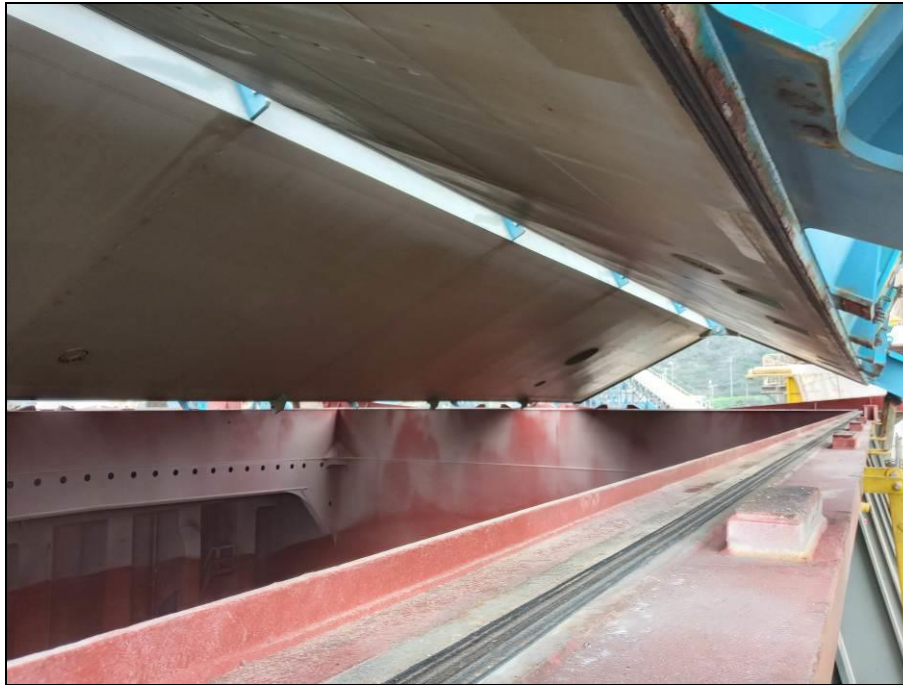
75. Hatchcover No. 5, compression bars in good conditions.

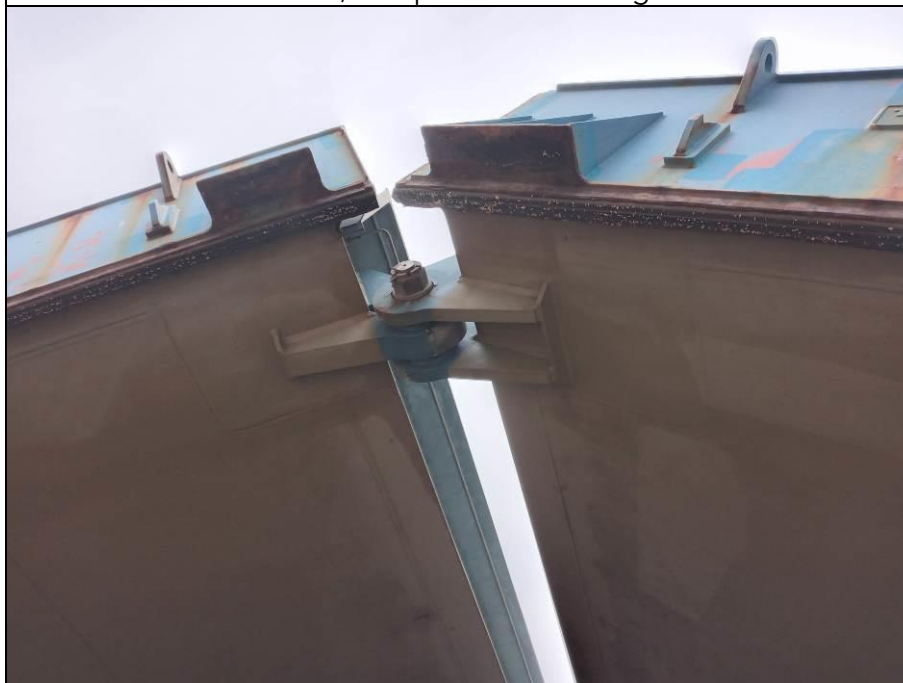
76. Hatchcover No. 5, rubber gasket in good conditions.
