MV "ASL SAKURA"

FULL OFF HIRE & BUNKER SURVEY

Report: SAI-2603-1081

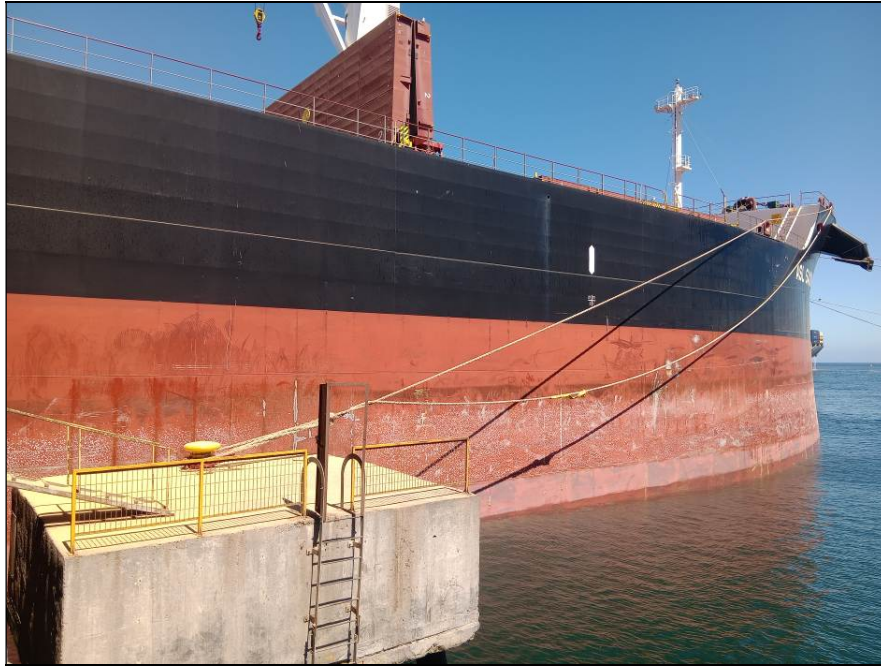
No. 1: Hull Plating, Starboard side noted with paint scratched, stained and rusty. (See photos from No. 1 to No.12)

3. Another view.

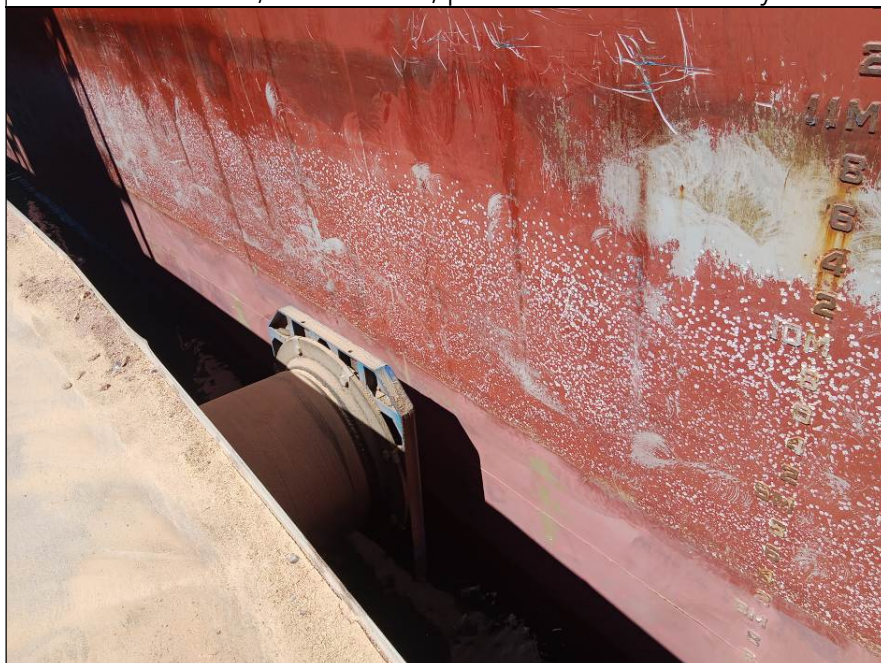
6. Another view.

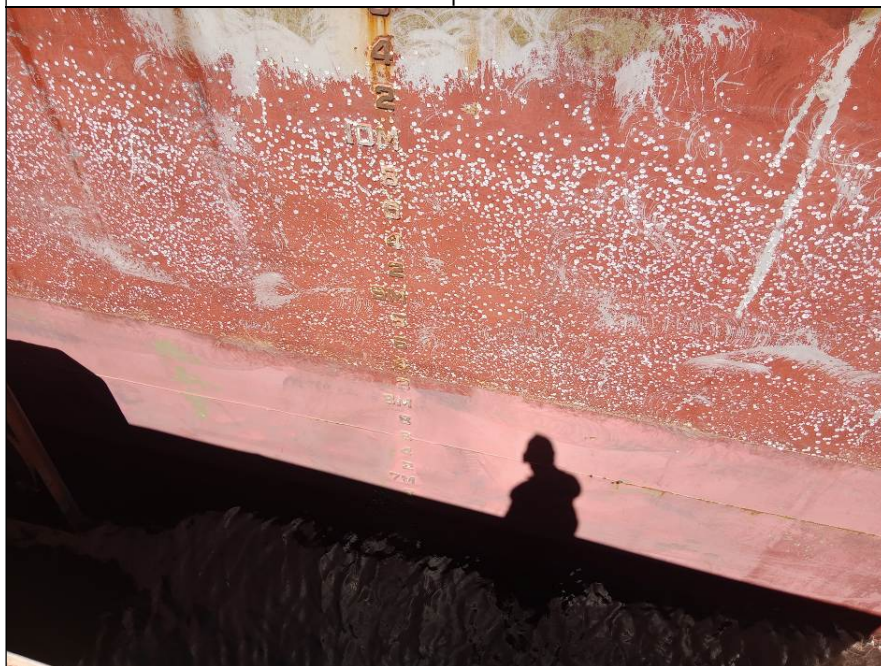
8. Midship draft marks.

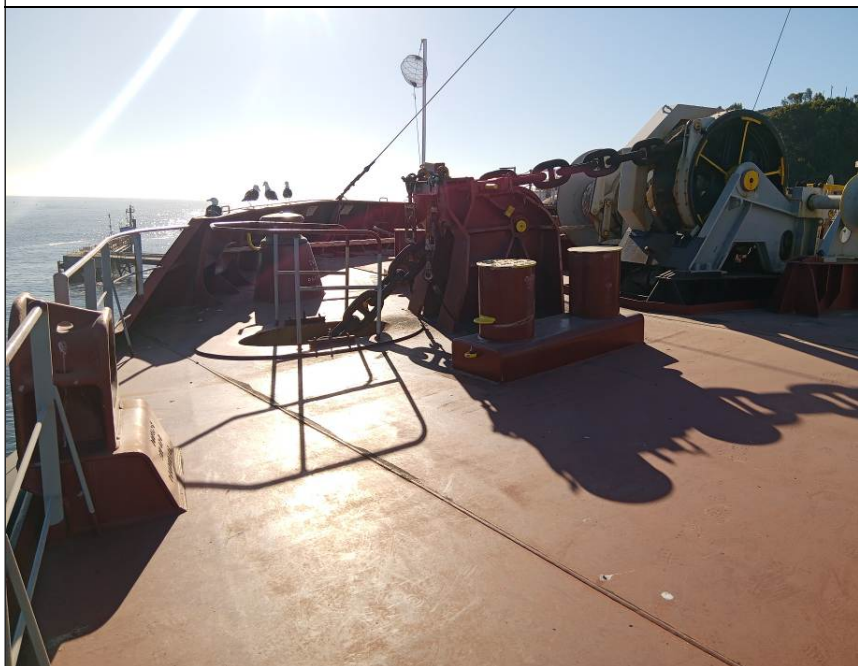
14. General view of Forecastle.

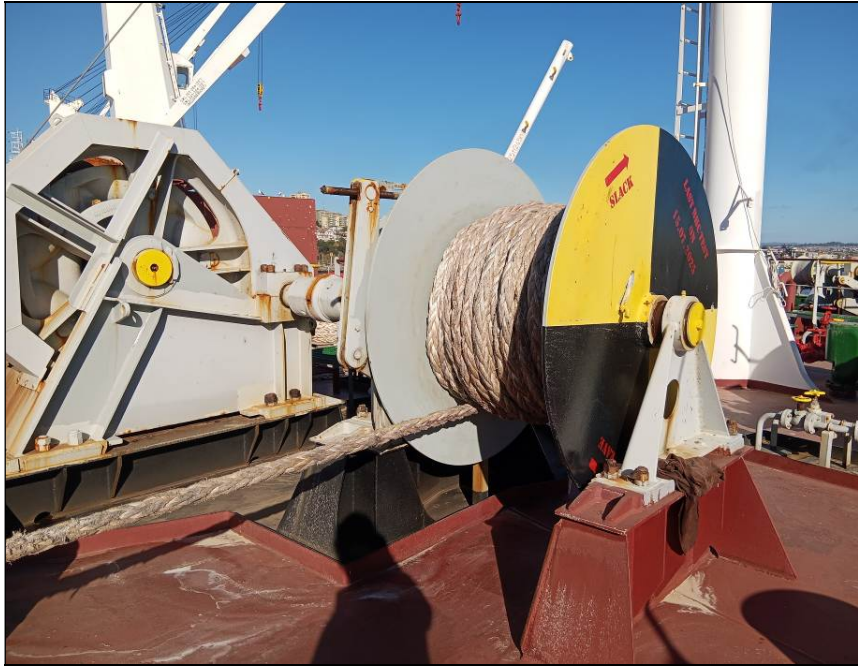
15. Winch Ss Fore deck, in good conditions.

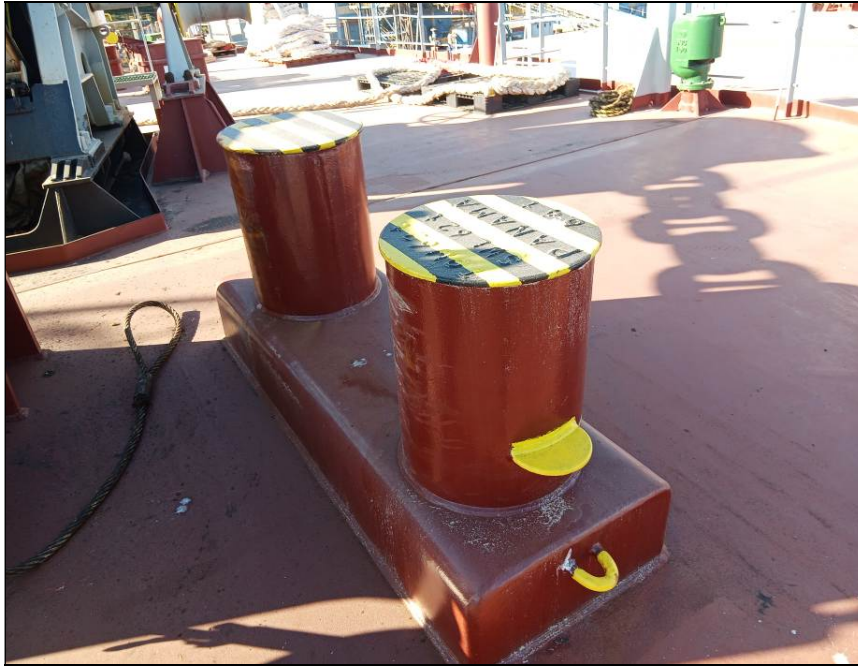
17. Bollards in good condition.

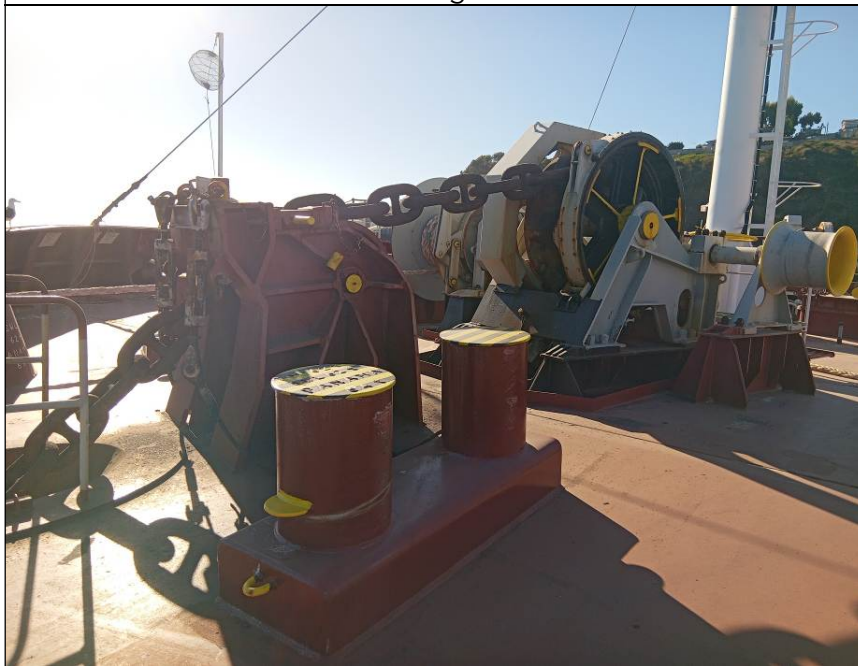
18. Ps capstans, in good conditions.

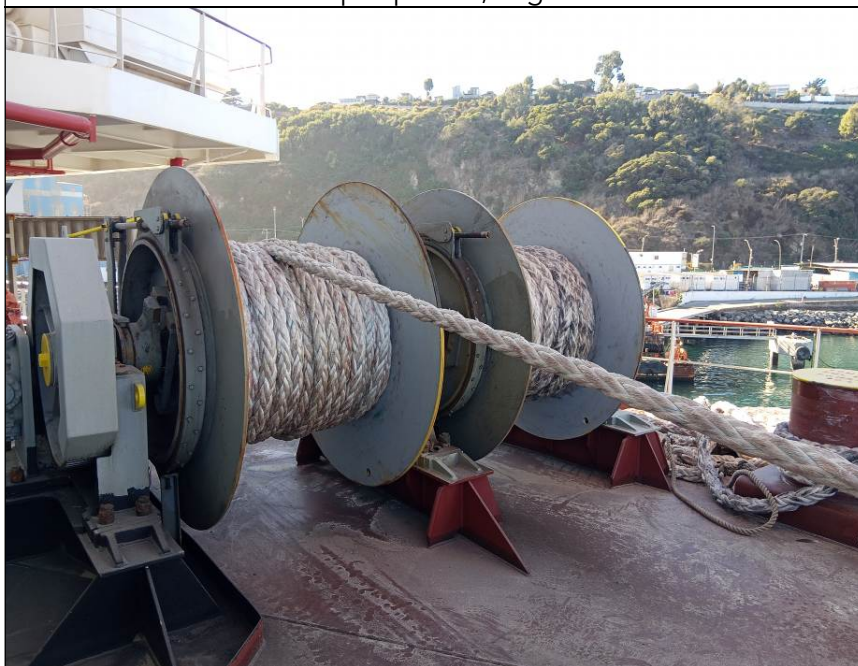
24. Winch Ss poop deck, in good conditions.

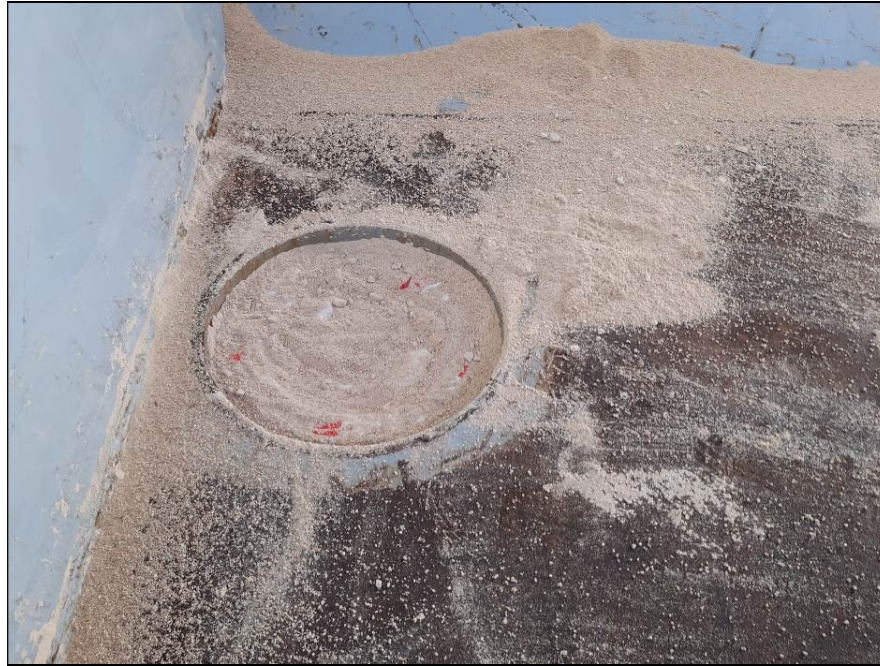
33. Bilge cover.

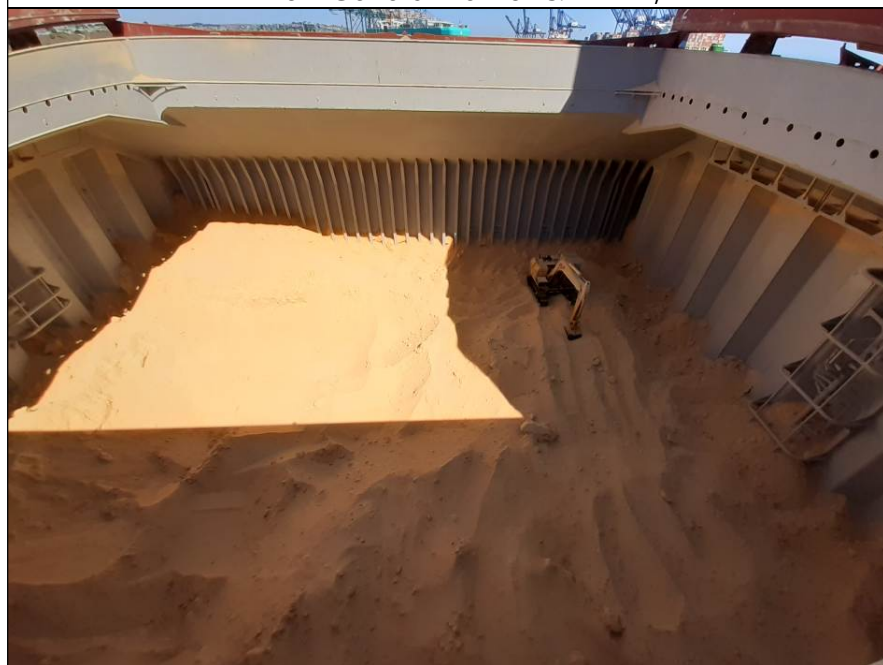
38. Ss to Ps view.

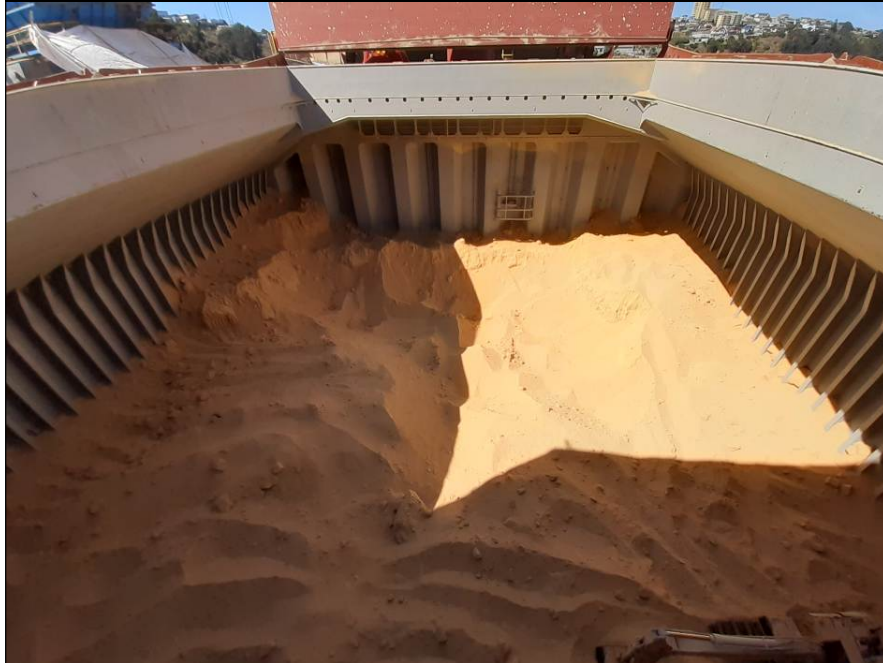
39. Fwd to aft view.

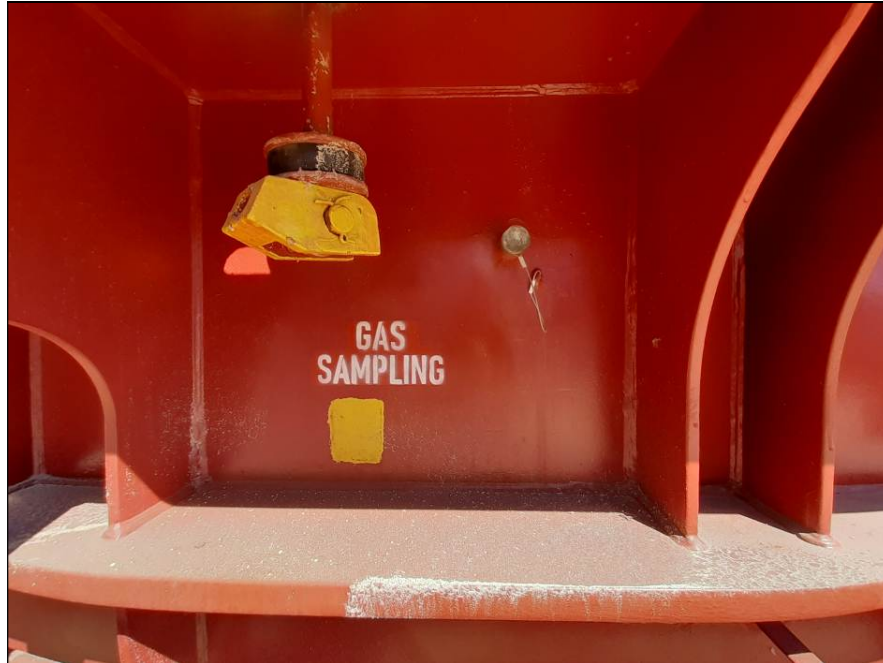
41. Hatchcover No. 2, active cleat in good conditions.

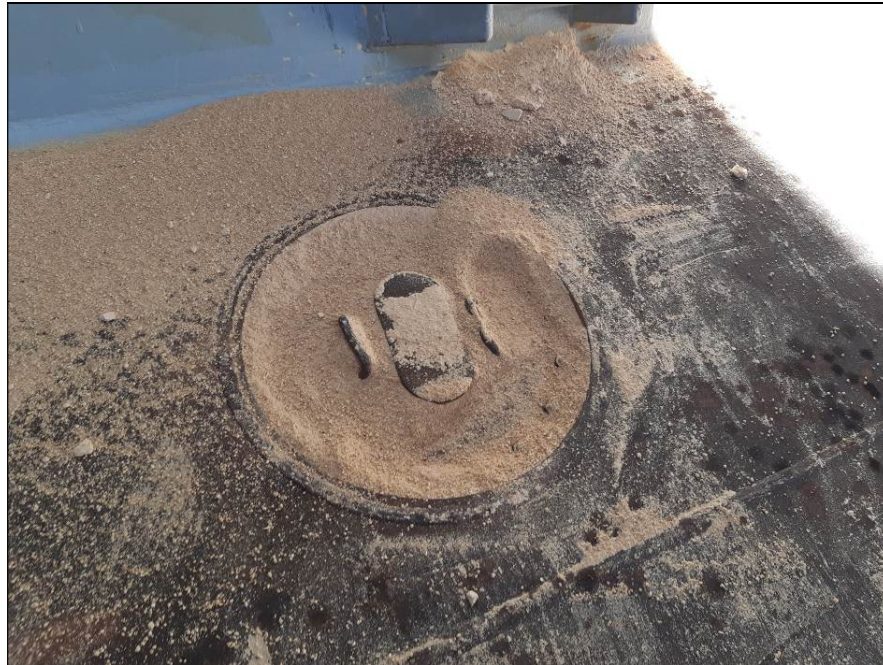
51. Bilge cover.

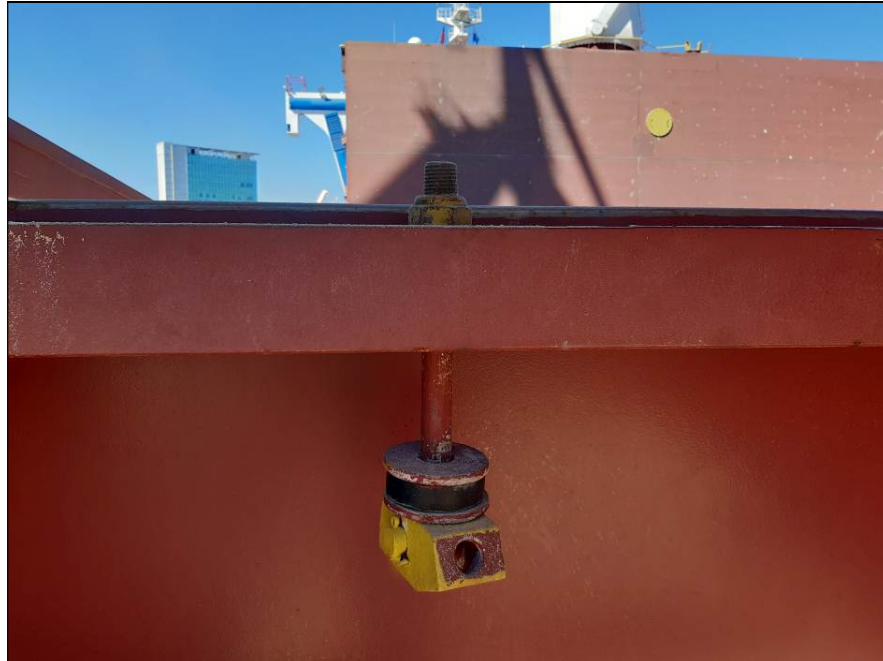
61. Hatchcover No. 4, active cleats valves in good conditions.

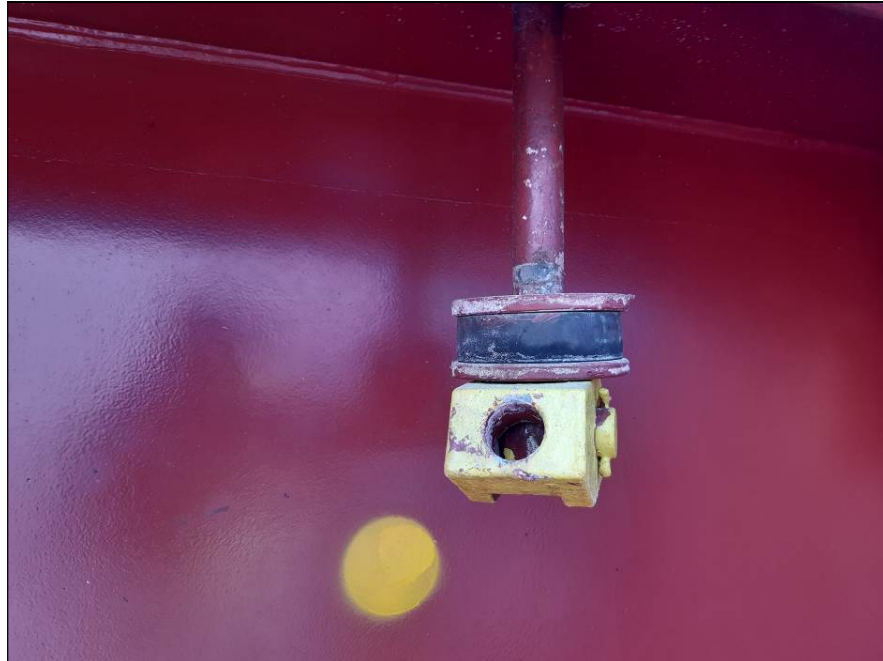
71. Hatchcover No. 5, active cleats valves in good conditions.

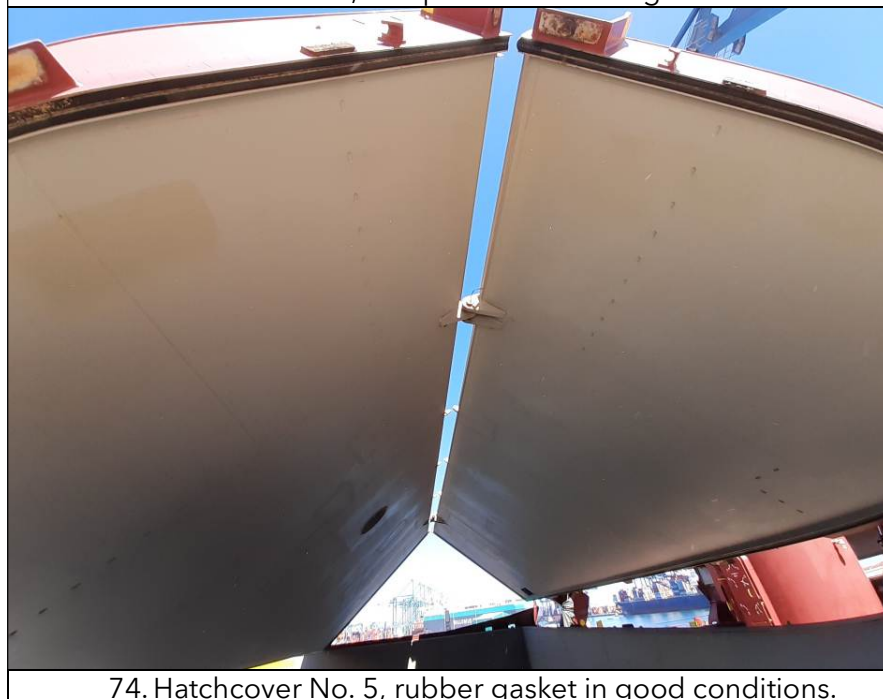
74. Hatchcover No. 5, rubber gasket in good conditions.
