MV "ULTRA FOREST"

FULL ON HIRE & BUNKER SURVEY

This is to certify that the undersigned representative of ALS Inspection Chile did, at the request of **Messrs. DAMPSKIBSSELSKABET NORDEN A/S**, attend on board motor vessel "**ULTRA FOREST**" with Master consent on May 31, 2026, while she was at berthed at **pier Nr. 8, Panul Port**, San Antonio, Chile, in order to carry out an On Hire, general condition survey and bunker survey, as follows:

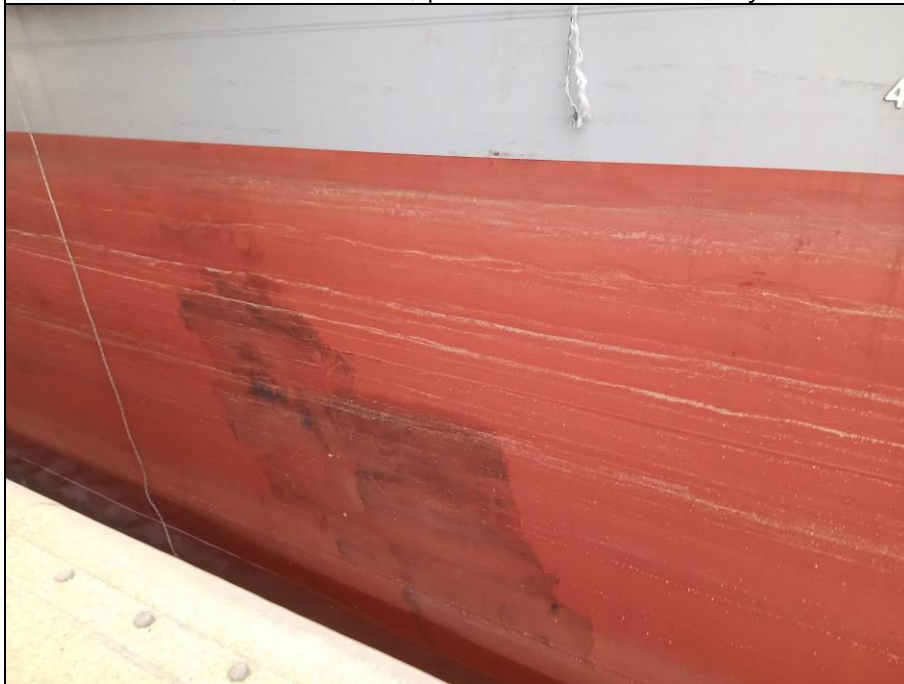
6. Another view.

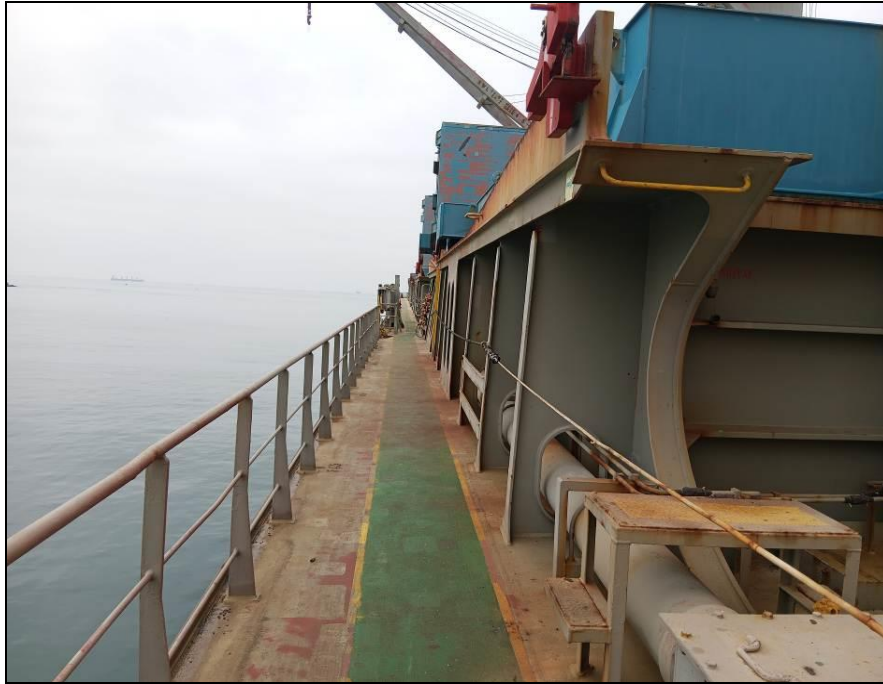
13. Main deck Ps.

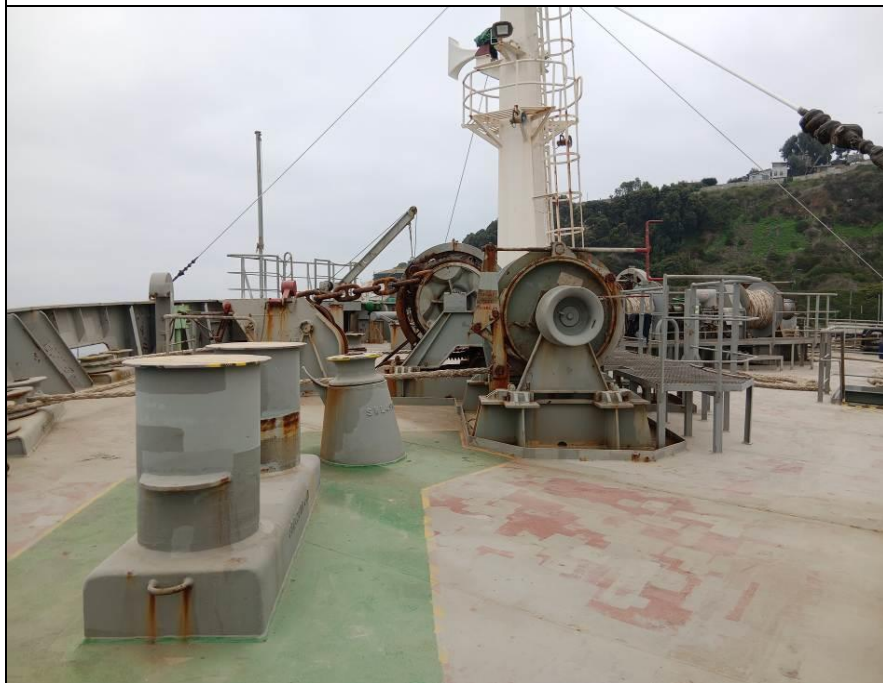
14. General view of Forecastle.

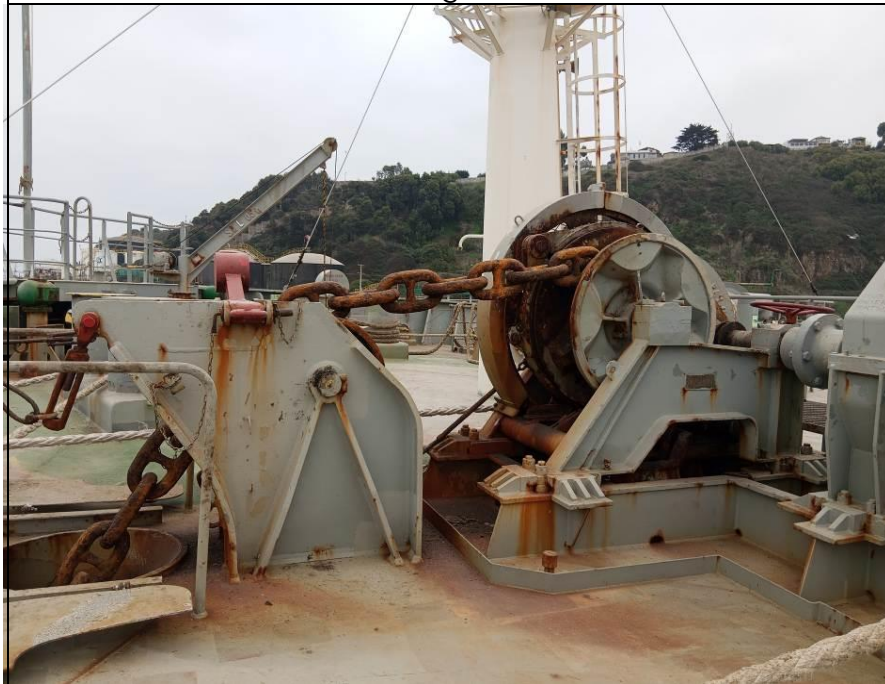
18. Ps capstans, in good conditions.

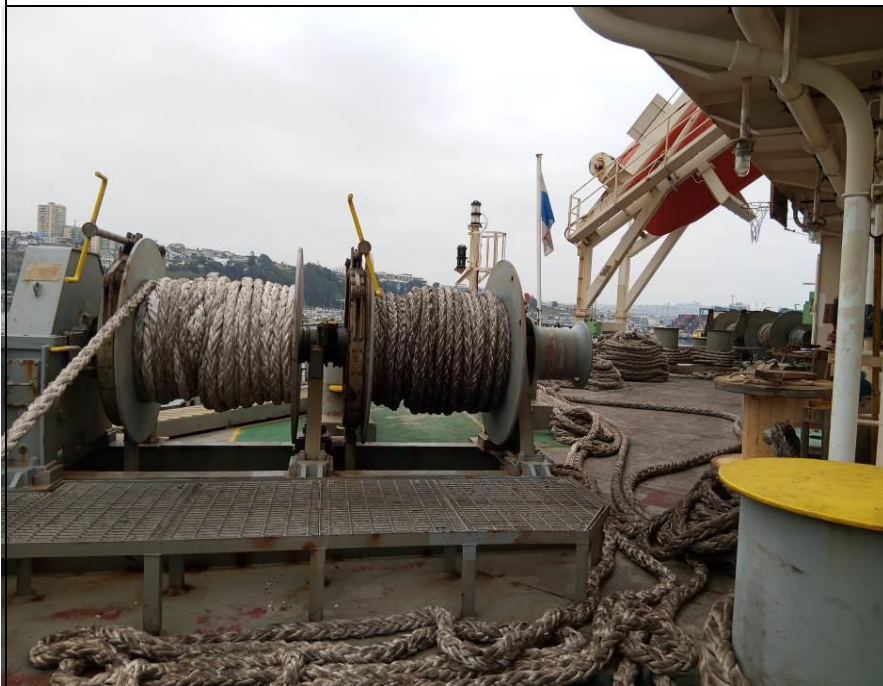
22. General view of Poop deck.

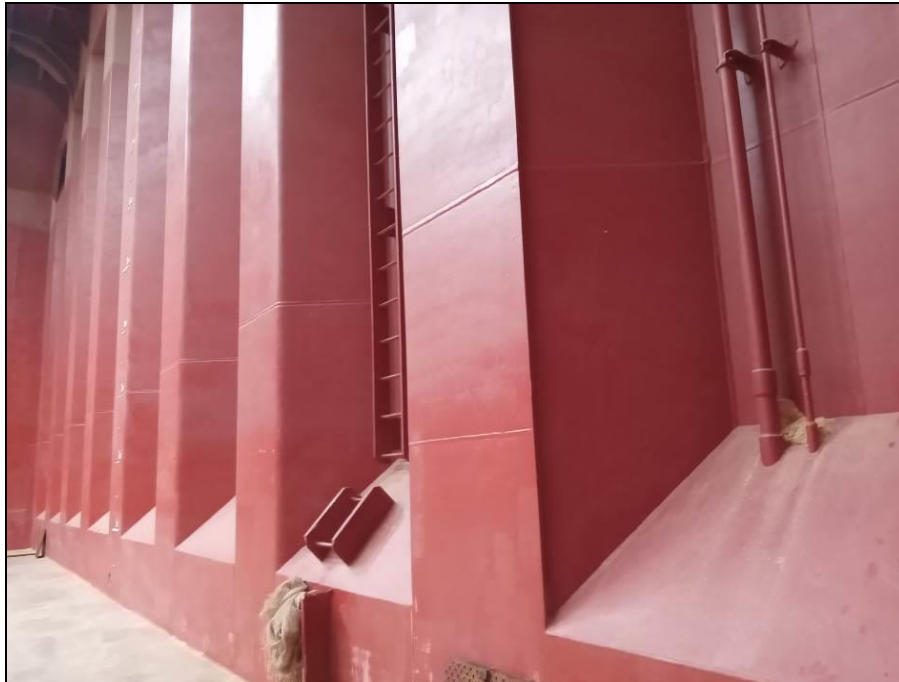
No. 5: After bulkhead with paint scratched and rust (See photo No. 29)

29. Aft bulkhead with paint scratched.

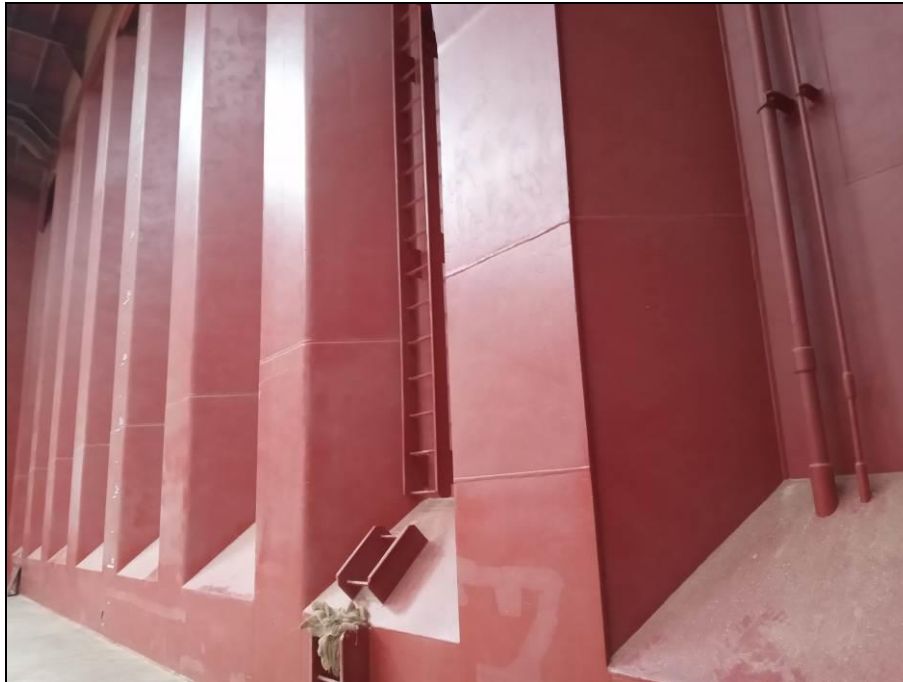
No. 10: After bulkhead with paint scratched and dust (See photo No. 39)

39. Aft bulkhead, with paint scratched and dust.

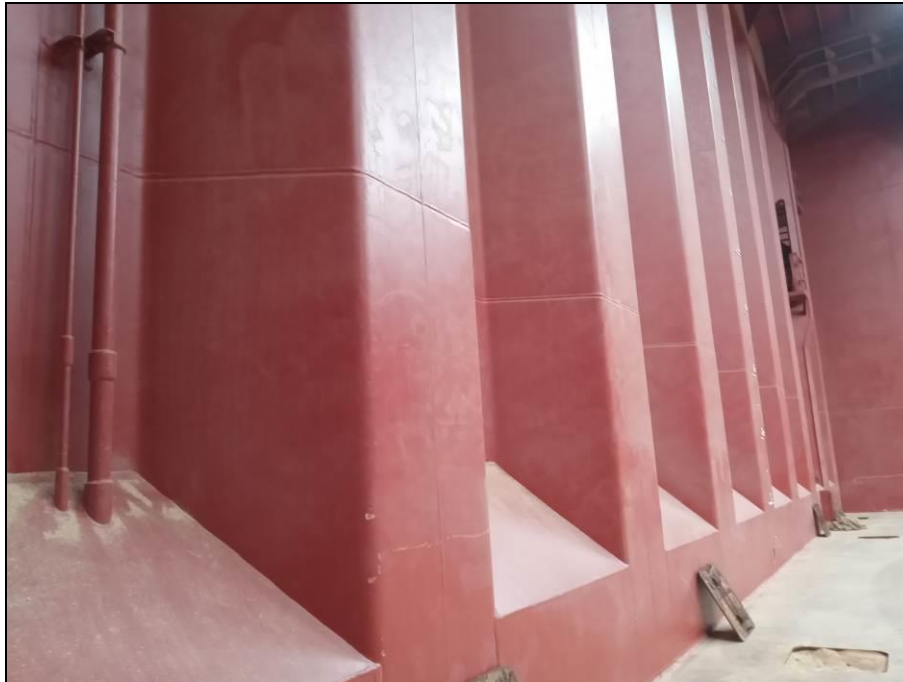
49. Aft bulkhead, with paint scratched and dust.

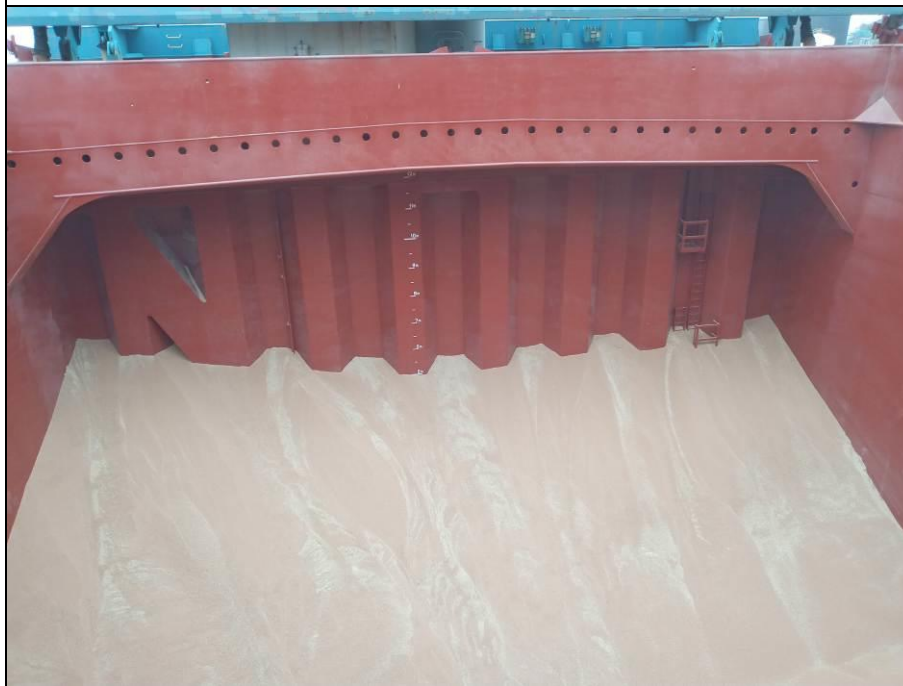
58. Fwd bulkhead view.

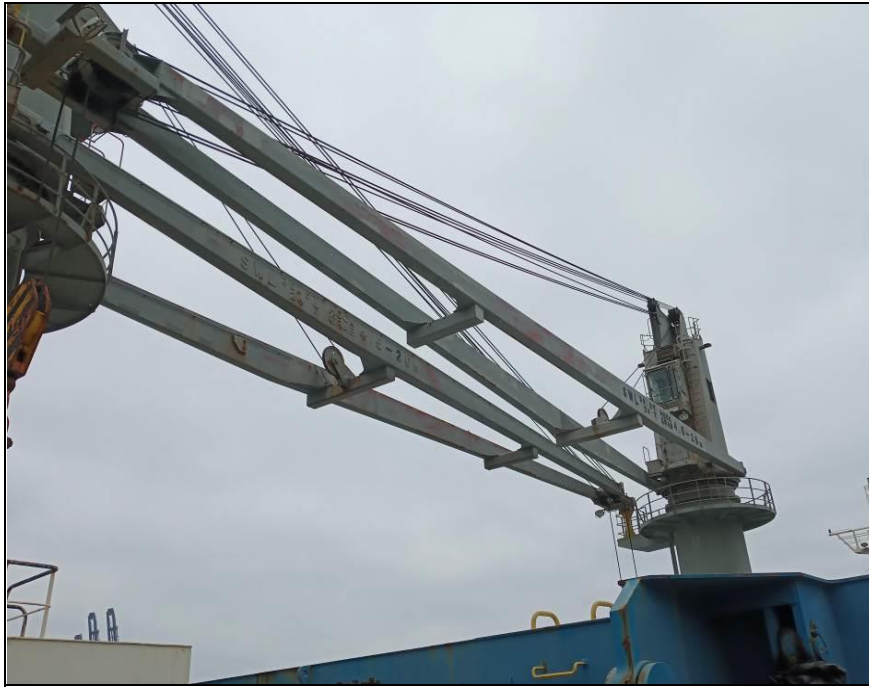
77. Crane No. 1.

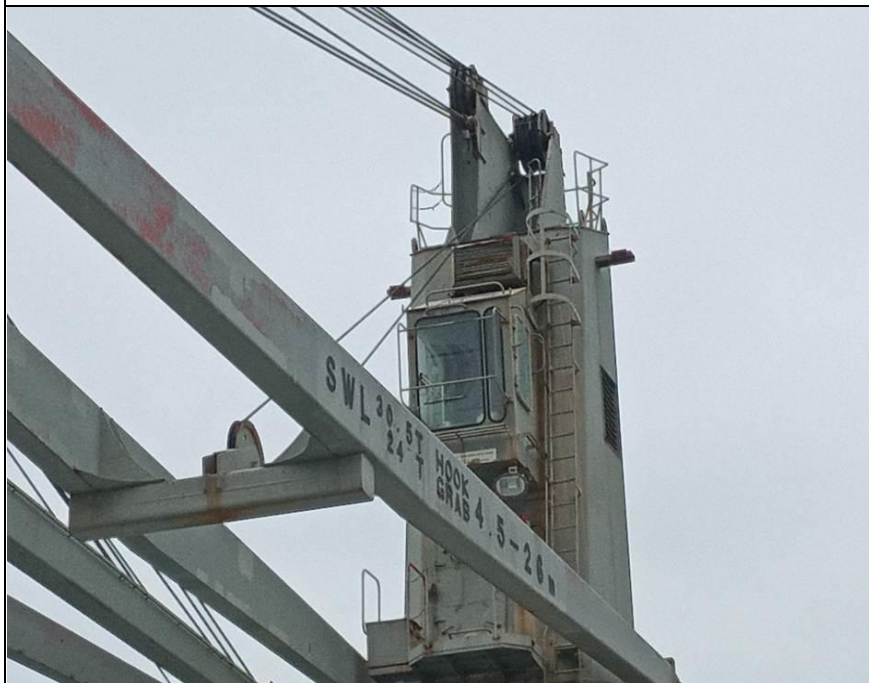
78. Another view.

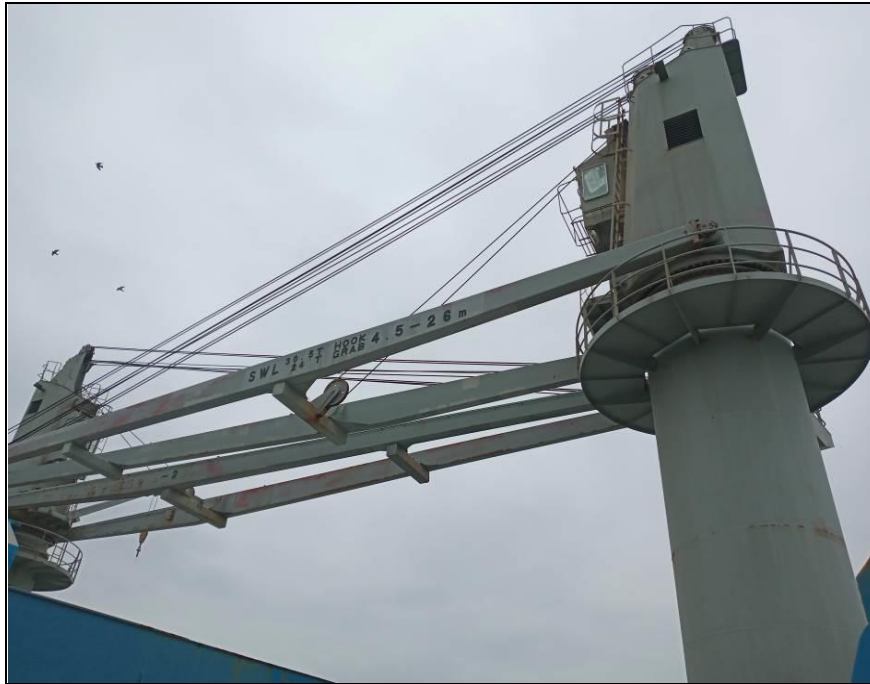
79. Crane No. 2.

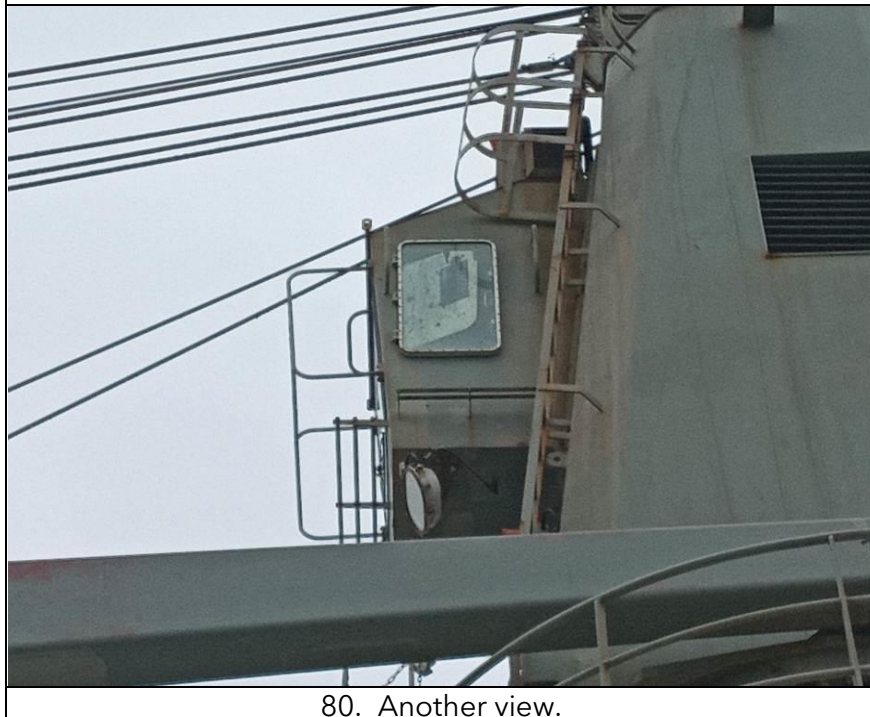
80. Another view.

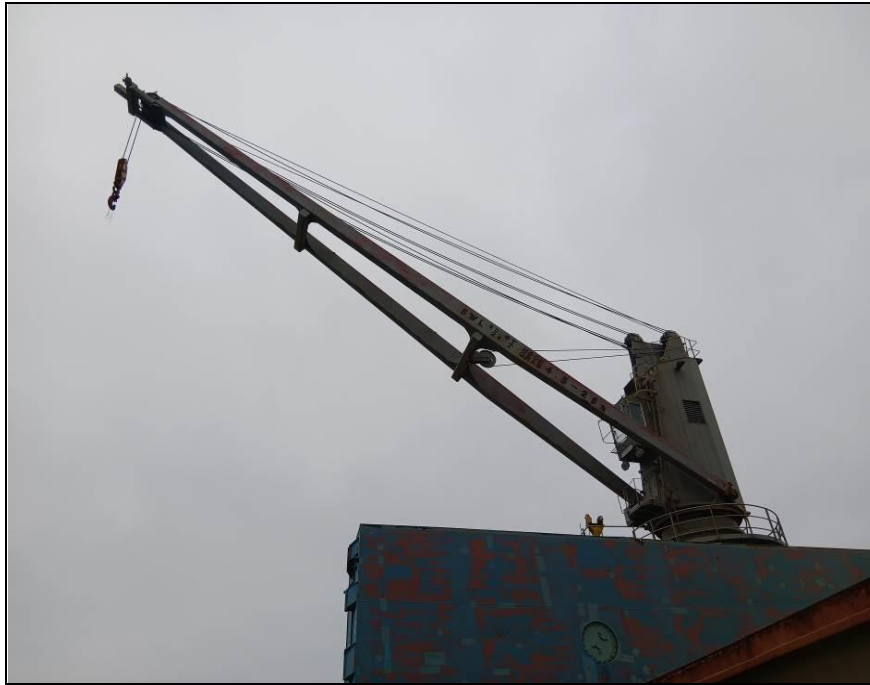
81. Crane No. 3.

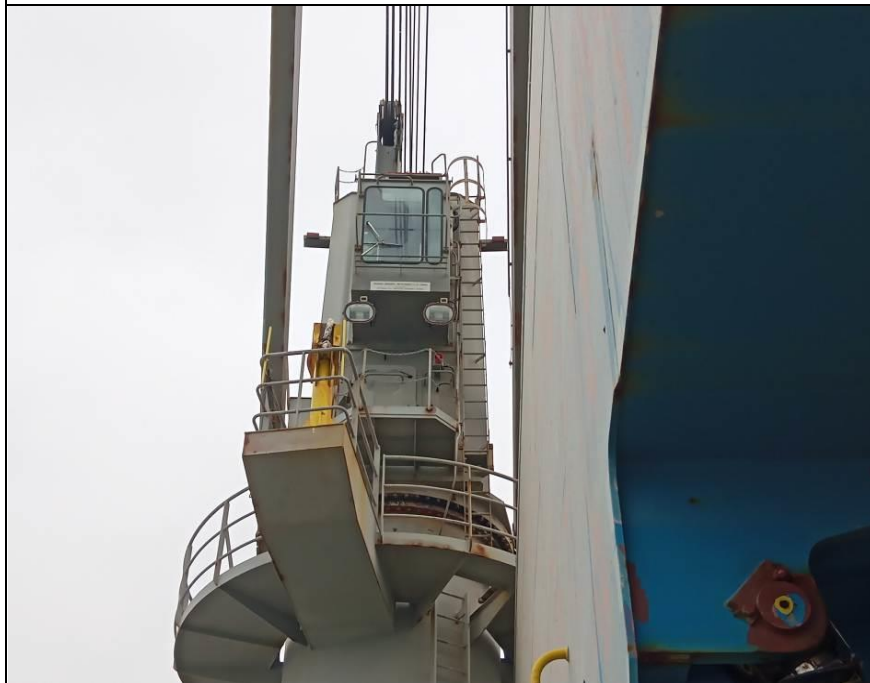
82. Another view.

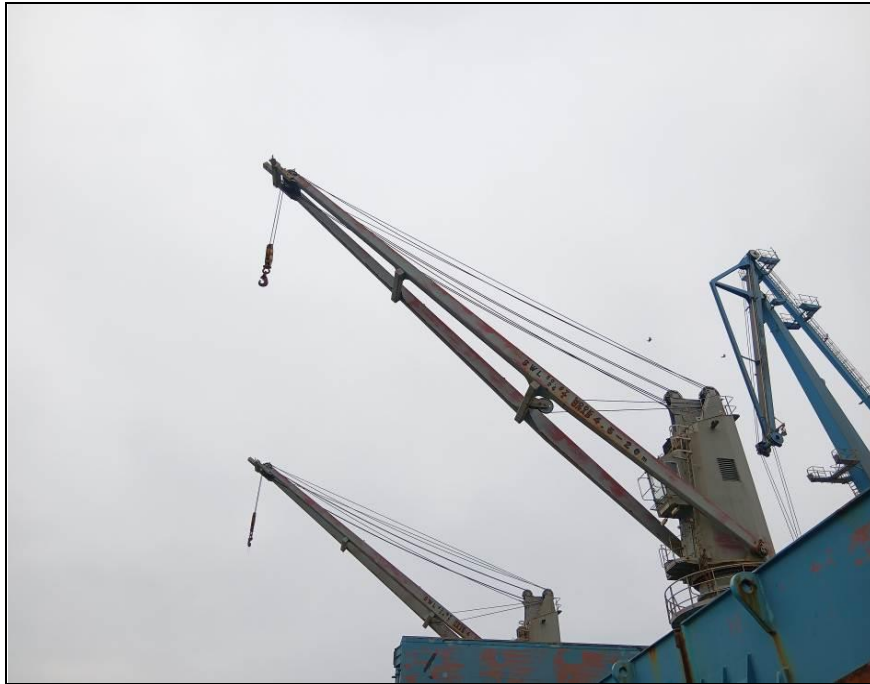
83. Crane No. 4.

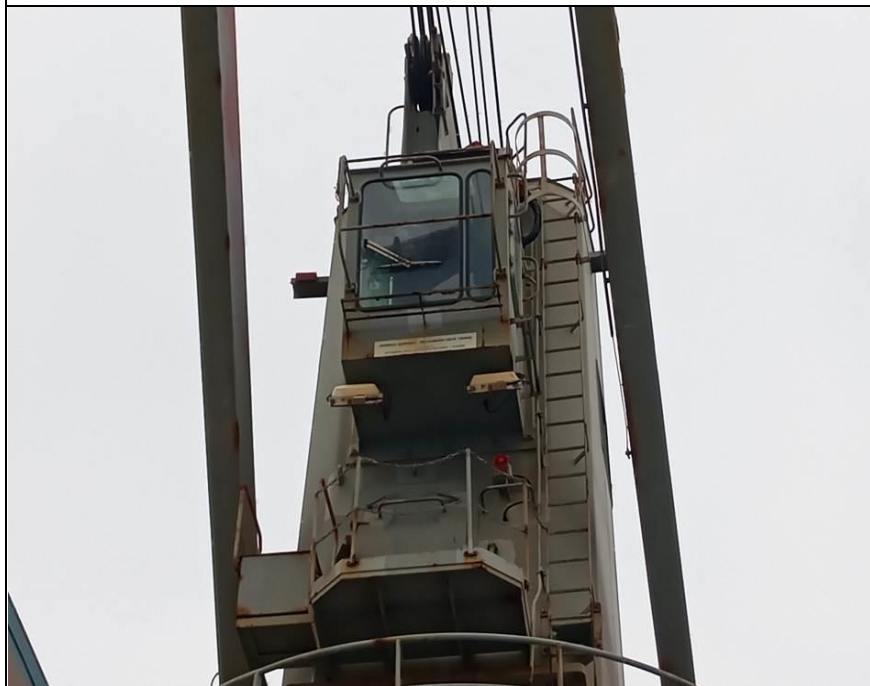
84. Another view.
