FINAL REPORT

SURVEY	MOORING ROPES INSPECTION
TO	GUAYACAN TERMINAL
FROM	ALS INSPECTION CHILE SPA.
CLIENT REF	N/A
ALS REF	VAP-2604-1462
SCOPE OF THE SURVEY	INSPECTION OF 18 MOORING LINES.
VESSEL NAME	NISEKO QUEEN
OWNER	GREEN SPANKER SHIPPING S.A.
DISPONENT OWNER	KOWA MARINE SERVICE CO. LTD.
CHARTERERS	CLASSIC MARITIME INC.
PLACE OF SURVEY	COQUIMBO BAY
DATE OF SURVEY	APRIL 16 & 17, 2026
TIME OF SURVEY	FROM 20:30 HRS TO 01:00 HRS

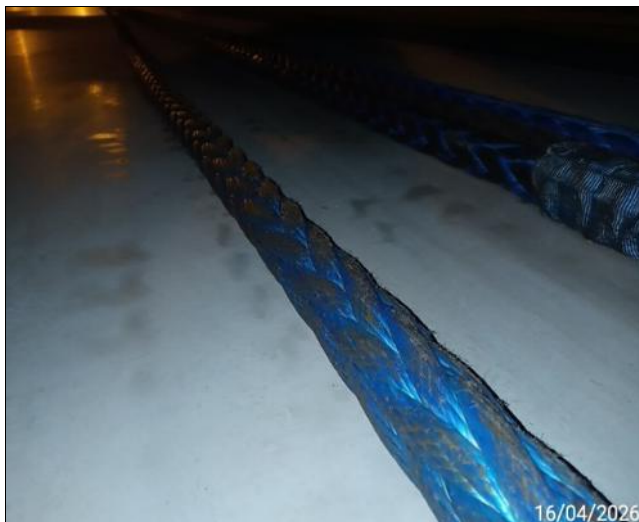
33. General view of the rope.

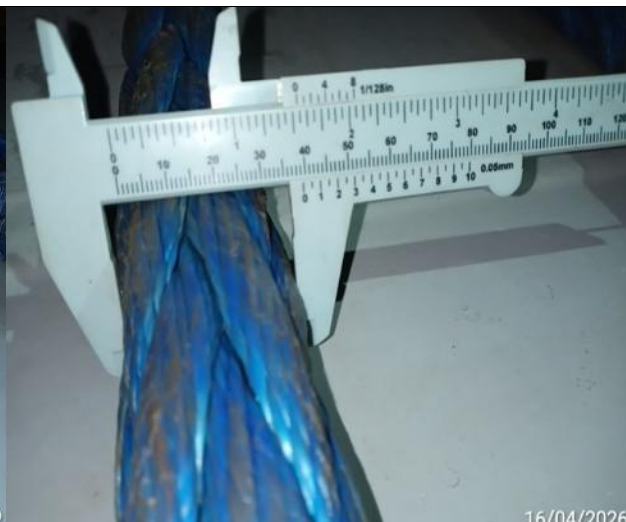
34. Diameter of the rope.

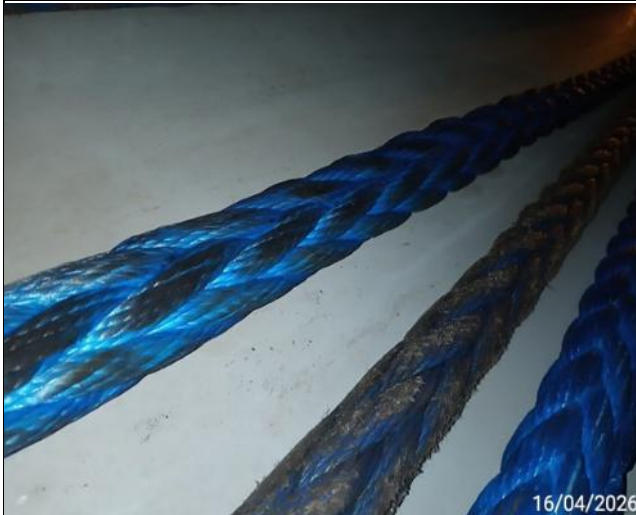
37. General view of the rope.

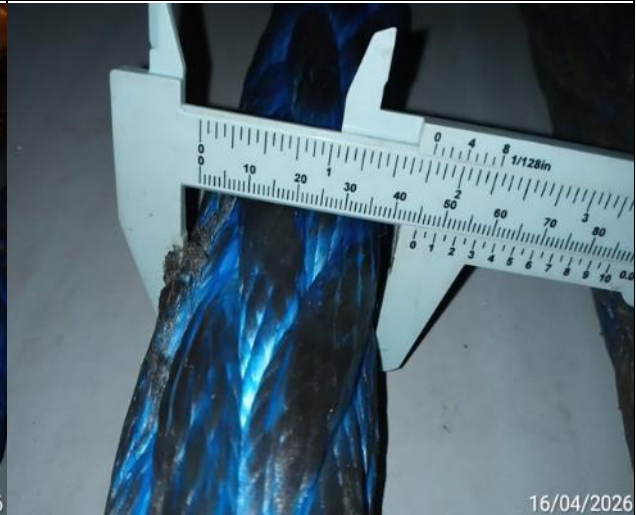
38. Diameter of the rope.

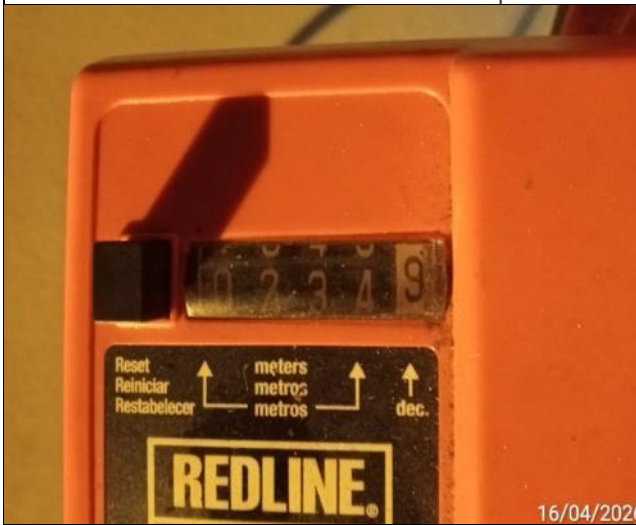
39. Measurement of the rope,
234.9 meters.

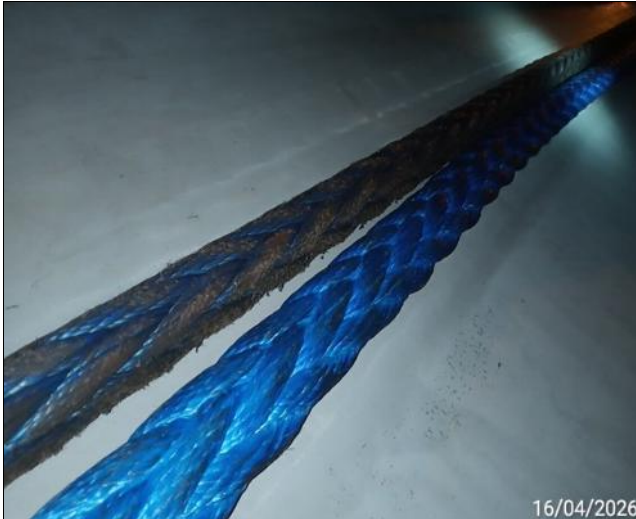
41. General view of the rope.

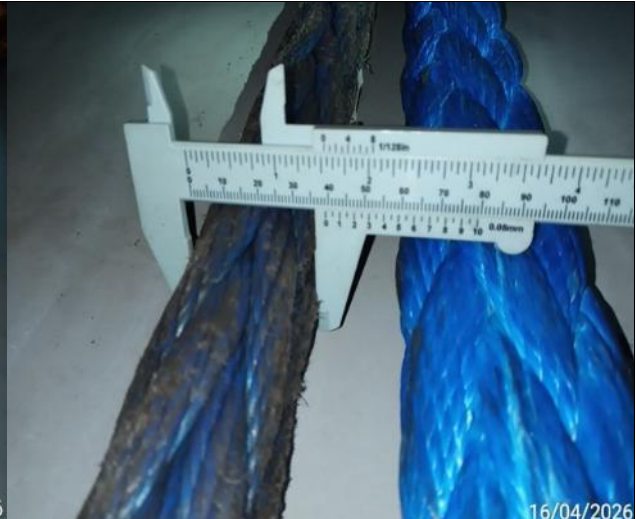
42. Diameter of the rope.

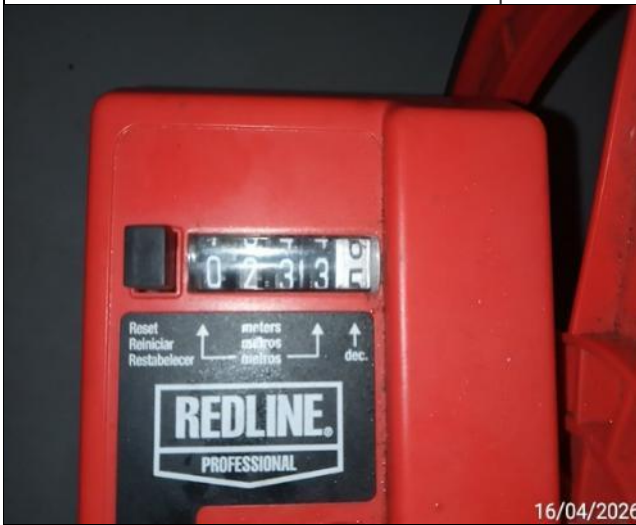
43. Measurement of the rope,
233.5 meters.

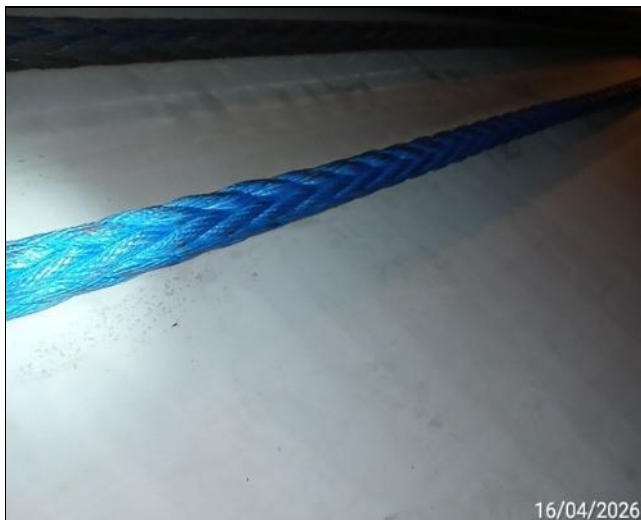
45. General view of the rope.

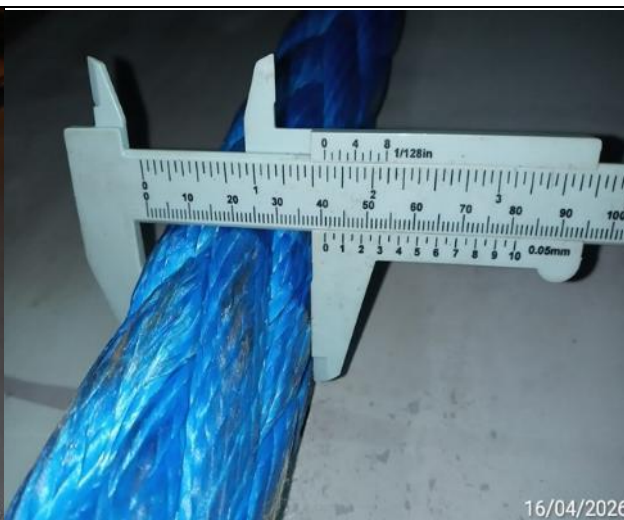
46. Diameter of the rope.

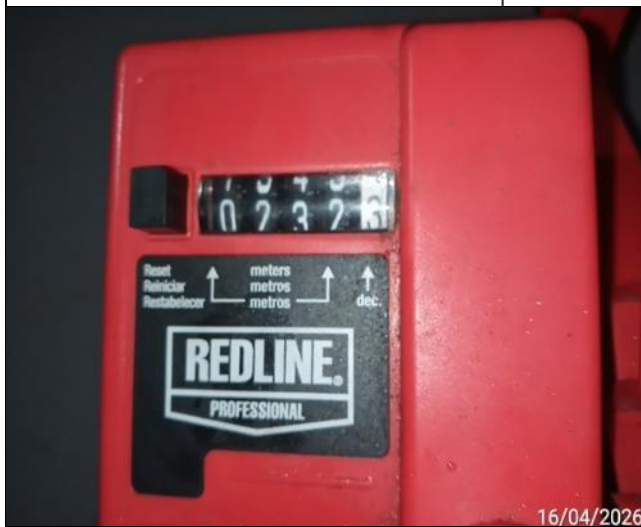
47. Measurement of the rope,
232.3 meters.

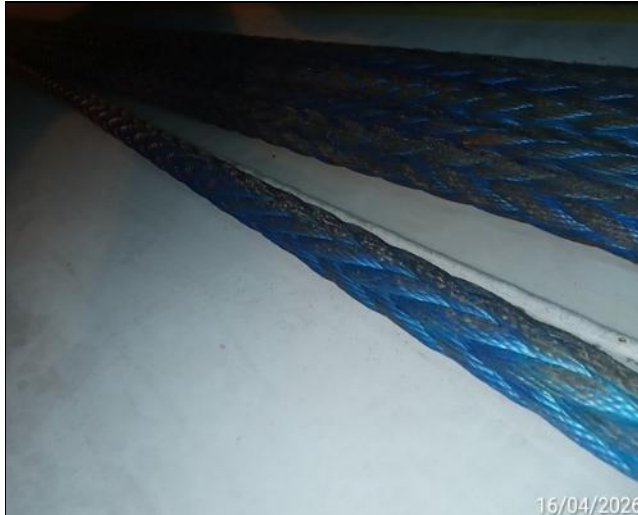
49. General view of the rope.

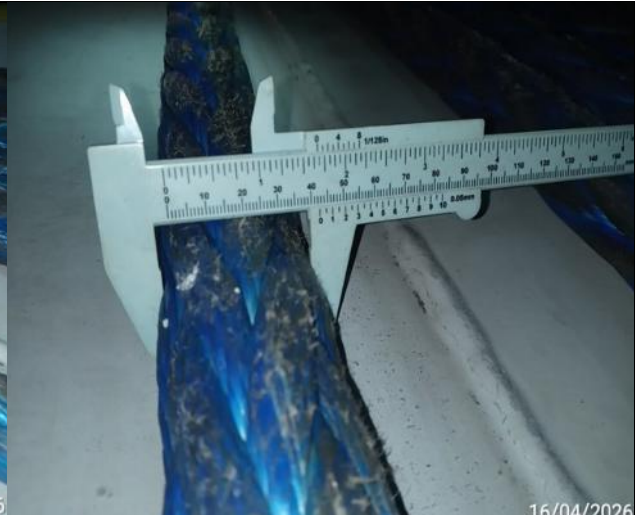
50. Diameter of the rope.

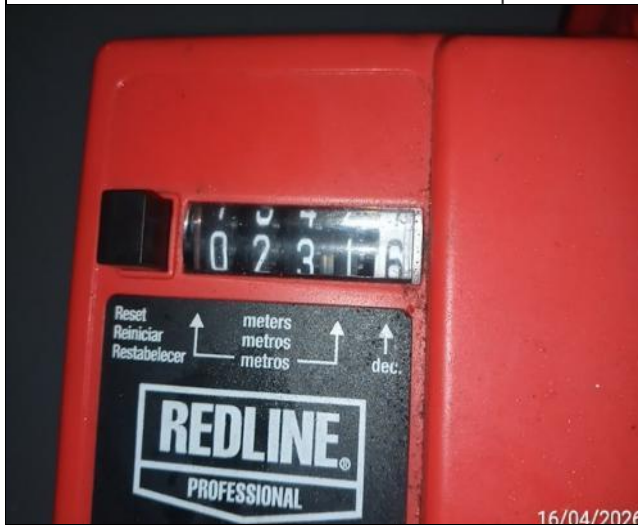
51. Measurement of the rope,
231.6 meters.

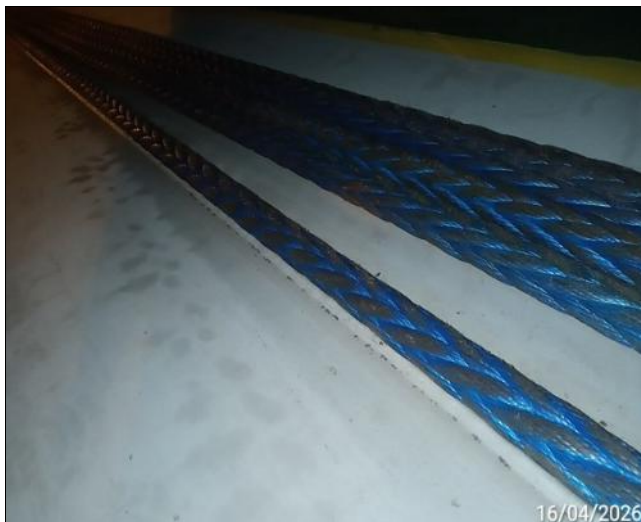
53. General view of the rope.

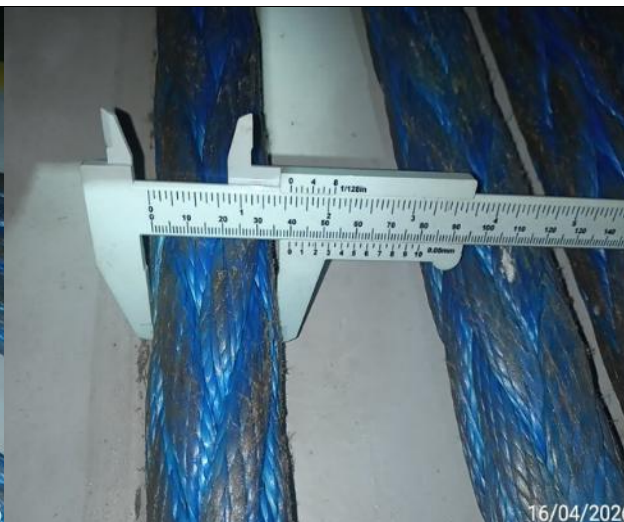
54. Diameter of the rope.

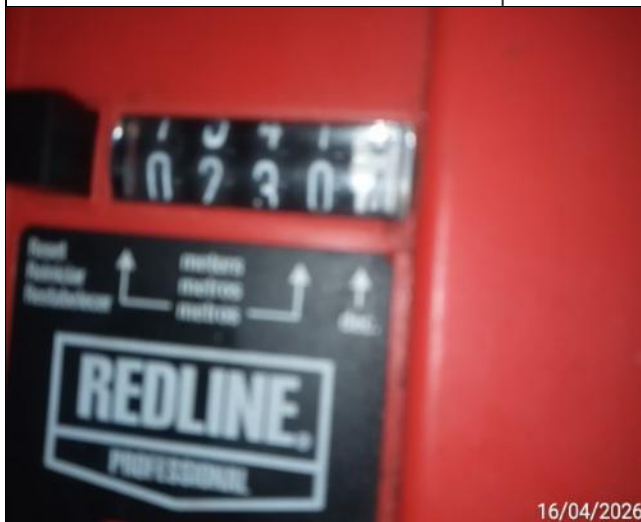
55. Measurement of the rope,
230.4 meters.

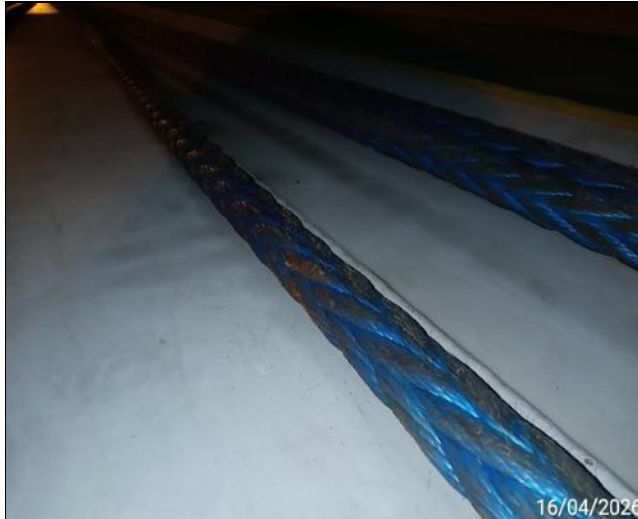
57. General view of the rope.

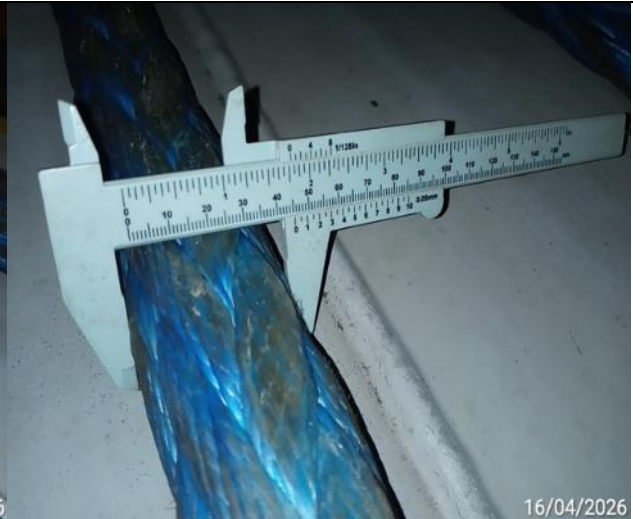
58. Diameter of the rope.

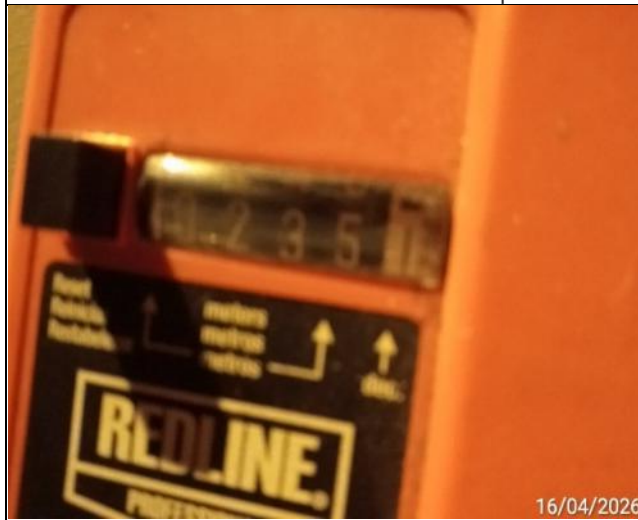
59. Measurement of the rope,
235.1 meters.

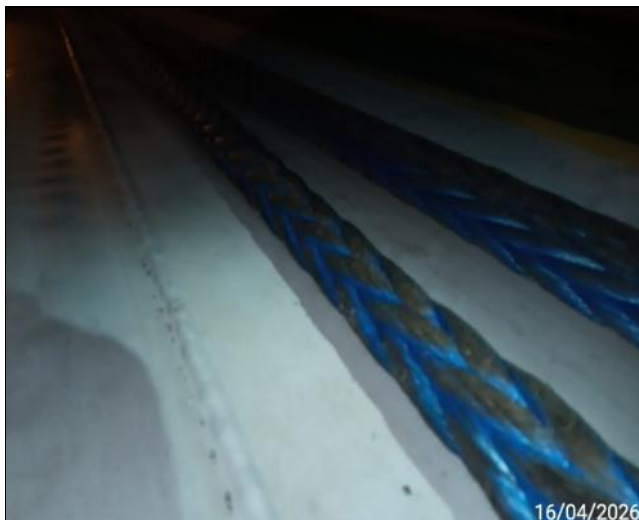
61. General view of the rope.

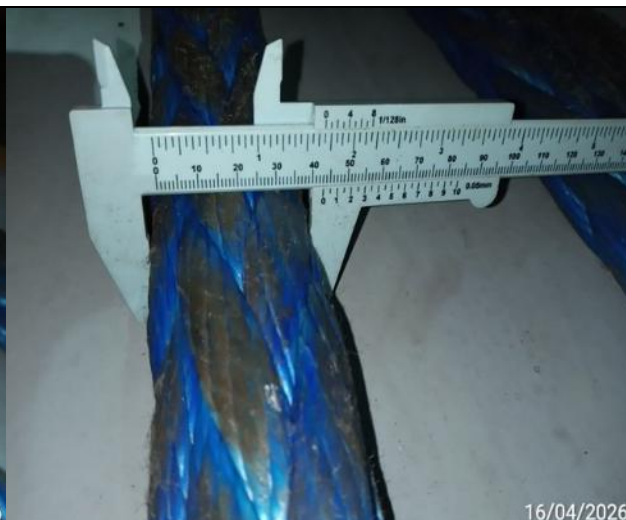
62. Diameter of the rope.

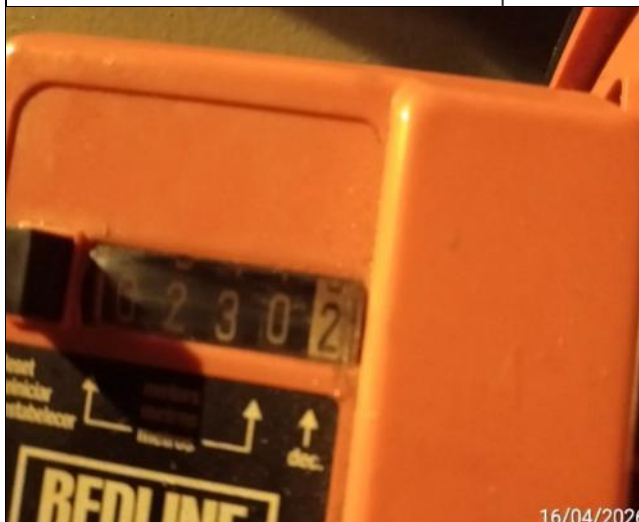
63. Measurement of the rope,
230.2 meters.

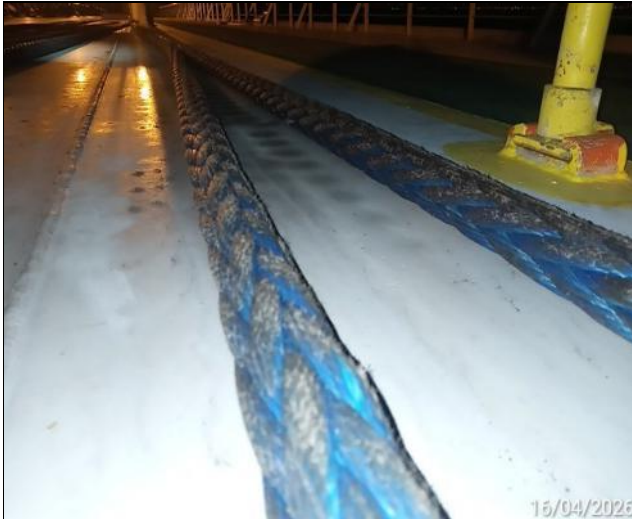
65. General view of the rope.

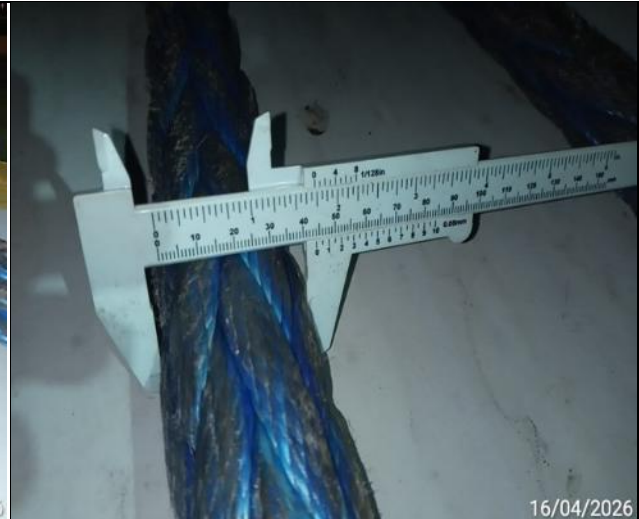
66. Diameter of the rope.

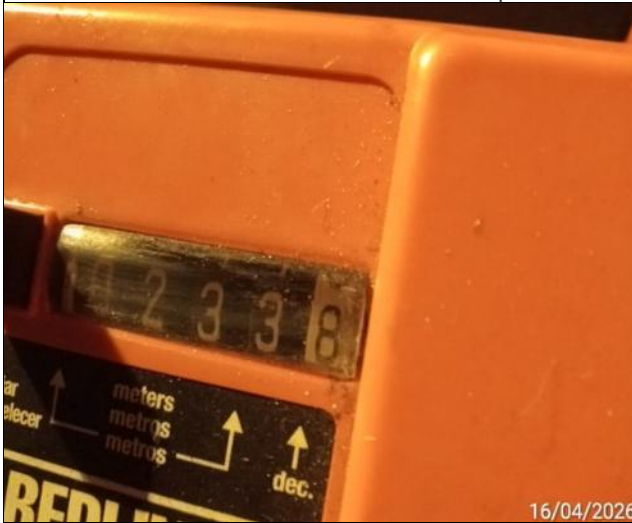
67. Measurement of the rope,
233.8 meters.

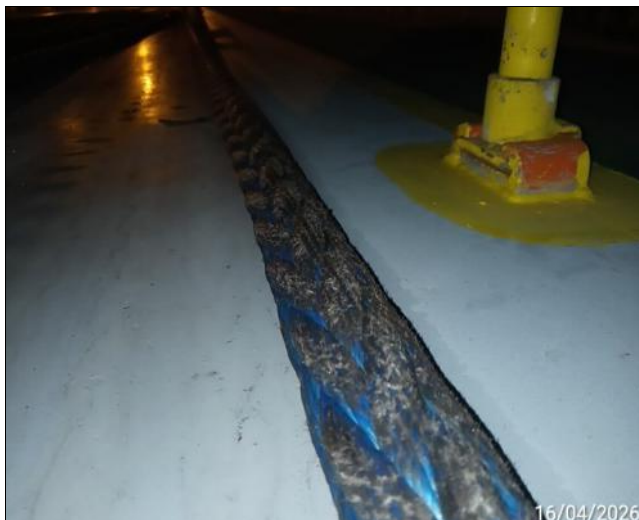
69. General view of the rope.

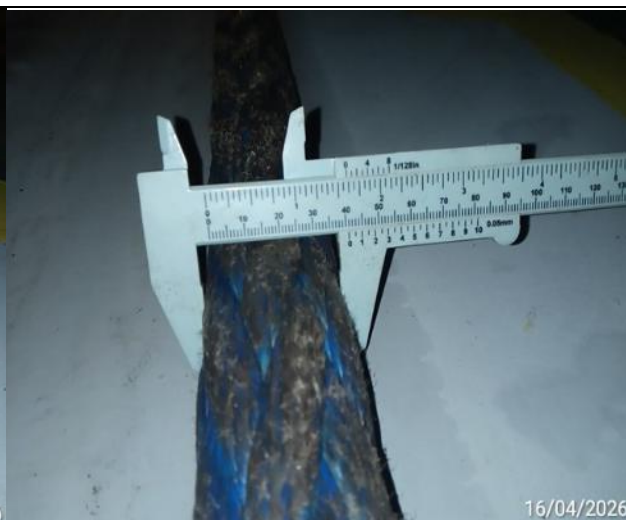
70. Diameter of the rope.

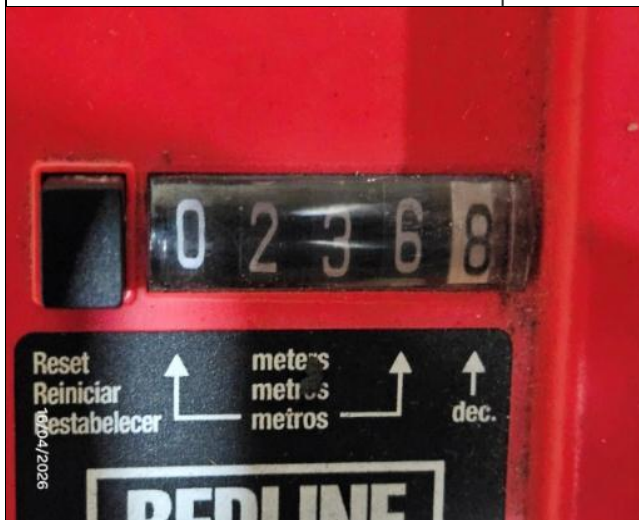
71. Measurement of the rope,
236.8 meters.
