FINAL REPORT

SURVEY	MOORING ROPES INSPECTION
TO	GUAYACAN TERMINAL
FROM	ALS INSPECTION CHILE SPA.
CLIENT REF	N/A
ALS REF	VAP-2605-1839
SCOPE OF SURVEY	INSPECTION OF 18 MOORING LINES.
VESSEL NAME	PIGI
OWNER	OLYMPIAN CORAL MARINE LTD.
DISPONENT OWNER	EAST 33 MARITIME LTD.
CHARTERERS	CLASSIC MARITIME INC.
PLACE OF SURVEY	COQUIMBO BAY
DATE OF SURVEY	MAY 19, 2026
TIME OF SURVEY	FROM 02:00 HRS TO 05:20 HRS

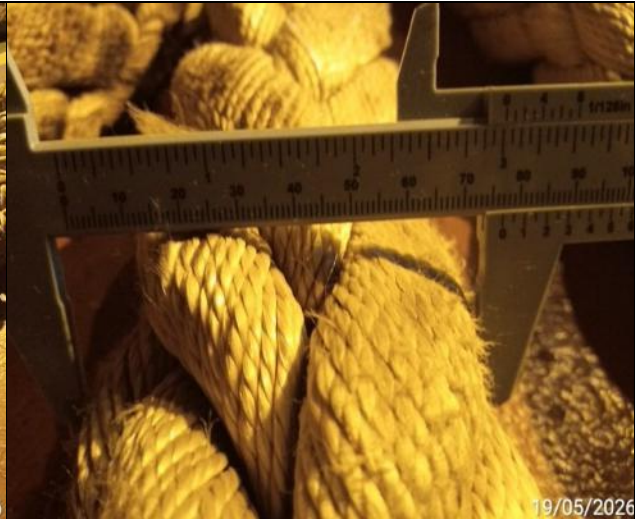
6. Diameter of the rope.

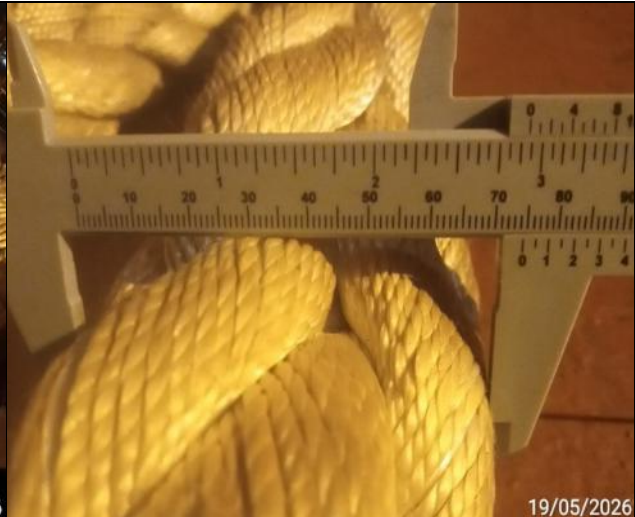
10. Diameter of the rope.

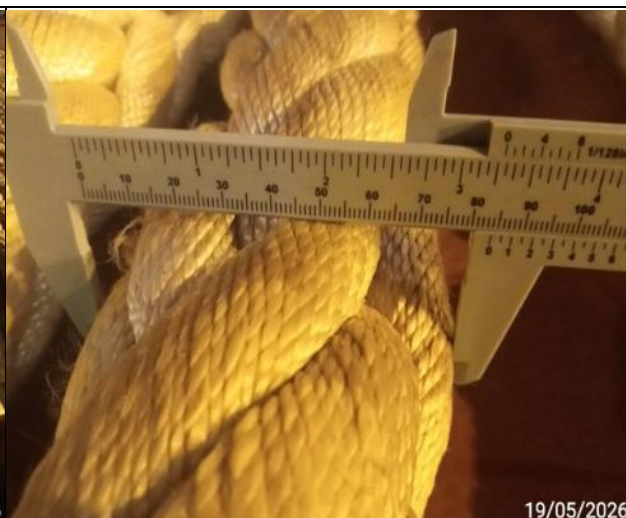
14. Diameter of the rope.

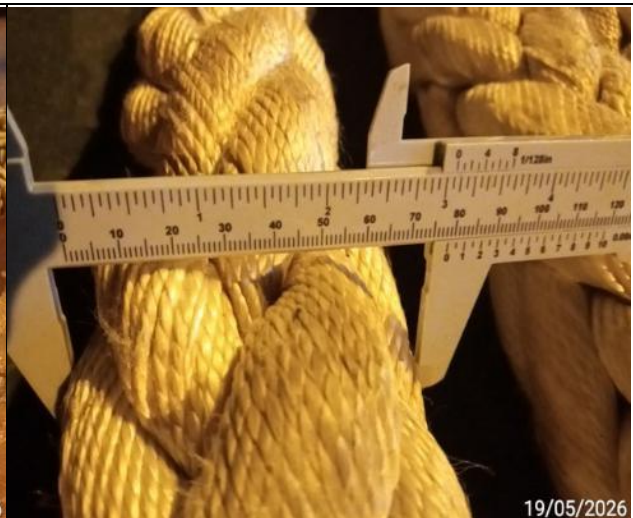
18. Diameter of the rope.

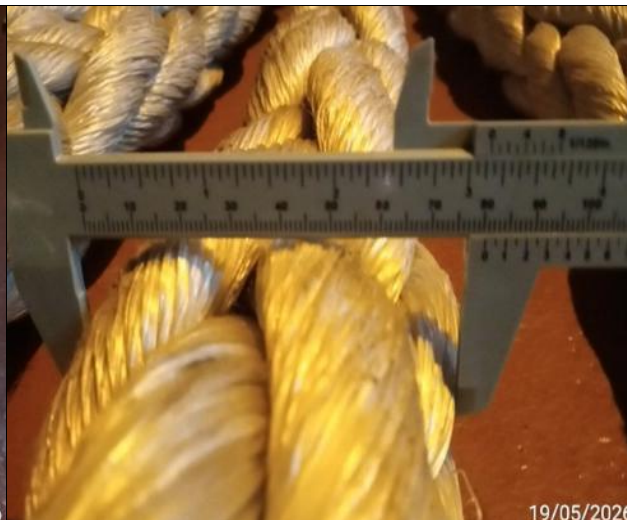
22. Diameter of the rope.

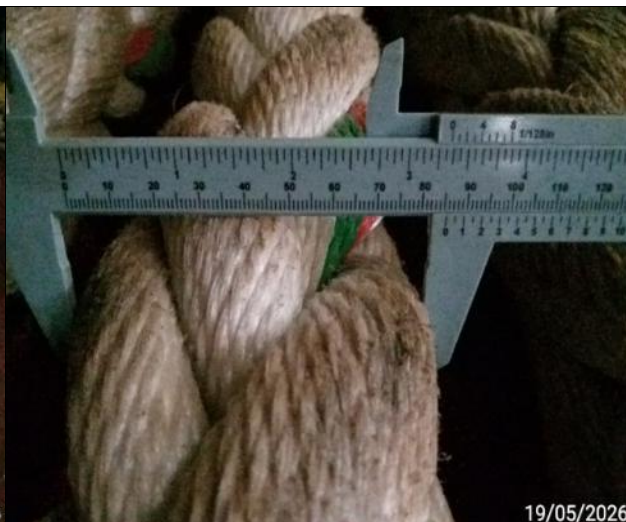
26. Diameter of the rope.

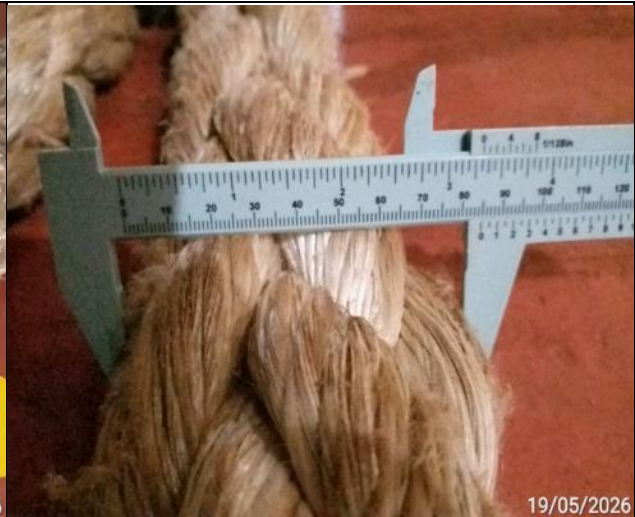
30. Diameter of the rope.

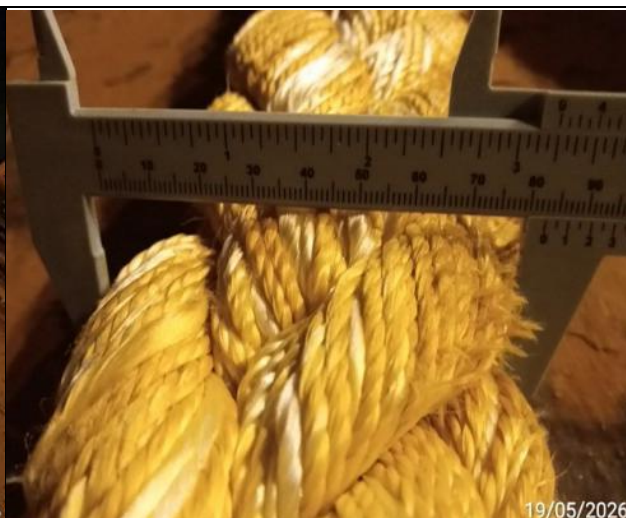
34. Diameter of the rope.

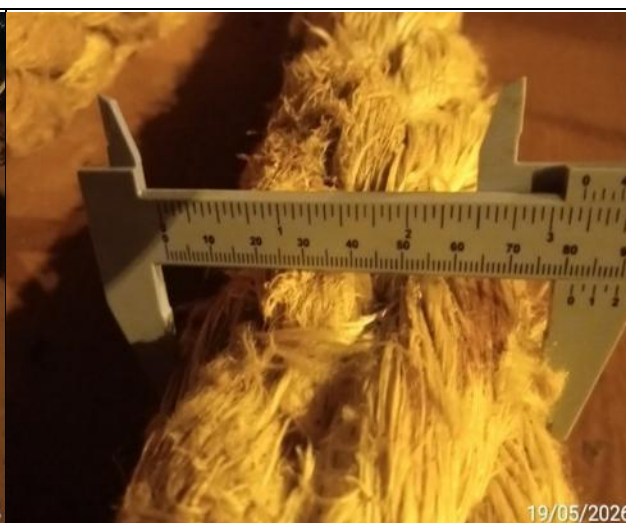
38. Diameter of the rope.

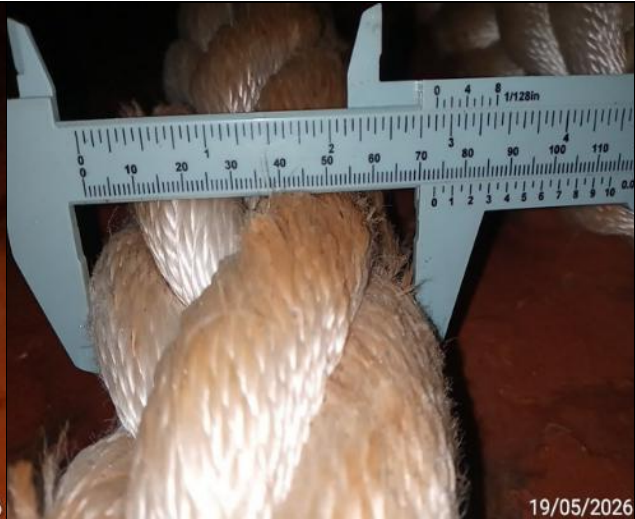
42. Diameter of the rope.

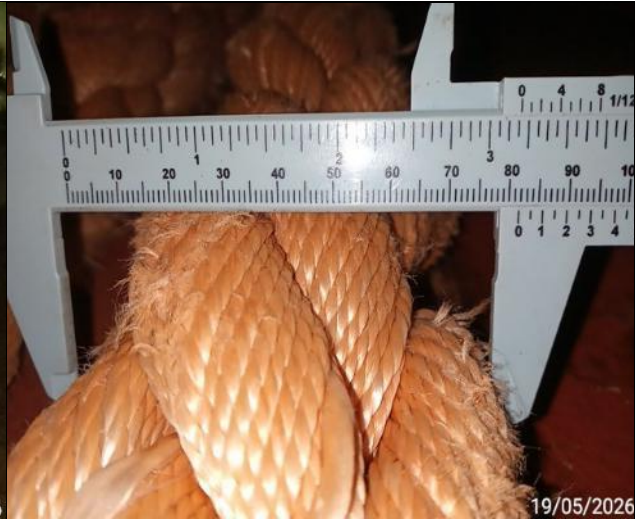
46. Diameter of the rope.

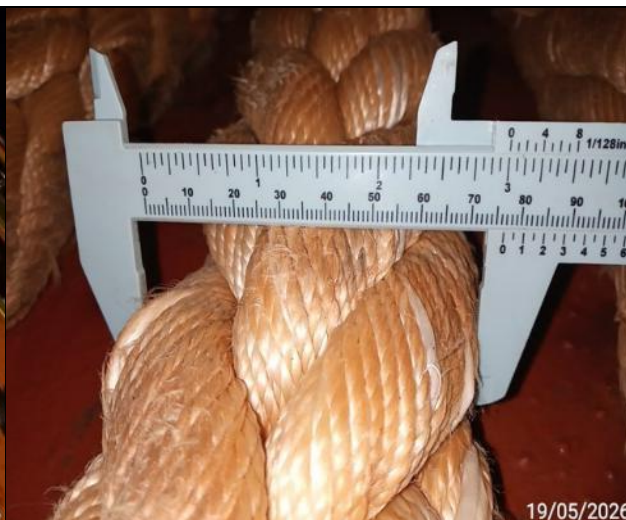
50. Diameter of the rope.

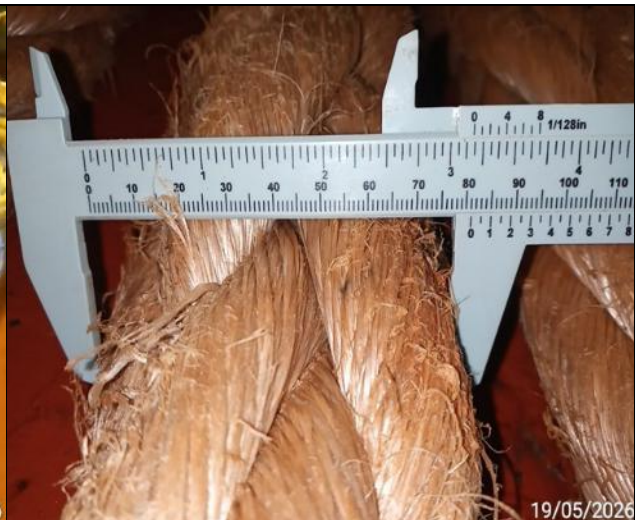
54. Diameter of the rope.

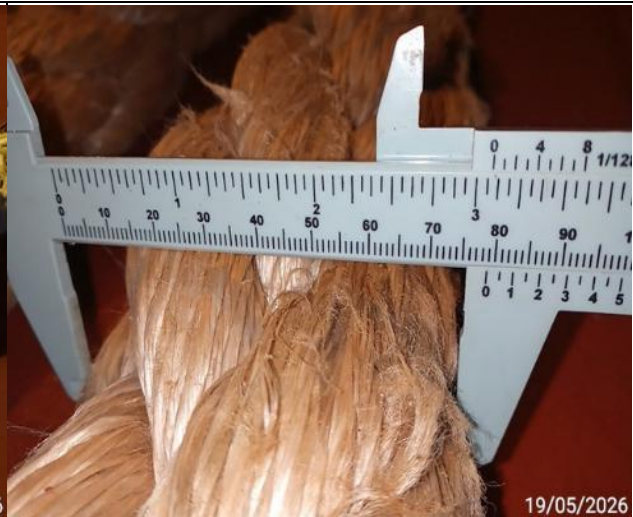
58. Diameter of the rope.

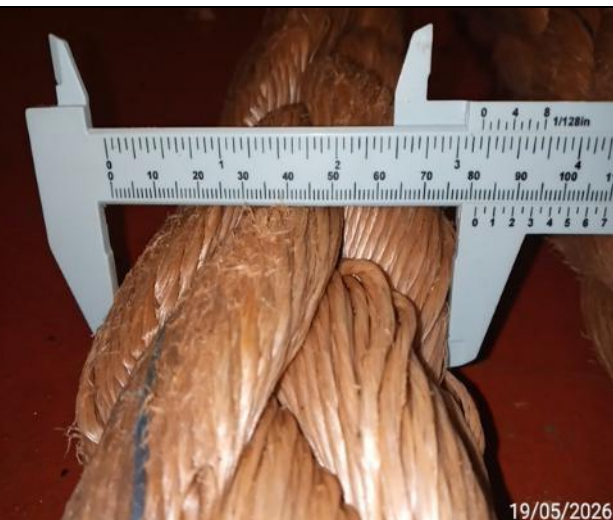
62. Diameter of the rope.

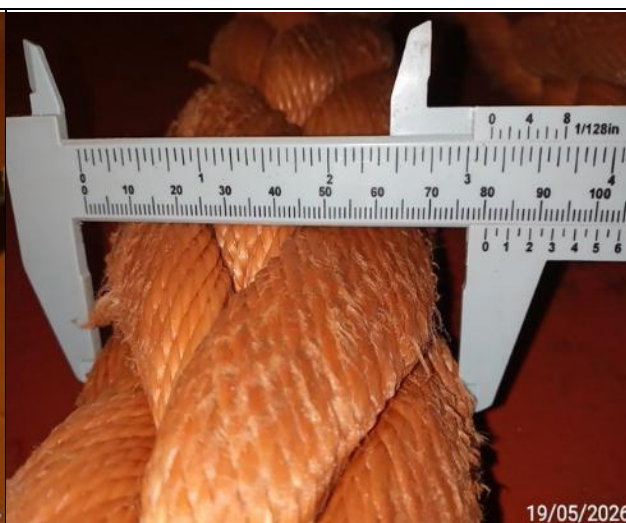
66. Diameter of the rope.

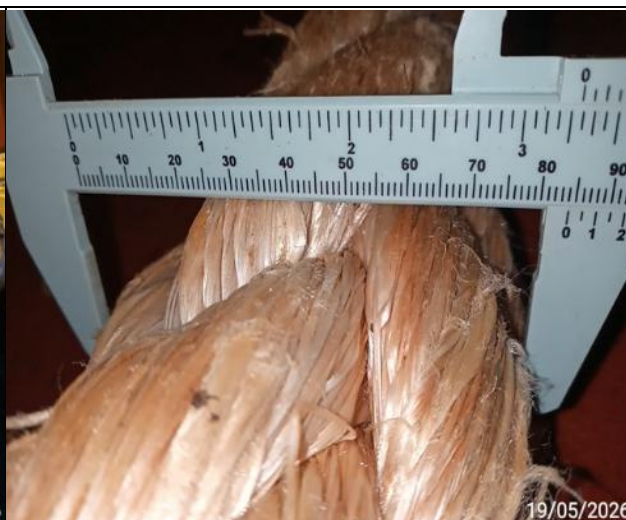
70. Diameter of the rope.
